RAILWAY INVESTIGATION REPORT

R03T0064

DERAILMENT

**CANADIAN PACIFIC RAILWAY
FREIGHT TRAIN NO. 938-12
MILE 39.5, PARRY SOUND SUBDIVISION
NOBEL, ONTARIO
13 FEBRUARY 2003**

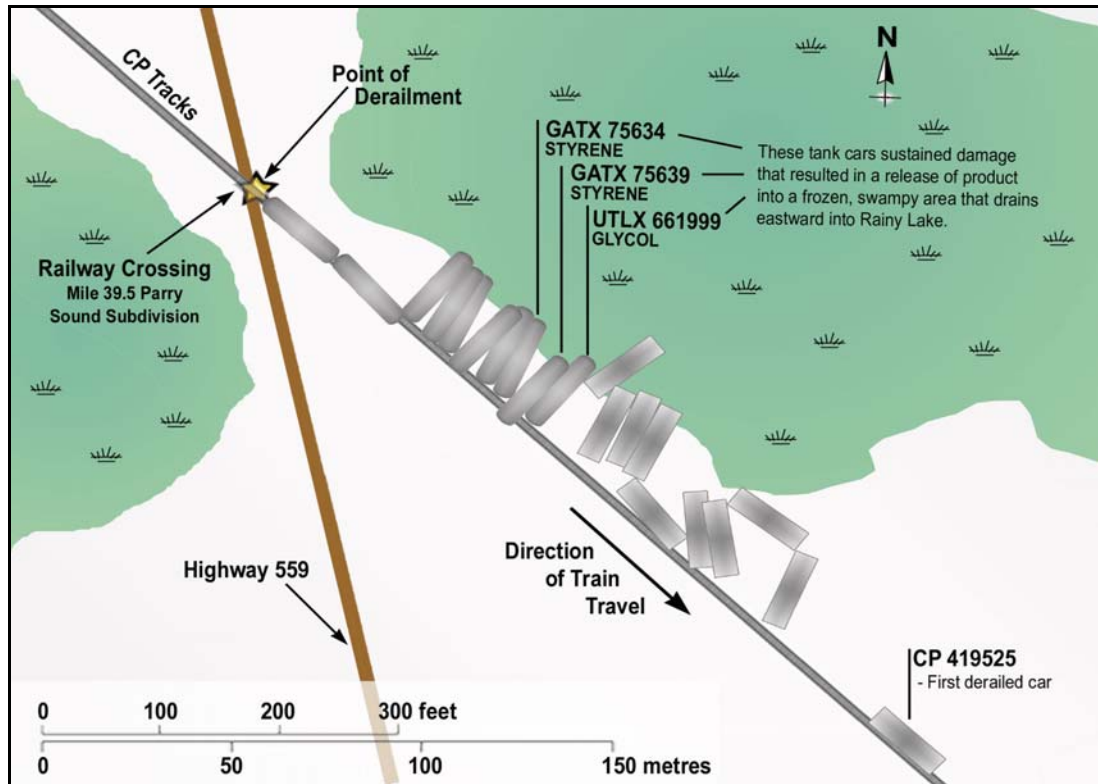
Figure 2. Derailment site sketch

The first derailed car was CP 419525, a flat car loaded with freight car wheel sets. This car, still attached to the front portion of the train, was upright with all wheels derailed. The following 20 derailed cars were separated from the front portion of the train by a gap of approximately 500 feet (150 m). Eighteen of these cars came to rest in various positions east of the track and immediately south of the Highway 559 public crossing at Mile 39.5 (see Figure 2). Approximately 430 feet (130 m) of track was damaged.

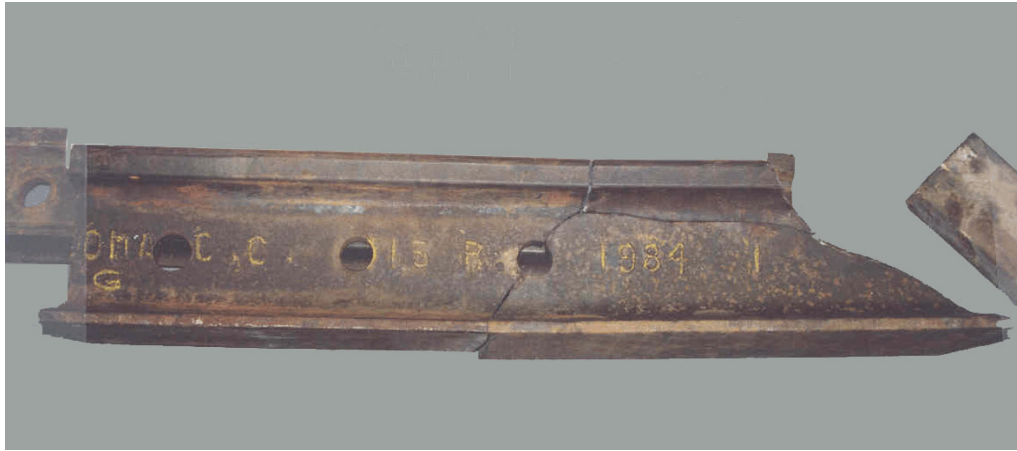
Photo 1. Reconstructed rail from suspected POD

The broken rail pieces were forwarded to CPR's Test Department in Winnipeg for failure analysis. TSB investigators were present during the tests. The rail material met CPR's specification for 115-pound carbon steel rails. Rail pieces containing the third bolt hole pre-crack and suspected POD from the east rail were reconstructed (see Photo 1).

1. The first rail piece contained the rail end, two complete bolt holes, and a portion of the third in its web. It measured 17 inches along the head and 14 inches along the base.
2. The second rail piece contained the remaining portion of the third bolt hole, measured 17 inches along the base, and was missing its rail head. The rail web fracture surface was damaged from wheel impacts resulting from wheel drop off.
3. The third piece was a seven-inch section of rail head that had separated from the web of the second piece and mated perfectly to the south-end rail head of the first piece. The third piece displayed fracture surfaces with brittle characteristics typical of catastrophic failure.

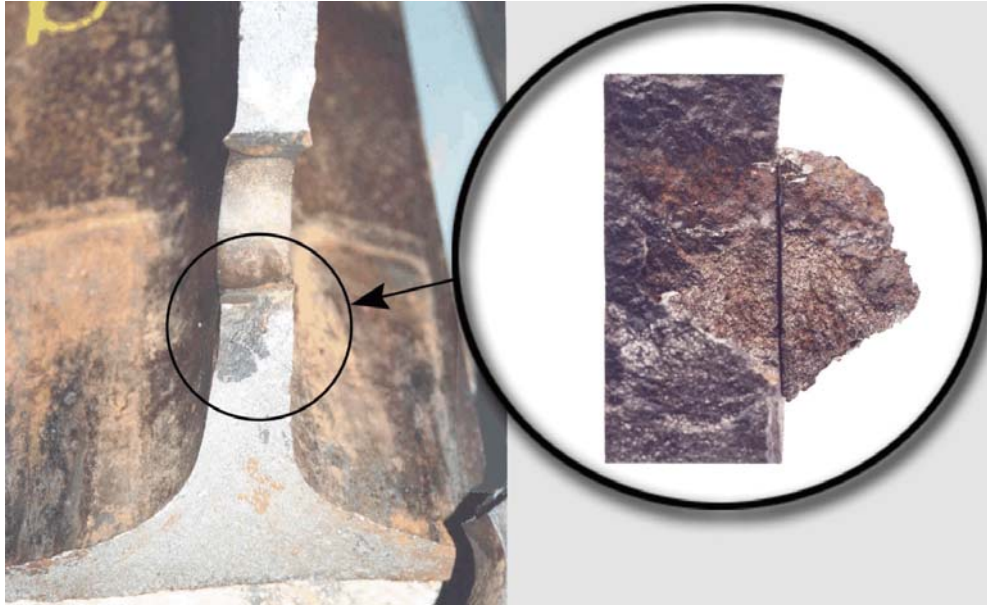
The observed dark oxidized area in the third bolt hole was determined to be a pre-crack (see Photo 2). It originated from the middle of the web in the hole's bore and extended through the entire thickness of the web downwards towards the base for 3/4 inch. From there, a secondary brittle fracture propagated down through the remainder of the rail base cross-section. Examination of a metallographic sample removed from near the pre-crack fracture origin revealed several corrosion pits and a secondary branch crack full of oxides extending from the surface of the hole bore. Two corrosion pits displayed microscopic cracks extending from their root. The examination determined that the pre-crack had been present for some time prior to the rail failure. Characteristics displayed by the pre-crack fracture surface were typical of brittle fracture with no evidence of fatigue.

Photo 2. Pre-crack in third bolt hole. Exploded view is a close-up of the full pre-crack fracture surface with the mating surface removed.

A corrosion test was performed by CPR using a broken rail from the site to determine the amount of time required to achieve the oxidized appearance observed on the pre-crack fracture surface. The test indicated that it would take longer than a month.

The train derailed just south of a public crossing when the east rail of the main track failed catastrophically in the location of a pre-existing rail joint bolt hole crack (pre-crack). A metallographic sample removed from near the pre-crack fracture origin revealed several corrosion pits and a secondary branch crack full of oxides extending from the surface of the hole bore. This suggests that at some time prior to the occurrence, a corrosion pit in the third bolt hole from the east rail end likely acted as a stress raiser and facilitated the development of the pre-crack. The lack of fatigue features on the pre-crack fracture surface suggests that it was generated by a single load some time prior to this occurrence. The amount of oxidation observed on the pre-crack, along with testing performed by CPR, confirmed that the pre-crack was likely present at the time of the ultrasonic inspection, one month prior to the accident, and had remained dormant until this occurrence.

Metallographic examination determined that the pre-crack likely developed from the root of a corrosion pit. The location of the failed rail joint, three feet south of the crossing, made it more susceptible to snow, salt, and debris from the road. The location of the rail joint in such close proximity to the road increased the risk of corrosion developing in joint components.
