**RAILWAY INVESTIGATION REPORT
R06C0104**

MAIN-TRACK TRAIN DERAILMENT

**CANADIAN PACIFIC RAILWAY
FREIGHT TRAIN CP 803-111
MILE 97.4, CANADIAN NATIONAL ASHCROFT SUBDIVISION
LYTTON, BRITISH COLUMBIA
31 JULY 2006**

Report Number R06C0104

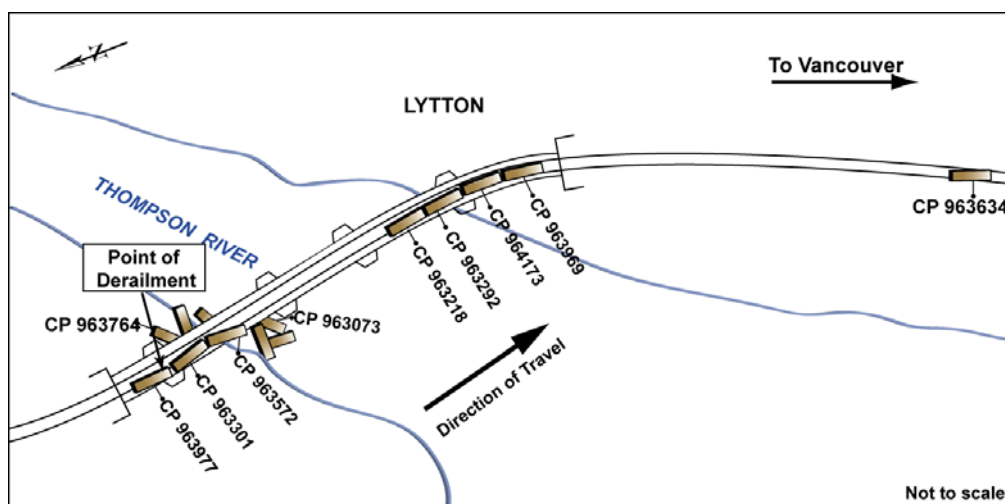
Figure 2. Derailment site

Twenty loaded hopper cars derailed in positions 77 to 96 behind the lead locomotive (see Figure 2). From the west to the east, the 77th car had its "B" end truck derailed approximately 15 car lengths west of the bridge. The next four cars (the 78th to 81st) had derailed upright at the west end of the bridge on spans four and five. The bridge consists of five spans numbered from east to west. Two cars, the 94th and 95th, had derailed and fallen into the steel structure of span 2. The 96th car "A" end truck had derailed and was upright on the east end of the bridge on span 1. Between the derailed cars at the east and west ends of the bridge, 12 cars (the 82nd to 93rd) had derailed and fallen off the bridge, 6 landing between the bridge pier and the east embankment and 6 landing in the river.

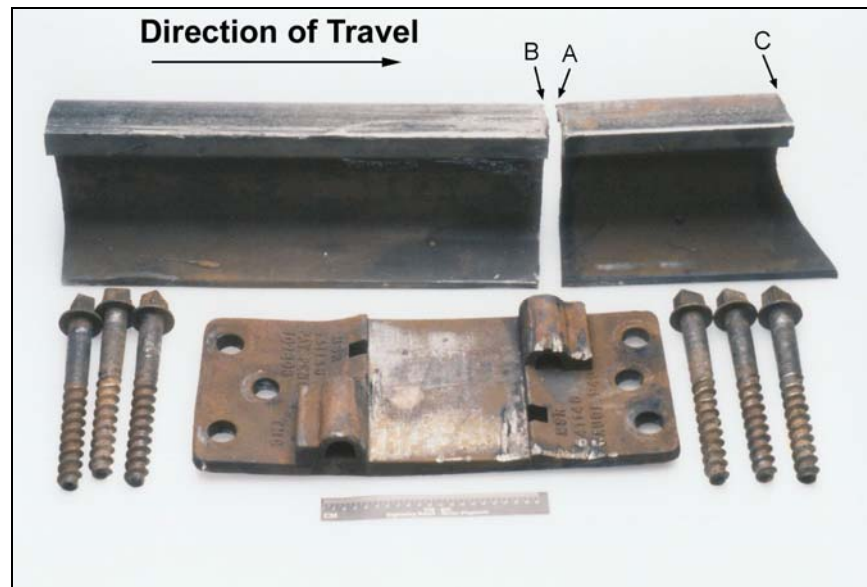
Photo 1. Recovered rail pieces and fastenings

The point of derailment was determined to be at a broken rail on a tie plate located approximately 67 feet, 4 inches west of the east abutment on the north (high) rail in the entry spiral of the eight-degree left-hand curve on the east end of the bridge. Two weeks later, another nine-inch-long piece of rail was found on the concrete pier directly below where the broken rail was found on the bridge. The two pieces of rail are shown in Photo 1 displaying fracture faces A, B, and C. The small rail piece with fracture faces A and C was ejected off the bridge deck. The rail with fracture face B remained on the bridge deck where it was struck by derailling rolling stock.

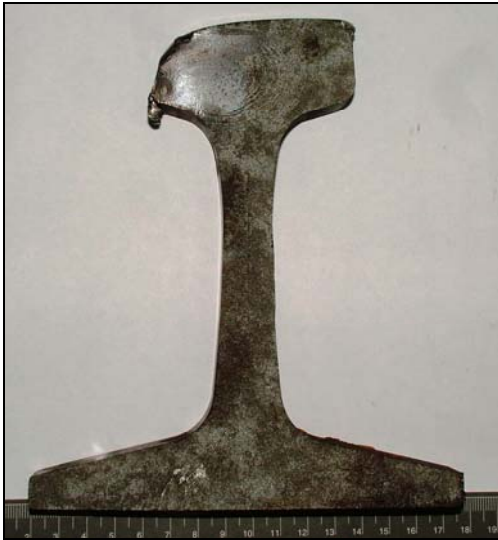
Photo 2a. Fracture face A

Fracture faces A and B matched and contained a progressive transverse fracture originating from the lower gauge corner that had propagated through a significant part of the head before it spread to the web (see Photos 2a, 2b, and 3). A significant portion of fracture face B was damaged by rubbing and impact damage was observed on the gauge corner. No corresponding rubbing damage was observed on fracture face A. Fracture face C on the east end of the smaller piece of rail also contained a progressive transverse fracture (see Photos 4a and 4b) that had propagated at an angle through the rail web and base. Beach marks² can be seen on fracture faces A and C marking the progression of the fracture.

Sperry and CN also visually examined the pieces of rail at the accident site on 05 August 2006. A reverse detail fracture type of defect on fracture face A, originating from the vicinity of a cold rolled lip condition at the lower gauge corner of the rail head, was observed.

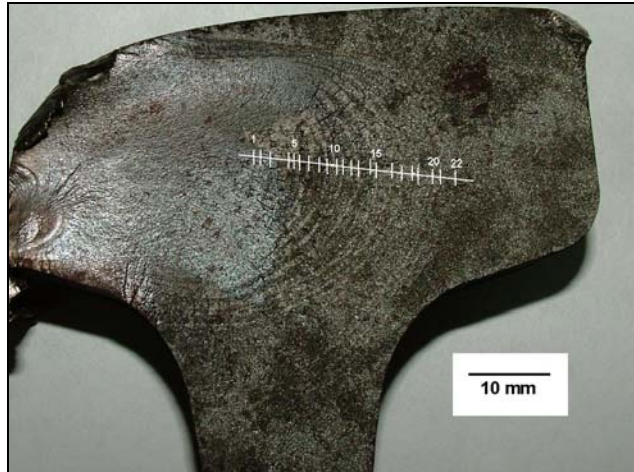
Photo 2b. Fracture face A with beach marks in the fatigue crack region

For the broken rail in this occurrence, rings or beach marks that indicate the progressive growth of the detail fracture with each fatigue cycle in fracture face A, B, and C are shown in Photos 2a, 2b, 3, 4a, and 4b. As the size of the detail fracture increases, less of the head area is available to support the load. The critical size is reached when the remaining head area can no longer support the load and a sudden and complete failure of the rail occurs.

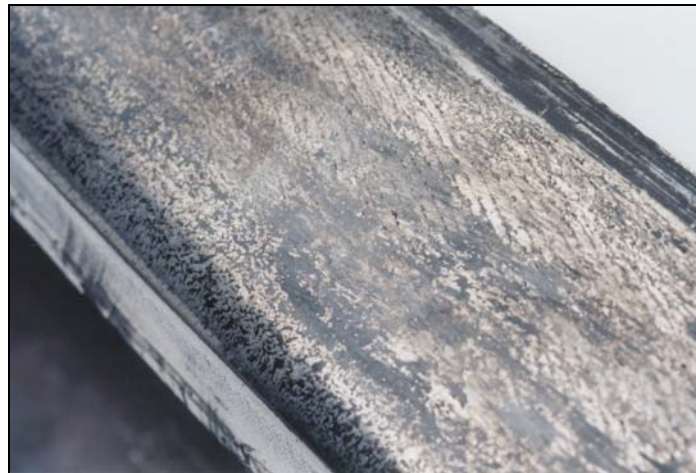
A visual inspection of the surface of the rail pieces showed fine head checking,³ some minor spalling,⁴ but no visible evidence of shelling⁵ or corrugation (see Photo 5). Minimal lubrication was observed on the top and flange of the rail.

Photo 5. Head checks in larger piece of recovered rail

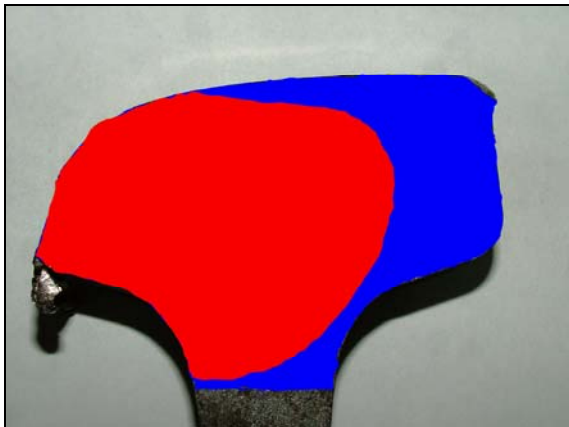
- On fracture face A, 70 per cent of the head cross-sectional area had failed due to fatigue (see Photo 6) and 34 per cent of the head cross-sectional area was burnished (see Photo 7). On fracture face C, 21 per cent of the head cross-sectional area had failed due to fatigue while 15 per cent of the head cross-sectional area was burnished (see Table 1). The size of the fatigue cracks and burnishing indicate that the defects were present for some time in the rail before the occurrence. The two defects were classified as large and medium as per the classification scheme described in the *CN Rail Defect Reference Manual*.

Photo 6. The fatigue crack area (red) of fracture surface A superimposed on rail head cross-sectional area (blue)

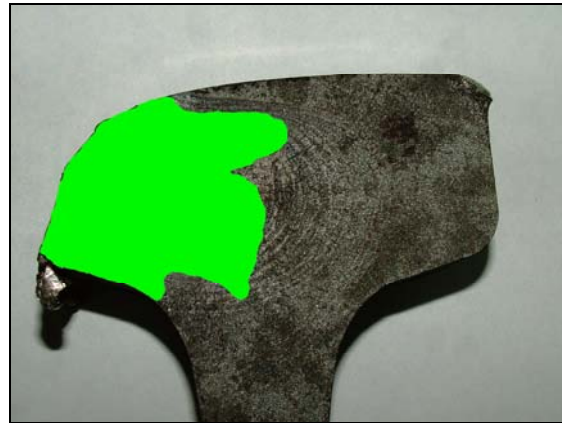
Photo 7. The burnished fatigue area (green) of fracture surface A

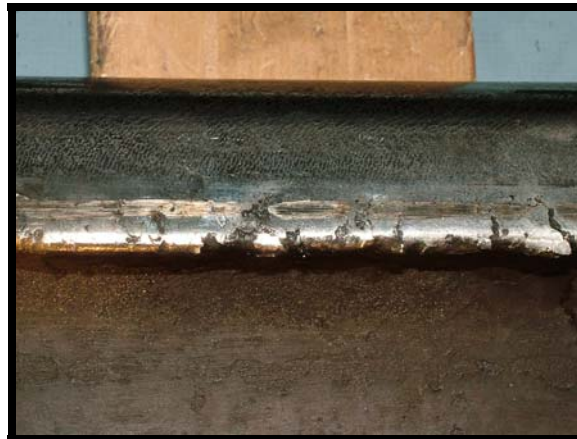
- Scuffing and tearing indicative of extreme loading were observed on the gauge side of the rail pieces (see Photo 8). In addition, heavily deformed pearlite grains and surface patches of martensite were observed on the gauge side. These observations are consistent with a rail loading condition conducive to the formation of subsurface shells that subsequently led to the initiation of transverse fatigue cracks.

Photo 8. Gauge face of rail showing indications of scuffing and tearing
