## **RAILWAY INVESTIGATION REPORT**

**R06Q0096**

### **MAIN-TRACK TRAIN DERAILMENT**

**FREIGHT TRAIN M-36231-25**

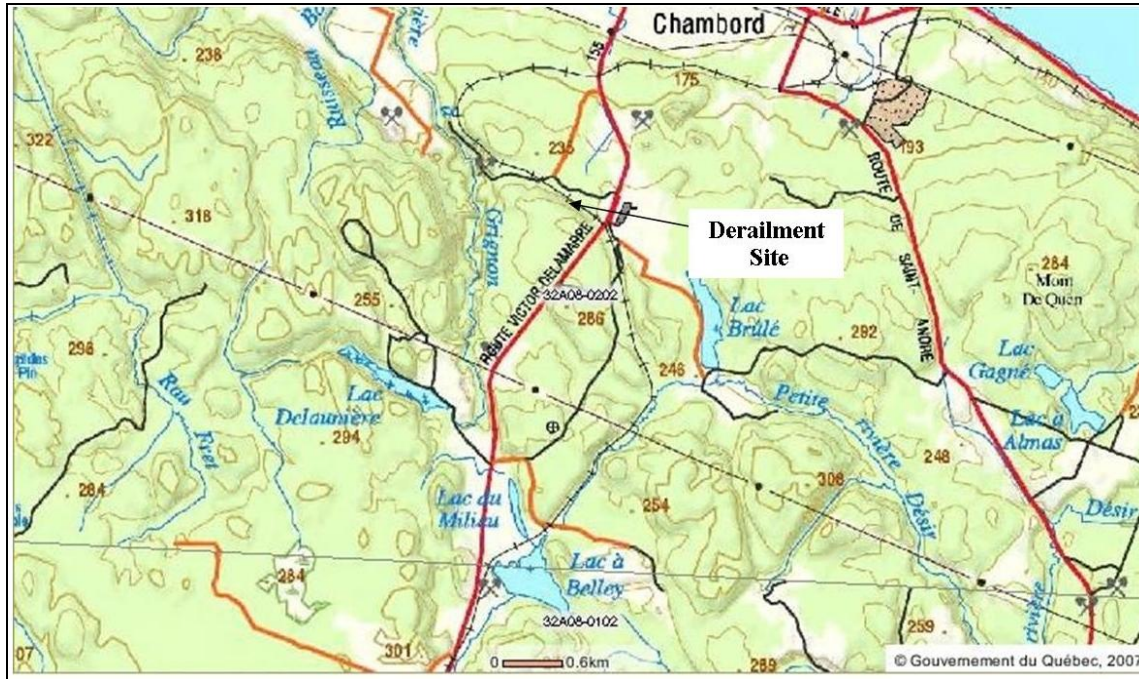
The track has a reverse curve configuration with a descending gradient to the north (direction of train movement) that varies from 0.0 to 1.0 per cent. The reverse curve consists of a two-degree, left-hand curve followed by a six-degree, right-hand curve. There is a public highway crossing in the left-hand curve and there are four private or farm crossings within one-quarter mile of the derailment in the right-hand curve (see Figure 2).

Figure 2. Derailment site

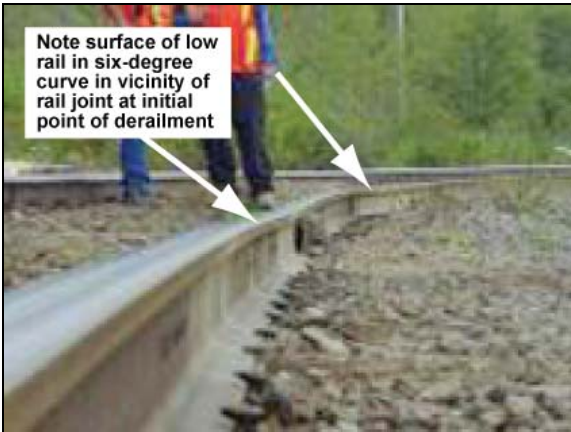
There were two rail joints, one located in each rail of the right-hand curve, staggered 10 feet apart. There was indication of vertical movement of the track structure under 12 ties on the field side of the low rail due to tie pumping. The web and base of the rail were muddy at this location as a result of the pumping. Additionally, there were small voids at the ends of the ties on the high rail indicating that the curve was moving slightly to the inside. The first marks on the head of the high rail were noted at Mile 153.2, approximately 11 feet north of a low spot on the low rail where the ties were pumping (see photos 1 to 3). The marks went to the field side of the high rail within 65 feet.

- There were two adjacent spots in the low rail where the difference in cross-level was  $5 \frac{5}{8}$  and  $5 \frac{7}{8}$  inches. In addition, there was  $\frac{3}{4}$  inch of vertical movement under the ties due to the previously described pumping conditions.

**Photo 1.** View of track surface looking northward from low rail in six-degree curve

Canadian National (CN) has been addressing superelevation on the Lac-Saint-Jean Subdivision through undercutting, surfacing, and localized work. In 2005, 22 miles were undercut and 40 miles were undercut in 2006. Approximately 10 000 ties were installed ahead of the undercutter in 2005 and more than 15 000 ties in 2006. Furthermore, in the fall of 2006, CN advised that it has enhanced the track inspection on the Lac-Saint-Jean Subdivision by increasing the frequency of track geometry car tests.

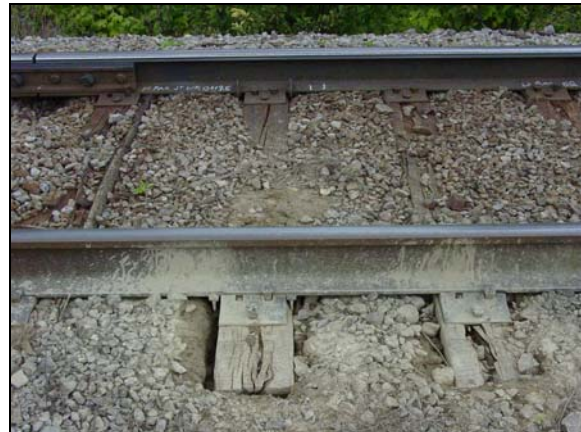
**Photo 2.** View of tie conditions on low rail of six-degree curve

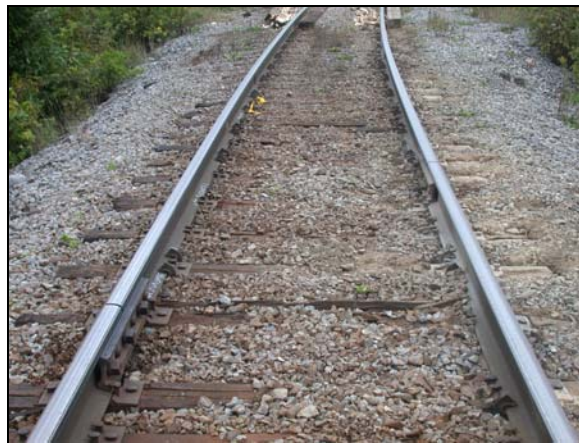
**Photo 3.** View looking northward showing location of rail joints

The natural rock-and-roll movement of the high-sided wood chip gondola cars was furthermore amplified by the pumping of the ties and the 10-foot spacing between the staggered joints, which was only slightly longer than the length of a freight car truck. As the cars were entering the exit spiral of the six-degree, right-hand curve, the combined effect of the excess superelevation and the pumping ties in the presence of the staggered rail joints resulted in wheel lift and the subsequent derailment of the loaded wood chip car to the field side of the high rail. As the car ran derailed, it damaged the track, resulting in the derailment of 11 other cars.

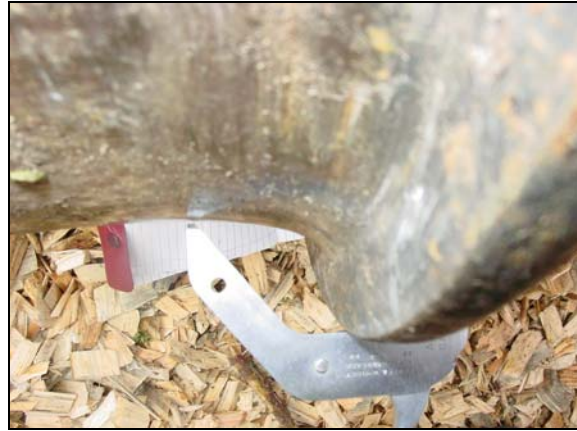
One derailed wheel set was noted to have a flange height of more than 1 ½ inches, exceeding the TC-approved *Railway Freight Car Inspection and Safety Rules* limit (a high-flange condition, see Photo 4).

**Photo 4.** High-flange condition on one wheel set

Although one of the derailed wheel sets was noted to have a high-flange condition, it was not considered to have been a contributory cause to the accident because wheels with high flanges are not typically prone to derailments involving wheel lift. The high flange and the condition of the centre plate rim, given its concealed location, were not detected during the safety inspection at Garneau Yard by qualified inspectors, highlighting the limitations of visual inspections in train yards to detect such conditions.

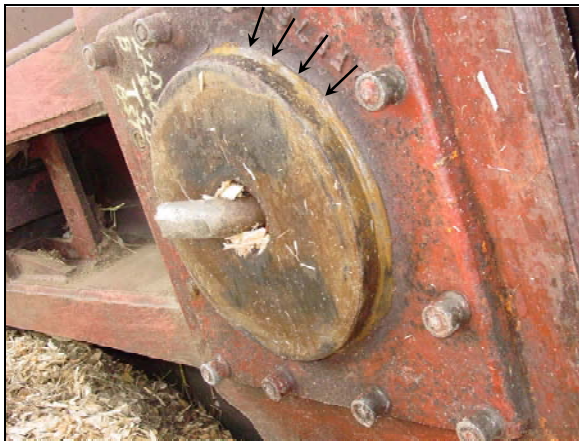
The centre plates on the second and third derailed wood chip cars were examined. Both the truck and body centre plates were noted to have wear beyond the vertical surfaces at the outer radii of the centre plates (see Photo 5 and Photo 6). The centre plate conditions would not have been easily identified during safety inspections of railway cars in a train due to their somewhat concealed location under the car body.

**Photo 5.** Body centre plate (B-end). Arrows point to wear area

- The wear areas on the centre plates were relatively equal and symmetric, suggesting that the wear was caused during rock-and-roll motion, which is not unusual for high-sided cars.
- The rim of the truck centre plate had been in long-term contact with the base of the body centre plate, which is a condition not allowed by the Association of American Railroad (AAR) rules.
- Even light rim contact off-centre can produce extra wheel unloading and increase rotational resistance moment of the truck.

The examination of the centre plates on the wood chip cars revealed that the cars were rocking and rolling to the extent that there was contact at the centre plate bowl rim locations. This modified the load distribution at the car body-to-truck interface and consequently affected the rock-and-roll and curving characteristics of the cars. Furthermore, the asymmetrical loading of the car contents was biased towards the low rail, resulting in wheel unloading on the high rail.

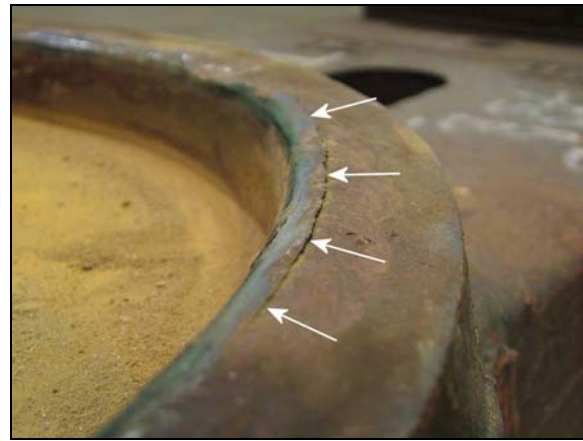
**Photo 6.** Edge of truck centre plate with raised lip that was smeared from contact wear
