**RAILWAY INVESTIGATION REPORT
R07E0129**

**CANADIAN NATIONAL TRAIN NUMBER 417
AND
CANADIAN NATIONAL TRAIN NUMBER 342
MILE 112.1, EDSON SUBDIVISION
PEERS, ALBERTA
27 OCTOBER 2007**

Report Number R07E0129

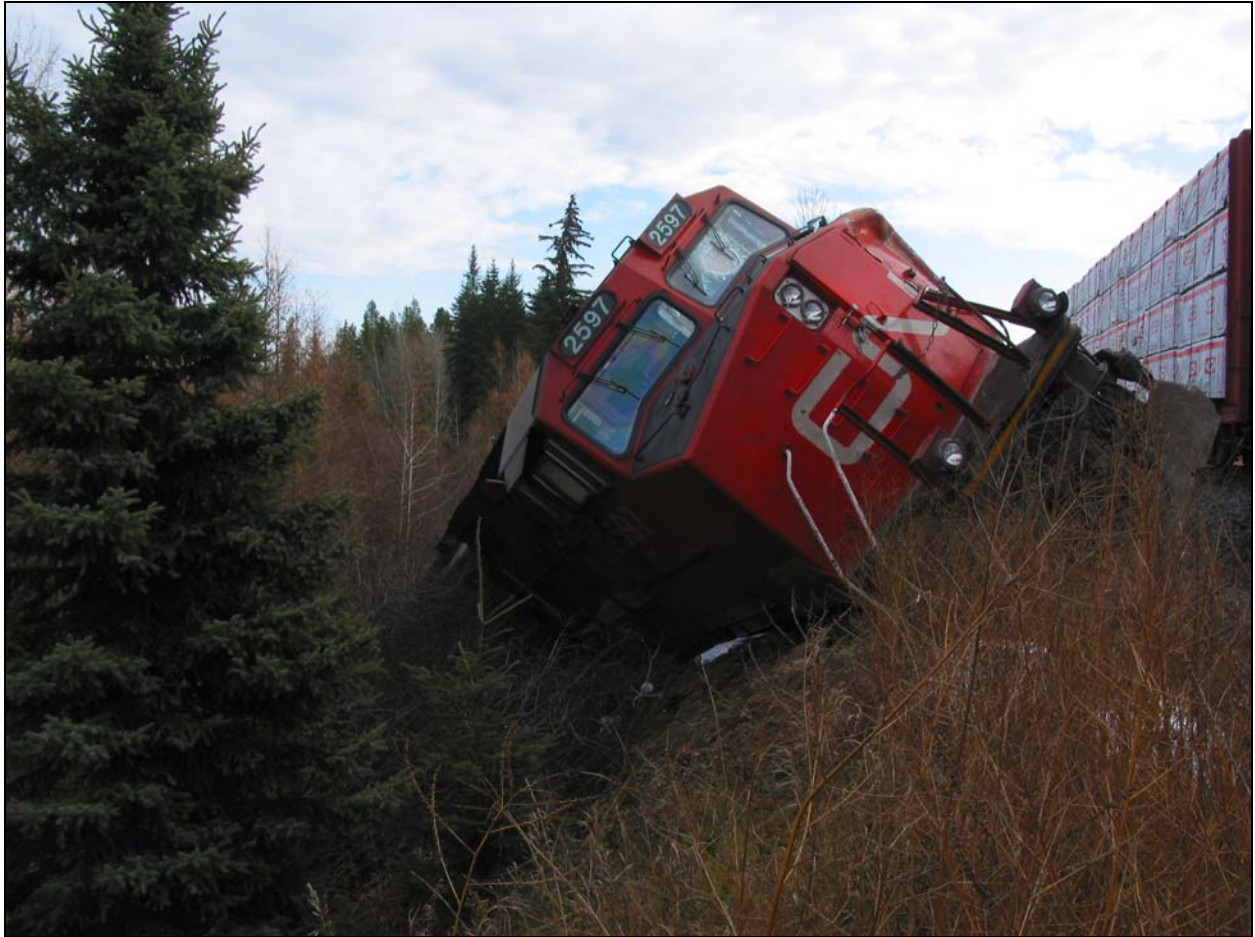
Photo 1. Derailed lead locomotive number 2597

Four cars from Train 342 (the 35th and the 45th to 47th cars) sustained damage in the initial collision. Train 417's abrupt stop caused an additional collision between the two trains further east as derailed cars from Train 417 contacted Train 342, derailing 5 cars (the 26th to 30th cars). Figure 2 shows the track layout and location of derailed equipment.

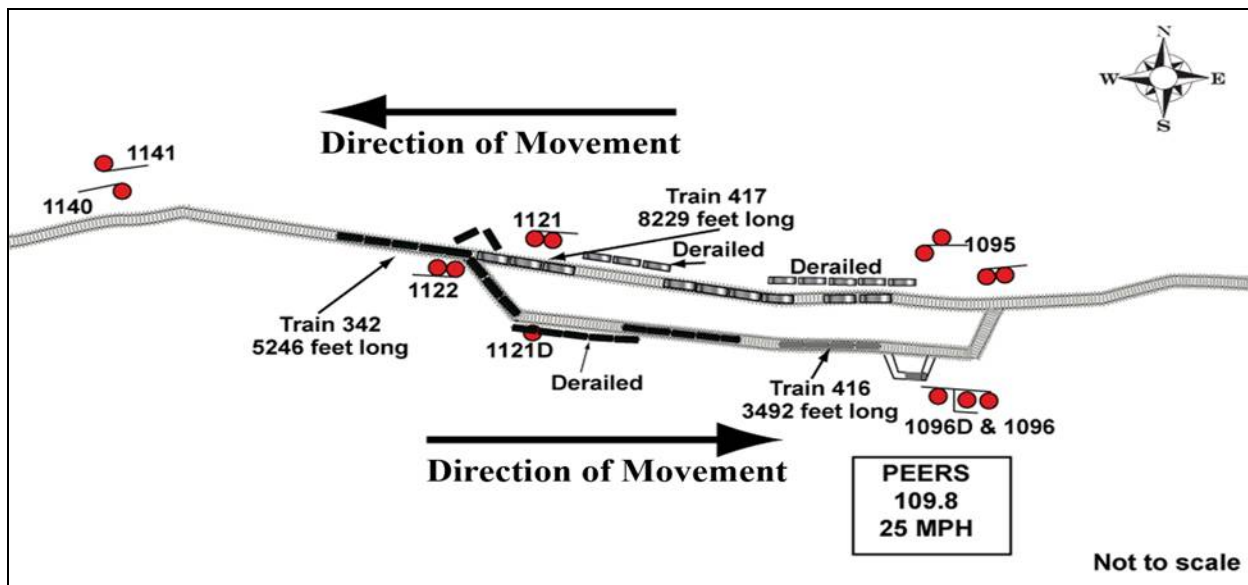
Figure 2. Track layout in the vicinity of the collision site and derailed rolling stock location

The collision occurred when Train 417 passed a stop signal at the west end of Peers and struck the side of Train 342 as it was entering the siding. Train 417's locomotives and a number of cars on both trains derailed. Train 417's fatigued locomotive engineer lost situational awareness as he approached Peers. He had formed a mental model that he was actually at another location, Yates, about 13 miles away, where there were also two tracks. Although he acknowledged the signal indication at the east end of Peers and he was aware of the requirement to stop at the next signal, these stimuli were not sufficiently compelling to correct his mental model and bring about the appropriate train control decisions.

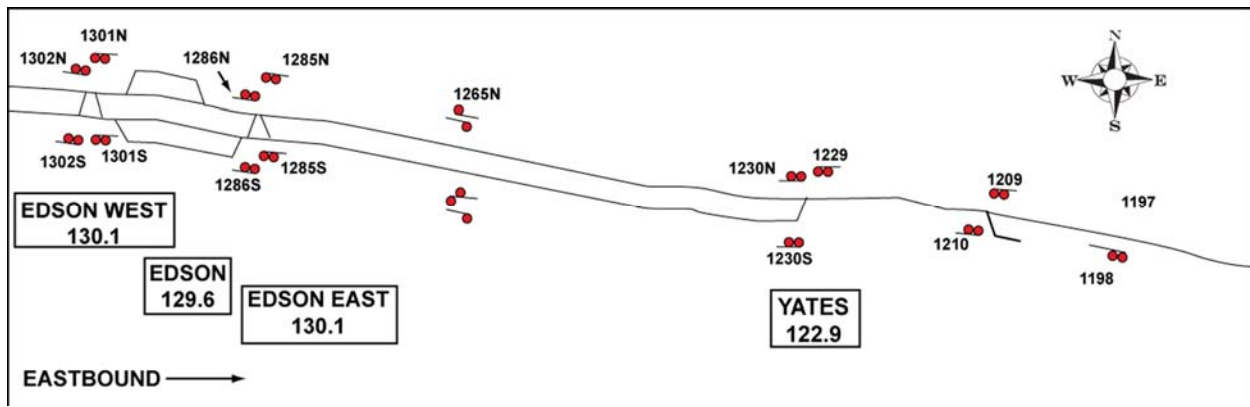
Just prior to the accident, the locomotive engineer formed a mental model that he was actually two stations away, in Yates, about 13 miles further to the west, where there are also two tracks (see Figure 3). The double track that commences at Yates continues for 12.8 miles, whereas the siding that commences at Peers extends for 2.6 miles. The distance between the first two signals encountered for westbound trains is 3.6 miles at Yates as compared to 2.6 miles at Peers.

Figure 3. Yates is the location on the Edson Subdivision where the locomotive engineer thought he was operating just before the accident

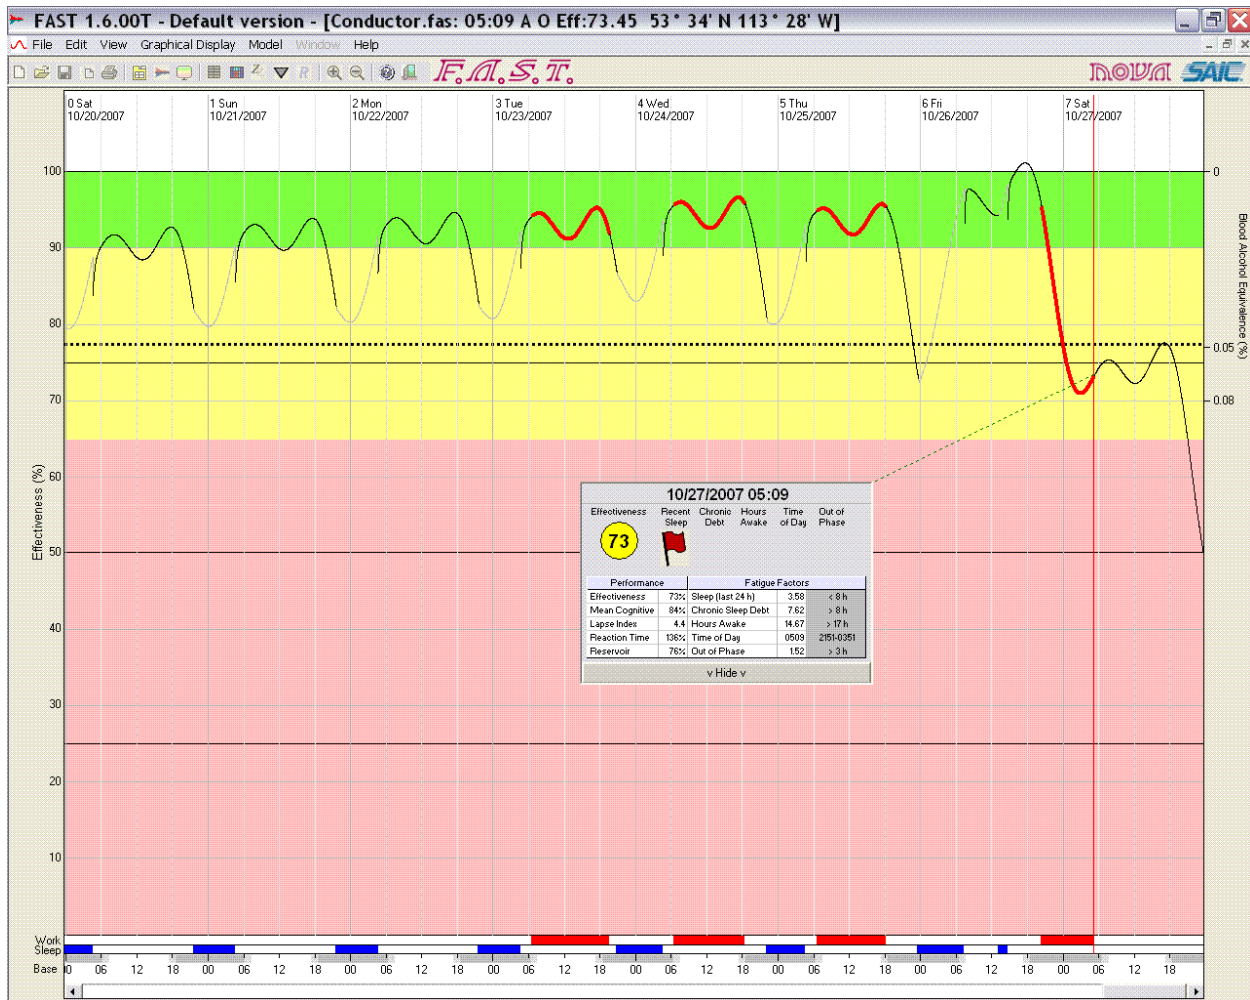
FAST Table for Locomotive Engineer – Train 417

Research has consistently shown that long periods of wakefulness result in fatigue¹³ and this can occur even if short naps are taken during periods of wakefulness of twenty hours or more. Considering that Train 417's locomotive engineer had been awake for about 22 hours without any restorative rest and the conductor had been awake for approximately 21.5 hours with only an approximate one-hour nap, it is very likely that the performance of the crew had diminished.

The results of the fatigue analysis indicate that Train 417's crew was insufficiently rested to be engaged in safety-critical tasks. While the railway's *General Fatigue Management Plan for Rail Operating Employees* lists a number of suggested strategies to deal with fatigue, opportunities to enact several of these countermeasures were not taken.
