**RAILWAY INVESTIGATION REPORT  
R07T0240**

**MAIN TRACK TRAIN DERAILMENT**

**CANADIAN PACIFIC RAILWAY  
FREIGHT TRAIN No. 230-25  
MILE 42.80, BELLEVILLE SUBDIVISION  
TICHBORNE, ONTARIO  
25 AUGUST 2007**

Report Number R07T0240

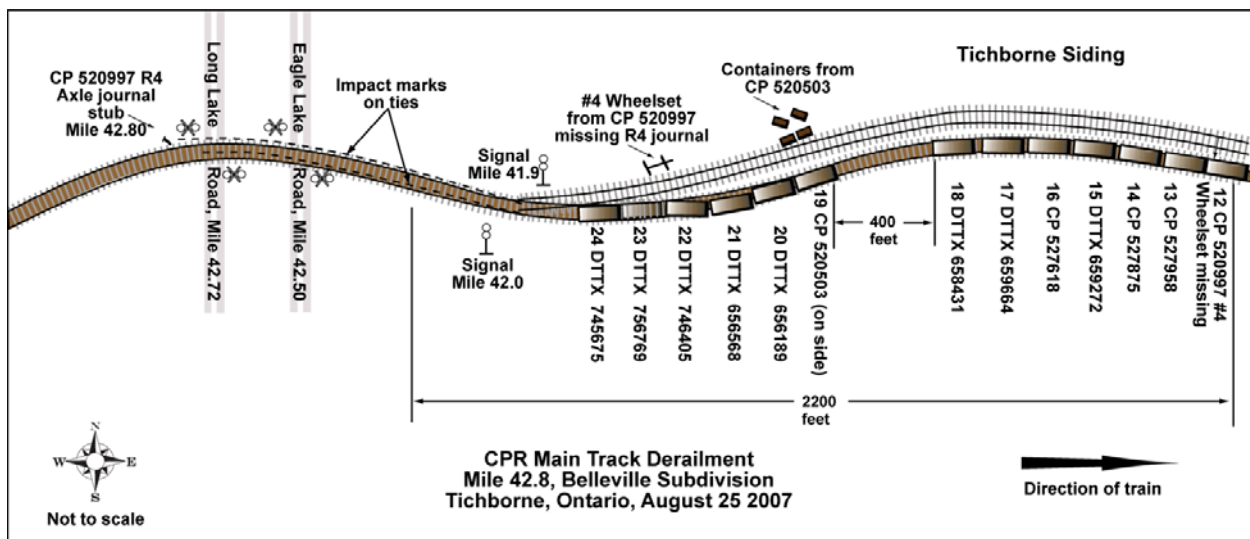
Figure 2. Diagram of derailment site

Cars 12 to 18 remained upright, coupled together, and were followed by a 400-foot gap. The 19th car, CP 520503, came to rest on its side while its containers were alongside the car in a ditch just north of the siding. The 20th to 24th cars remained upright and coupled together.

Approximately 2200 feet of track, including the Tichborne west end siding turnout, and the signal mast at Mile 41.90 were damaged.

At the west end of the derailment site near the siding turnout, the mainline track had been displaced approximately two feet northward. Impact marks were observed on the track ties along the gauge side of the south rail and the field side of the north rail extending westward from the turnout. The marks were traced back, over two automated public crossings, to Mile 42.80 where the axle journal stub, with its roller bearing still attached, was located on the north (high) side of a right hand curve in the direction of travel (see Figure 2). The failed wheelset and severed axle journal stub, complete with the roller bearing, were sent to CPR's Test Department in Winnipeg, Manitoba, for failure analysis.

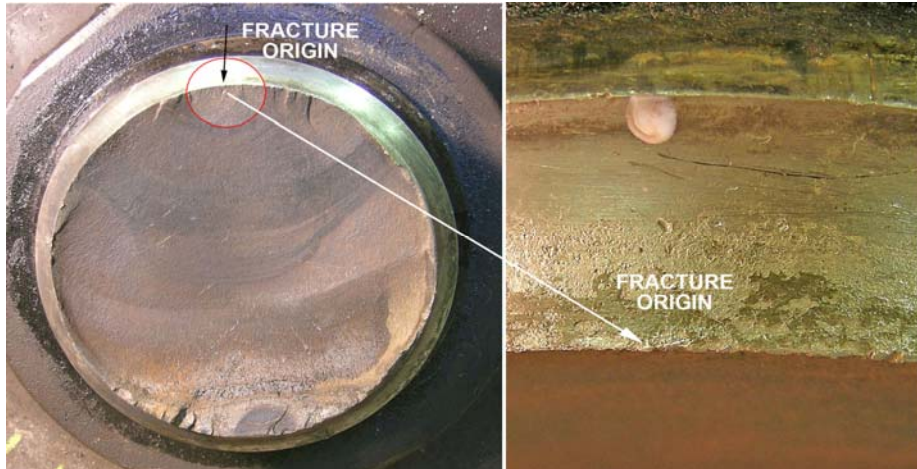
**Photo 1.** Exposed fracture surface identifying fracture origin and a close-up of corrosion pitting on the fillet radius (Source: CPR).

- The axle fractured in the area of the R-4 fillet radius, approximately 11 inches inboard of the end of the journal. There was no evidence of overheating. The fracture was perpendicular to the principal stresses acting on the axle. The fracture displayed primary and secondary fatigue cracks as well as a small, brittle failure zone which is normally associated with sudden or catastrophic failures. The fatigue fracture zones were characterized by beach marks which were traced back and identified an area of suspected fracture origin.

- The primary fatigue fracture originated at several corrosion pits on the fillet radius and propagated as multiple small fatigue cracks. These small cracks joined to form a common crack front. Driven by rotating bending stresses, the primary crack propagated in fatigue through approximately 80 per cent of the axle's cross-section over some finite period of time. Typical of rotating bending failures, a small secondary zone of fatigue was observed directly opposite the primary fatigue crack fracture origin (see Photo 1).

- Metallurgical examination confirmed corrosion products at the root of pitting on the fillet radius. No other anomalies were identified. The axle material conformed to the requirements of AAR Specification M-101 for Grade F steel. The microstructure consisted of a mixture of fine-grained pearlite and ferrite, which was consistent with the specified material and heat treatment.

The R-4 axle journal failed in fatigue which originated at several corrosion pits on the fillet radius and propagated as multiple small fatigue cracks. These small cracks joined to form a common fatigue crack front which progressed through approximately 80 per cent of the axle's cross-section over some finite period of time. The final failure occurred catastrophically, under normal service conditions, when the applied load exceeded the diminished strength of the journal's reduced cross-section.

On 28 March 2008, the AAR issued Circular Letter C-10711 for comments which contained proposed revisions to the G-II manual, Rules 1.1.8 and 1.2.4. The proposals essentially required the fillet radii of both secondhand unmounted axles and turned wheelsets to be wet magnetic particle tested for cracks. In addition, it was proposed that a requirement be added to scrap any axles where cracks can not be removed without going below the condemnable axle dimensions. It is expected that these changes will be effective by the fall of 2008.

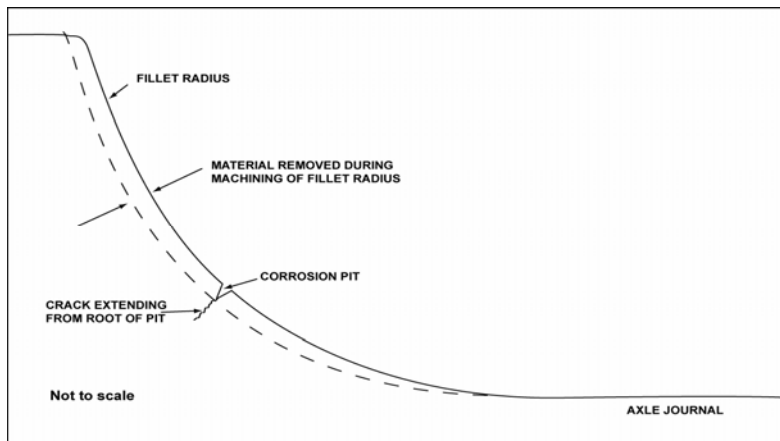
**Figure 4.** Potential effect of machining on pitting in the fillet radius

The failed wheelset was reconditioned by Progress Rail's wheel shop facility (PRWW) in accordance with Association of American Railroads (AAR) requirements in May 2002. The fillet radii were machined to remove any pitting and then visually inspected; no cracking was observed. However, a wet magnetic particle inspection was not conducted on either fillet radii. Furthermore, there was no AAR requirement to conduct such testing on the fillet radii of either secondhand unmounted axles or turned wheelsets. While there is no way to determine precisely when fillet radius pitting and fatigue cracking initiates, it is possible for small fatigue cracks to be present and go undetected during reconditioning despite compliance with current AAR G-II criteria.

The fillet radius is a critical transition area of the axle that is subject to high loading and flexing during normal service as the weight of a freight car is transferred through the fillet radius to the wheel. Due to the loading, the fillet radius is notch sensitive and surface imperfections or subsurface cracking within the area can become nucleation points for fatigue crack development. Corrosion pits are typically "U" or "V" shaped. Applied loads tend to focus at the root of the pit which in turn initiates small fatigue cracks. Such cracking may still be present after the fillet radius pitting is removed (see Figure 4). The cracks tend to remain tight and are not detectable by visual inspection alone. Therefore, additional non-destructive testing methods such as ultrasonic or wet magnetic particle testing are required to consistently detect such cracks.
