RAILWAY INVESTIGATION REPORT
R07T0323

MAIN TRACK DERAILMENT

CANADIAN NATIONAL
TRAIN NUMBER M-38461-29
MILE 9.30, HALTON SUBDIVISION
MALPORT, ONTARIO
30 OCTOBER 2007

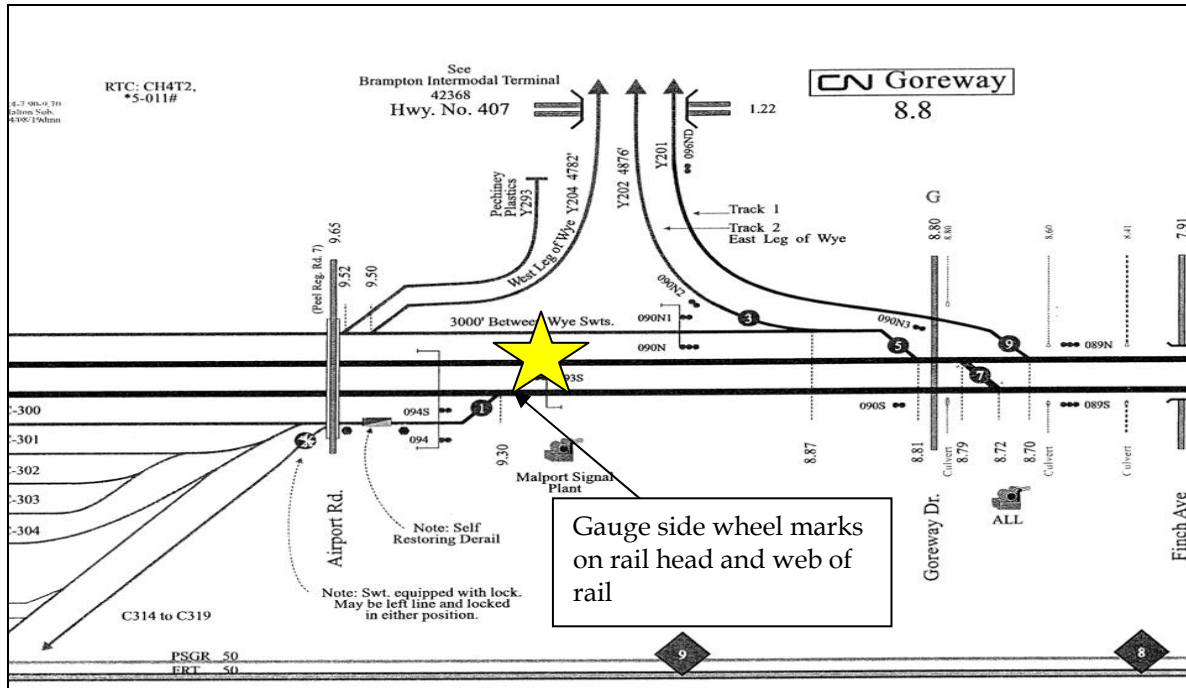
Figure 2. Derailment site at entrance to BIT

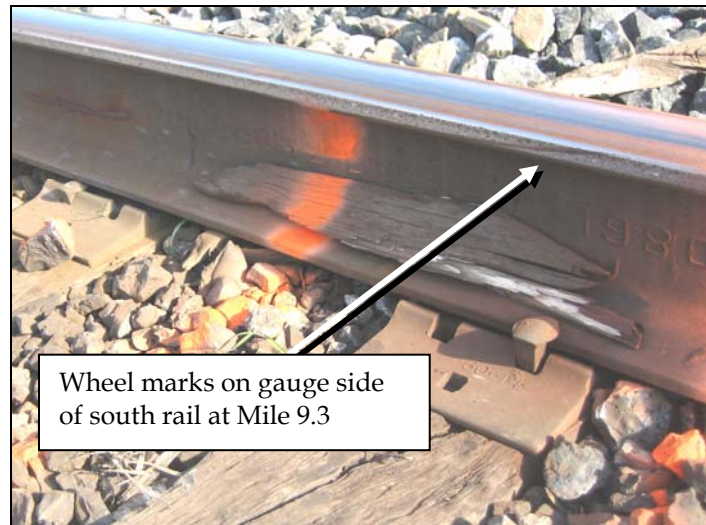
Examination of the rail revealed multiple wheel flange marks on the gauge side of the north and south rail. Some wheelsets were straddling the south rail, east of where the rail had fractured at thermite welds. Damage to cross-ties, anchors, and spikes was predominantly to the gauge side of both rails. The wheel marks were traced back to the vicinity of Mile 9.3, where there were marks on the head and gauge side of the south rail (see Photo 1). Approximately 20 feet to the east, there were similar wheel marks on the north rail. In the vicinity of these wheel marks, spikes on the gauge side were lifted, consistent with the rail having canted out.

Photo 1. Mile 9.3 of the north track of the Halton Subdivision

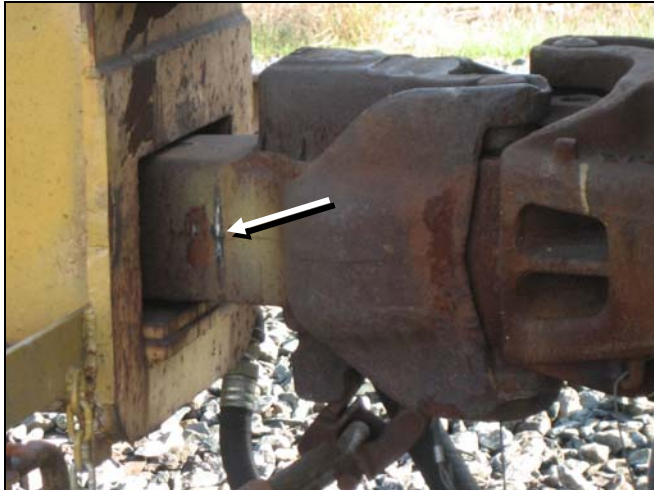
Many of the derailed cars showed recent impact marks on the centre of the car end sill draft opening and the coupler horn. Examination of a group of 10 air dump cars revealed that 7 of these cars ⁴ had severe gouging on the sides of their coupler shanks and impact marks on the side of the car end sill openings (see Photos 2a and 2b). These gouge marks were most prominent between cars BGSX 122226 (the 23rd car) and BGSX 122227 (the 24th car). In addition, the wheel treads on these two cars were battered and scored.

Photo 2a. Severe gouging on the side of the coupler shank of car BGSX 122226

Impact marks on the coupler shank and end sill opening in a group of derailed air dump cars were consistent with a train slack run-in event. Track damage was consistent with rail roll out and wheel drop in. A dynamic analysis was conducted, focusing on the two air dump cars with the most damage: BGSX 122226 and BGSX 122227 (the 39th and 40th cars in the train consist, prior to the setoff of cars at BIT). Based on analysis of detailed track, equipment, and event recorder data, it appears that an elevated buff force event occurred when the train originally came to a stop on the Halton Subdivision. The timing of the buff force event placed the two air

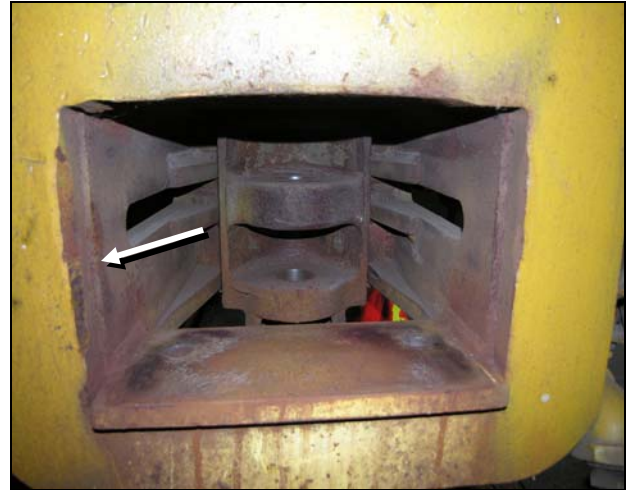
Photo 2b. Impact marks on the end sill opening

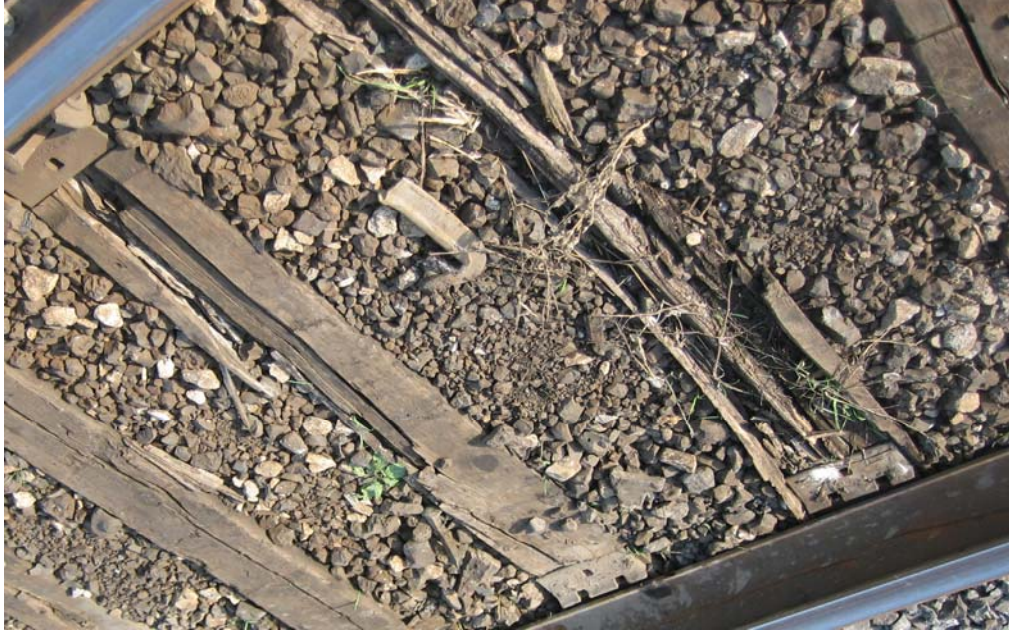
Tie condition in the vicinity of the derailment area was marginal (see Photo 3). Prior to the derailment, CN's most recent documented tie count (conducted in April 2007 - see Appendix A), identified 41 defective ties out of the 100 ties just west of the point of derailment (POD), and 1056 defective ties between Mile 9.0 and Mile 10.0. The last major tie program in the area was completed when the rail was installed in 1987.

Photo 3. Tie condition in the vicinity of the derailment

However, the track structure was weakened by a deteriorated tie condition, resulting in a reduced resistance to lateral forces.

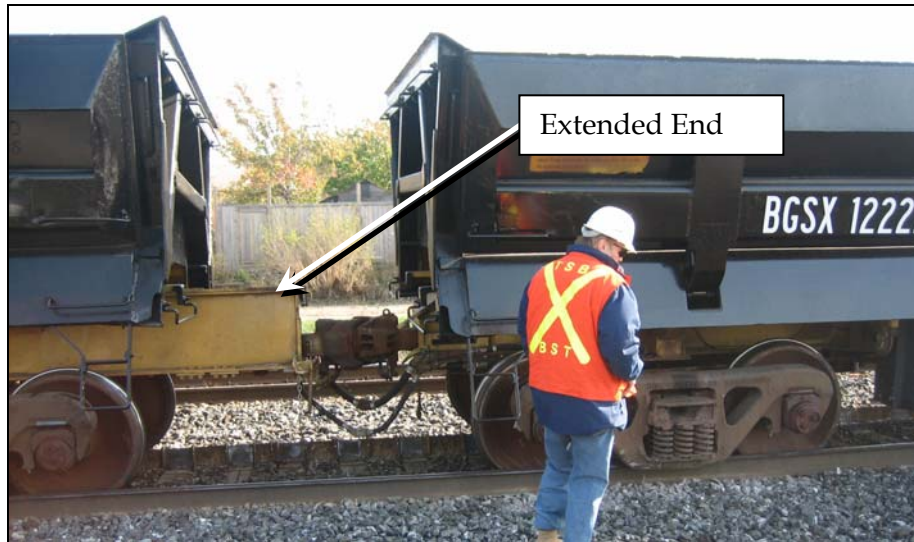
Some of the air dump cars involved in this occurrence were designed to carry a cab unit for controlling car dumping activities. However, the cab unit on these cars had either been removed or had not been installed. These cars, such as BGSX 122226 had an extended end sill (see Photo 5).

Photo 5. Side view of BGSX 122226 (extended end sill) and BGSX 122227

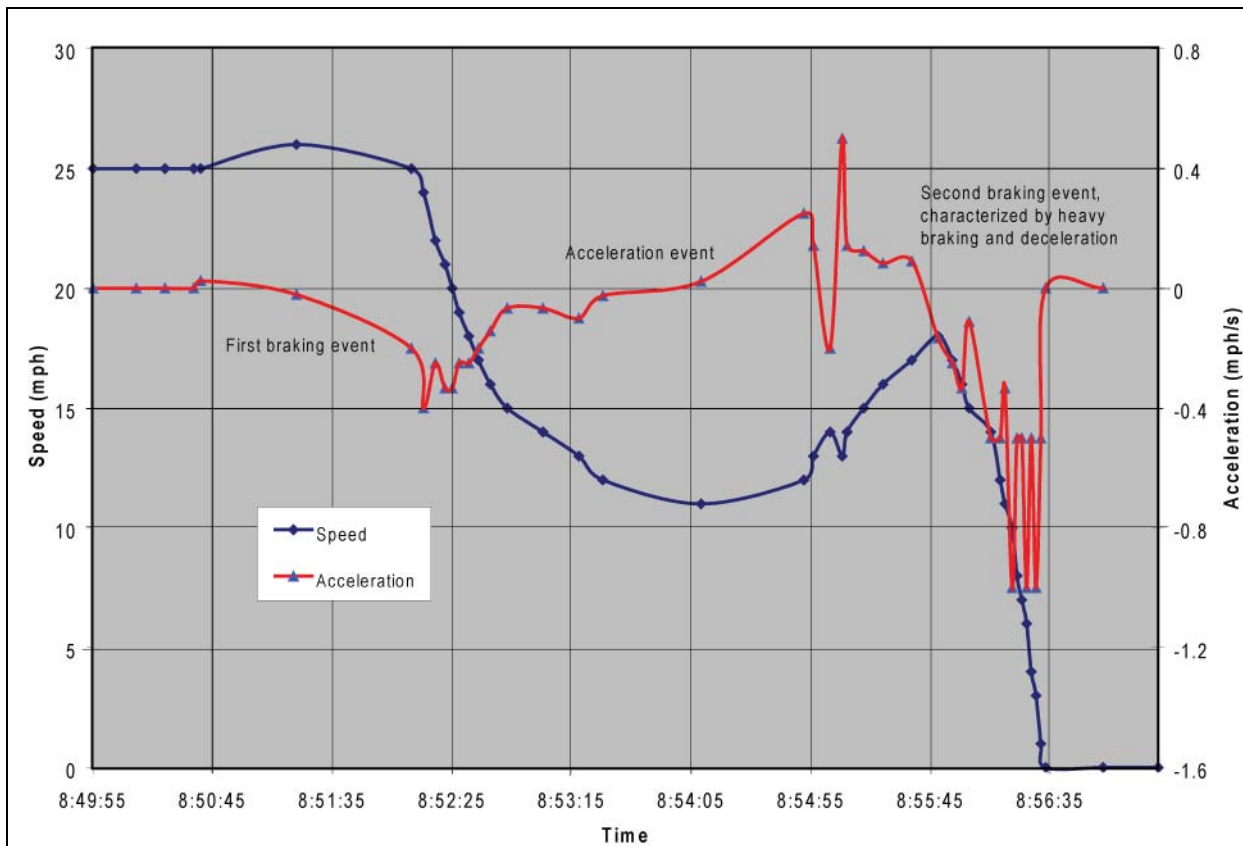
Figure 3. Speed and acceleration versus time

- Just prior to the derailment, the train experienced two braking (deceleration) events and one acceleration event.
- The first braking event was carried out through a combination of a light, short automatic braking reduction and a sustained dynamic brake (DB) application.
- At 0851:47, the automatic braking reduction and release caused a local, but not significant, disturbance of the deceleration. The train deceleration was within a safe range (-0.4 mph/second).
- The train decelerated smoothly throughout the sustained DB application.
- Once the conductor detrained, the throttle was advanced.
- The surge oscillation at 0855:04 correlates with a rapid change of throttle positions.

- The second braking event was characterized by heavy braking and deceleration. The locomotive independent brake was not bailed off, allowing a rapid build-up of the locomotive independent brake. As brake cylinder pressure approached a full nominal application of 80 pounds per square inch just before the final stop, three deceleration peaks of approximately 1 mph/s occurred.
