## **RAILWAY INVESTIGATION REPORT**

**R08M0063**

### **NON-MAIN-TRACK COLLISION**

**BETWEEN CANADIAN NATIONAL TRAIN Q121-11-03  
AND VIA RAIL CANADA INC. TRAIN P614-21-02  
MILE 1.3, CANADIAN NATIONAL BEDFORD SUBDIVISION  
HALIFAX, NOVA SCOTIA  
03 JULY 2008**

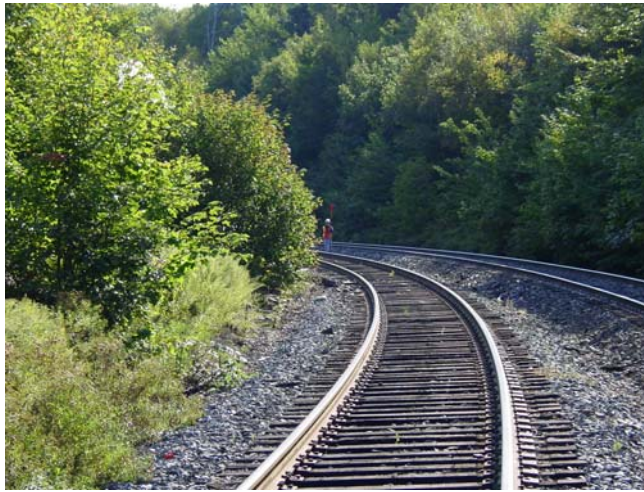
In the accident area, the track is approximately a four-degree curve and a one per cent descending grade for eastward movements. The sightlines were restricted due to vegetation, the curvature of the track, and the deep rock cut (see Photo 1).

**Photo 1.** Track curvature and sightlines at Mile 1.3 looking eastward

The VIA train had five additional cars due to Canada Day passenger traffic. Therefore, it needed to move further westward than usual to clear the tail end of the train for the transfer tracks. This placed the leading end of the VIA train in a location seldom encountered by other crews and in the curved part of the rock cut, where the sightlines were the most restrictive.

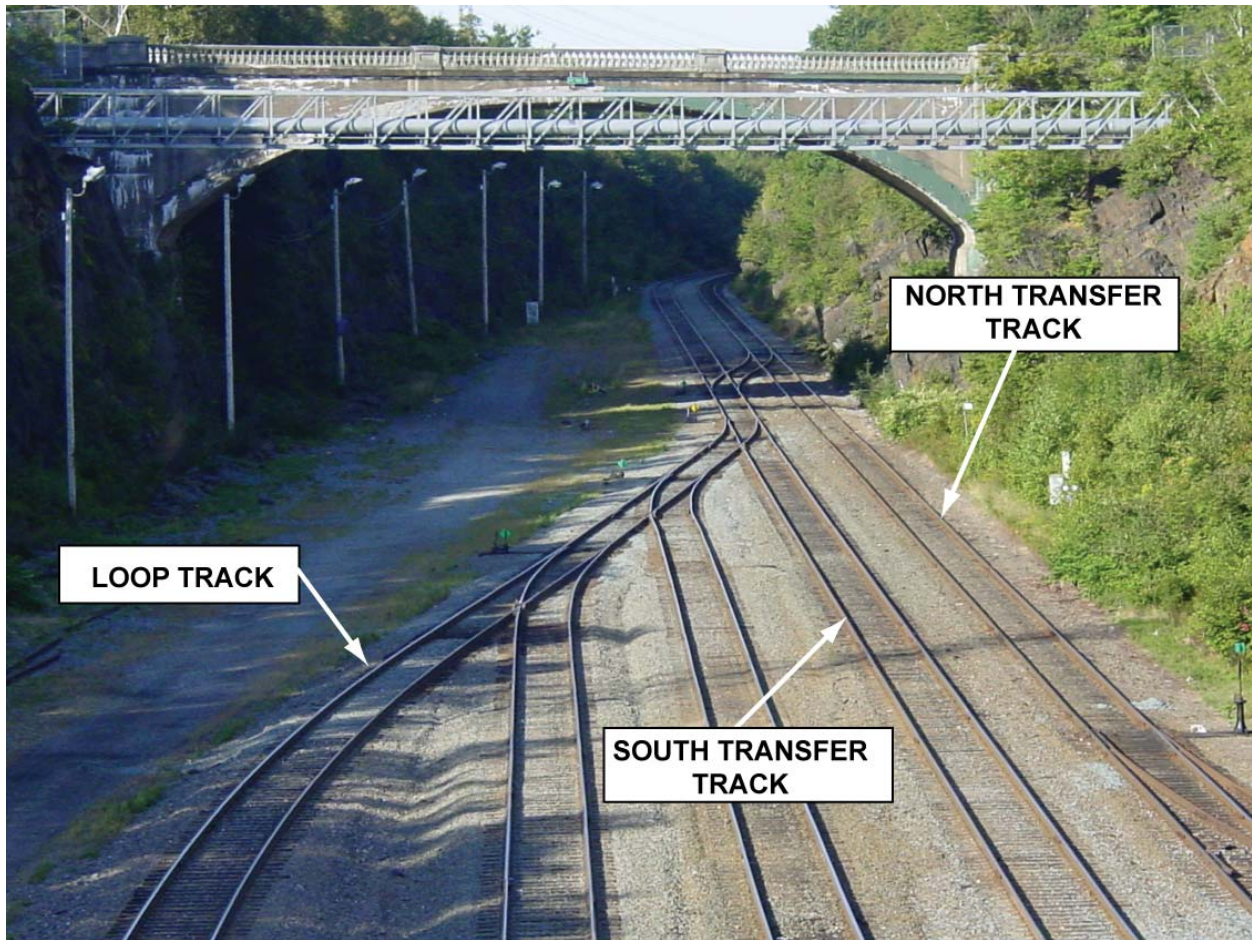
**Photo 2.** View westward showing lead from loop track on left and transfer tracks (south and north) on right

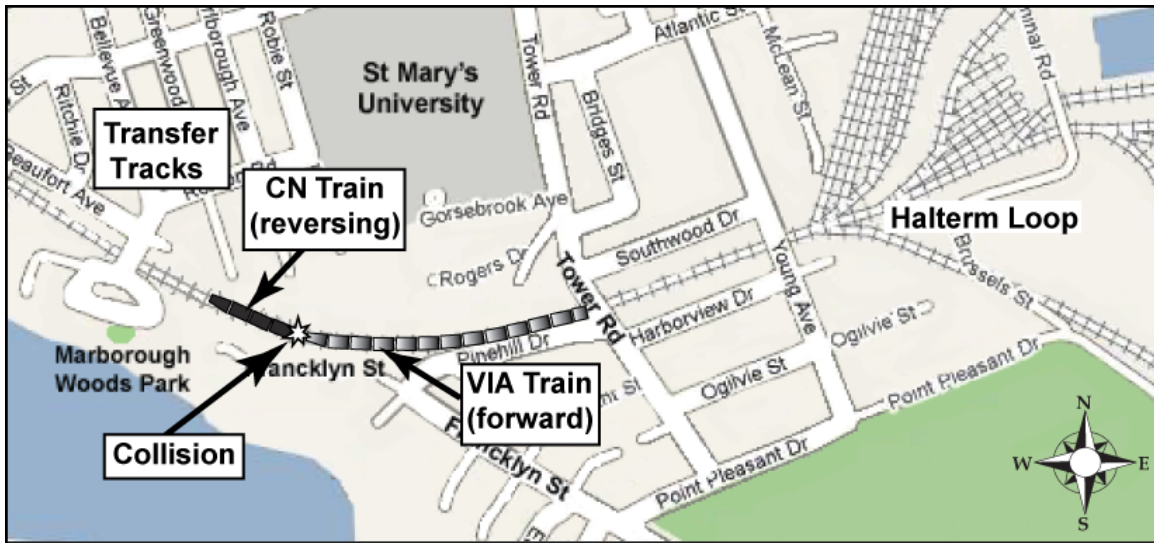
The conductor gave the locomotive engineer instructions to move five car lengths westward to clear the south transfer track switch. After moving about three car lengths, the locomotive engineer started throttling down while moving at 13 mph in preparation to stop. When he heard the CN conductor call his locomotive engineer, he put the VIA train into emergency. Shortly after, the trains collided (see Figure 2).

Figure 2. Schematic showing the direction and relative position of trains at the time of collision

The stopping distance of the VIA train was approximately 140 feet, while CN required 320 feet. Therefore, the collision was unavoidable at the speed at which the trains were proceeding because the combined stopping distances exceeded the range of vision, which was slightly more than 300 feet. Tests showed that the VIA train would have been able to stop within one-half the range of vision of equipment. However, the CN train stopping distance was close to the entire available distance of visibility. It would not have been able to stop within one-half the range of vision, even though the CN conductor alerted both locomotive engineers eight or nine seconds before the impact. Had the speed been restricted in this curve to 10 mph, as several Canadian railways have done on non-main tracks, the range of vision and the stopping distance could have been sufficient to avoid the collision.<sup>5</sup>

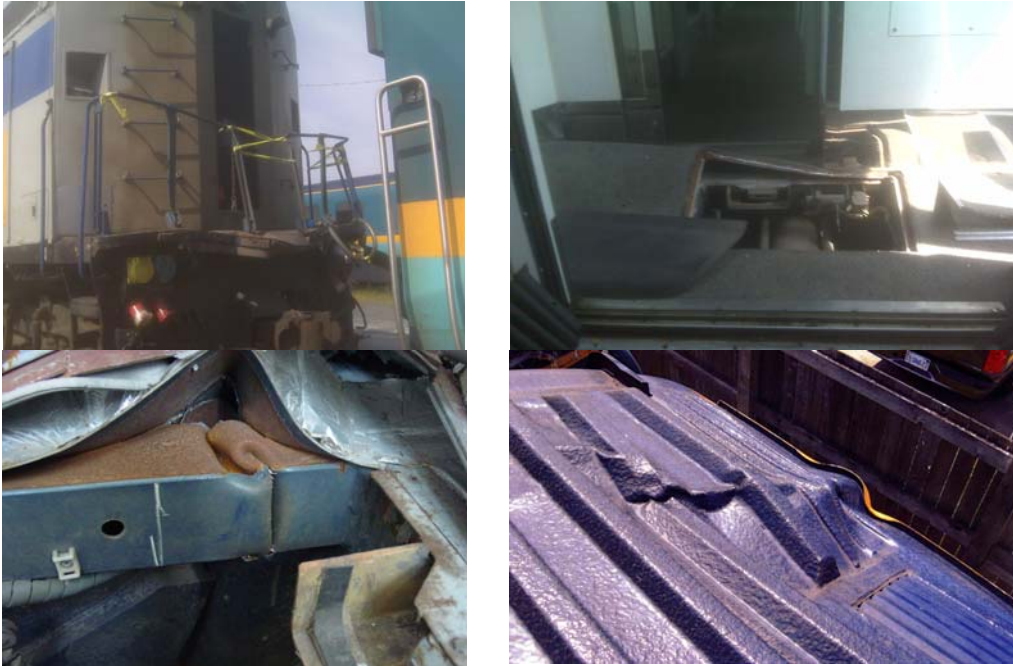
Subsequent inspection revealed that no equipment derailed. However, some of the vestibules and roofs of the Renaissance equipment were buckled.<sup>4</sup> The two VIA locomotives, a baggage car and five coaches were severely damaged (see Photo 3). No one was seriously injured. There was minimal track damage.

<sup>4</sup> The ends of the cars are equipped with crash management zones. These zones are engineered to collapse in a progressive way so as to dissipate the forces involved in a head-on collision.

**Photo 3.** Damaged VIA equipment (top left: locomotive end damage, top right: buckled car vestibule floor, bottom left: collapsed crash management zone, bottom right: damaged car roof)

Due to their shock-absorbing capabilities, the VIA Renaissance cars are less likely to derail upon frontal impact with other equipment. The crash management zones on the Renaissance equipment functioned as designed and helped to protect the crew members and the maintenance employees who were on board from injurious impact forces (LP 023/09<sup>7</sup>).
