**RAILWAY INVESTIGATION REPORT**  
**R09W0118**

**MAIN-TRACK TRAIN COLLISION**  
**CANADIAN NATIONAL TRAIN NO. M30131-27 AND**  
**CANADIAN NATIONAL TRAIN NO. Q10131-27**  
**MILE 104.32, REDDITT SUBDIVISION**  
**JONES, ONTARIO**  
**28 JUNE 2009**

Report Number R09W0118

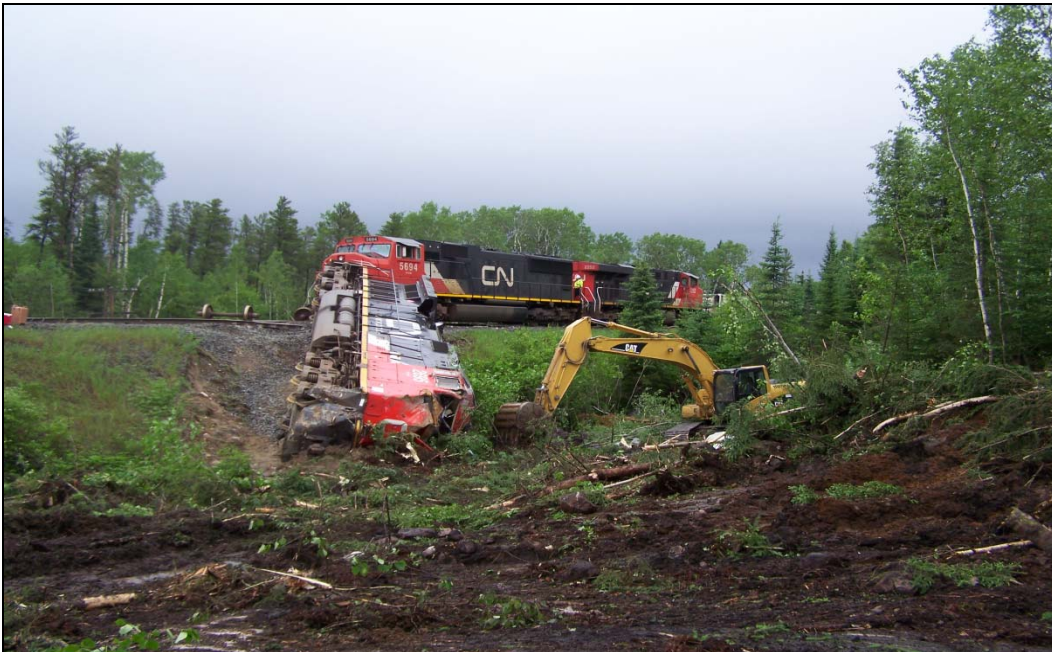
At 0623:00, Train 101 departed westward from Favel on the main track. At 0630:13, Train 101 was travelling at 40 mph in throttle 8 as it exited a four-degree right-hand curve (in the direction of travel) and observed signal 1043 (advance signal to Jones East), about 1200 feet ahead. Train 101's crew observed a restricting signal indication and the tail end of Train 301 stopped on the main track clear, and just west of, the signal. At 0630:37, Train 101's locomotive engineer initiated an emergency brake application. Anticipating the impending collision, the crew exited the rear cab door of lead locomotive CN 2695 and moved toward the tail end of the locomotive. The locomotive engineer climbed onto the footboard between the lead and second unit while the conductor remained on the rear platform deck. At 0631:00, while travelling at 29 mph, Train 101 struck the tail end of Train 301. At 0631:23, Train 101 came to rest at Mile 104.31 (see Photo 1). The conductor had jumped clear of the wreckage; the locomotive engineer had held on to the locomotive. The locomotive engineer sustained minor injuries.

**Photo 1.** Derailed lead locomotive number CN 2695

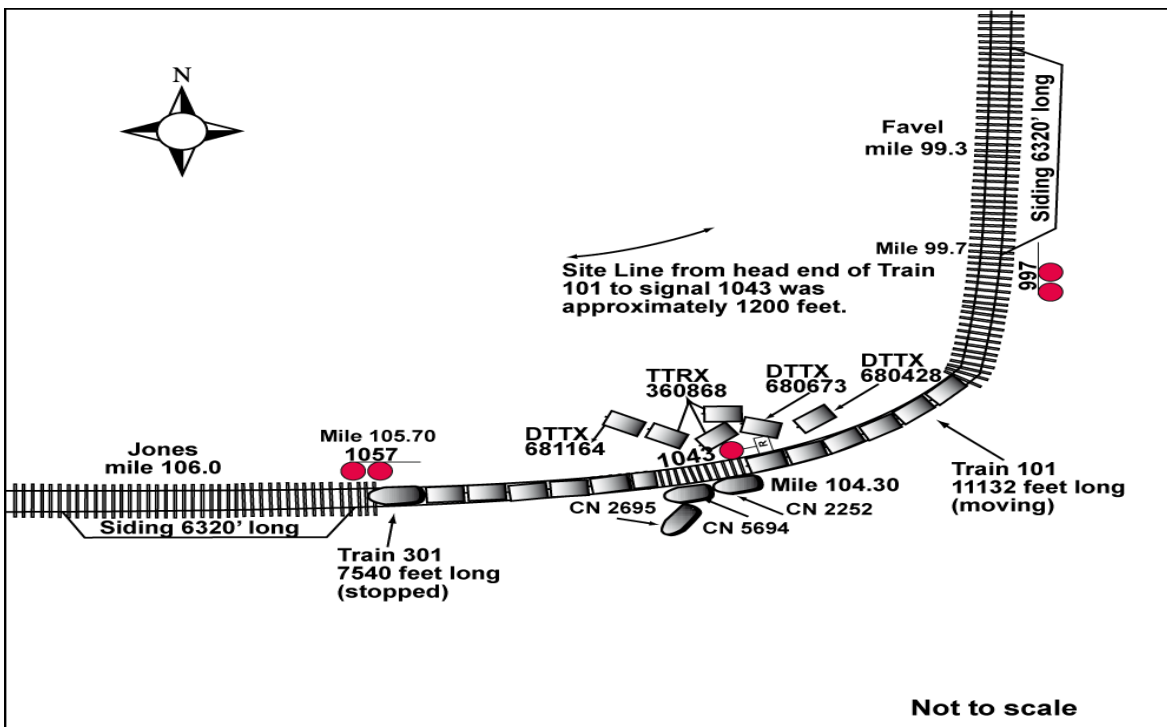
Site examination revealed that the four tail-end inter-modal cars (6 platforms in total) from Train 301 had derailed and come to rest approximately 75 feet north of the main track. The three locomotives from Train 101 had derailed with the lead locomotive CN 2695, coming to rest down an embankment on its side (see Figure 2).

Figure 2. Track layout and derailed rolling stock location

All derailed equipment was heavily damaged and approximately 200 feet of track was destroyed.
