**RAILWAY INVESTIGATION REPORT  
R09D0053**

**NON-MAIN-TRACK COLLISION**

**VIA RAIL CANADA INC. LOCOMOTIVE 6425  
VIA RAIL CANADA INC. MONTRÉAL MAINTENANCE CENTRE  
MONTRÉAL, QUEBEC  
09 SEPTEMBER 2009**

Report Number R09D0053

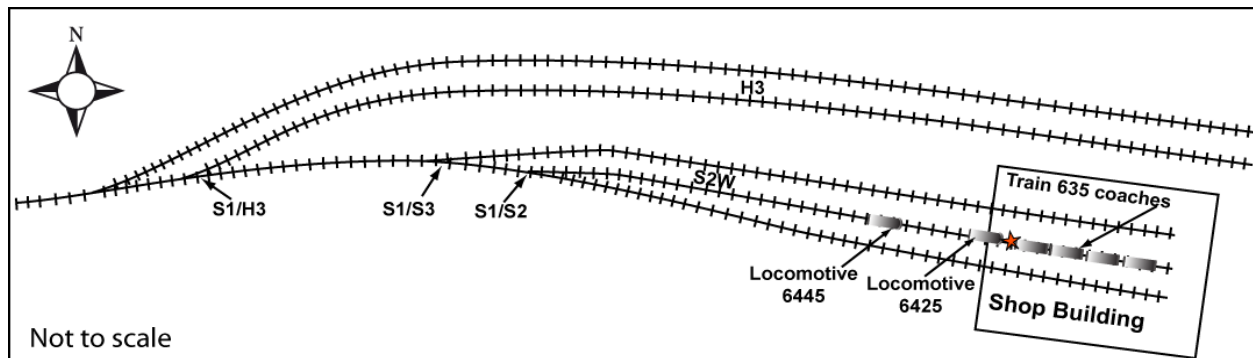
Figure 1. Diagram of the accident site

At 0018,<sup>1</sup> the crew was called by the yard controller and was instructed to exchange locomotive VIA 6425 with locomotive VIA 6445 on passenger train 635, stationed within the maintenance shop building (the shop) on track S2W (see Figure 1). At 0123, after finishing their switching operations in the east end of the MMC, the crew members stopped VIA 6425 in track H3 adjacent to the shop, where the CH detrained. He then uncoupled VIA 6445 from train 635 and proceeded west past the S1/H3 turnout. Locomotive VIA 6425, controlled by the ICH, followed on track H3, and stopped approximately 40 feet behind. The ICH applied the brakes on VIA 6425, exited the locomotive and instructed the CH to couple the locomotives.

At approximately 0131, as the train approached the shop and the CH began to slow the movement, the locomotives separated. Locomotive VIA 6445 stopped approximately 100 feet from the shop entrance while VIA 6425 continued uncontrolled and collided with the coaches of train 635. The ICH jumped off VIA 6425 just before the locomotive entered the shop. No MMC workers were on or near the passenger coaches at the time of the accident. There were no injuries.
