National Energy
Board

Investigation under the *National Energy Board Act*

2012-01-24 Trans Mountain Pipeline ULC
Sumas Tank 121 Leak

November, 2012

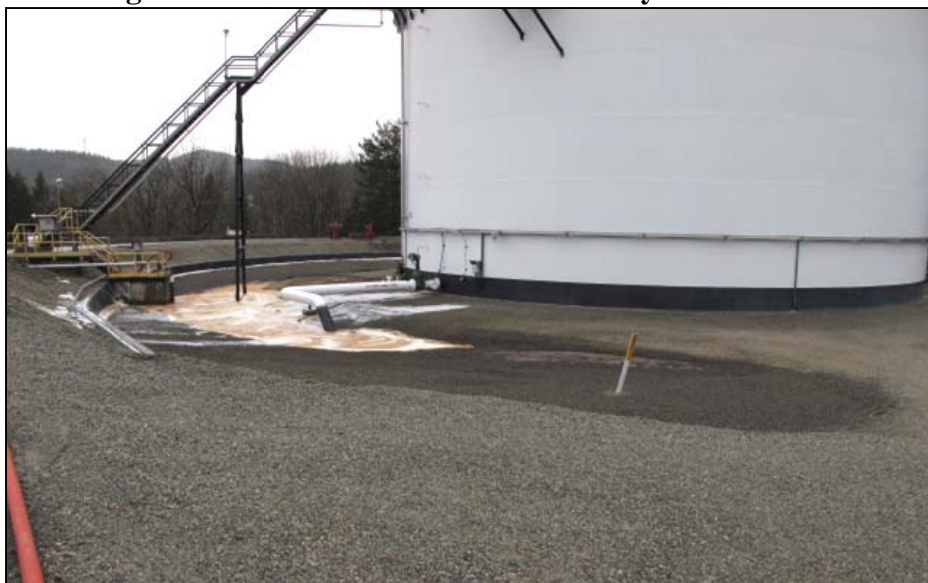
Early in the morning of 24 January 2012, a release of crude oil from Tank 121 at TMPU's Sumas Terminal in Abbotsford, BC occurred (see Maps 1, 2 and 3 in Appendix I). Approximately 90 m³ of crude oil was released within the secondary containment of Tank 121. At 06:50 PST¹ a TMPU operator arrived on site, discovered the release and closed the Tank 121 roof drain valve to stop the release. The company incident response was initiated and an Incident Command Post (ICP) was established at the nearby Sumas Pump Station. The NEB was notified at 08:16. Soon after receiving the notification, the NEB's Emergency Operations Centre (EOC) was activated. NEB staff arrived at the TMPU ICP at 17:00 on 24 January 2012. The emergency phase of the incident was terminated at 12:50 on 25 January 2012 when the last free oil was removed from the secondary containment. No one was injured during the incident and environmental consequences were limited to the contamination of the secondary containment gravel and air emissions. The secondary containment liner prevented the oil from migrating outside the secondary containment. Figure 1 shows the oil release in the secondary containment of Tank 121 after most of the free oil had been recovered. A foam blanket covers the remaining oil and the darkened gravel shows the original extent of the spill.

Figure 1: Release in Tank 121 Secondary Containment

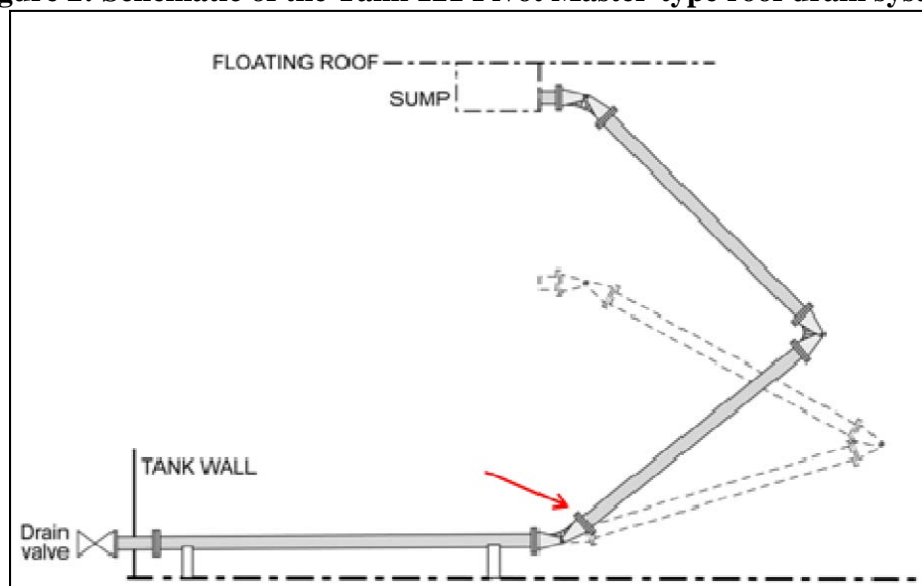
Figure 2: Schematic of the Tank 121 Pivot Master-type roof drain system⁵

TPMU visually inspected the roof drain system and identified that the leak resulted from a failed gasket located in the flange pair indicated by the red arrow in Figure 2. This joint was disassembled and the failed gasket is shown in Figure 3 below. TPMU determined that the gasket appeared to have been damaged by excessive pressure, likely caused by freezing. TPMU explained in its investigation report that the combined effect of the unusually cold weather and low level of oil in Tank 121 in the two weeks preceding the leak may have caused water to freeze in the roof drain system (see section 3.2 for more details on the weather). TPMU indicated that temperature variations throughout the days and within the tank are suspected to have caused cycles of water freezing and melting on the tank roof and in the roof drain system, which led to the accumulation of water and ice in the roof drain system even though the roof drain valve was open and the drain sloped to prevent water accumulation. The freezing of water in the roof drain system would have resulted in excessive internal pressure in the roof drain system causing the gasket to fail while preventing the oil from leaking outside the roof drain system. Tank 121 received the 3400 m³ of oil on 23 January 2012, thereby increasing the temperature of the tank content from -0.1 °C to 9.7 °C. This would have melted the ice in the roof drain system and therefore allowed the oil in the tank to enter the roof drain system where the gasket was damaged. Because the drain valve of the roof drain system was open, the oil could then flow into the Tank 121 secondary containment.

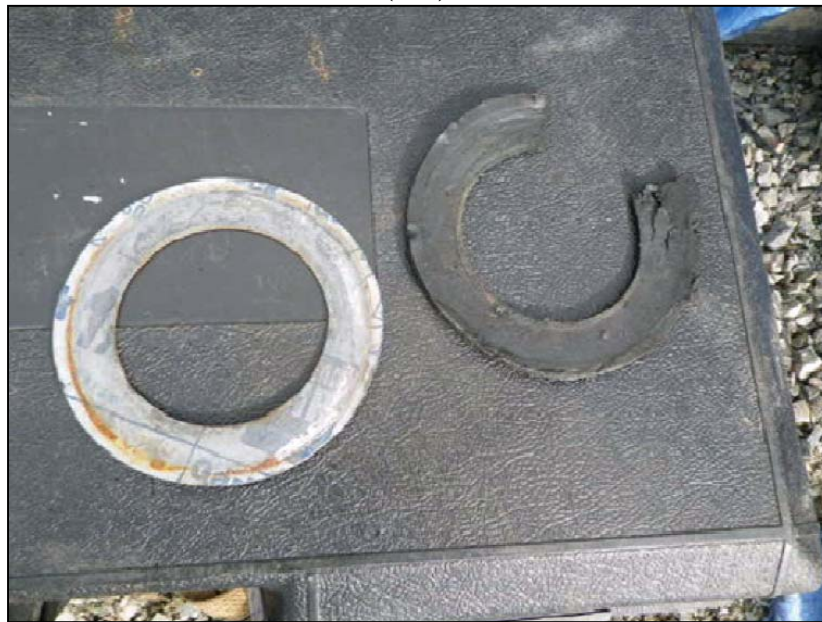
Figure 3: Photograph of the damaged gasket (right) as compared to a functional gasket (left)⁶

TPMU has determined that no other factors contributed to the failure of the flanged joint aside from excessive pressure resulting from ice expansion within the piping system. Also, TPMU confirmed that no other damage was identified during the visual inspection of the roof drain system of Tank 121. The failed gasket was replaced and the roof drain system was pressure tested to confirm its integrity prior to returning Tank 121 to service.

Finding 1	The mechanism of failure of the roof drain gasket appears to be excessive internal pressure caused by freezing of water in the roof drain system.
------------------	---

This corrective action may not completely eliminate the risk of freezing of water in the roof drain system components inside the tank, but it will significantly reduce the risk of freezing of water in the drain valve and external nozzle which, with the drain valve now normally kept closed (see Corrective Action 2), would contain the crude oil in the internal components of the roof drain system if such components were to fail again.

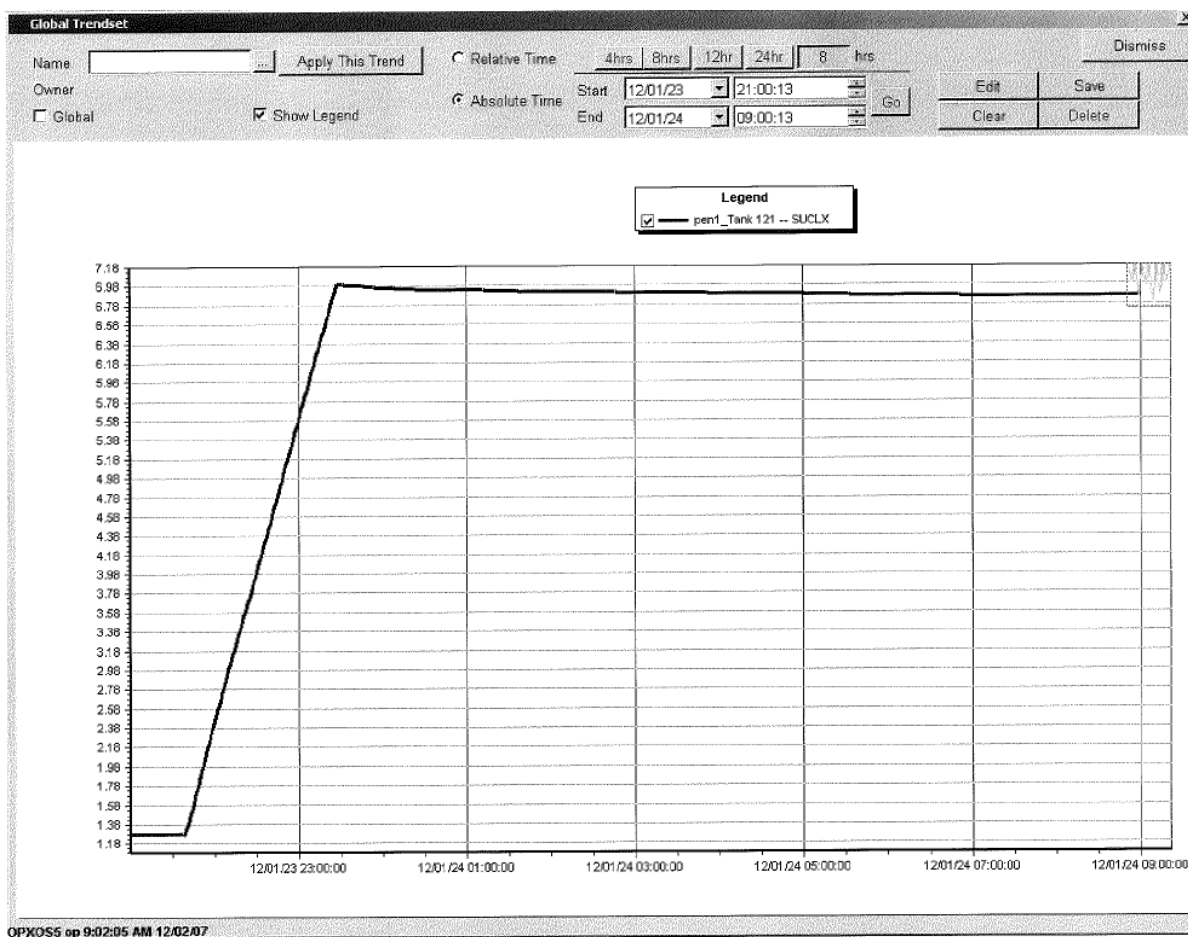
Tank 121 Level Trend

This Level Trend contains the Tank 121 level trend from a time prior to the receiving of crude oil in Tank 121 on 23 January 2012 to a time after the leak was found and stopped by the field technician in the morning of 24 January 2012. Note the time reported on this trend is Mountain Standard Time (MST) and times referred to in this investigation report are PST.

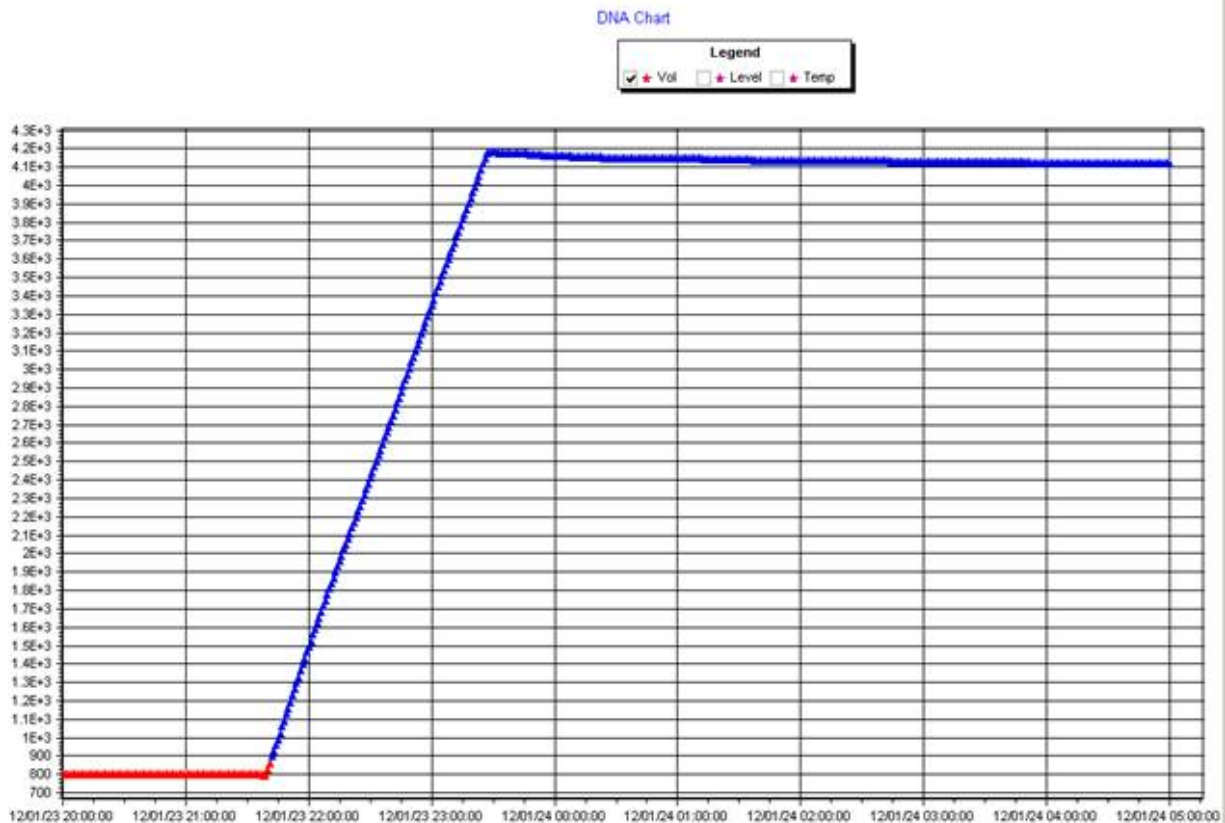
Tank 121 Volume trend from the Test System

As described in section 3.2, the night shift CCO received three alarms, two from the Legacy System and one from the Test System, between 02:39 and 04:11. Each time, the night shift CCO failed to recognize the possible leak situation when viewing the Tank 121 volume trend. Appendix II shows the Tank 121 level and volume trends and, at 02:39, when the night shift CCO received the first alarm, the level and volume trends show a noticeable drop of level and volume from the time the receipt of oil was completed. The night shift CCO had access to both the volume and level trends for the Tank 121, which both show similar trends, but the night shift CCO only viewed the volume trends from the Legacy and Test systems. TMPU indicated that the volume trend was adequately displayed and the night shift CCO did notice the trend but, considering the initial volume change as relatively small, the night shift CCO interpreted the cause as a weather event, not a possible leak. The night shift CCO also had access to the analog (number) value information for the level or volume of Tank 121, but the night shift CCO did not use this information. The SCADA settings allow a change to be made to the volume scale to make it more pronounced, however this scaling feature was not used by the night shift CCO.

The volume trend from the Test System that was viewed by the night shift CCO during the incident. Note the time reported on this trend is Mountain Standard Time (MST) and times referred to in this investigation report are PST.

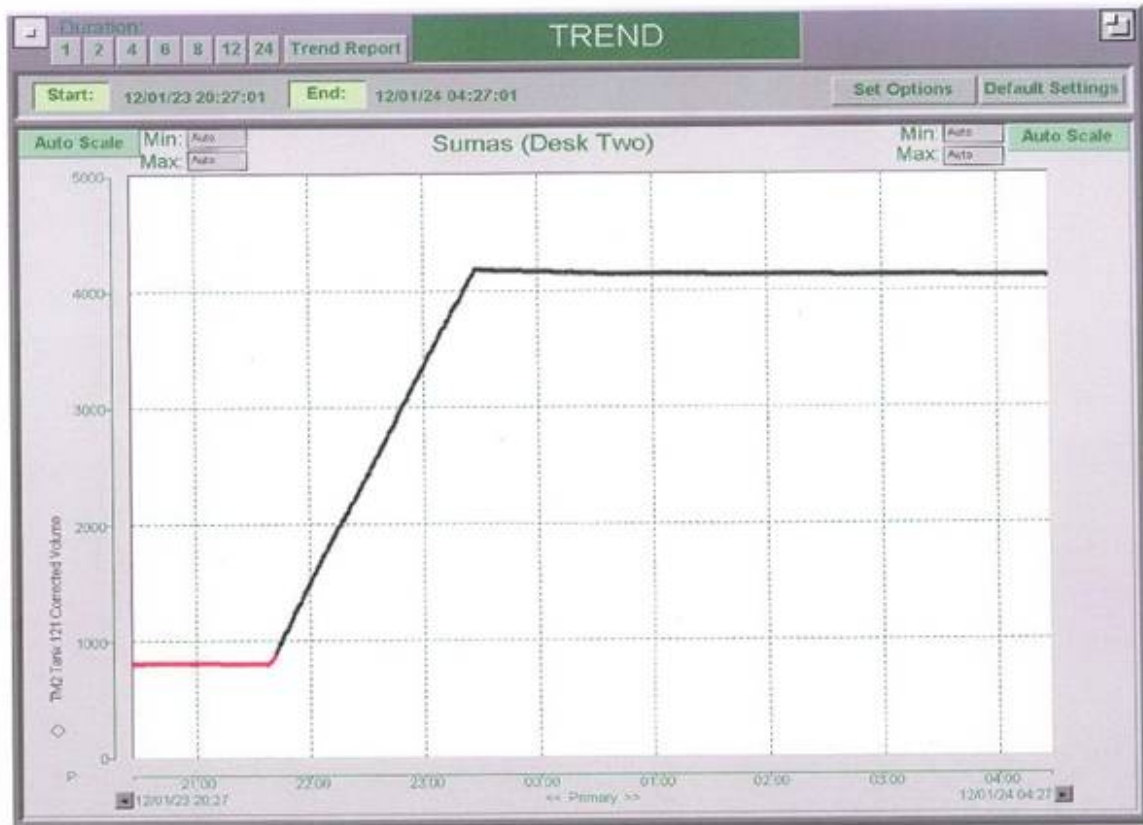
Tank 121 Volume trend from the Legacy System

The volume trend from the Legacy System that was viewed by the night shift CCO during the incident. Note the time reported on this trend is Mountain Standard Time (MST) and times referred to in this investigation report are PST.
