Transport
Canada

TP 185E
Issue 3/2013

AVIATION SAFETY LETTER

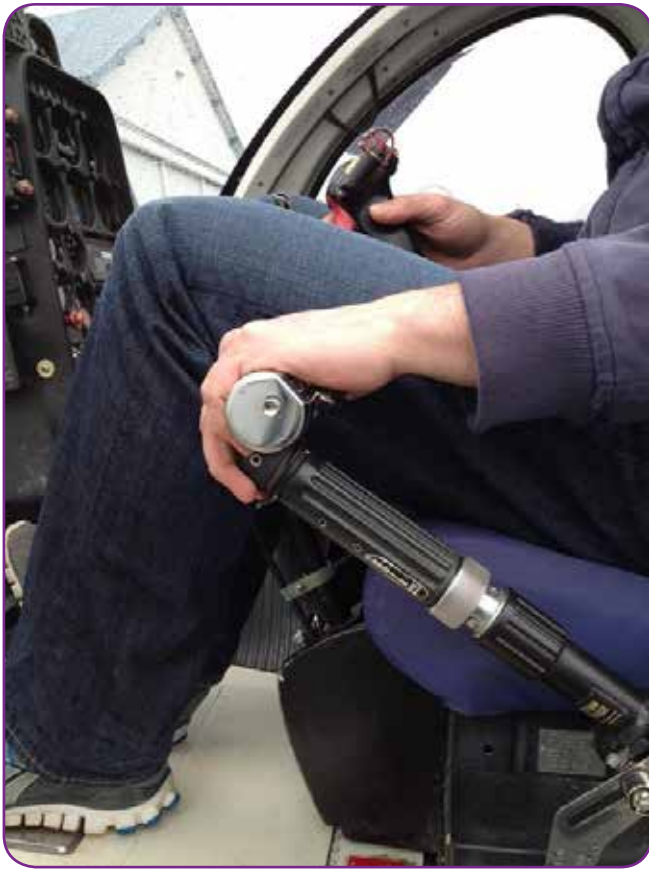
Wrong position (on top of the governor beep switch)

As a result, our operator issued a bulletin making it company policy that pilots should never fly with their hand over the end of the collective. Our operator also announced additional training sequences on reduced power setting flight, low rotor rpm recognition and recovery, and the use of the governor range in order to show that the aircraft will still fly at the low end of the range.

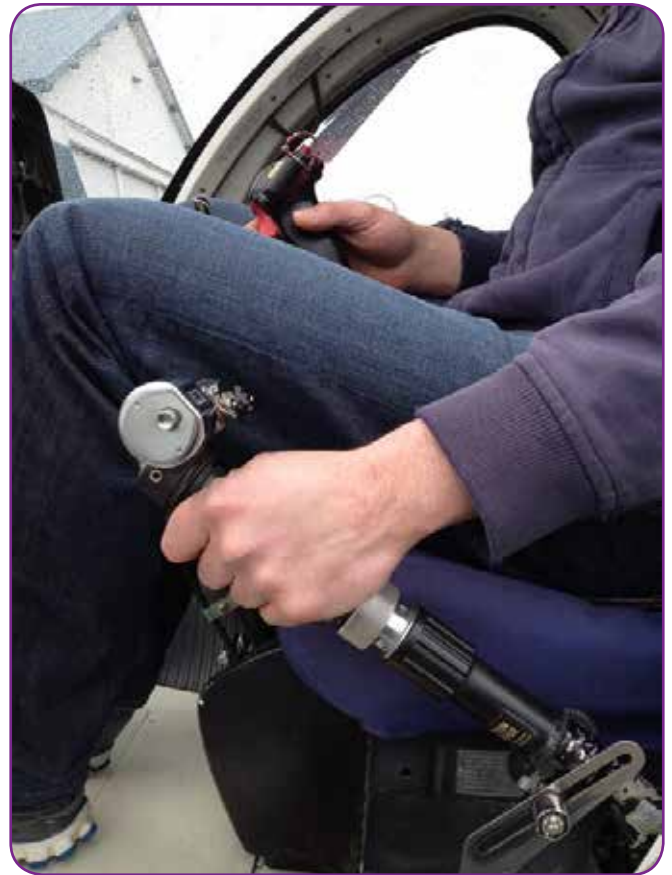
Right position

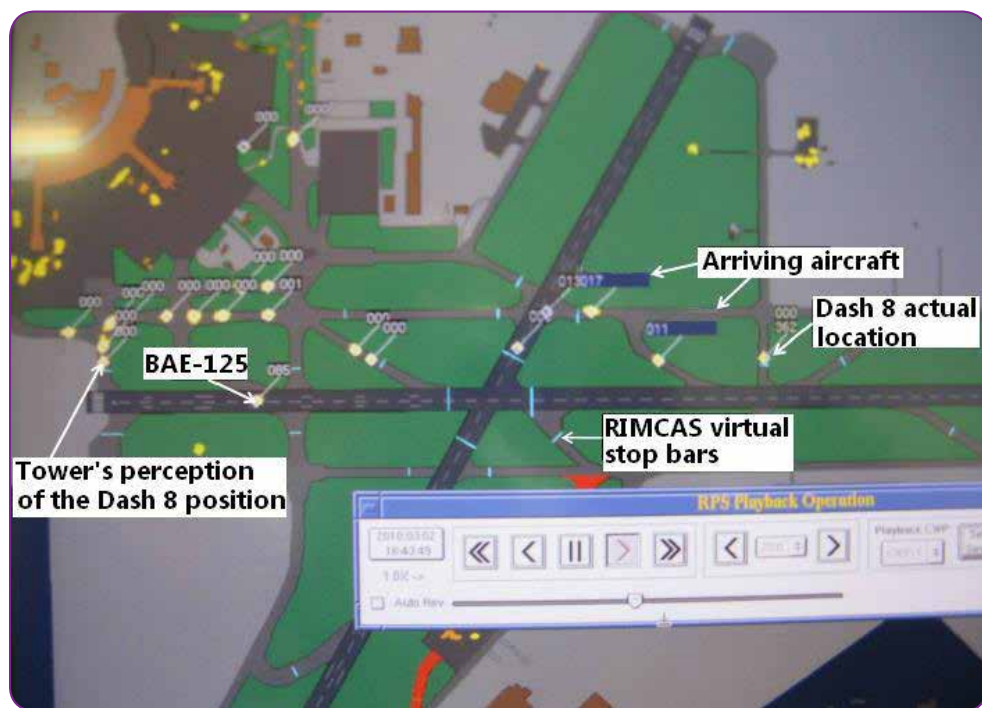
Airport Surface Detection Equipment (ASDE) display at 0943:49

The controller believed the Dash 8 to be at the threshold of Runway 16 (Taxiway C8), and the flight crew believed the controller knew they were at Taxiway U. It is likely that, as a result of the unexpected clearance of two flights between arriving flights, the flight crew of the Dash 8 felt rushed to get into position and simultaneously unsettled by their takeoff clearance that appeared to be sequenced much more quickly than previous departures. The assimilation of the departure heading instruction, the completion of the before takeoff check list, and the concern about a possible aircraft departing from the threshold all contributed to a high workload for the flight crew of the Dash 8. This would have resulted in little reserve to figure out that ATC believed them to be at Taxiway C8, as opposed to Taxiway U.

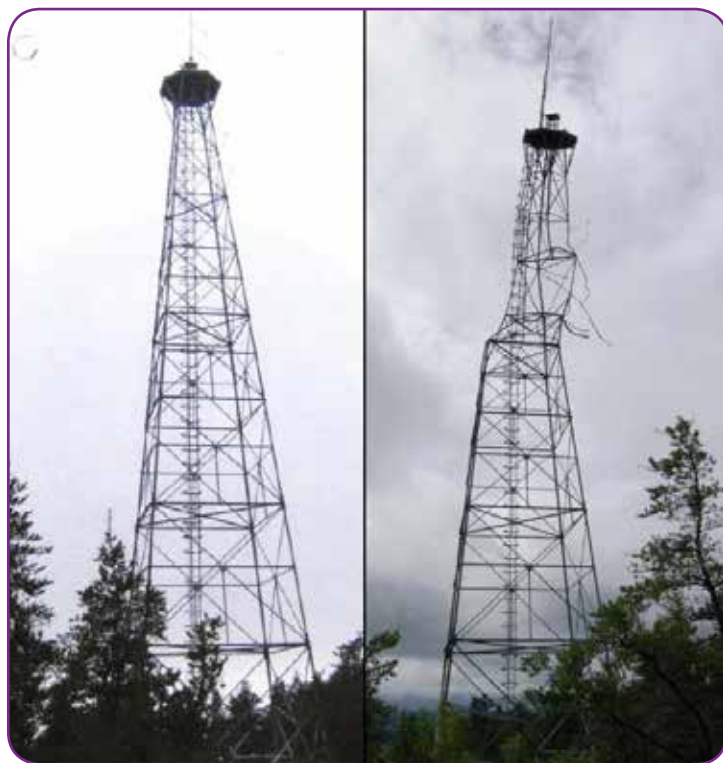
The helicopter was travelling at a normal cruise speed (104 kt) about 1 000 ft from the tower, and the damage sustained by both the helicopter and tower were indicative

Side-by-side photos of the tower pre and post impact

of a frontal impact with significant velocity. The global positioning system (GPS) data did not indicate any sudden manoeuvring. The velocity and course appeared constant, implying the pilot did not see the tower with enough time to react prior to impact, likely because the tower was obscured by the weather or blended into the overcast conditions.

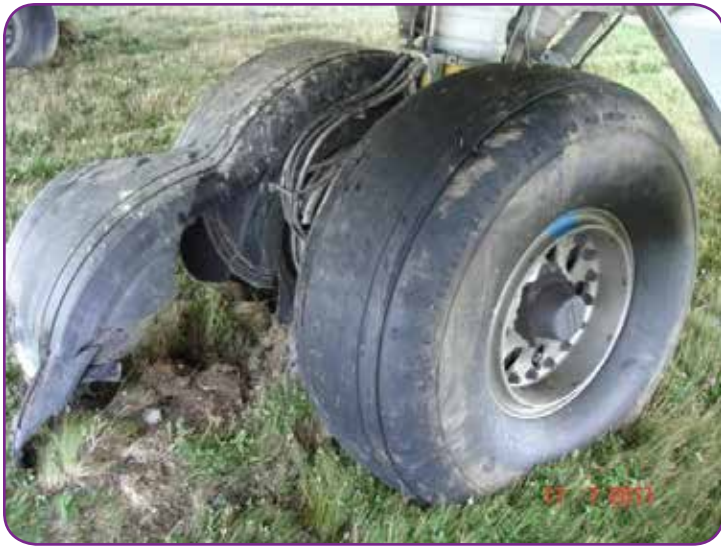
The TSB calculated the wear, based on an initial retread depth of 0.43 in. and the average tread depth remaining, on the occurrence aircraft's no. 1 tire to be about 65%, no. 2 tire about 90%, and the no. 3 and no. 4 tires, shown above, were in excess of 95% worn.
