Issue 4/2012

Canadian Aviation Service Difficulty Reports

TP 6980E
(4/2012)

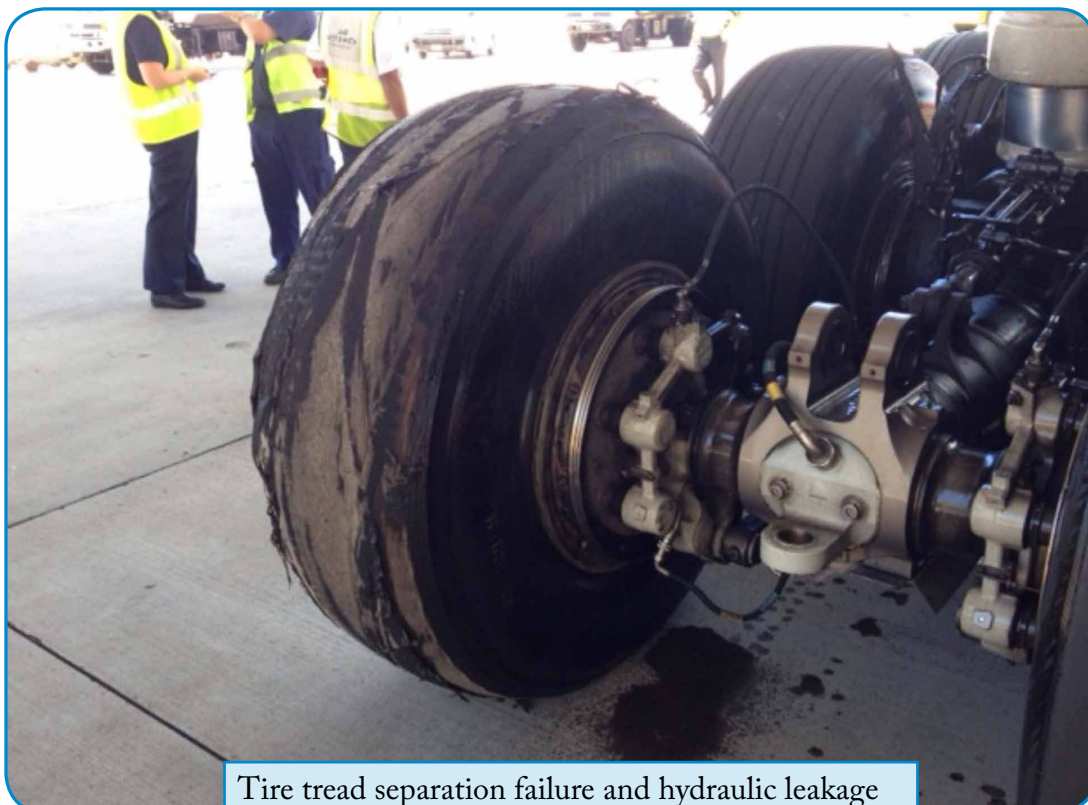
During cruise and approximately 4 hours prior to landing at the scheduled destination, the crew reported low hydraulic quantity in the center hydraulic system. An emergency was declared prior to landing and the aeroplane was met by emergency vehicles on arrival. The crew performed an uneventful landing, shut the engines down on the runway and was towed to the gate due to the inoperative steering system from the loss of the center hydraulics. Maintenance inspection at the gate confirmed extensive tire damage including the under-wing area and flap panel along with the associated tires brake line, which was the source of the hydraulic fluid loss.

Through further analysis and the retrieval of tire debris from the departing airport, it was concluded that the tire failed on take-off, damaging the aeroplane and causing the eventual loss of the hydraulic system. Concerns were raised of possible foreign object damage (FOD) being picked-up off the runway, causing the tire failure, but no direct evidence to support this was found.

The tire was replaced and sent to Bridgestone where a complete shop inspection and analysis was performed where no conclusive findings or indication of its failure or FOD was found. With this particular tire, an initial retread was applied where there were no clear indications of low adhesion between the tire retread components. The tire had also completed 139 landings prior to its failure and typically flaws with material or workmanship during the retreading process would result in a tread separation quickly after installation.

Tire tread separation failure and hydraulic leakage

The concluding corrective action defined by Bridgestone is the standard tire maintenance practice of the operator which includes checking for indications of damage from FOD or any signs of developing bulges or bubbles. Maintaining correct tire pressure inflation are also essential preventative measures to help guard against the possibility of tread separation, tire failure and possible extensive aircraft damage. ✖

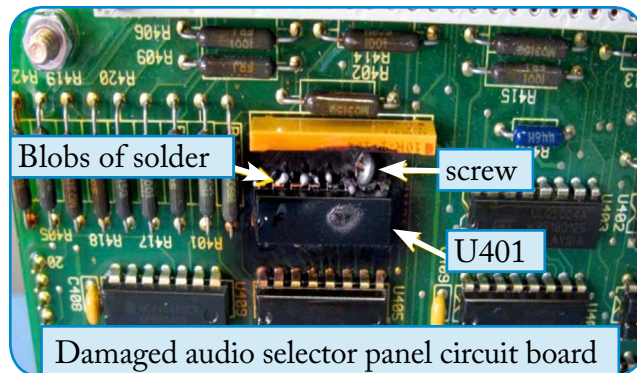
The aeroplane returned to the gate due to loud feedback on the captain's audio channel and a report of electrical smell. Maintenance confirmed that the captain's audio selector panel (ASP) failed, causing the electrical smell. The defect was resolved through the replacement of the ASP and tested as per Aircraft Maintenance Manual 23-50-00.

Feedback from the operator through the ASPs shop teardown report confirmed its failure due to foreign object damage (FOD) where a dislodged screw was found within the unit, causing a short.

It is suspected that while the aeroplane was in operation, a screw was inadvertently dropped into the ASP, causing the eventual failure of the unit.

Transport Canada Civil Aviation would like to advise all operators and maintainers of the dangers of FOD. ✖

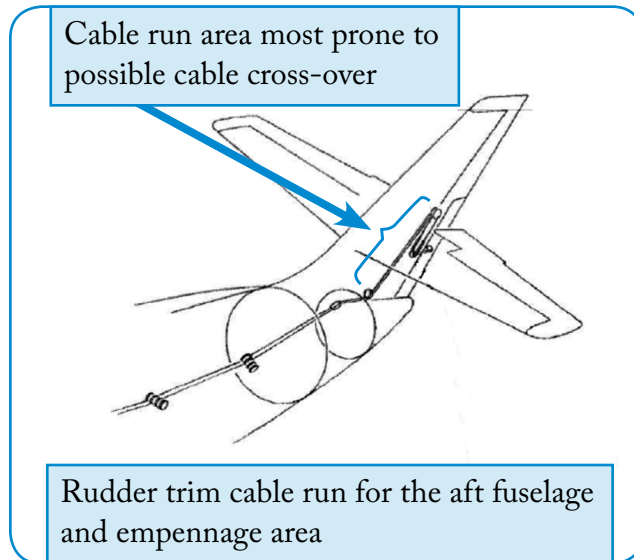
During a maintenance inspection of the rudder trim tab control system, it was noted that the rudder trim cables were crossed in the leading edge of the rudder above the lower leading edge panel.

The Aircraft Maintenance Engineer, through consultation with other operators, has confirmed several other similar occurrences where it has been stated that rudder cable cross-over in the vertical stab is a known problem and "it is easy to do".

Both cables were replaced due to minor kinks noted and installed correctly as per Aircraft Maintenance Manual (AMM) 27-23-11.

Transport Canada Civil Aviation is advising all BAE 3112 operators and maintainers of the possibility for the elevator trim cables to be twisted and to follow the AMM 27-23-11 procedures closely. ✖

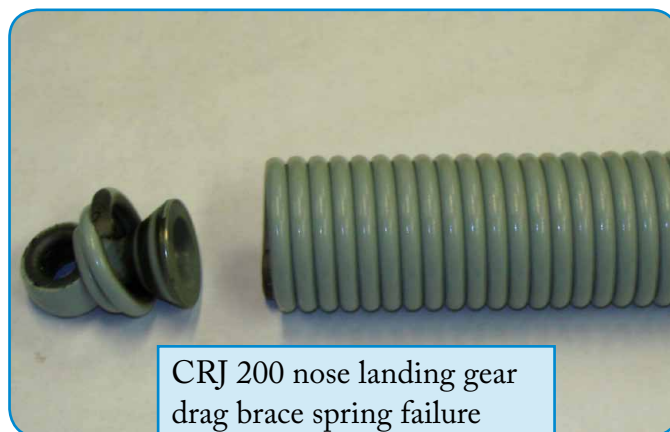
On a pre-flight first flight of the day walk-around check, it was noticed that on the nose landing gear, the right hand drag brace spring was broken and hanging.

The failure of a spring may lead to a possible inability to safely over-center the drag brace and down-lock the gear.

The discrepant spring was replaced and the aeroplane was made serviceable.

Transport Canada Civil Aviation would like to advise all owners, operators and maintainers to pay close attention to the condition of these springs. ✖

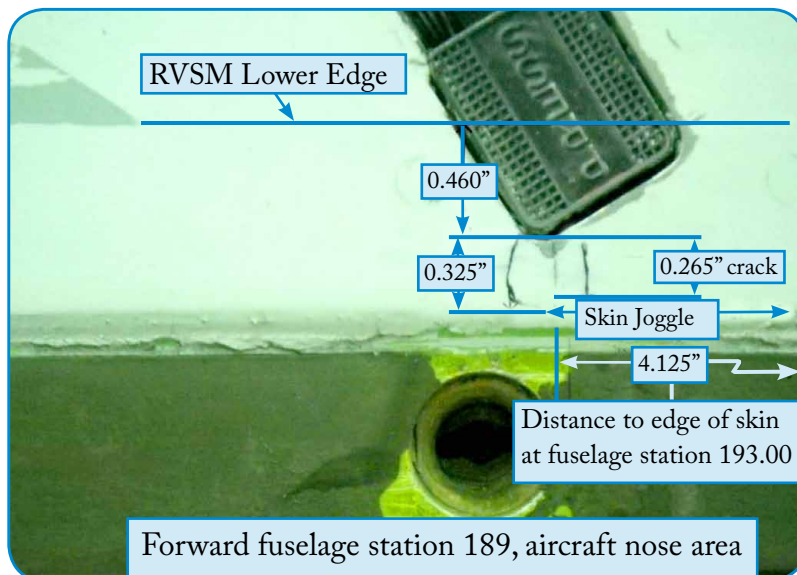
During a scheduled in-house task for a scratch and dent survey of the external fuselage, the Aircraft Maintenance Engineer noticed a crack emanating from the aft latch cut-out of the left hand electronics bay door at the nose of the aeroplane.

The crack was located at Fuselage Station 189, water-line 75.25 just below the Reduced Vertical Separation Minimum (RVSM) critical area. The damage was reported to Bombardier where the aeroplane was returned to service in accordance with temporary disposition Repair Engineering Order (REO) 601R-53-11-2189.

Transport Canada Civil Aviation is advising all CRJ operators and maintainers to be aware of this area for possible crack formations and the available Bombardier repair order. ✖

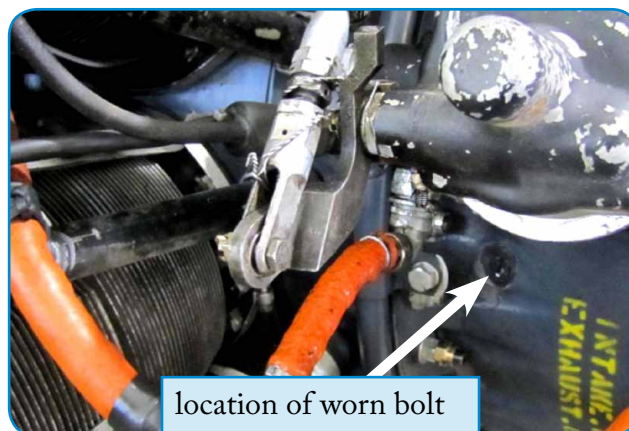
location of worn bolt

The bolt that attaches the left hand propeller governor cable fork end to the propeller governor lever was found severely worn part way through the shank of the bolt. This was discovered during a scheduled engine maintenance check. When the lever was wiggled to check for tightness and security, obvious play was noted. The rod end bearing in the lever was solid within the governor arm. The bolt was removed and found worn.

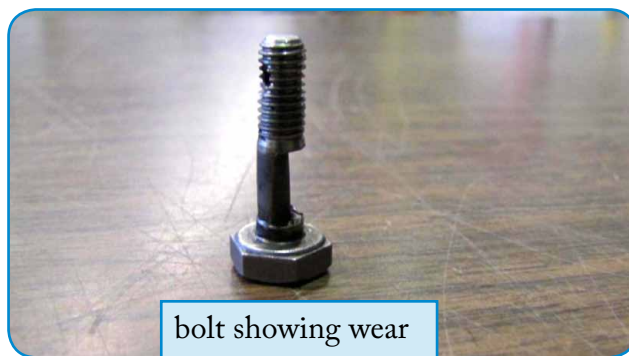
bolt showing wear

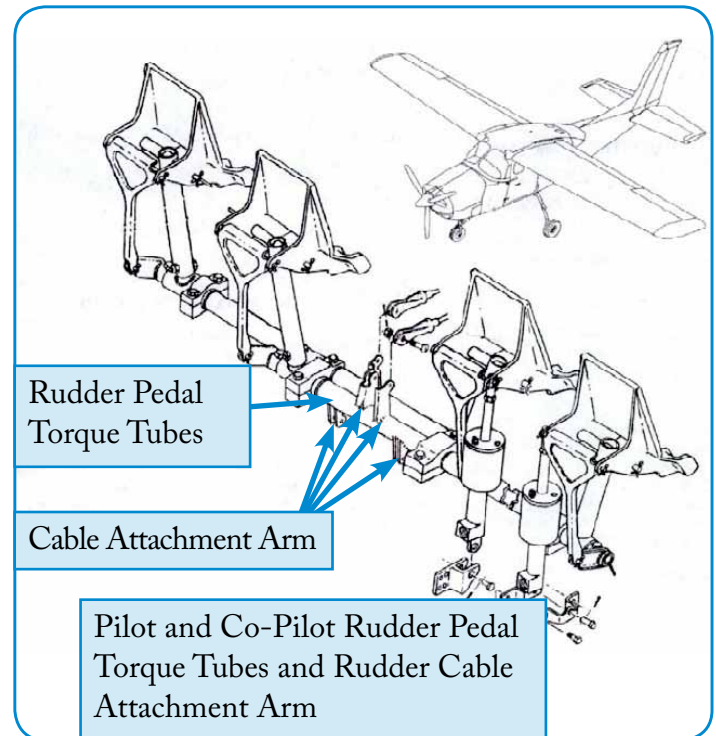
During inspection, the pilots left hand rudder pedal arm, part number (P/N) 0411307, was found loose and severely corroded at the torque tube, P/N 1260465-5. Internal inspection of the mounting arm and stub end of the torque tube revealed severe corrosion in various locations. Two of the four rudder pedal mounting arms showed significant internal corrosion.

Additionally, the interiors of torque tubes, P/N 1260456-5 & 12600456-6, were also found significantly corroded when disassembled. The inboard rudder torque tube bearing blocks were found cracked on both sides.

The Federal Aviation Authority is aware of the corrosion problems and has advised Transport Canada Civil Aviation that Cessna will soon issue Supplemental Inspection Number (SID) 27-20-01 to verify the integrity of the rudder pedal torque tube assembly. (effectivity 21059062 thru 21059199). Areas of particular concern are rudder torque tubes, cable attachment arms and weld area degradation due to corrosion or fatigue. ✖

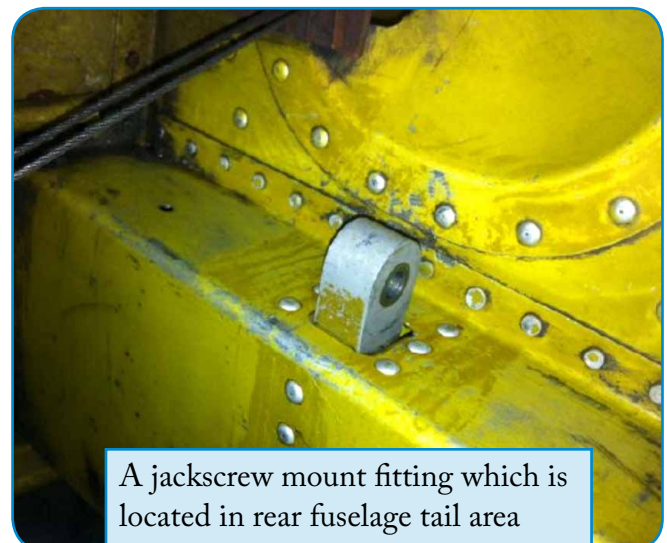
During a repetitive inspection of the horizontal stabilizer trim jackscrew; it was found that the bottom jackscrew mount was loose and was working into its fuselage-mounting retaining bracket.

Following the removal and disassembly of the fuselage-mounting bracket, it was discovered that three mounting rivets and their associated holes were worn (elongated) causing the bracket to become excessively loose.

This is an area that needs attention during inspections. Should the jackscrew mounting bracket become jeopardized; it could cause an undesirable flutter condition affecting the stabilizer trim flight control system. ✖

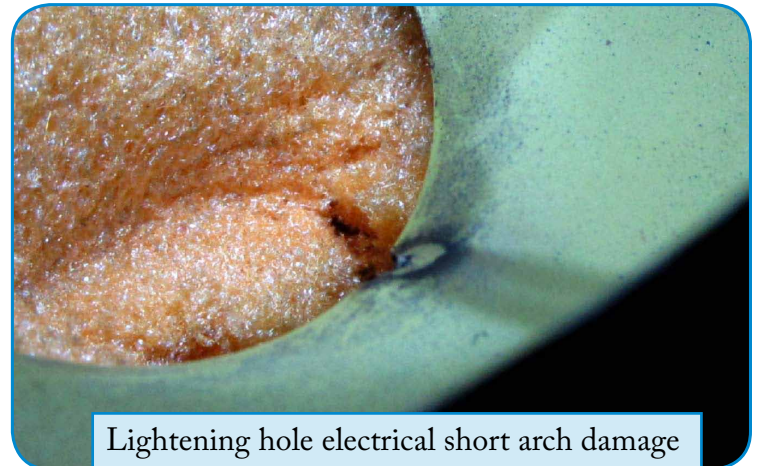
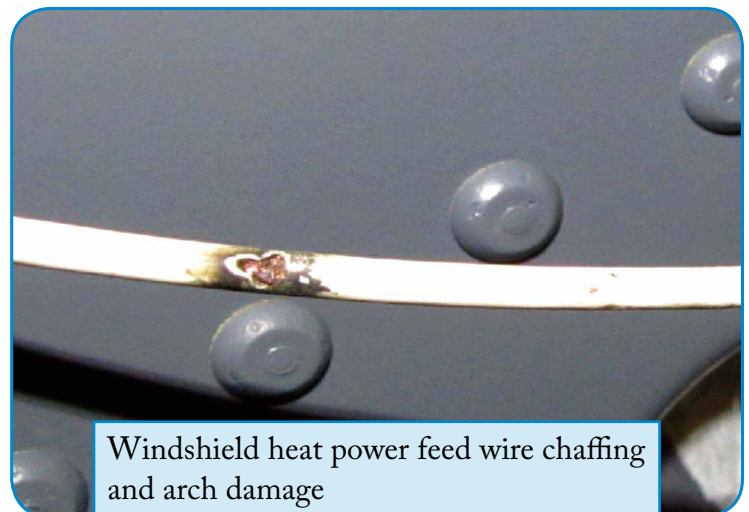
During a major inspection of the aeroplane, all cockpit windshields were removed for inspection of associated structure. Upon installation of new windshields, the airframe wire connections for the right-hand heated windshield were too short so were removed from the cockpit overhead run for replacement with new longer wires. Upon removal of the wire loom, one wire # H307/C12 was noted in having a significant burn mark. Further inspection showed a corresponding burn mark in a lightning hole where the wire passed through at frame 15.

The discrepant wire loom was installed 12 years previous as part of Service Bulletin (SB) 30-005, however a braided hose or grommet was not used at the lightning hole as a means of chafe protection defined in the SB. There were no previous reports of windshield heat defects recorded in the log book. The damaged lightning hole was repaired per Structural Repair Manual (SRM) procedures and the wire loom replaced.

As AMEs, we are all responsible in knowing and following our Instructions for Continuing Airworthiness (ICAs), as with this scenario being the SB and Aircraft Maintenance Manual Standard Practice reference. ✖

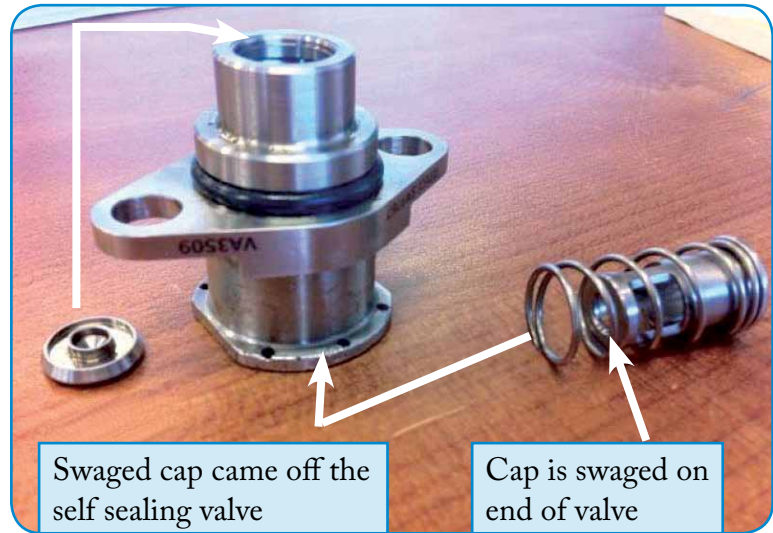
During master magnetic chip detector (MCD) inspection, on removal of the MCD probe, the self sealing valve broke off and fell down the oil tube. The oil tube was removed to recover the parts, the MCD housing was replaced (part number VA3509), the parts were sent to engineering and Rolls Royce was advised.

Caution is advised whenever disassembling aeroplane components. Thankfully in this case, the broken piece was easily recovered and did not damage another component. ✖

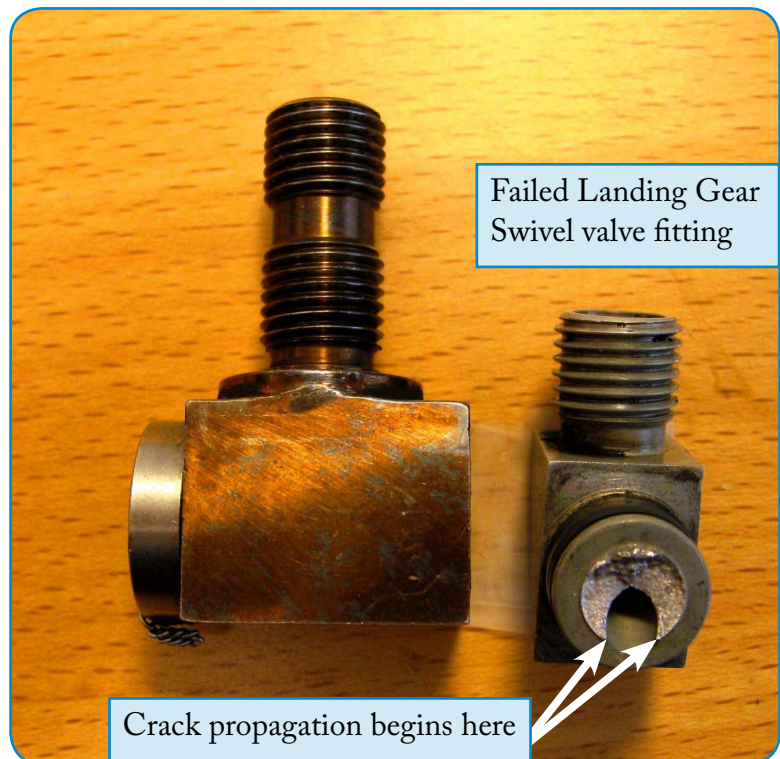
On climb-out during gear retraction the crew noticed a decrease in the hydraulic pressure while the pump was running with an eventual complete fluid loss. The aeroplane returned to the airport and the landing was uneventful. The cause of the problem was a failed landing gear (LDG) down-lock actuator hydraulic swivel valve. A fitting of the valve had split and allowed the loss of the hydraulic fluid.

Through the research of our Service Difficulty Report database via the Web-based Service Difficulty Reporting System (WSDRS), a high failure rate of these swivel valves was noted.

The swivel valve was replaced and the aeroplane was made serviceable.

All operators and maintainers are asked in the meantime to pay close attention to these LDG swivel valves for hydraulic fluid leaks which could indicate a possible internal crack condition. ✖

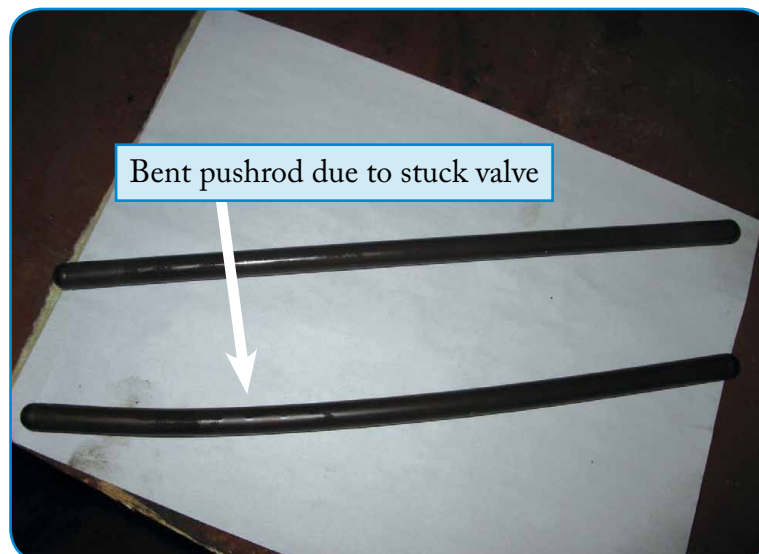
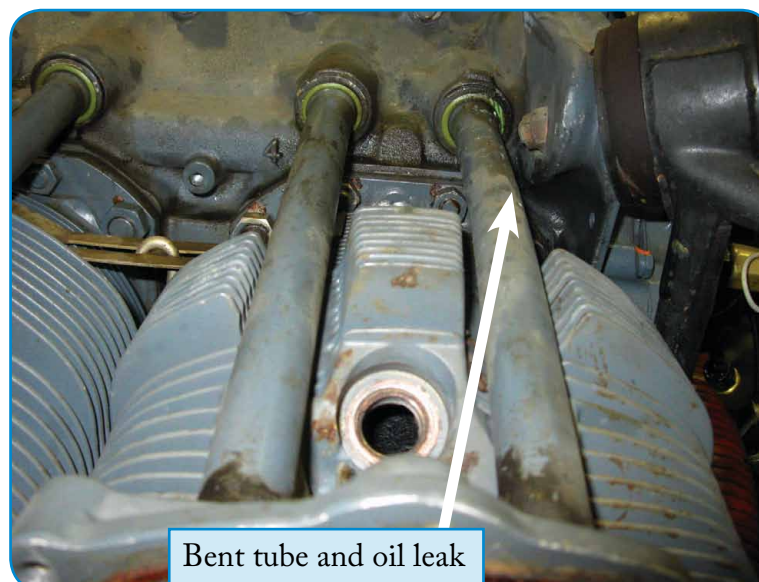
The aeroplane had to land because of a loss of engine power and high vibration. A stuck valve and bent push rod were found on the left-hand rear cylinder (engine was on condition). The customer decided to replace the engine with an overhauled unit. No damage to the aeroplane.

Operating a piston engine on condition can certainly offer significant cost savings to the owner. This does however come with certain risks. Extra maintenance can be performed to help mitigate those risks. As mentioned in a previous Feedback article, Avco Lycoming Service Bulletin (SB) 388 and Service Instruction (SI) 1425A provide great information regarding engine operation and valve maintenance. Both are available to the general public on Avco Lycoming's web site. (<http://www.lycoming.textron.com/>). ✖

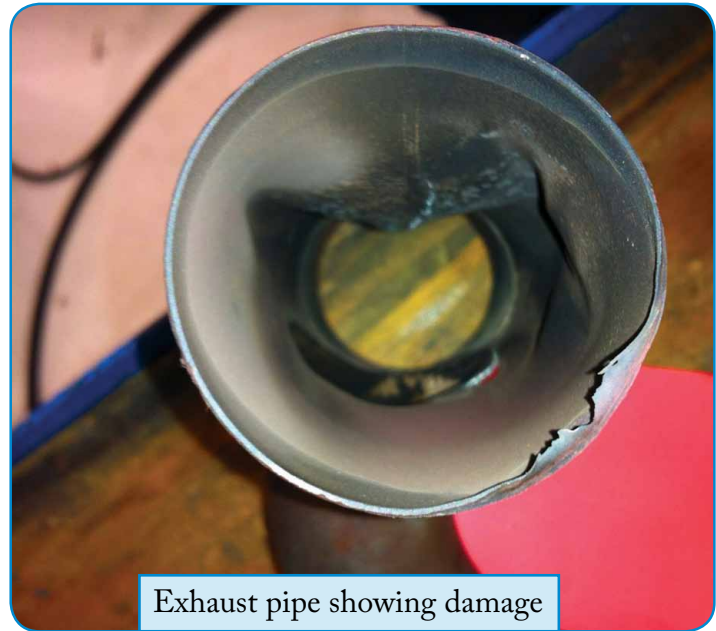
During the 100 hour inspection, cylinder #4 exhaust riser was found bulged at the collector. The bulge is consistent with the direction of cylinder #4 exhaust flow. Upon removal, the exhaust was noticed to be quite thin and appeared to have lost material. A gentle tap with a soft faced hammer easily collapsed the pipe. The engine has individual cylinder head temperature and exhaust gas temperature probes so overheating would be unlikely. Engine cylinder #4 was still serviceable, no other issues were found.

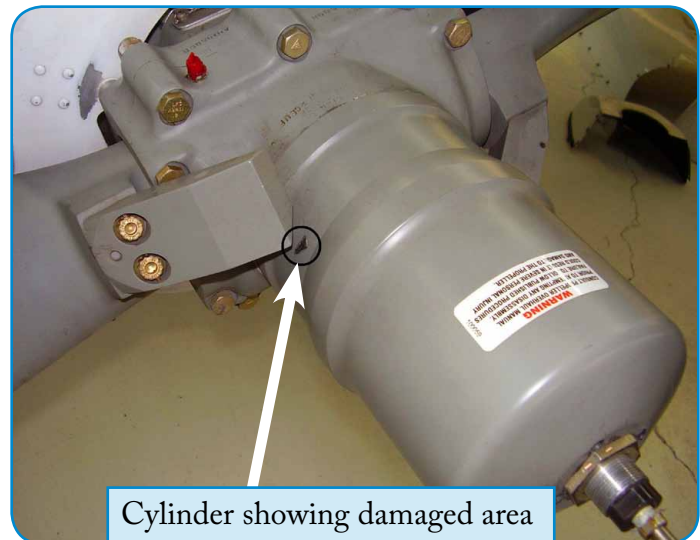
An investigation revealed improperly installed counter weights at some point in the propeller's history. A careful inspection is required after any maintenance task. ✖

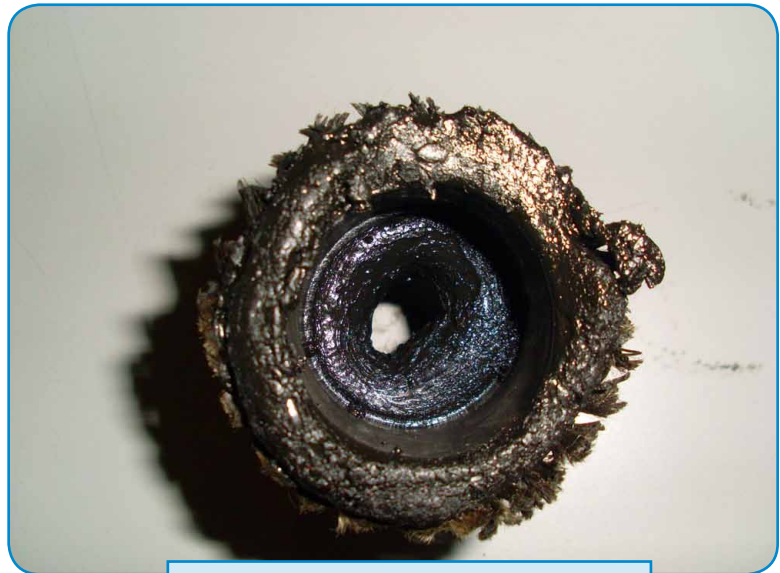
Left-hand engine was shut down after losing engine oil pressure in flight due to oil starvation. The aeroplane landed safely at the closest airport. A ground inspection revealed that the oil starvation was caused by a swollen engine breather line coupling that caused breather restriction. This restriction caused an internal engine pressure build up and oil escaping through the engine bearing labyrinth seal and accessory gearbox output shaft seal. A negligible oil leak was found on the left-hand engine cowling because a majority of the oil was internally burnt in the engine and could not be detected in-flight by the crew.

The swollen breather coupling, part number 159P10019-75, on the left-hand engine breather line rear section was repaired prior to 1997 and is not the original breather installation. The coupling was replaced. A ground run-up and a flight test revealed no more oil consumption on the left-hand engine.

Swollen coupling causing oil loss

Both engines breather lines were inspected for defective couplings before maintenance released the aeroplane.
