Transport  
Canada

# Issue 2/2013 **Feedback**

## Canadian Aviation Service Difficulty Reports

TP 6980E  
(2/2013)

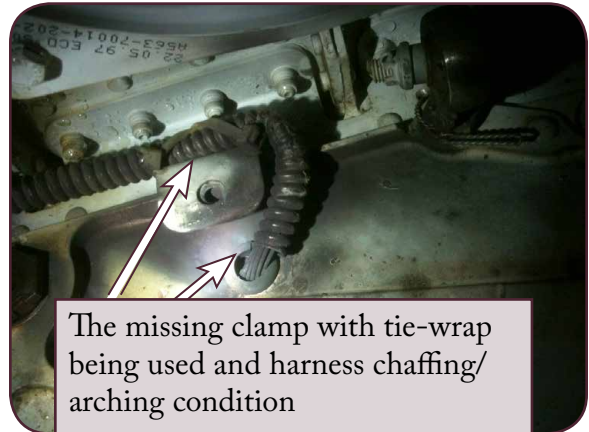
At arrival, it was noted that circuit breaker (C/B) 2LW on the cabin overhead panel was out. When the C/B was reset for troubleshooting, significant sparking was noted at the forward right (R1) passenger/crew door. The sparks were concentrated near the main interior door operating handle.

When the trim was removed from the door, it was noted that the main wire bundle for the door was completely burnt and had arced at one location. It appeared that a grommet was adrift and had split open, allowing a chaffing condition of the harness on the door structure.

Also noted was a missing clamp where a tie-wrap was used to secure the harness, inducing a misalignment condition and eventual harness failure.

The grommet and wires were replaced and a clamp was installed, making the aeroplane serviceable.

*Correct installation of any part or assembly of an aeroplane is essential for its continued airworthiness and safety of flight. ✖*

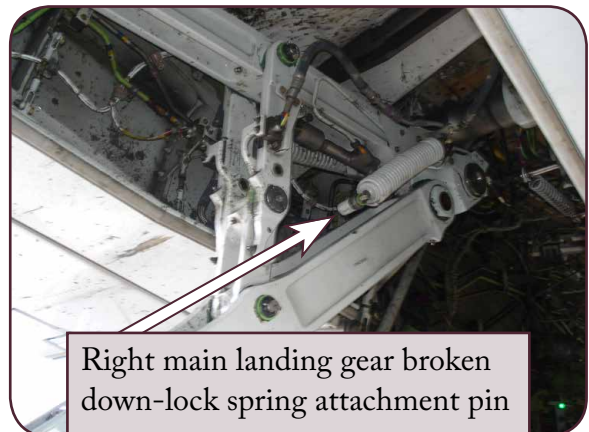
## Broken Main Landing Gear down-lock assist spring attachment pin

During a standard walk-around, the pilot reported that the right hand main landing gear had a loose spring hanging. Upon further investigation it was noted that the right hand down-lock spring attachment pin had sheered and the forward spring assembly had come loose.

The pin was replaced and the aeroplane was returned to service.

*The importance of the walk-around inspection from both the flight crew and maintenance engineer is an essential task prior to any flight. ✖*

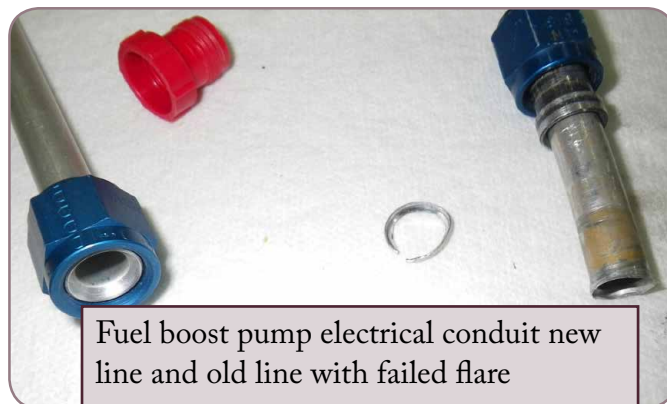
The centre fuel tank was fueled to maximum capacity at 2270 kg (5005 pounds). The aeroplane was parked in the hangar and fuel was noted to be dripping from the left-hand aft face of the main landing gear wheel well forward bulkhead just to the left of the aeroplane centerline. Further investigation revealed the leak was coming through the left boost pump electrical connector backshell.

The fuel was entering the wiring conduit because of a cracked flare at the left fuel boost pump canister.

*It is suspected that from past boost-pump canister changes, the electrical conduit B-nut was over-torqued, causing the eventual failure of the conduits flare end.*

Fuel boost pump electrical conduit new line and old line with failed flare

The aeroplane was removed from service and power lockout procedures were immediately carried out. The tube assembly was replaced and all appropriate leak checks were completed, returning the aeroplane back to service.

*Transport Canada Civil Aviation is advising all owners, operators and maintainers to reference the Aircraft Maintenance Manual for all required torque values with special consideration when working electrical fuel conduit lines. ✖*

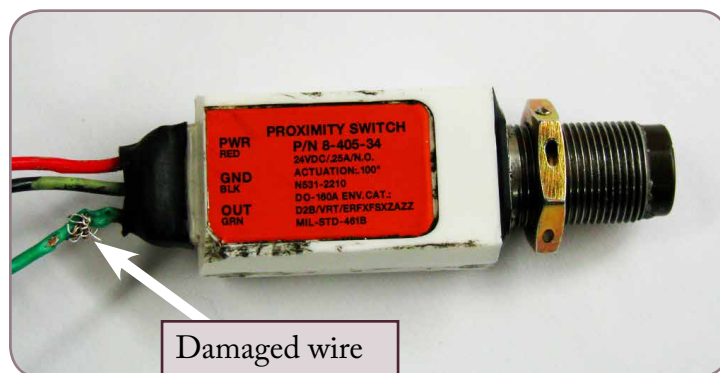
Troubleshooting found the main cabin door (MCD) handle proximity sensor (PS1MB) had a frayed and damaged wire from interference with the MCD handle linkage.

*The normal installation and wiring support requires the wires to be bent back 180 degrees against the sensor body and ty-wrapped in place to provide clearance from the inner door linkage mechanisms. It appears that the wires under the ty-wrap migrated back resulting in contact with the handle linkage, causing the damage to the wire.*

Damaged wire

The proximity sensor was replaced and the aeroplane was made serviceable.

*Transport Canada Civil Aviation (TCCA) is advising all maintenance personnel to adhere to all standard wiring practices and maintenance manual instructions. ✖*

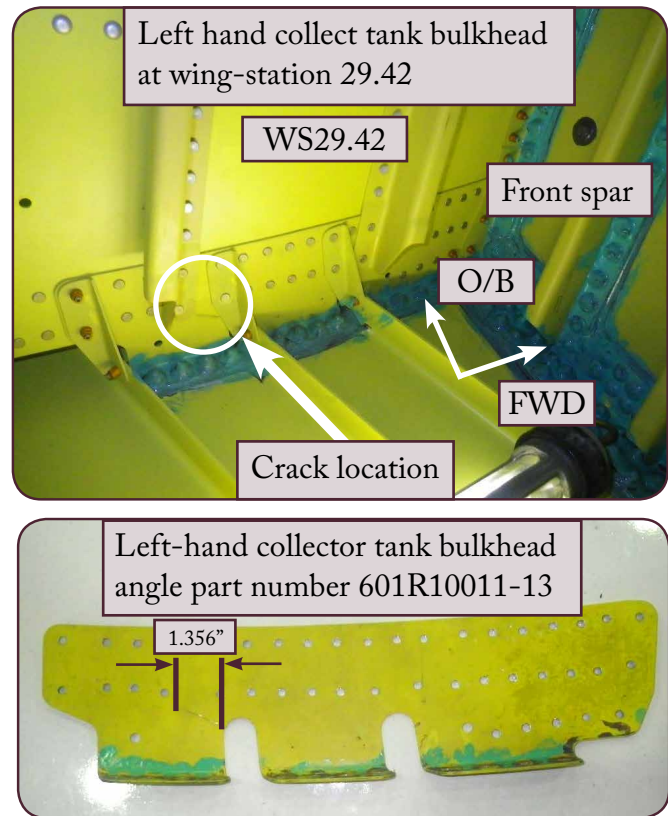
The maintenance technician was performing a internal zonal inspection of the centre wing section as per task card #RJ2-57-900-320 when he found cracks emanating from one of the two relief stringer cutouts for the web of the support angle at both sides of wing station 29.42.

New parts were fabricated and heat treated as per Structural Repair Manual (SRM) 51 10 06 section 3D and corrosion protection reapplied as per SRM 51 25 00 and 51 25 16.

*Transport Canada Civil Aviation (TCCA) is advising all CRJ 100/200 operators to pay close attention to this area in reference to the above mentioned task card for probable crack propagation. ✖*

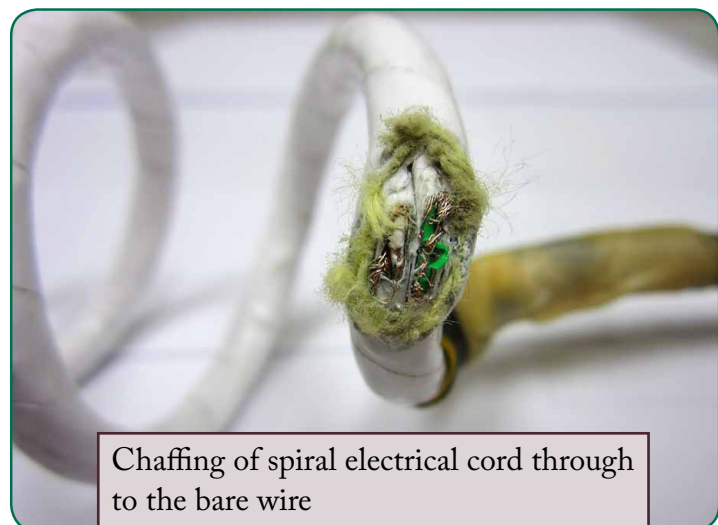
## Chaffed wing leading edge harness

The outer harness insulation was worn through and were repaired or replaced as required making the aeroplane serviceable.

*Wire harness chafing such as described in this service difficulty can cause intermittent system failures that can be difficult to trouble-shoot and correct. ✖*

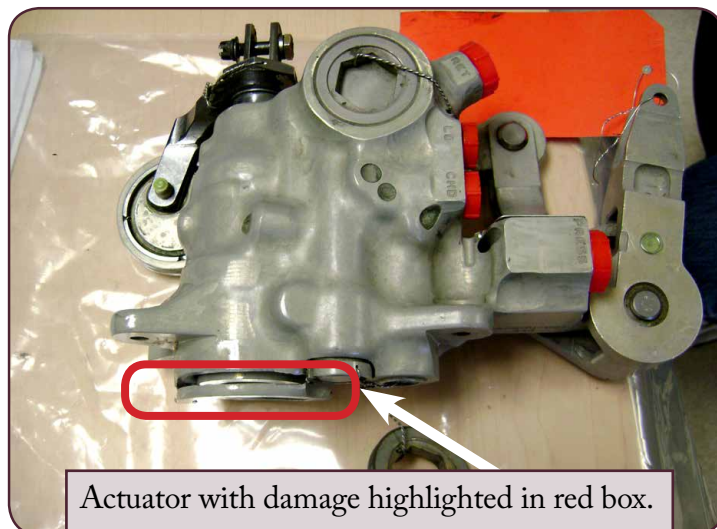
## Damaged Spoiler Actuator

The pilot noticed during taxi for take-off that the right hand outboard spoiler was not deployed. Upon inspection, hydraulic fluid was found to be leaking from the right hand out board wing. Further investigation revealed a loss of hydraulic fluid at a rate of 1 qt per 10 min of engine operation. Maintenance found the spoiler actuator broken and resulting damage to the mounting bracket at the rear spar. (Actuator damage – threaded portion of end cap cracked 270 degree of circumference)

*This could be a possible area of concern as the fleet ages. ✖*

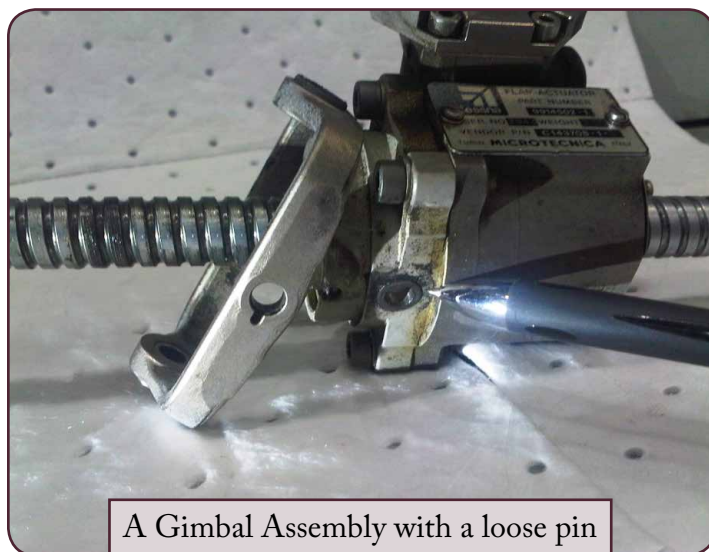
During a walk-around inspection, it was noted that the left-hand inboard flap segment had an excessive amount of fore and aft movement. Further investigation revealed that the flap actuator gimbal assembly that provides the flap actuator to airframe mounting interface was loose at the flap actuator body.

Upon removal, it was evident the two gimbal retaining pins that hold the gimbal assembly to the actuator body were not properly in place. The lower retaining pin was missing entirely and the upper pin had migrated enough that it was no longer engaged into the flap actuator body. These retaining pins are supposed to be held in place by snap rings; however both snap rings were missing. This led to a condition whereby the flap actuator was no longer secured to the trailing edge of the wing, and was only held in position by the Teleflex cable that operates the flap actuator.

This created a potential for the inboard flap segment to jam or to come entirely free from the aeroplane.

*It is recommended that operators pay particular attention to this area. Flap assemblies are subjected to significant airloads during flight conditions. ✖*

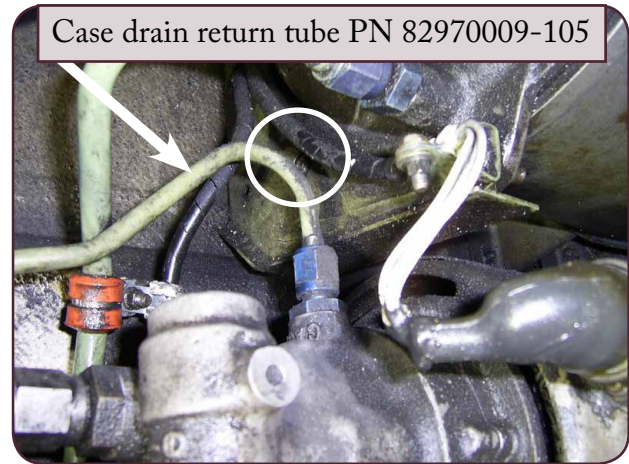
During descent, the flight crew observed a rapid pressure drop of the #1 hydraulic system which directly affected wing flaps, inboard roll spoilers, normal brakes and anti-skid functionality. An emergency was declared and the aeroplane landed without further incident.

*This is a good reminder to all maintenance personnel to inspect for signs of chafing and fouling conditions at every opportunity when in these confined areas.*

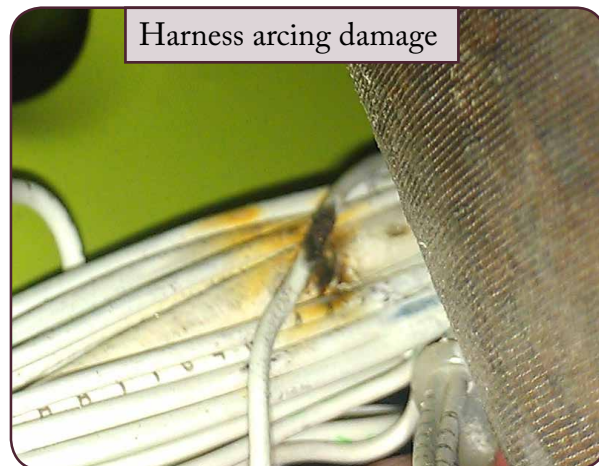
During the pilot walk around, the baggage light circuit breaker (C/B) was noted as “popped” or out. After a reset the C/B immediately popped. Maintenance removed the baggage panels in order to inspect a suspected wiring harness run and with the ceiling panels down, the maintenance technician noted a flash when the light switch was turned on.

Further inspection found two wires chafed through the insulation by the auxiliary power unit (APU) intake duct.

The wires were repaired and the clamp holding the bundle was adjusted for better clearance and the aeroplane was released for service.

*Proper harness support and protection to prevent occurrences as stated is essential for the safe continued operation of all aeroplanes. ✖*

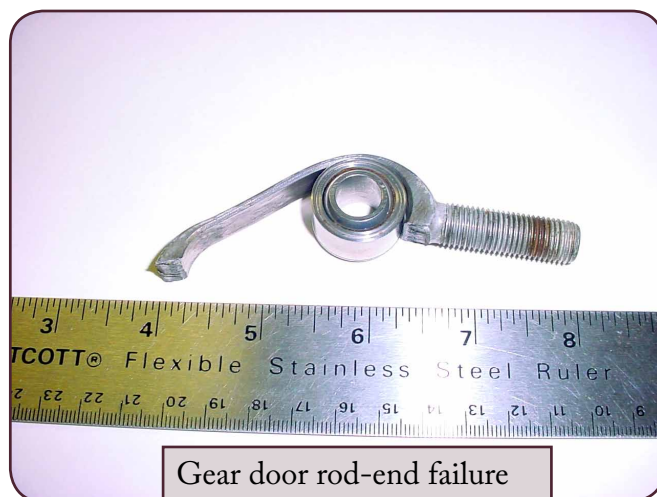
## Landing Gear Door Rod-end Failure

During gear retraction and extension, the pilot heard a loud bang. The aeroplane landed without incident and maintenance found the right-hand forward gear door rod-end broken.

The rod-end assembly was replaced and the aeroplane was made serviceable.

*Transport Canada Civil Aviation (TCCA) is advising all Mitsubishi MU-2B60 owners, operators and maintainers to pay close attention to the main landing gear door rod-ends for possible signs of cracks. ✖*

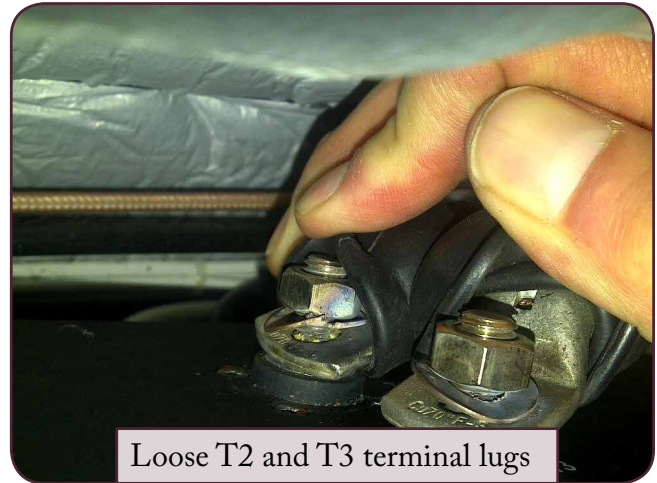
A defect was recorded where the battery assist function was inoperative (secondary start) which was rectified by the replacement of the left-hand power junction box (LHPJB). A few days later a defect was recorded: “generator 1 bus crew advisory status CAS message, unable to clear”. While conducting troubleshooting with the external power on, the battery 1 voltage drained down below 20 volts. During further troubleshooting it was confirmed that the battery 1 generally would not charge with external power connected and would continue to discharge, with the exception of a few instances when battery 1 would receive a partial charge (approximately 27 volts from a 28.5 external power unit). During engine runs, it was also confirmed that the secondary start sequence was not functioning. Additionally there was no load sharing when generator 1 or generator 2 was turned off line where it was suspected that the bus tie was not closing.

Extensive trouble shooting was carried out with no faults found. The left-hand power junction box was again replaced with nil fix. While removing the right-hand power junction box for replacement, the two rear connections at Terminal 2 and Terminal 3 were found to be significantly loose and arcing on the lugs.

*It is suspected that due to the finding where both terminal attachments were loose, previous maintenance work in this area was performed where the error was induced. ✖*

The lugs were tightened and the system was tested serviceable. The right-hand junction box was replaced due to terminal lug damage.

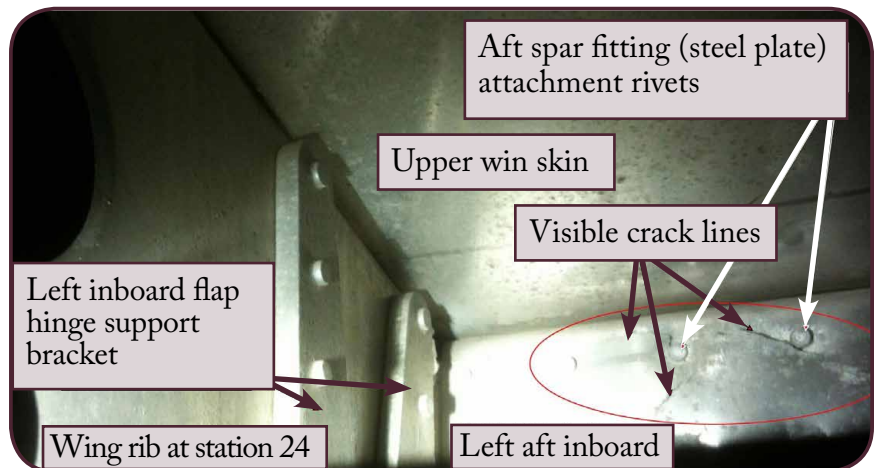
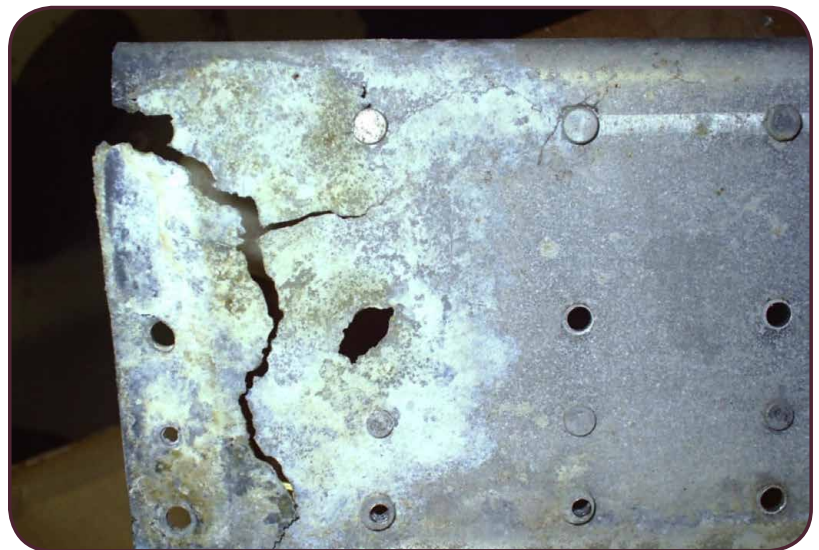
A visual inspection of the wing rear spar attachment fitting (using light and mirror) (Wing Rib Station 24) revealed evidence of corrosion. This area is very difficult to inspect (no inspection panel), thus a video camera was needed to facilitate a more detailed inspection.

Subsequently, a detailed inspection using the camera revealed cracks on the steel aft spar plate attachment fitting, part number (P/N) 66762-000, located on the aft wing spar. Severe, dissimilar metal related corrosion was also found between the rear wing spar and the spar plate attachment fitting.

An earlier Service Difficulty Report reported similar corrosion in this same area. It appears that the aluminum spar and steel attachment fitting were assembled during manufacturing process without corrosion preventive protection. Initially, some metal flaking was visible, but upon disassembly; it was found that over 50% of the aft left-hand spar fitting was degraded by corrosion.

*Transport Canada Civil Aviation (TCCA) highly recommended that owner/operators comply with Piper Service Bulletin (SB) 977 (applicable to PA-28/PA-32, PA-34 & PA-44 series) and carry out a one-time inspection and other recommended corrective action. The installation of these access panels to the rear floorboards will then allow maintenance personnel to conduct a thorough corrosion related inspection of this important area. Additionally, TCCA recommend that operators also comply with the inspection procedures outlined in Piper SB 789A.*

*In the interim, it is recommended that maintenance personnel use a video camera or a small borescope to access this area to carry out these inspections. ✖*

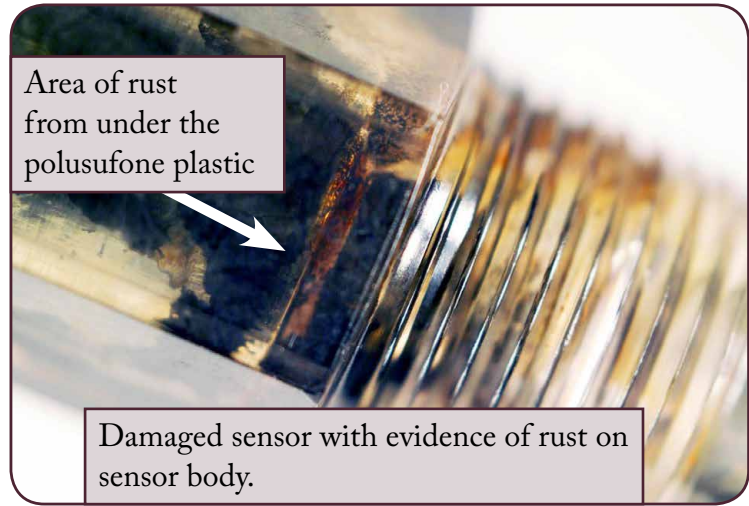
Investigation found that a water level sensor was the cause of the smoke. The unit was sent for testing with the following results:

*The lab report suggests that a crack was likely caused by an over torque situation probably during installation of the unit. Water from the tank was able to penetrate the sensor body and cause the failure of the device.*

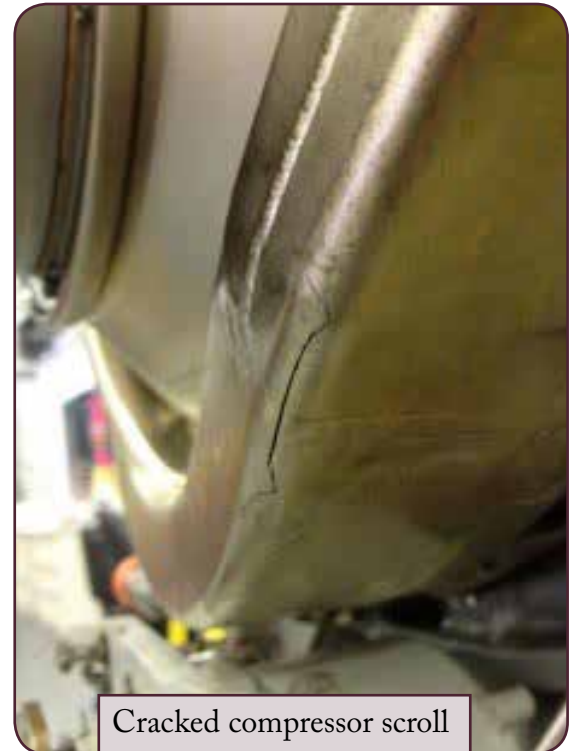
An approximately 10 cm (4 inch) vertical crack was found on the left forward side of the engine compressor scroll during a scheduled daily inspection. The engine was completely replaced. The compressor was sent for overhaul. The scroll was a thin-wall type and will be exchanged for a thick wall version.

*Cracks are common with the thin wall compressor scroll. The cracks in this area are easy to detect and if large enough will cause an increased turbine temperature and likely a degradation of performance. Operators are reminded to be aware of this potential. ✖*

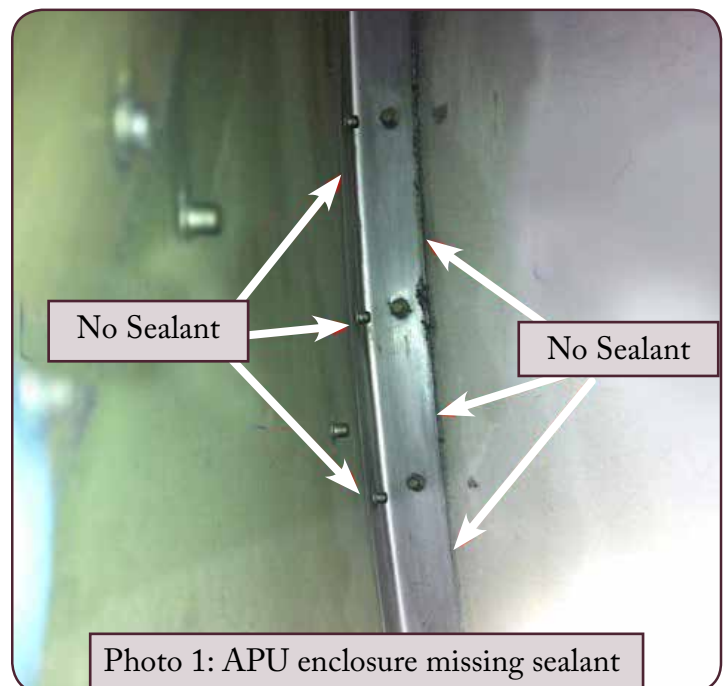
While the aeroplane was climbing through 10 000 feet with auxiliary power unit (APU ) operating, the red indication & crew alerting system (ICAS ) "APU fire" posted. Crew selected the APU fire switch to shutdown the APU and message cleared. Crew declared an emergency and returned to the departure airport. An investigation revealed no sign of a fire.

An inspection indicated that sealant inside the APU compartment was missing at the seams and at the APU mount to firewall interface. This resulted in lower pressure within the APU enclosure and may have resulted in reduced APU eductor efficiency. This caused the APU exhaust gases to be sucked into the APU enclosure tripping the fire loops.

Sealant was applied to the missing areas and the aeroplane flown with the APU running. Checked serviceable.

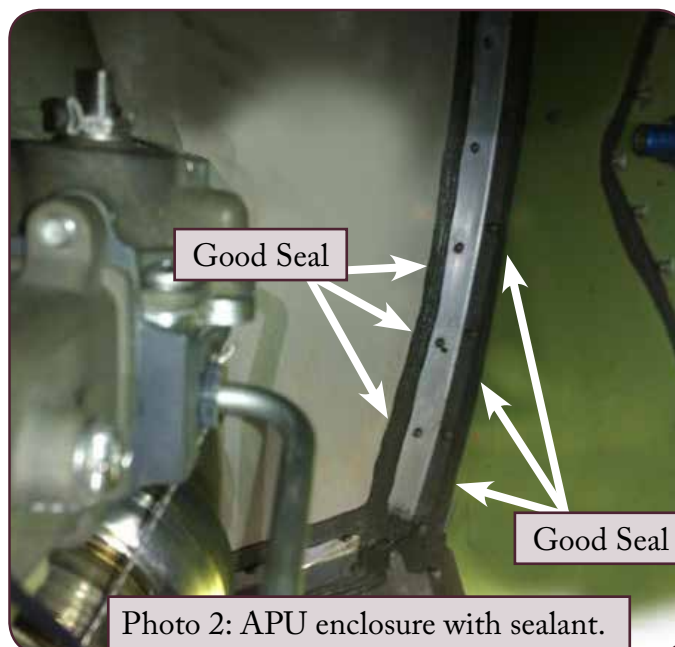
Photo 2: APU enclosure with sealant.

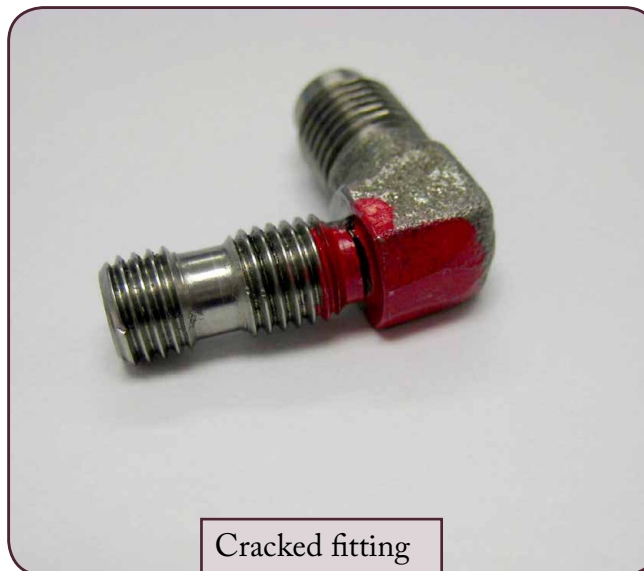
During the daily inspection, it was noted that oil was leaking out of the left engine cowling. Upon investigation, a fitting on the left engine propeller governor was found cracked. The fitting was replaced and the aeroplane was returned to service.

Cracked fitting

*Oil leaks can sometimes be an indicator of major problems. What may appear to be a minor leak can actually be an indicator of an impending failure which can lead to an in flight shutdown. ✖*

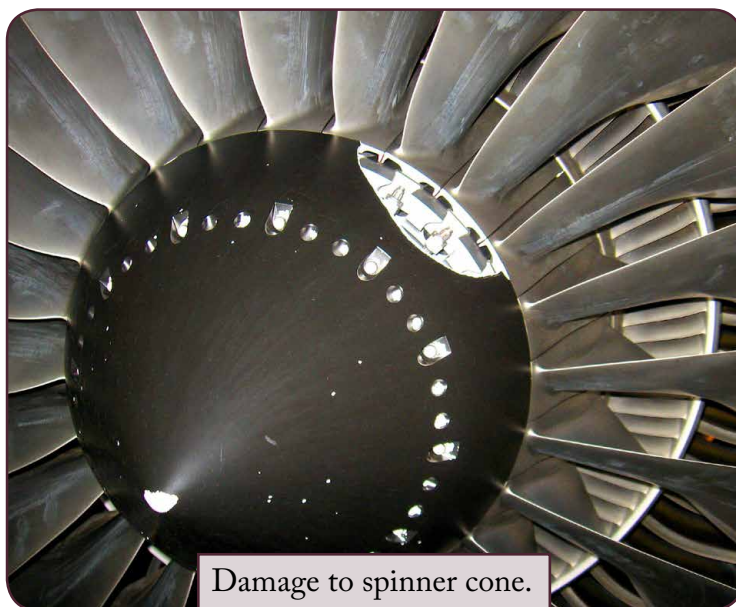
## Cracked Spinner Cone Causing Fan Blade Damage / in Flight Shut Down

While at flight level 320, the crew reported high engine vibrations on the number 2 engine. They reduced power on the engine to idle to reduce/stop the engine vibrations. They declared a pan pan emergency and returned to departure airport where they landed overweight by approx 3000-4000k. After landing, the crew inspected the engine and found damage to several fan blades due to a missing segment of the engine nose cone.

*This issue may have been caused by pre-existing cracks prior to re-work in accordance with service bulletins 72-0159 and 72-0186. Maintainers are urged to become familiar with the contents of these bulletins. ✖*

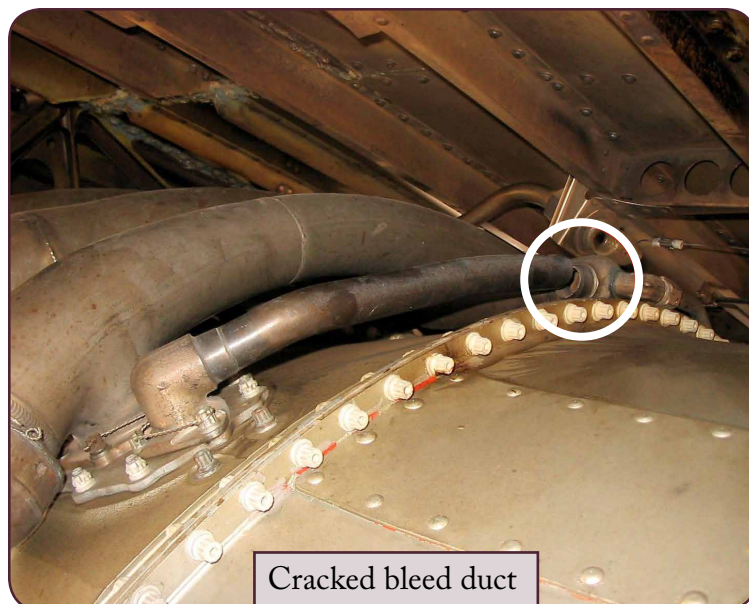
## Fractured Bleed Air Line Causing Fire Warning

After takeoff, climbing through 6000 feet #2 engine fire warning activated. Crew followed the check list and returned with #2 engine shut down. Inspection of the engine found no evidence of fire however a ruptured bleed air duct was discovered. The duct was repaired and the aeroplane returned to service.

*As aeroplanes age, special attention must be given (during inspections) to components that are subjected to high heat and vibration loads. ✖*
