TP 185E
Issue 1/2014

AVIATION SAFETY LETTER

TSB Final Report Summaries

Accident Synopses

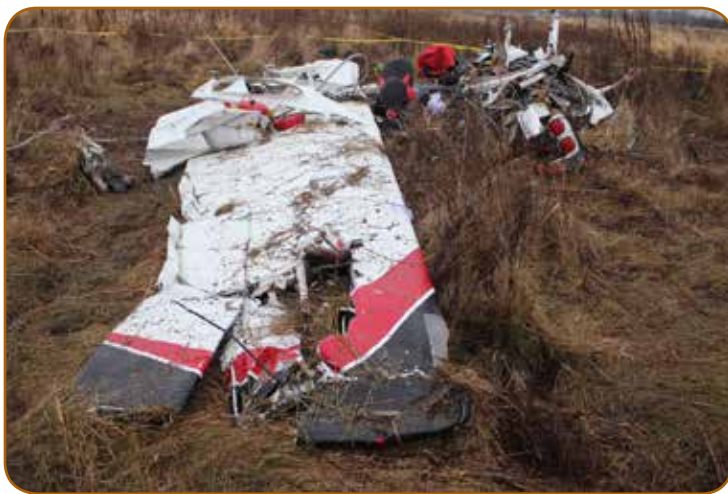
Wreckage of Cessna Cardinal 1.9 NM west of the threshold of Runway 07 at CYOW

At approximately 19:12, the aircraft entered a steep right turn with a rapid descent, and struck power lines before impacting the ground 1.9 NM west of the threshold of Runway 07. Radar data show that, while on the approach, the aircraft twice deviated

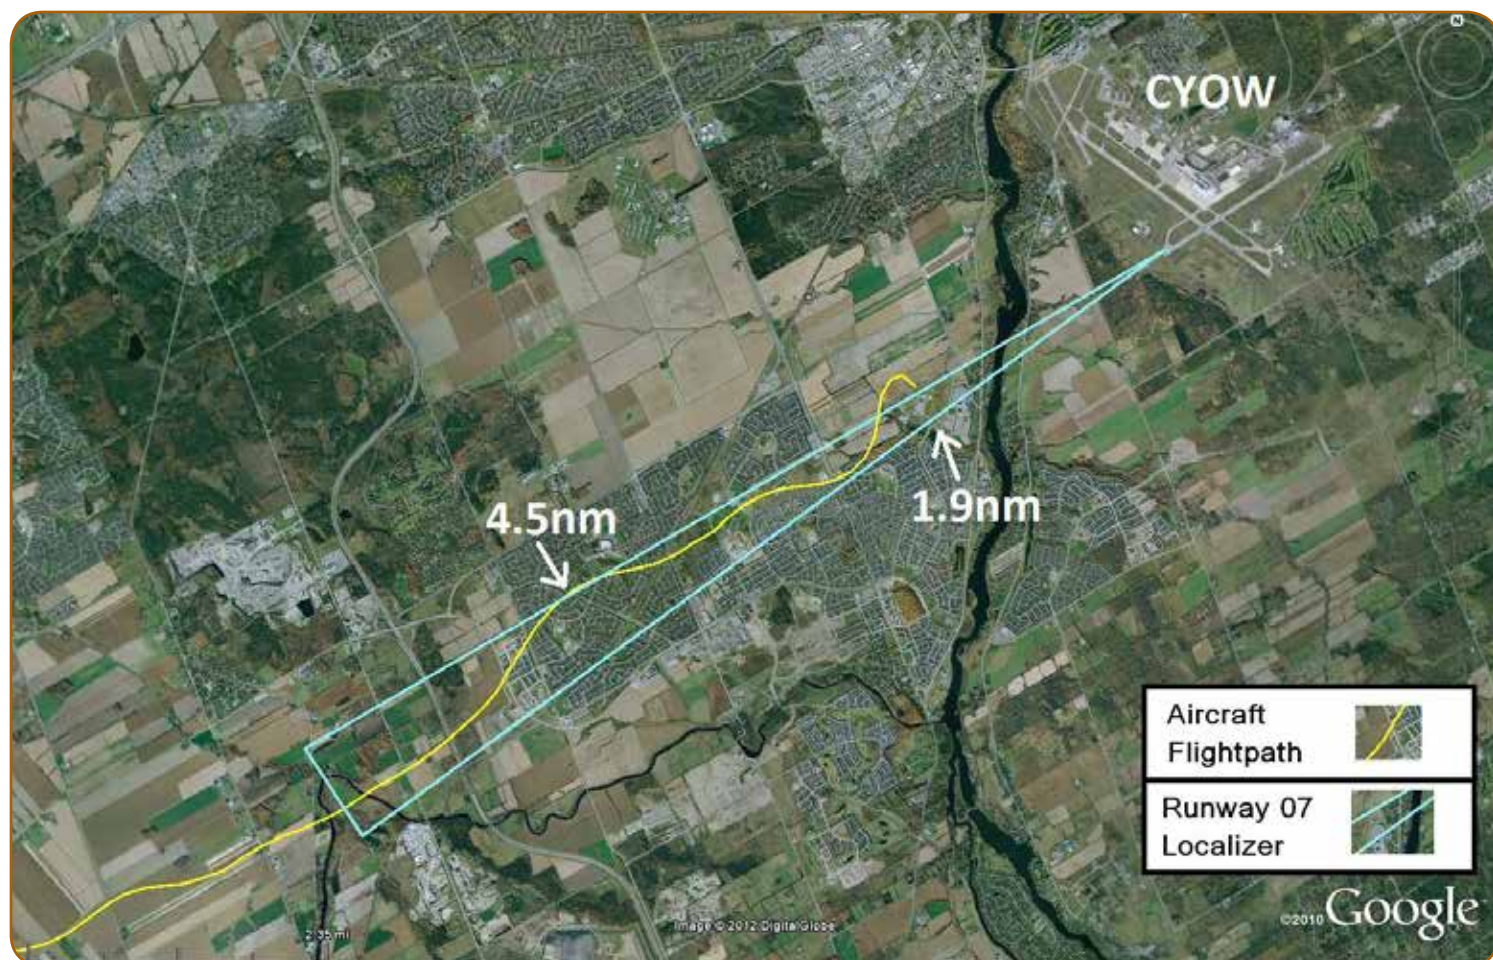
Figure 1—Aircraft's flight path showing its deviations from the localizer during the final approach.

significantly from the localizer to a point that would have caused the localizer indications on the aircraft instruments to go to full deflection. Airspeed on the approach was maintained above 100 kt until the loss of control (Figure 1).

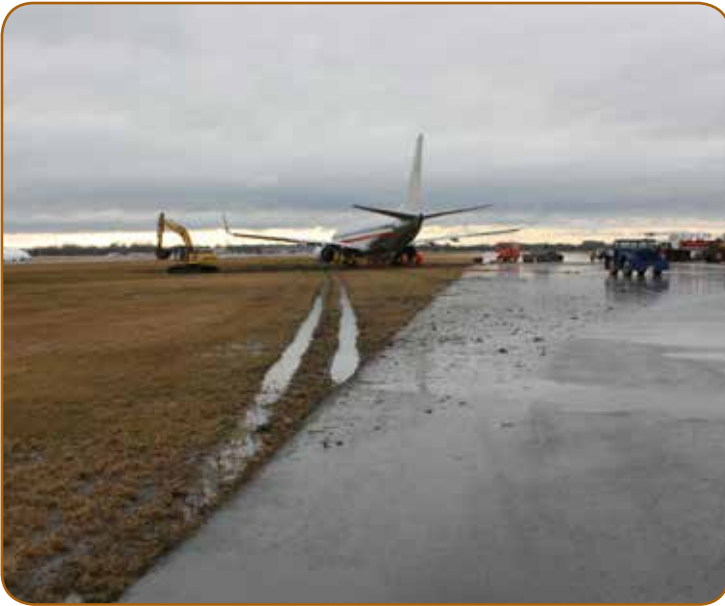
Boeing 737 off the runway

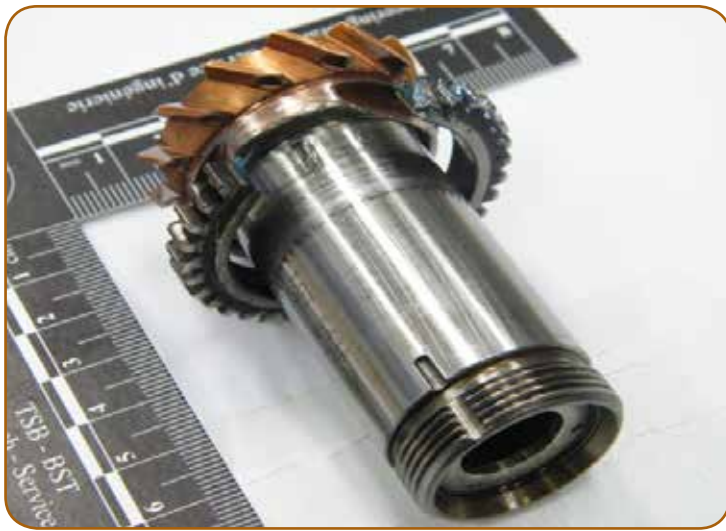
The torque sensor had accumulated approximately 6 470 hr since overhaul in 1997. The torque sensor assembly does not have a designated overhaul period and is normally overhauled with the engine. The laboratory analysis indicated that the case hardening of the gear tooth flanks and roots of two spur gears in the torque sensor gear train was below the manufacturer's specification requirements and likely led to the wear of the loaded faces and flanks of the gear teeth. The combined wear of the two gears likely caused an abnormal vibration that produced excessive cyclic loading and eventual fatigue cracking in the tooth roots of the intermediate gear. The intermediate

spur gear subsequently separated into several fragments and caused the loss of power transmission to the high-pressure, engine-driven fuel pump. The immediate result would have been fuel starvation of the engine, flameout and loss of power.

Failed gear on the torque sensor shaft

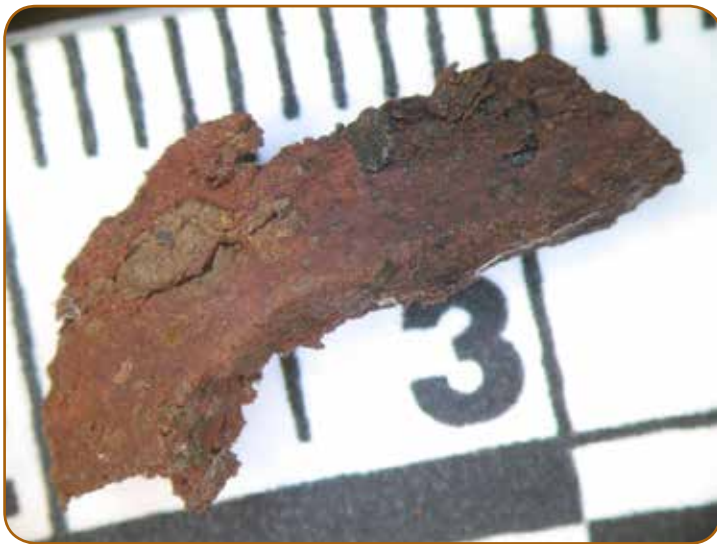
The left engine lost power due to fuel starvation. Investigators found debris in a fuel pump nozzle, which reduced the amount of fuel the pump delivered to the left collector tank. Fuel depletion in the left collector tank caused the engine to shut down while usable fuel remained in the left inboard tank. Additionally, the fuel cross-feed valve remained closed, which meant that the left engine was only receiving fuel from the left fuel tank, rather than from both tanks.

Debris found in fuel pump nozzle (ruler scale is cm)

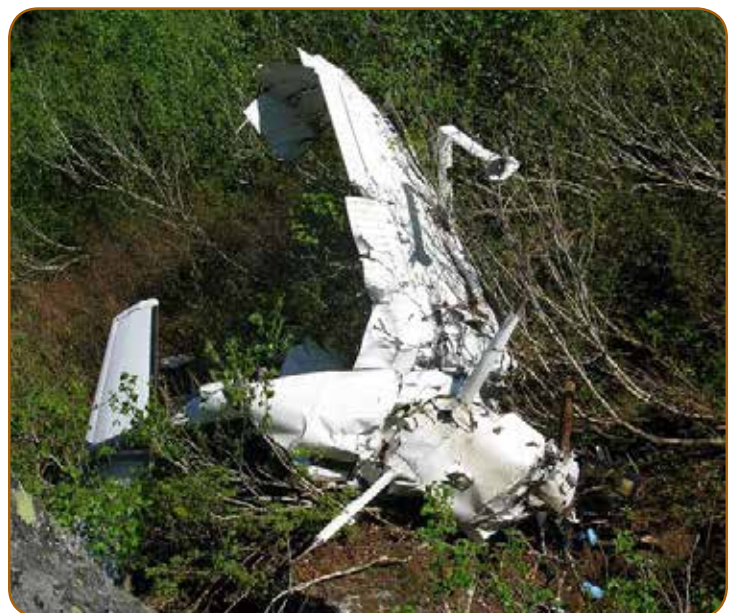
Wreckage of Cessna 152

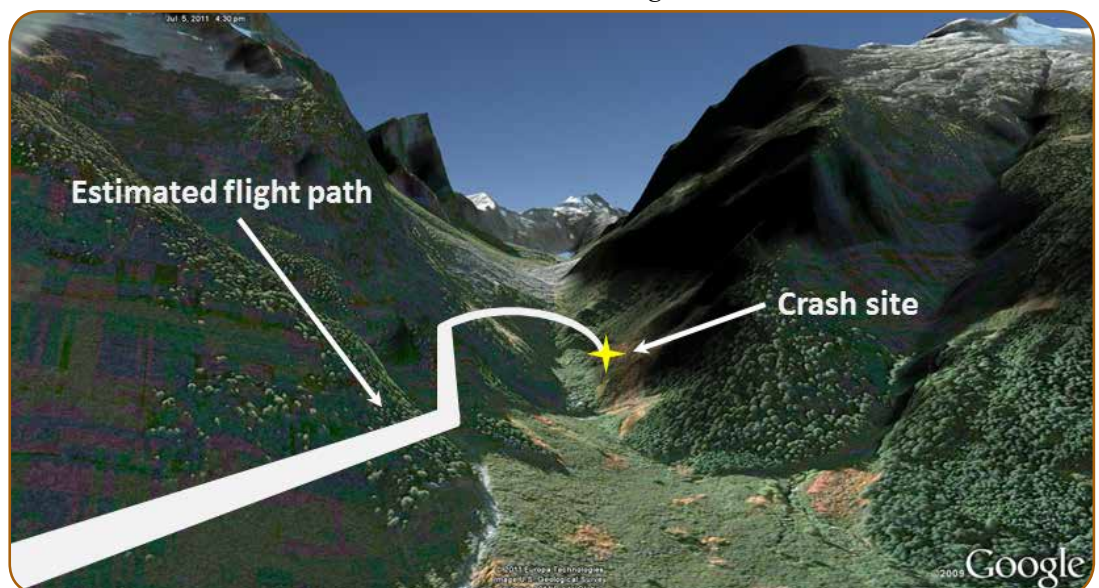
It is not known why the aircraft was at such a low level before the crash. However, conducting a turn at a low altitude would have increased the risk level of the manoeuvre and was not in accordance with the flying school policy regarding minimum flight altitudes. If the instructor delayed the decision to initiate the turn-around, it would have further reduced safety margins. With the flaps in the up position, the stall speed would have been 7 kt higher than if the flaps had been fully down. In addition, it is possible that once the turn was initiated, the aircraft encountered a downdraft on the shadow side of the valley, which could have caused the aircraft to sink. If the pilots were not cross-checking their instruments, it is also possible that the loss of horizon and visual illusions caused by the surrounding terrain may have caused the pilots to inadvertently stall the aircraft while conducting the turn.

Estimated flight path with shadows at the time of the accident (Image: Google Earth)

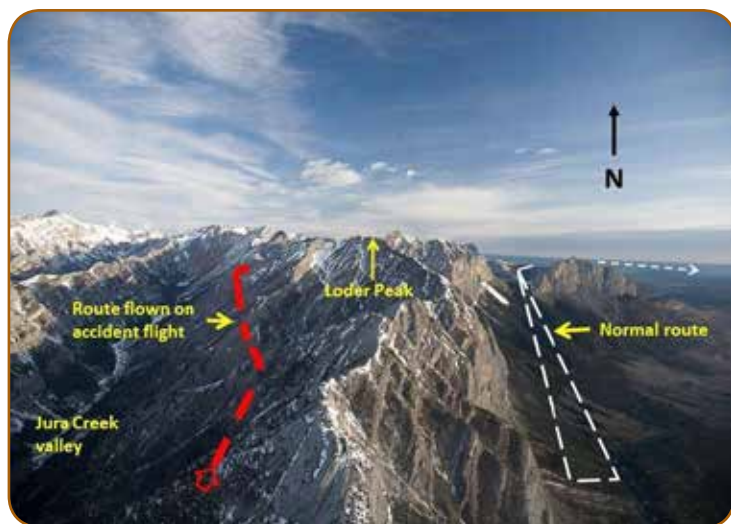
Route of flight

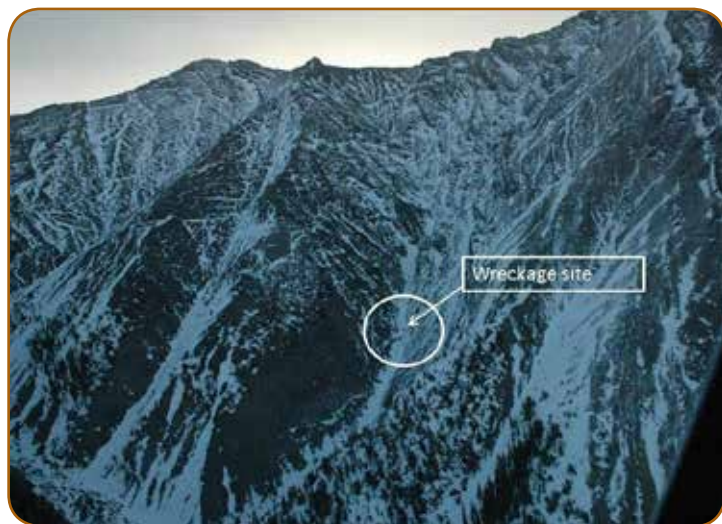
Wreckage site

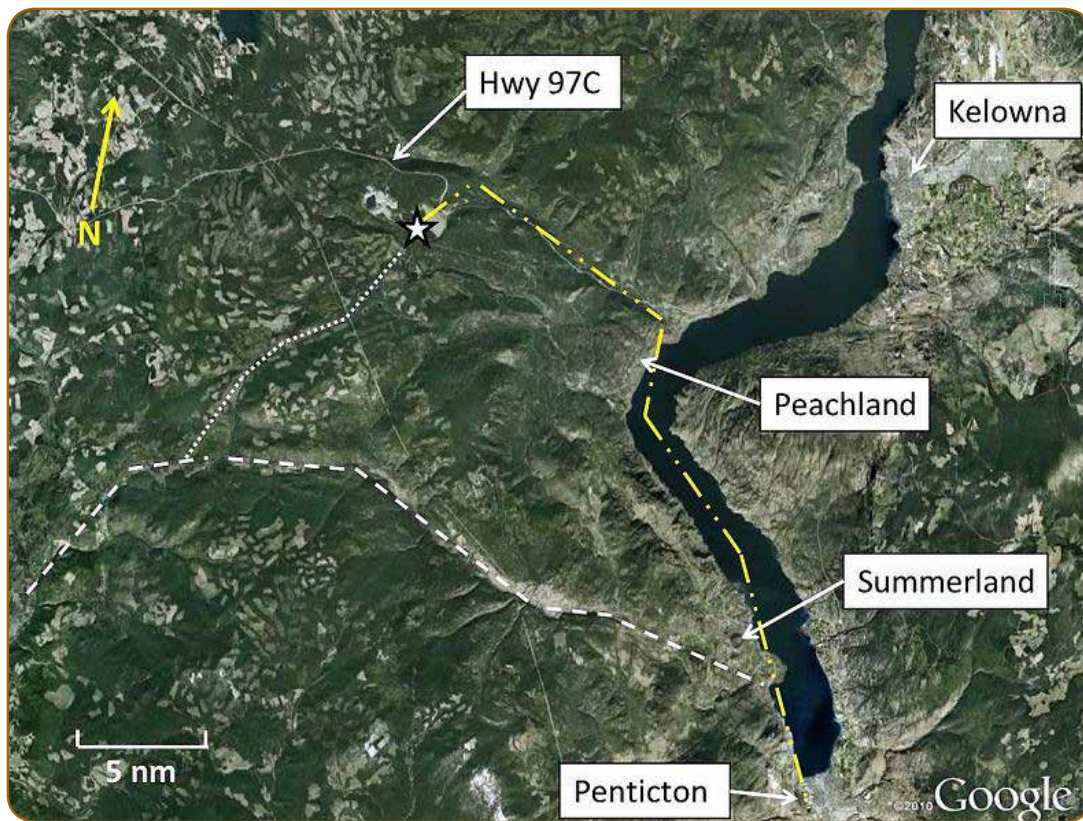
The pilot decided to conduct the flight despite being aware that visibility to the west (the flight planned route) was reduced by smoke. Reduced visibility was almost certainly encountered in the vicinity of Brenda Mines.

Map showing the probable route up the lake to the accident site (dashed/double-dotted line), the published VFR route to the west of the lake (dashed line) and the low ground route connecting the two (dotted line)

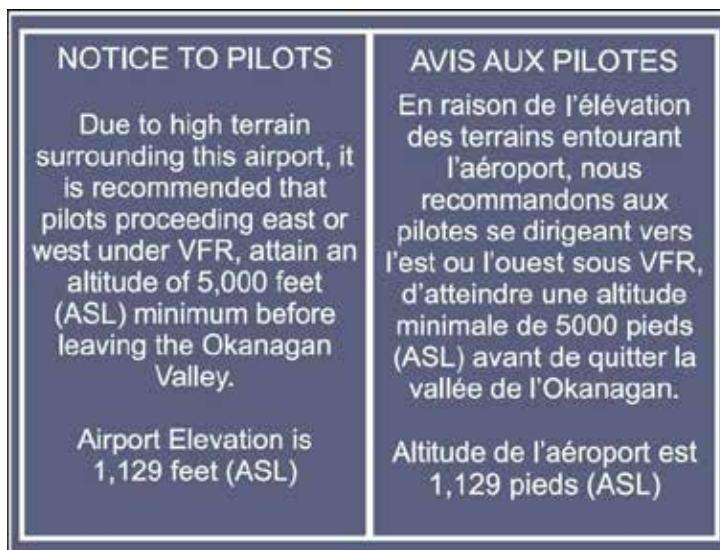
Modified sign at Penticton Airport

The following sign was installed at Penticton Airport, advising pilots to climb to 5 000 ft before turning west or east when departing the Okanagan Valley. △

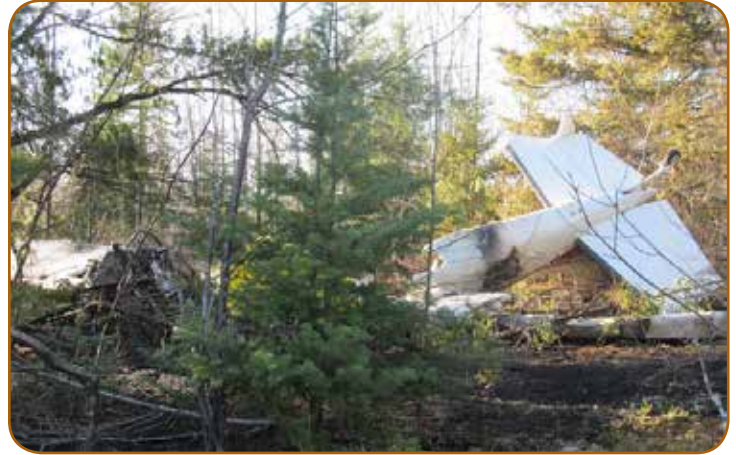
— On May 4, 2013, a **Cessna 185F** took off from Runway 25 at Mont-Laurier aerodrome (CSD4), Que. with a pilot on board. Runway marks made by the left wheel extended into the sand located off the runway, indicating that the aircraft had left the runway before taking flight. Once in flight, the aircraft banked left, crashed nose first in the opposite direction and caught fire. The pilot was killed. The TSB sent the seat to the laboratory for further analysis. *TSB File A13Q0077.*

Cessna 185F at Mont-Laurier on May 4, 2013

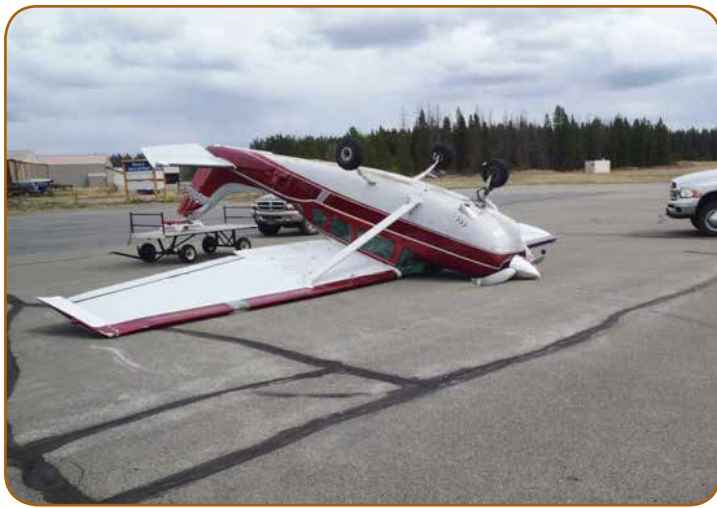
TSB File A13P0080

— On May 13, 2013, a **Cessna 205** was being run up after maintenance by an aeronautical maintenance engineer (AME) on the apron at Anahim Lake Airport (CAJ4), B.C., when the aircraft flipped over its nose. It was reported that the aircraft had a 5 kt tailwind and was just powering up (about ½ throttle) when a whirlwind gust caught under the tail. The AME was alone on board and was not injured, but the aircraft was substantially damaged. *TSB File A13P0080.*

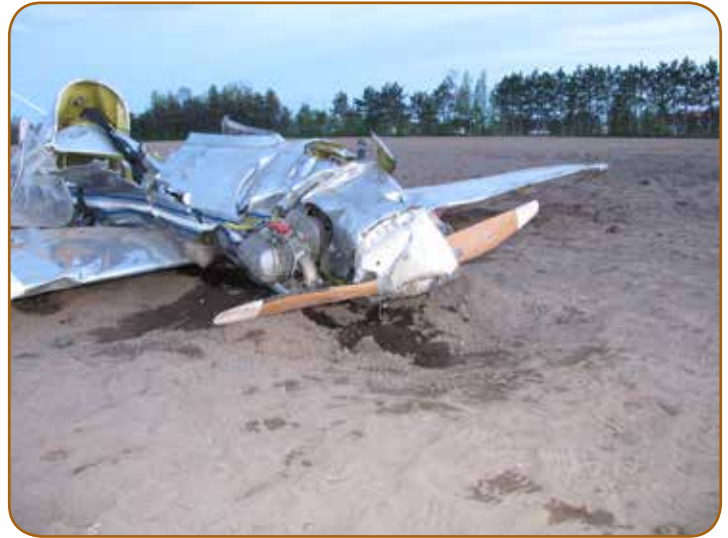
— On May 18, 2013, an **amateur-built Hummelbird** aircraft was conducting a local VFR flight from Mascouche Airport (CSK3), Que., in clear and calm weather conditions. While the aircraft was above Lavaltrie, Que., the pilot made a distress call without specifying the nature of his difficulties. The aircraft crashed at an impact angle of about 60° into a sandy field. The pilot suffered fatal injuries. The aircraft was substantially damaged but the propeller was relatively undamaged. The engine was taken to a TSB laboratory for assessment. *TSB File A13Q0086.*

Hummelbird amateur-built, May 18, 2013

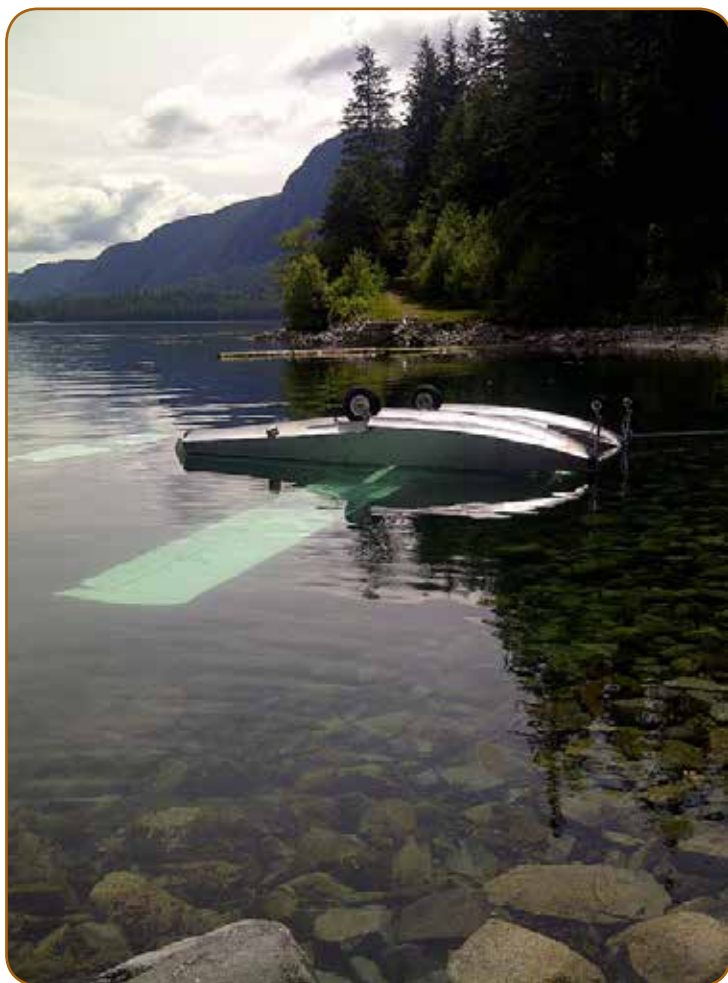
17:45 PDT. The one person on board was confirmed deceased. The aircraft was equipped with a 406/121.5 MHz emergency locator transmitter (ELT), but no transmission was received or reported by others. *TSB File A13P0086.*

Sunken DHC Beaver on May 21, 2013 near Stuart Island, B.C.

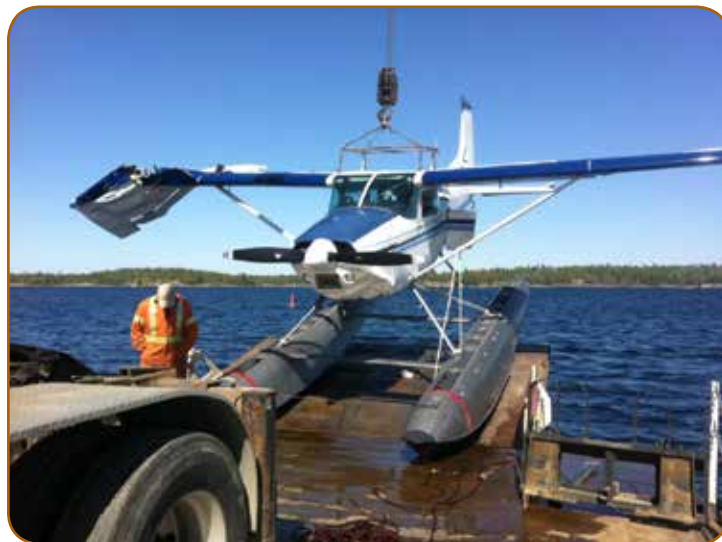
TSB File A13O0099

The aircraft came to rest approximately 50 ft from a small island. Although both retrieved life jackets from the aircraft, they decided the distance to shore was minimal and carried the life jackets instead of wearing them. After a short period of time, a boat passed by and called rescue services. Neither pilot was injured; the aircraft sank in approximately 10 ft of water. *TSB File A13O0099.*

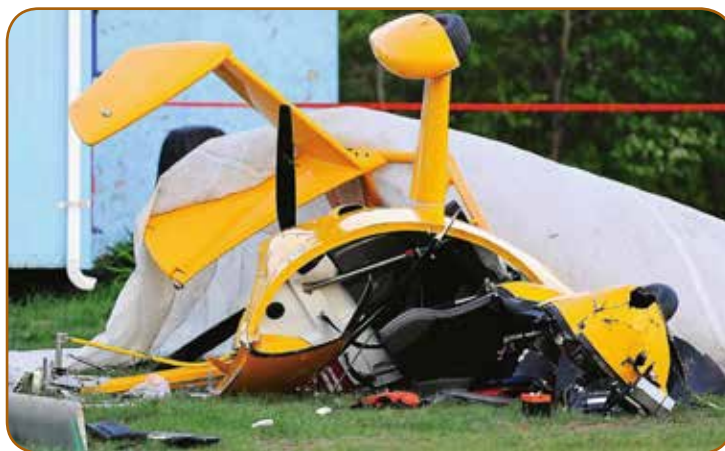
The pilot died in hospital. The aircraft was destroyed by the impact but there was no post-crash fire. Two TSB investigators went to the accident site. The reasons for the loss of control are not yet known. *TSB File A13Q0089.*

Gyroplane accident at the St-Lambert- de-Lauzon aerodrome

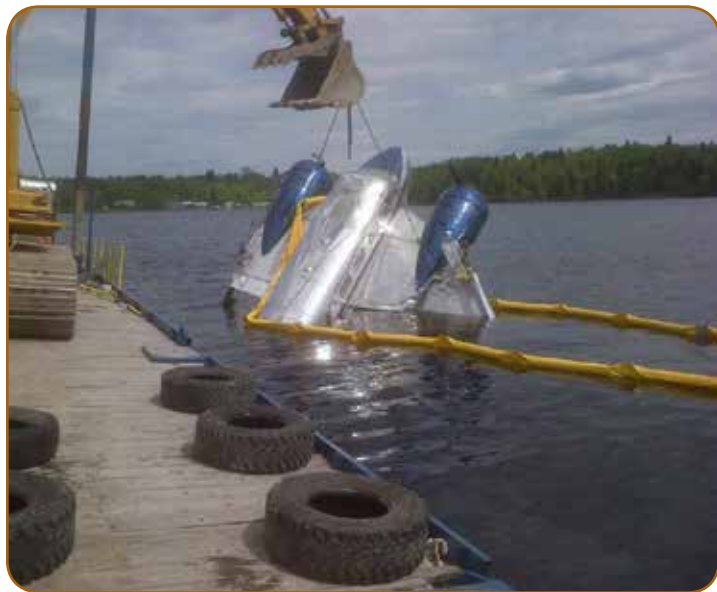
— On May 30, 2013, a **float-equipped Beech 18** was departing Cochenour (Red Lake), Ont., en route to McCusker Lake, Ont., on a camp service flight with a pilot and one passenger on board. On departure, the aircraft banked slightly right then 90° left. The left wing tip struck the water, and the aircraft cartwheeled and sank. The two occupants sustained fatal injuries; the aircraft was substantially damaged. *TSB File A13C0058.*

Beech 18 being recovered out of Red Lake, Ont.

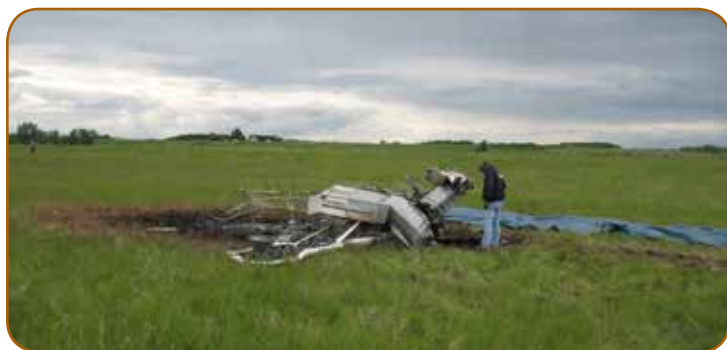
TSB File A13C0063

— On June 13, 2013, a **Piper PA-14** was departing North Battleford/Cameron McIntosh Airport (CYQW), Sask., en route to Calling Lake, Alta. Shortly after takeoff, the aircraft banked into a turn, descended and struck the ground. A post-impact fire ensued. First responders reached the scene shortly after the accident occurred. The two occupants were deceased and the aircraft was destroyed by impact forces and fire. *TSB File A13C0063.*

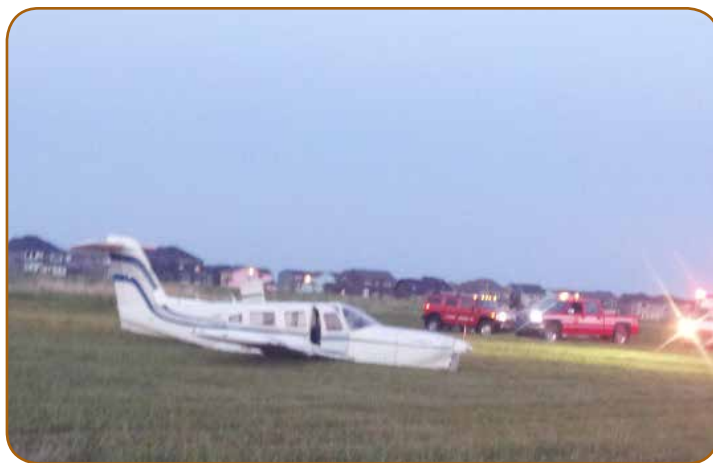
TSB File A13W0090

— On July 1, 2013, a **Piper PA-32RT-300T (Turbo Lance II)** was arriving at Okotoks (CFX2), Alta., from Elko (CBE2), B.C., when the engine began to lose power while downwind for Runway 16. The pilot switched fuel tanks with no change. With insufficient power to maintain altitude, the pilot conducted a successful forced landing in a stubble field approximately 1 km north of the airport. Two passengers and two dogs exited the aircraft, and additional fuel (approximately 30 L) was added for an attempt to reposition the aircraft to the airport. Shortly after becoming airborne from the stubble field (1 ft stubble), the aircraft struck a chain-link fence and landed heavily short of the runway, resulting in substantial damage to the aircraft. The pilot sustained injuries. *TSB File A13W0090.*

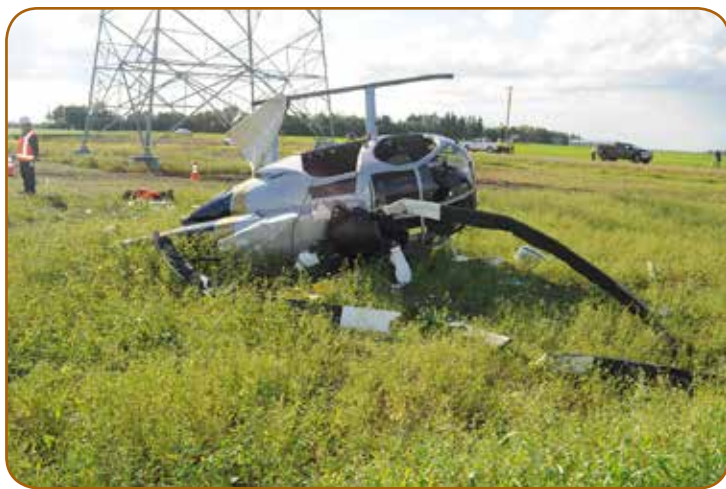
— On July 5, 2013, a **Hughes 369D (500D)** helicopter was operating 5 NM NW of Fort Saskatchewan, Alta., in support of the construction of a 500 kV transmission line. While hovering next to a lattice tower, the main rotor blades struck the tower structure and control of the helicopter was lost. The helicopter crashed near the base of the tower, and the pilot and lineman both received serious injuries. The helicopter was substantially damaged; there was no post-impact fire. *TSB File A13W0093.*

Downed helicopter near Fort Saskatchewan, Alta.

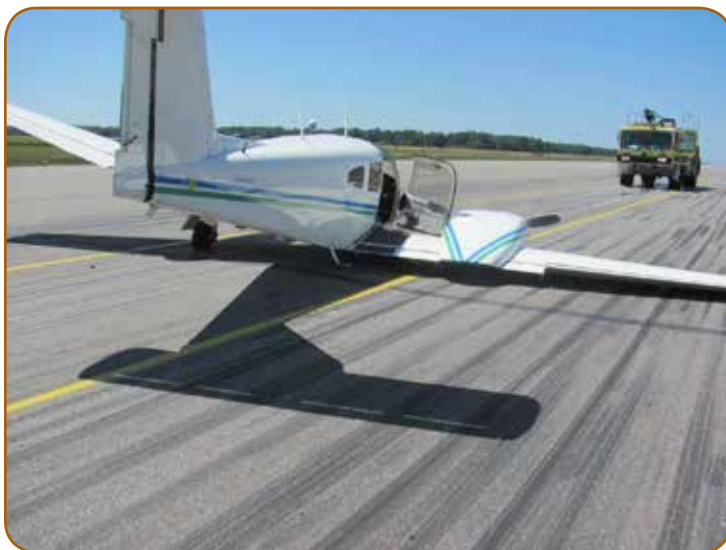
TSB File A13O0134

— On July 11, 2013, a **Piper PA-44-180** aircraft was conducting stop-and-go circuits on Runway 30 at Sault Ste. Marie Airport (CYAM), Ont., with one instructor and two students on board. During the occurrence landing, the student retracted the flaps as the aircraft was slowing down and inadvertently retracted the landing gear at the same time. The aircraft right main landing gear and nose landing gear retracted. The right wing suffered damage and the propellers on both engines struck the ground. There were no injuries. *TSB File A13O0134.*

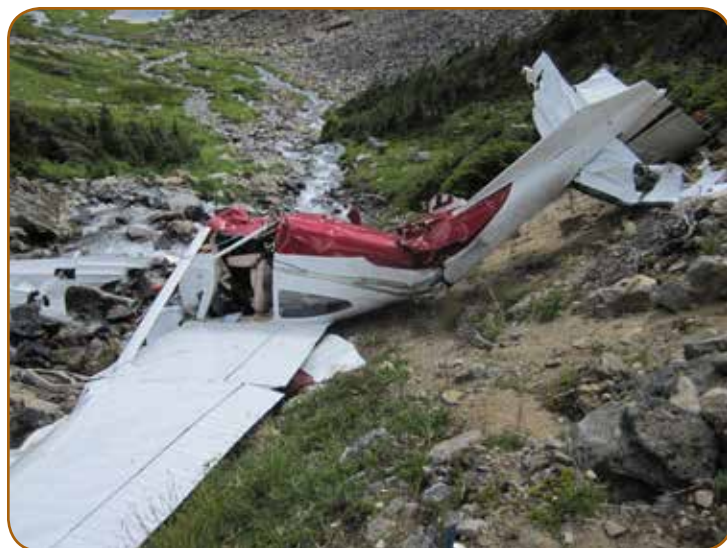
The pilot was deceased. There was no fire. The coroner's office said it is not known why the pilot elected to fly up the Alnus Creek valley. No indications were found of power or control loss prior to impact. Physical evidence was consistent with high power setting upon contact with terrain. High altitude and high air temperatures resulted in high density altitude, factors known to degrade aircraft performance. This accident is consistent with other accidents the TSB has investigated where pilots have intentionally flown into rising terrain, and degraded aircraft performance resulted in the aircraft being unable to stay above the terrain. *TSB File A13P0154.* △

The C182T was equipped with amphibious floats, a Garmin 1000 integrated flight instrument system, a SPOT tracker and a 406 MHz ELT. (Photo: Roger Cross)
