TP 185E  
Issue 2/2014

# AVIATION SAFETY LETTER

TSB Final Report Summaries

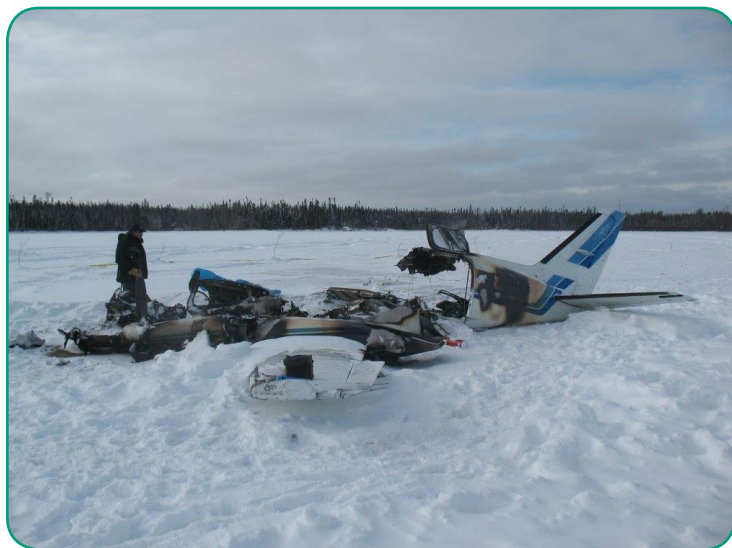
TSB investigators arrived on scene approximately 26 hr after the accident. The aircraft struck the frozen surface of the lake in a right wing-low attitude at both a high rate of descent and forward speed. Contents of the aircraft, such as baggage and cargo, were found strewn halfway up the wreckage trail, indicating an early breakup of the cockpit and cabin area. The wreckage trail was generally aligned with the extended centreline of the runway. It was approximately 380 ft long, and the aircraft had come to a rest in an upright position, facing a southeasterly direction (Photo 1). Damage to the propellers suggests that the engines were producing power at the time of the impact. A post-impact fire consumed a majority of the aircraft.

*Photo 1. Wreckage on site*

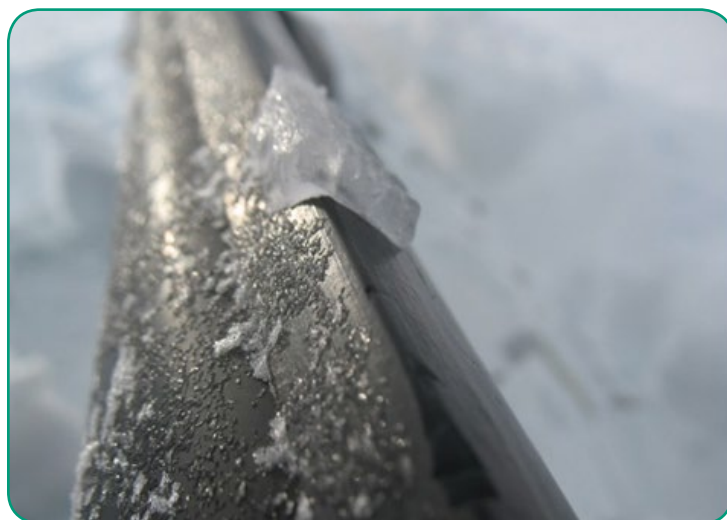
An approximate 4-ft section of the right wing leading edge containing the stall warning vane was torn off and found approximately halfway down the wreckage trail. This section of leading edge was not affected by the fire and exhibited some clear and mixed ice that was approximately  $\frac{3}{8}$  in. thick (Photo 2). The stall warning vane was not heated and exhibited hard packed ice inside the stall warning housing, trapping the vane in a downward position (Photo 3).

*Photo 2. Leading edge ice*

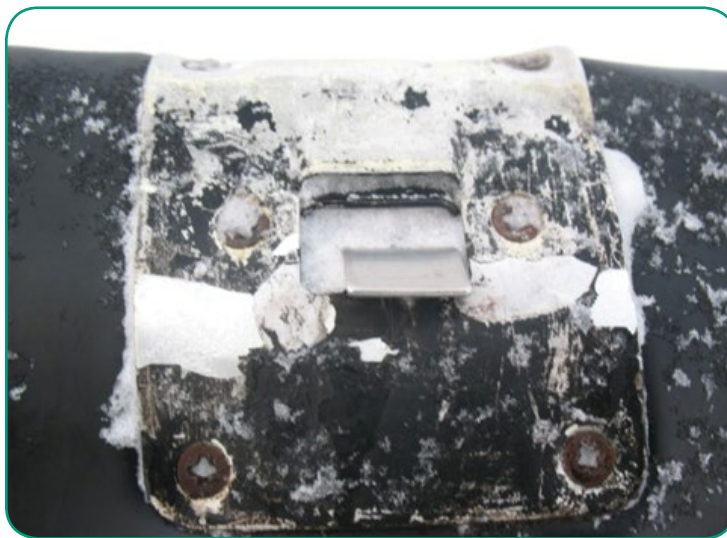
*Photo 3. Stall warning vane*

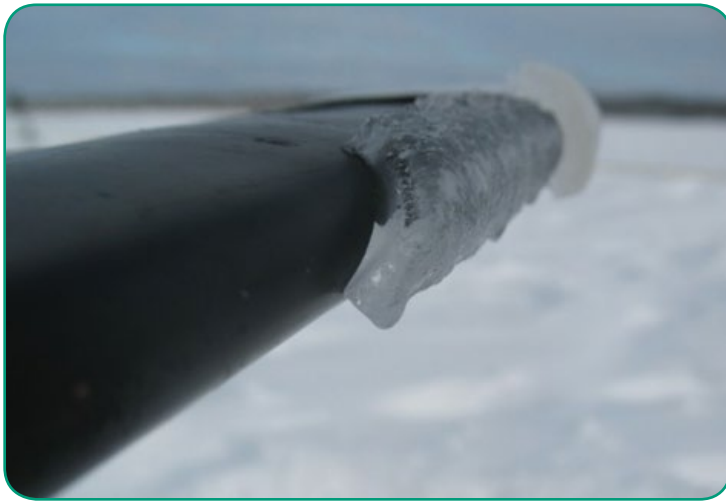
The left horizontal stabilizer leading edge was also not affected by the fire and exhibited ice accumulation (Photo 4).

Photo 4. Ice on the horizontal stabilizer leading edge

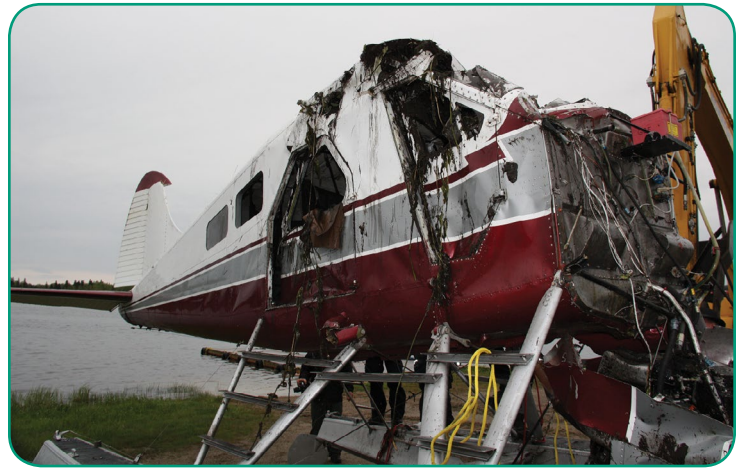
*The floatplane, shown here after being removed from the water, was heavily damaged in the crash.*

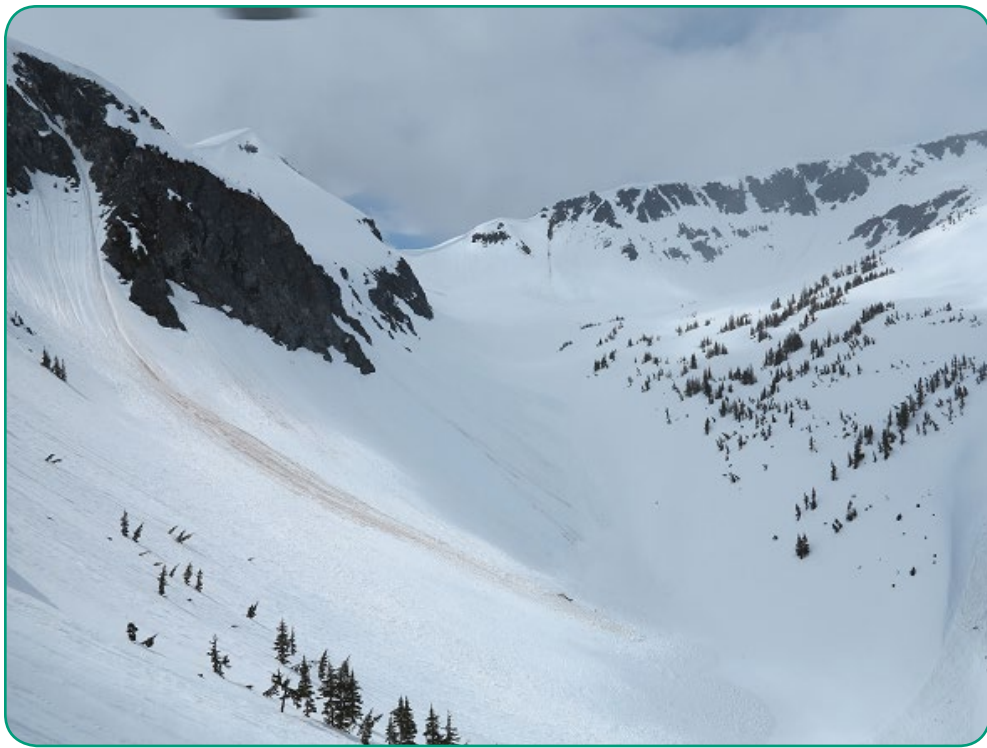
*An aerial view of the crash site on the mountainside: the tail-end of the helicopter appears as a small dark line on the snow of the mountain valley.*

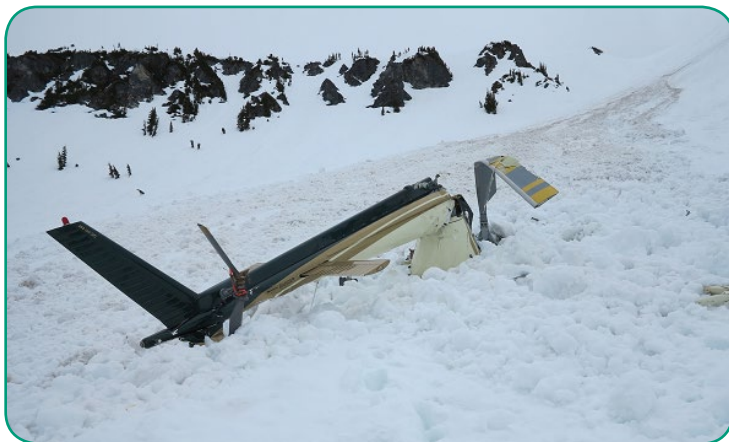
*The rotor and tail-end of the crashed helicopter, protruding from the snow of the mountainside*

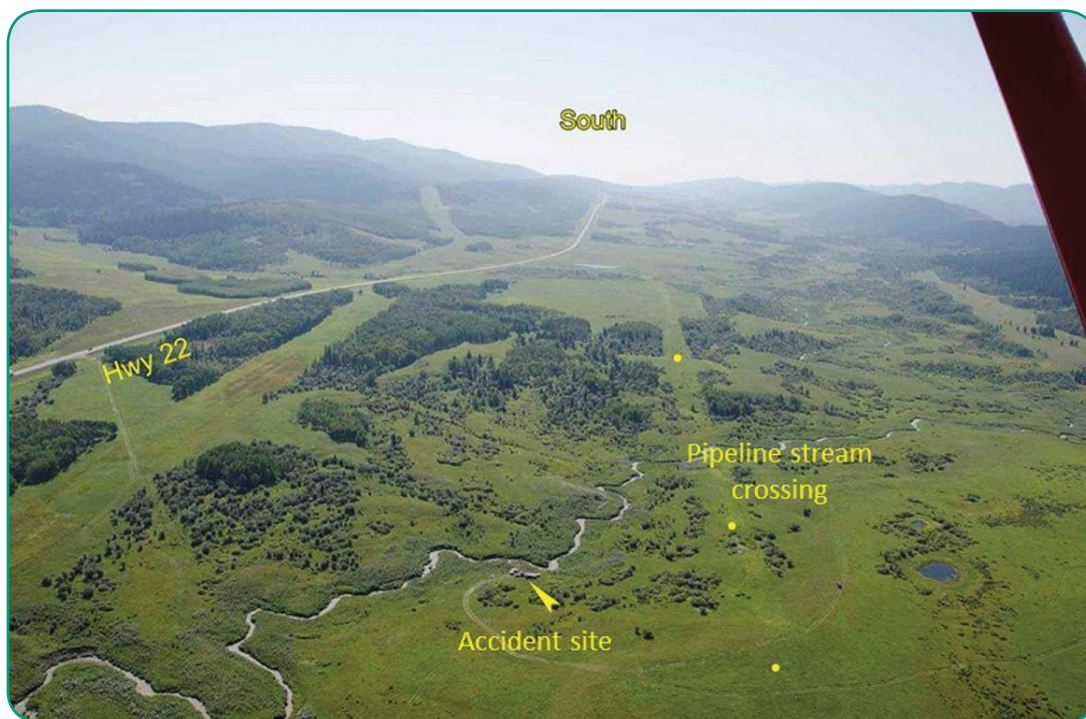
*Aerial photograph of the accident site*

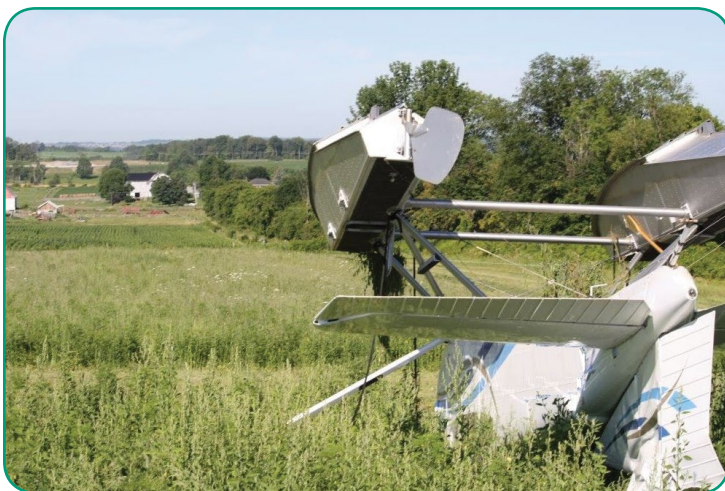
*TSB File A13O0142*

— On July 25, 2013, a **Cessna 185B** was flying from Billy Bishop/Toronto City Airport (CYTZ), Ont., to Orillia Airport (CNJ4), Ont. While en route, the engine stopped. The pilot made a forced landing in a farm field and the aircraft came to rest inverted. When the aircraft was righted, the right fuel cap was found hanging from the attaching chain. Six L of fuel was recovered from the tanks. The aircraft was substantially damaged; however, the pilot was uninjured. *TSB File A13O0142.*

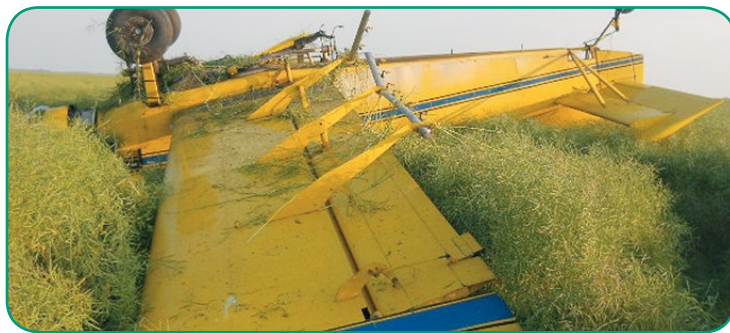
*TSB File A13C0096 (RCMP photo)*

— On August 13, 2013, an **Air Tractor AT401** was departing Quill Lake, Sask., on an application flight. During the takeoff run, the engine (Pratt & Whitney R-1340) sputtered and lost power. The pilot rejected the takeoff, but could not stop the aircraft on the runway. The aircraft continued 200 feet past the end of the runway into a canola field, and overturned. The pilot suffered minor injuries and the aircraft sustained substantial damage. Some of the chemical (Silencer) and some avgas was released from the overturned aircraft. The aircraft operator is recovering it for repair. *TSB File A13C0096*.

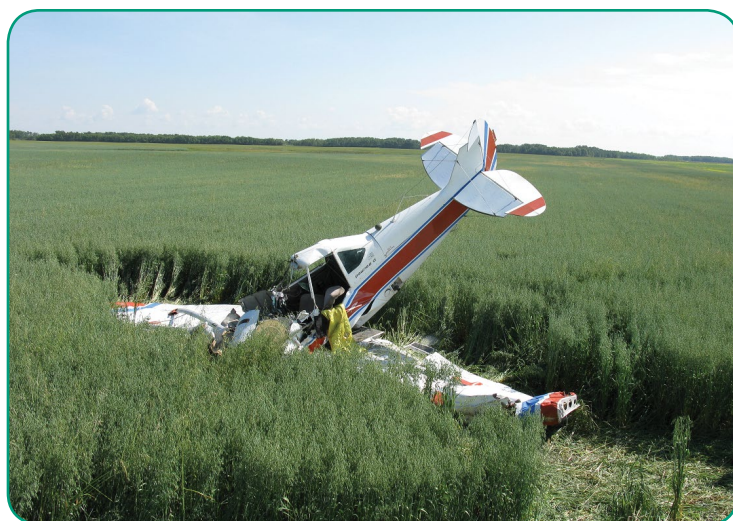
*TSB File A13C0102*

— On August 16, 2013, a **Piper PA-25-235 Pawnee** departed Rose Valley, Sask., on an aerial application flight. The aircraft wreckage was discovered in a grain field, and the pilot had sustained fatal injuries. The aircraft was substantially damaged, but there was no post-crash fire. TSB investigators were deployed to the site. An inspection of the wreckage revealed both fuel caps were missing and both fuel cells contained residual fuel only. First responders and TSB investigators did not notice any evidence of a fuel leak or spill in the surrounding area. Investigators searched the crop in the surrounding area and the aircraft operating areas at the departure point but did not locate either fuel cap. *TSB File A13C0102.*

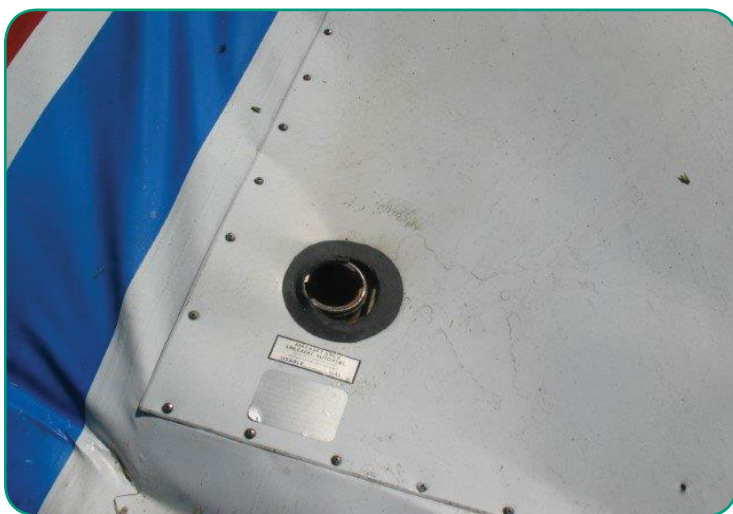
*TSB File A13C0102*

*Both fuel caps were missing and could not be found.*

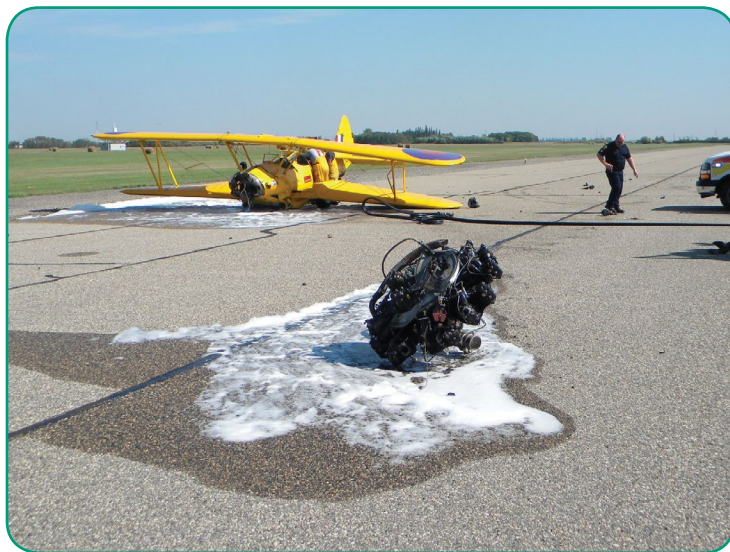
*TSB File A13C0116*

— On September 10, 2013, a **Boeing B75N1 Stearman** was en route from Regina, Sask., to St. Andrews, Man., with a stop for fuel in Brandon, Man. Upon takeoff and initial climb from Runway 26 at Brandon, one of the propeller blades failed at the blade root (Hamilton Standard 5404) and departed the aircraft. A severe vibration ensued which broke the Continental W670 engine from the engine mounts, causing the engine to fall off in flight. The aircraft pitched up and became uncontrollable. The aircraft struck the runway in a nose down attitude and both occupants sustained serious injuries. There was no fire and both occupants were taken to hospital. *TSB File A13C0116.*
