**AVIATION INVESTIGATION REPORT
A12Q0182**

IN-FLIGHT ENGINE FIRE LEADING TO A FORCED LANDING

**PIPER PA-34-200, C-GNAS
NADEAU AIR SERVICE INC.
VICTORIAVILLE, QUEBEC, 2 NM E
15 OCTOBER 2012**

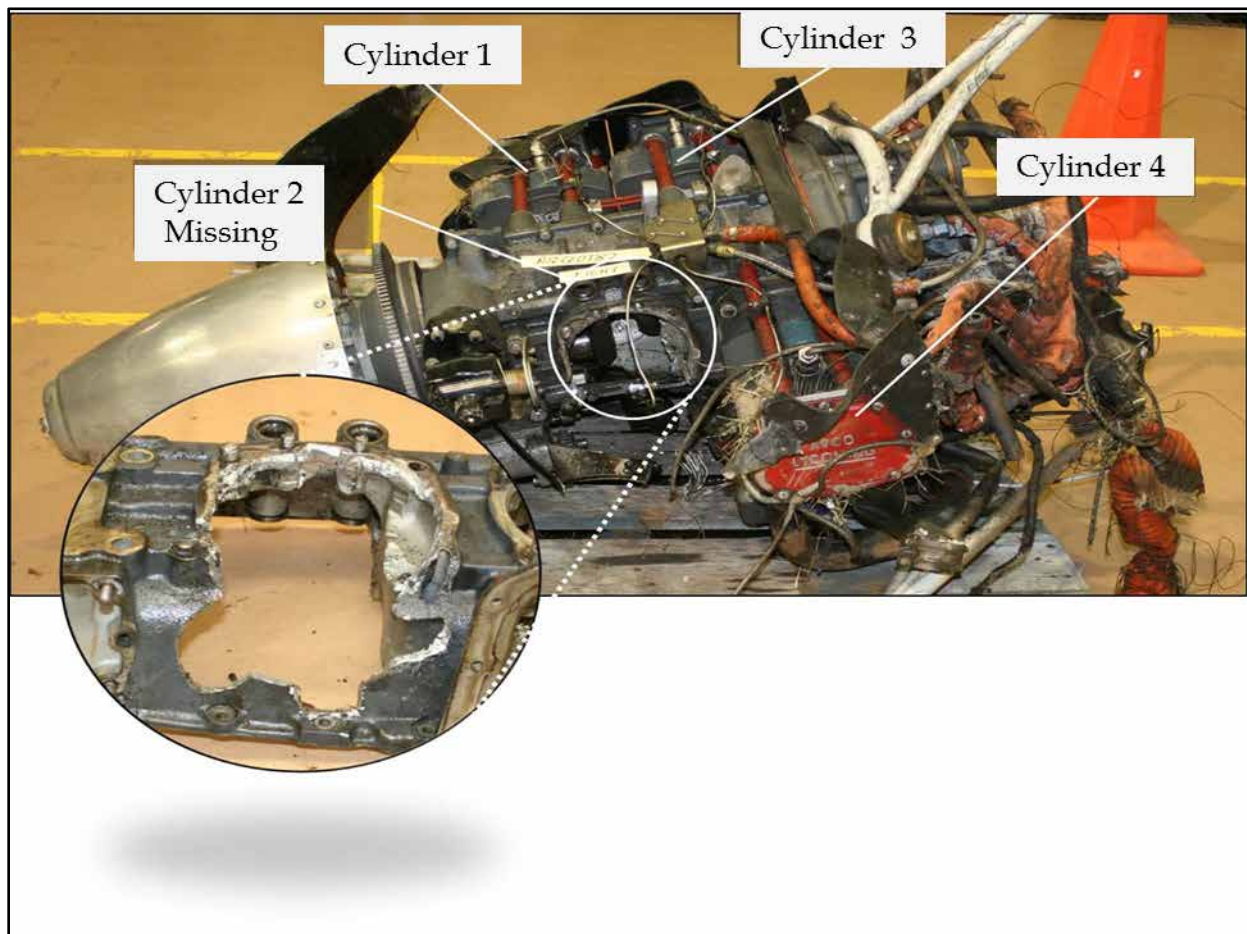
Figure 4. Right engine

The no. 2 cylinder had separated from the engine. The part of the crankcase connected to the no. 2 cylinder was missing, as were studs 3, 7, and 8 (Figure 4). The remaining no. 2 cylinder studs were broken. The broken parts of the studs were missing, as were their bolts.

- The stud screw torque for the no. 1, 3, and 4 cylinders was normal.¹⁵
- All of the recovered¹⁶ studs of the no. 2 cylinder had failed due to fatigue cracks.
- The studs exhibited no manufacturing defect, and the stud material complied with Lycoming's specifications.
- Fretting was observed on the surfaces where the crankcase and the no. 2 cylinder meet.
- The right engine airframe fuel filter was heavily contaminated.

- There was a fatigue crack in the no. 2 through-bolt hole of the no. 2 cylinder. The crack began in a welded area on the surface of the crankcase.
- A porosity that exceeded Lycoming's acceptance limit was found on the contact surface of the right crankcase near the no. 2 through-bolt.
- The crankcase hardness was either at or just below the minimum limit of Lycoming's hardness requirements. The measure of hardness of the repaired areas was less than that of the unrepaired areas. The repaired areas of the crankcases were susceptible to fatigue because they were softer.¹⁷
- There was no indication of detonation or hydraulic locking in the no. 2 cylinder's combustion chamber.

The engine failure was caused by the separation of the no. 2 cylinder after its tightening studs broke due to fatigue. All of the other damage to the right engine components occurred after the cylinder separated.

The fatigue failure of the no. 2 cylinder studs probably occurred as a result of insufficient preload in at least one stud. However, it was not possible to determine whether this insufficiency was caused by improper torque application during assembly or to loosening in service.

The crankcase contained a fatigue crack in the no. 2 stud hole. This crack extended from the welding area to the surface of the case. The metallurgical examination showed that the repaired parts of the crankcase were softer than specified by the manufacturer and contained welding defects, which made them more susceptible to fatigue. The fatigue crack in the no. 2 stud hole and the porosity of the contact surface could have contributed to release of the torque of the no. 2 through-stud. In such a case, the release of torque, which reduced the stud preload, eventually resulted in a fatigue crack in the stud and caused it to break.

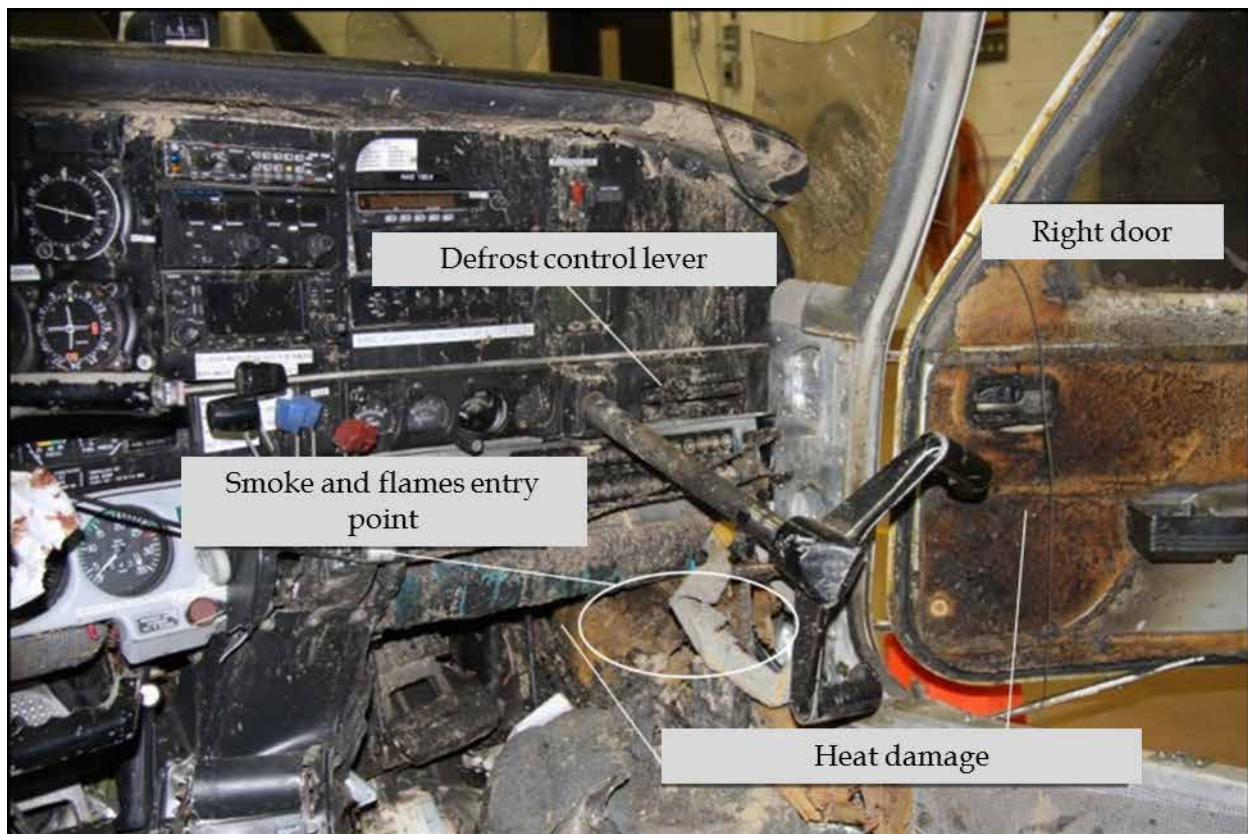
Figure 5. Fire damage to the cockpit

The damage to the cockpit indicates that the fire was concentrated in the space at the instructor's feet (right side), in the front portion of the right door and behind the instrument panel (Figure 5). The fire did not burn through the aircraft skin at any place along the fuselage. There were varying degrees of soot accumulation on the interior surface of some of the elements in the area of the fire. The fire was partially fuelled by flight documents in a pocket located on the right fuselage wall, at the pilot's feet. The insulation blanket that was located where the defrost air conduit turns at a right angle toward the top suffered the most damage due to the heat; the thermoplastic conduit had almost entirely melted. Part of the insulation blanket installed directly against the right door skin was charred.

The soot accumulation found in the ventilation system indicates that the smoke and flames entered the cabin through the ducts and conduits of the defrost system on the right side. The smoke spread through the cabin through the vents at first, then through the hole created by the flames in the right side of the cabin, at the instructor's feet.
