20 March 2014

DRDC-RDDC-2014-L101

Scientific Letter

Deck paint failure on HMCS GLACE BAY

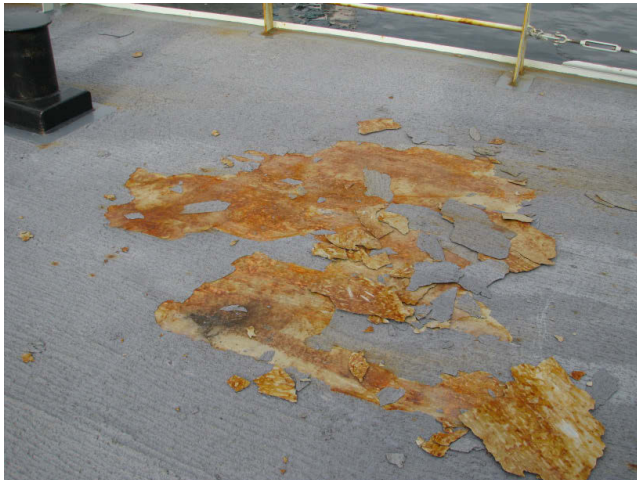
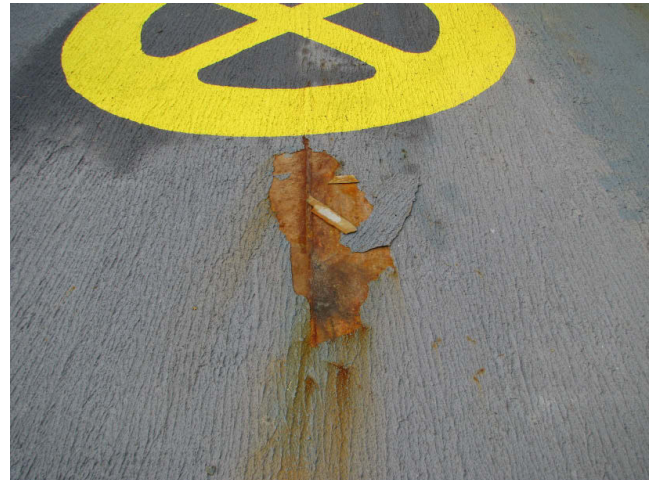
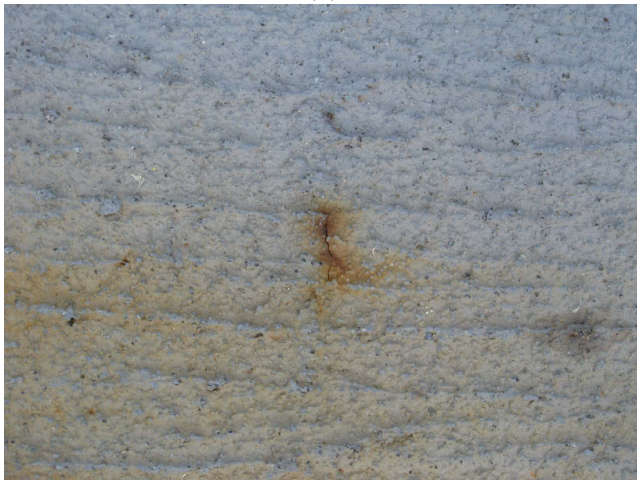
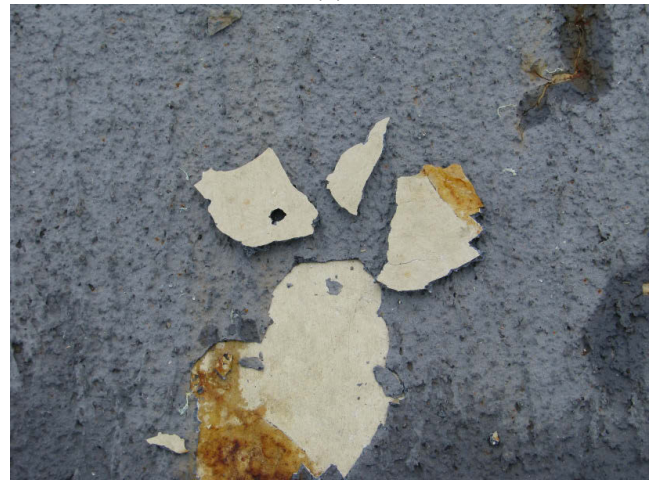
An on-site inspection confirmed the deterioration of the coating in at least three regions on the foc's'le (Figure 1). The major damage was localized in patches having areas on the order of a few square feet each. There was no apparent peripheral wear that would be attributed to high foot traffic, nor was the damage in locations that would immediately seem prone to such use. The coating around the affected spots was still attached to the steel substrate, but it could be easily pried up in large pieces with a small lab spatula. In other area, small cracks and pinholes appeared to be leaking rust from the steel deck below. Representative samples of the paint were taken back to the laboratory for further examination.

Figure 1: Photographs of the foc's'le deck on HMCS GLACE BAY: (a,b) two regions showing widespread coating lift-off, (c) one of many small cracks around 1 cm long found at random locations on the deck, and (d) flakes of coating that were easily pried off with a small spatula, revealing a pristine surface underneath.

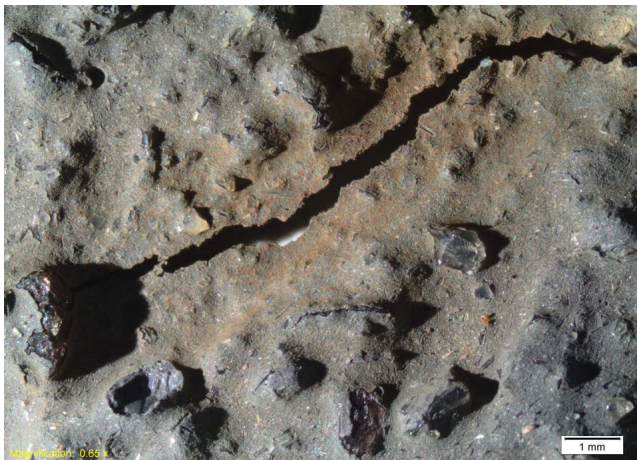
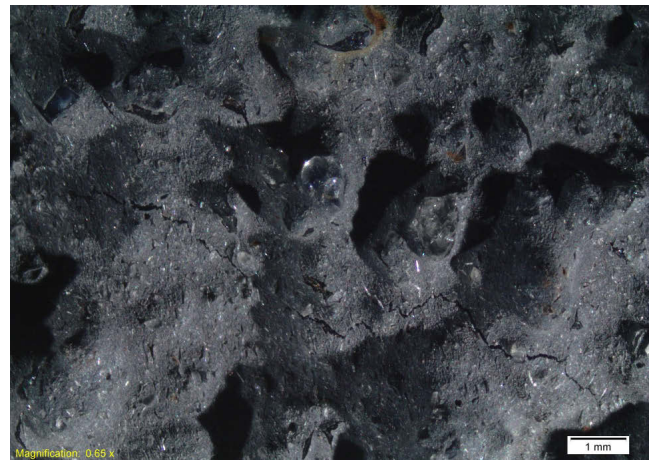
A cursory microscopic survey of the coating did not reveal any surface problems that could be ascribed to mechanical damage, e.g., gouges caused by ice chipping. There were, however, a number of microscopic cracks having morphological features consistent with shrinkage (Figure 2), i.e., mud cracking. Fourier transform infrared (FTIR) spectroscopy showed no evidence of compositional anomalies such as amine blooming.

The inconsistent thickness of the topcoat could account for the cracking noted in Figure 2. The International 6GV application guide (Ref. [2], § 5.7.2) cautions that "thick, carelessly applied coats will result in minimum coverage and be subject to mud-cracking and/or blistering." The morphology of the cracks and the observed thickness discrepancies point strongly to an improperly-applied top coat. The pinholes indicate improperly-applied top coat and primer.

Figure 2: Microscopic images of the surface of the deck coating. The cracks are consistent with the tearing-apart failure of a material that had shrunk and developed internal stresses. No signs of mechanical damage (i.e., gouges or tool marks) were detected.

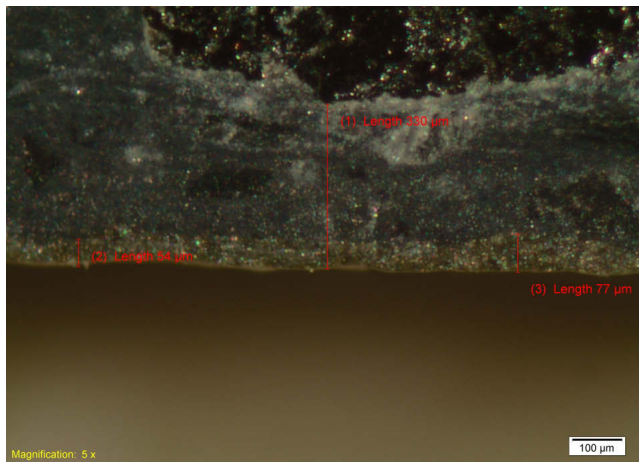
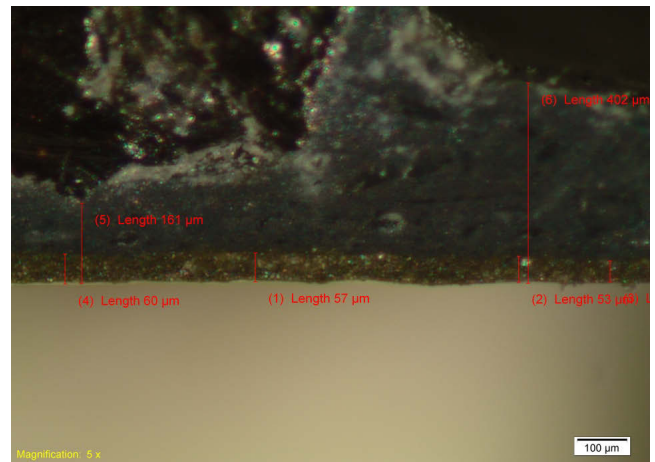
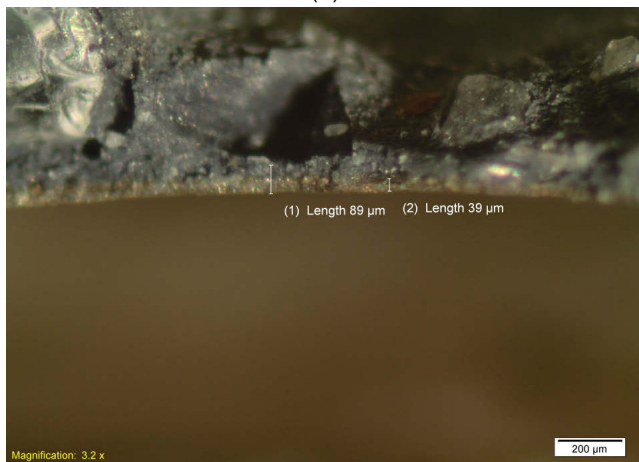
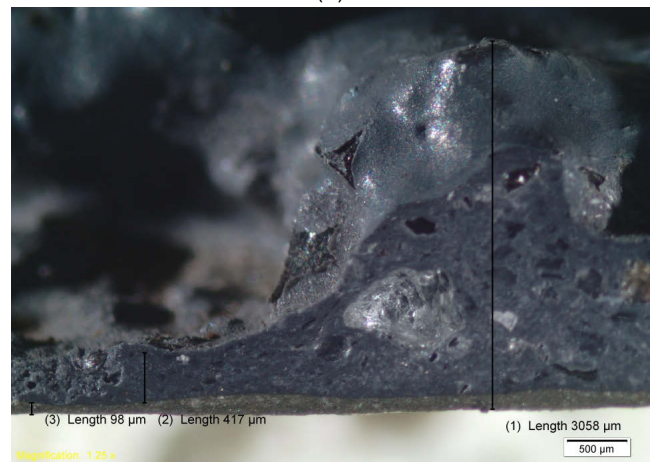
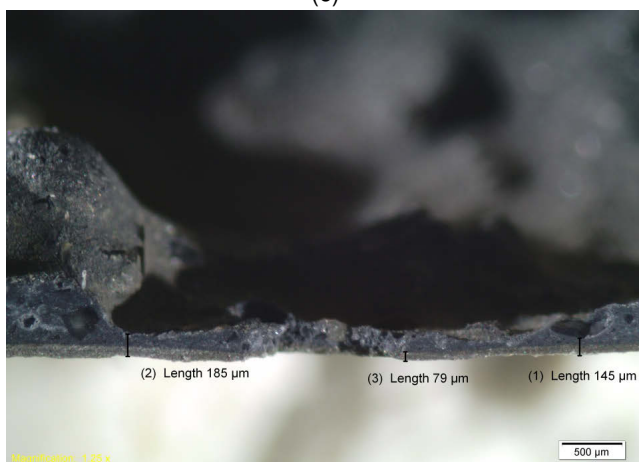
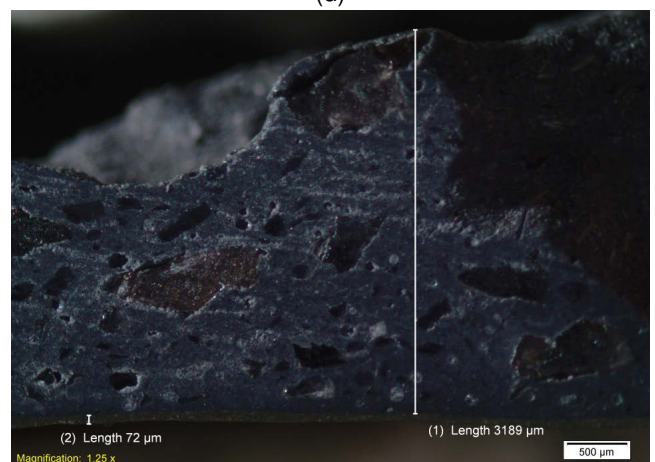
Randomly chosen cross-sections of the lifted paint were mounted, polished, and examined microscopically. A selection of images is shown in Figure 3. Consistently, the primer layer was thinner than the 125–150 μm (Ref. [1], page 5-8-16) thickness specified for product C420, *Epoxy Primer for Epoxy Non-Skid* (for which International Intershield 300 is an approved product per Ref. [1], page 5A-25). The topcoat also exhibited overall problems with thickness. The specified thickness should be 750–1000 μm (Ref. [1], page 5-8-16), although the manufacturer does note that the surface profile should exhibit a uniformly rough appearance, with ridges 1.5–2.4 mm high, and no thinner than 0.030" (760 μm) at the thinnest point (Ref. [2]). It is clear in Figure 3 that the thicknesses of both the primer and the top coat are not within specification. In fact, the combined coating was so thin in some spots that pinholes had formed. Figure 4 shows light coming through such a pinhole.

In addition to thin regions and pinholes, there are many voids in the topcoat (e.g., Figure 3f). While there is no mention of voids in either Ref. [1] or [2], it is generally true that voids indicate deteriorated or poorly-handled product (e.g., at or past its usable pot life), or improper application. Furthermore, such voids usually represent a weakness in the material.

The Daily Inspection Reports (DIRs) also do not show any evidence that dry film thickness (DFT) measurements were performed on the primer coat during the course of its application. The PMS2O instructions § 12.2 (Annex B, page 41) mandate such readings along a 2-meter grid. None is recorded, though the final page of the PMS2O Instructions (Annex B, page 45) does include an unclear reference to such measurements, dated July 9th. The only three DIRs for the topcoat 6GV (Table 1, rows 14, 20, and 27) each indicate a DFT of exactly 0.030", meeting the nominal minimum thickness. This however, is not consistent with the cross-sectional thickness determined microscopically and discussed earlier (Figure 3).

Figure 3: Assorted microscopic images of coating cross sections. The thinner, silver-gold layer is Intershield 300 primer, while the thicker blue-grey layer is the Intershield 6GV topcoat.

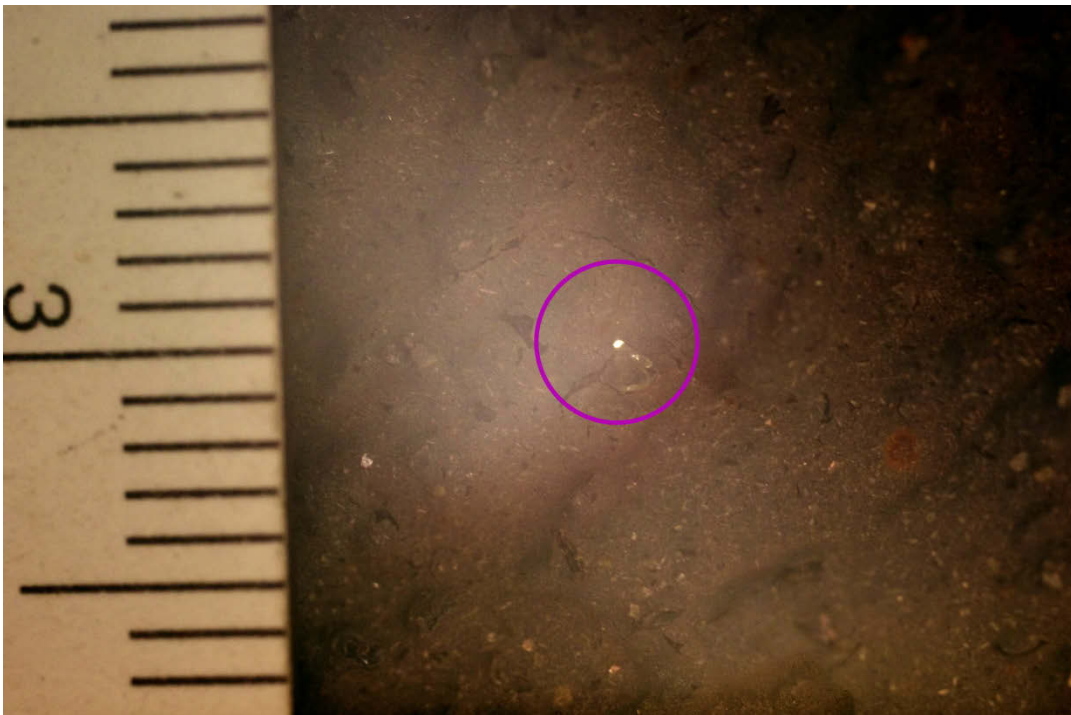
Figure 4: A pinhole in the coating, allowing light to shine through from behind.
