7 July 2014

DRDC-RDDC-2014-L150

Produced for: David Crowe, DND Fire Services

# Failed Fluorescent Ballast in Building S-89

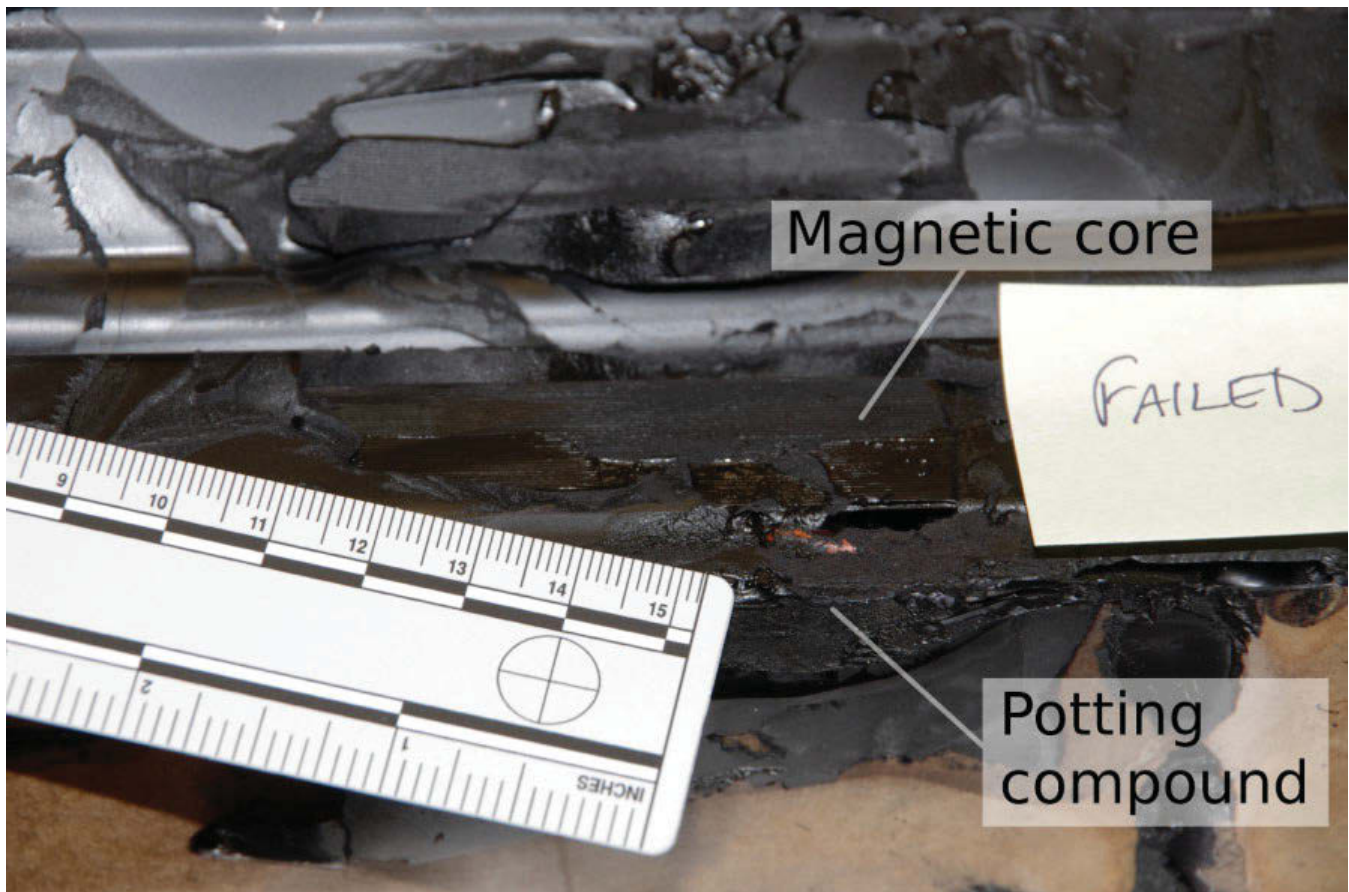
The metal casings were removed from both ballasts, revealing components embedded in a black potting compound. In the case of the failed ballast, the potting compound had evidently melted to a small extent near the magnetic core, and had become brittle (Figure 1). It also had a strong burnt odour.

**Figure 1:** Inside the metal casing of the failed ballast, where the potting compound had evidently melted and charred slightly in the vicinity of the magnetic core.

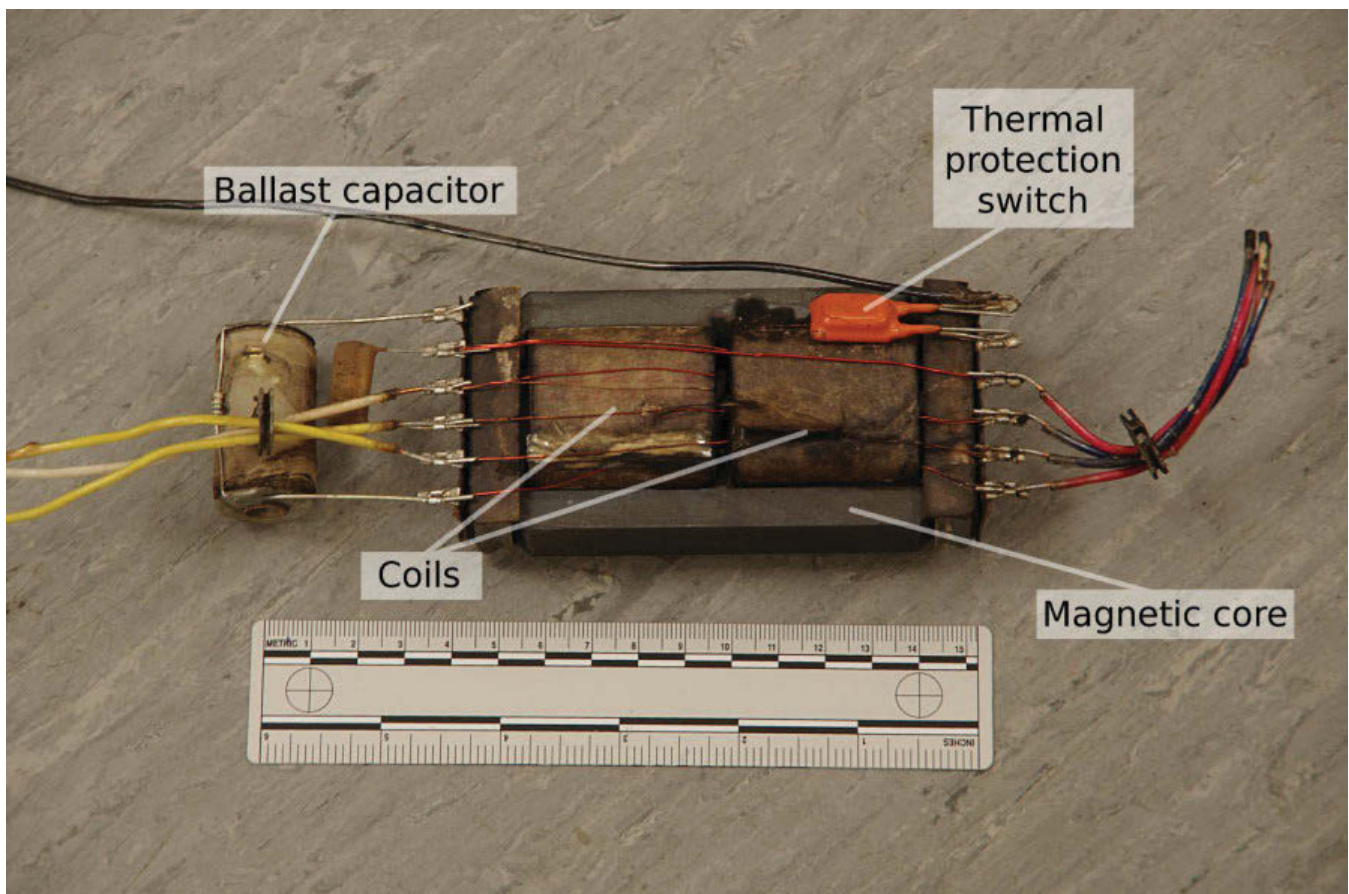
The potting compound was removed by dissolution in tetrahydrofuran, revealing the internal components (Figure 2). There was no immediately obvious damage to any component, but conductivity tests revealed three anomalies that indicated internal damage: the red wire heater coil had an open circuit, the primary winding had an open circuit, and there was a short between one red wire and a blue wire, suggesting the high voltage secondary coil had shorted (see Figure 3).

**Figure 2:** The failed ballast following the removal of the potting compound.

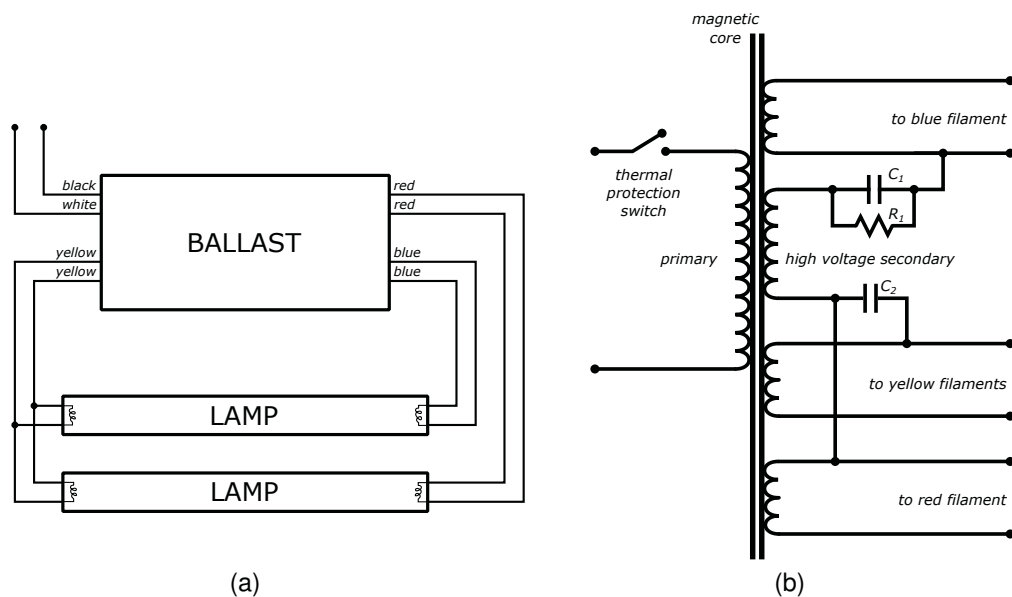
The evidence points to worn-out fluorescent tubes being the root cause of this failure. Electrical imbalance due to the loss of a power phase was likely not related, since the failure did not occur immediately after the event, and other ballasts were not affected. The imbalance of a failing or failed tube could account for the overheated ballast unit.

**Figure 3:** (a) Wiring diagram for a two-lamp magnetic ballast. The filaments at each tube end are heated by the application of a small current and become thermionically emissive. The emitted electrons are accelerated along the lamp tubes by the voltage difference between the filaments, impacting vaporized mercury, which emits ultraviolet light. The ultraviolet light is then converted to visible light by a phosphor coating on the inside of the tube. In such a two-lamp configuration, the lamps are driven in opposite phase to reduce perceived flickering, hence the red and blue circuits. (b) A schematic circuit diagram to illustrate the function of a magnetic ballast (some connections are omitted for clarity). Three windings provide power to the filament heaters, and the high voltage secondary drives the electron flow that ultimately produces light. The inductance of the coils and the action of capacitor  $C_1$  contribute to the ballasting, i.e., they prevent a current runaway that would destroy the lamp. In the event of a fault, the thermal protection switch is meant to open before the coils overheat.

The Dockyard Laboratory (A) suggests that all fluorescent fixtures in the building be surveyed, and any aging fluorescent tubes be replaced promptly. Aging tubes can be identified by a heavy buildup of black deposit at the ends of the tubes. Any fixture known to have exhibited spontaneous on-off cycling should be considered damaged and should have its ballast replaced. Furthermore, it might be desirable to replace all the obsolete electromagnetic ballasts with new electronic ballasts. The newer technology is more energy-efficient, produces less flicker, and it is less susceptible to overheating and damage in the case of lamp failure.
