INQUIRY INTO THE MATTER OF A CRASH OF A
PANARCTIC ELECTRA AIRCRAFT AT REA POINT,
NORTHWEST TERRITORIES, OCTOBER 30, 1974.

before His Honour Judge W. A. Stevenson.

R E P O R T

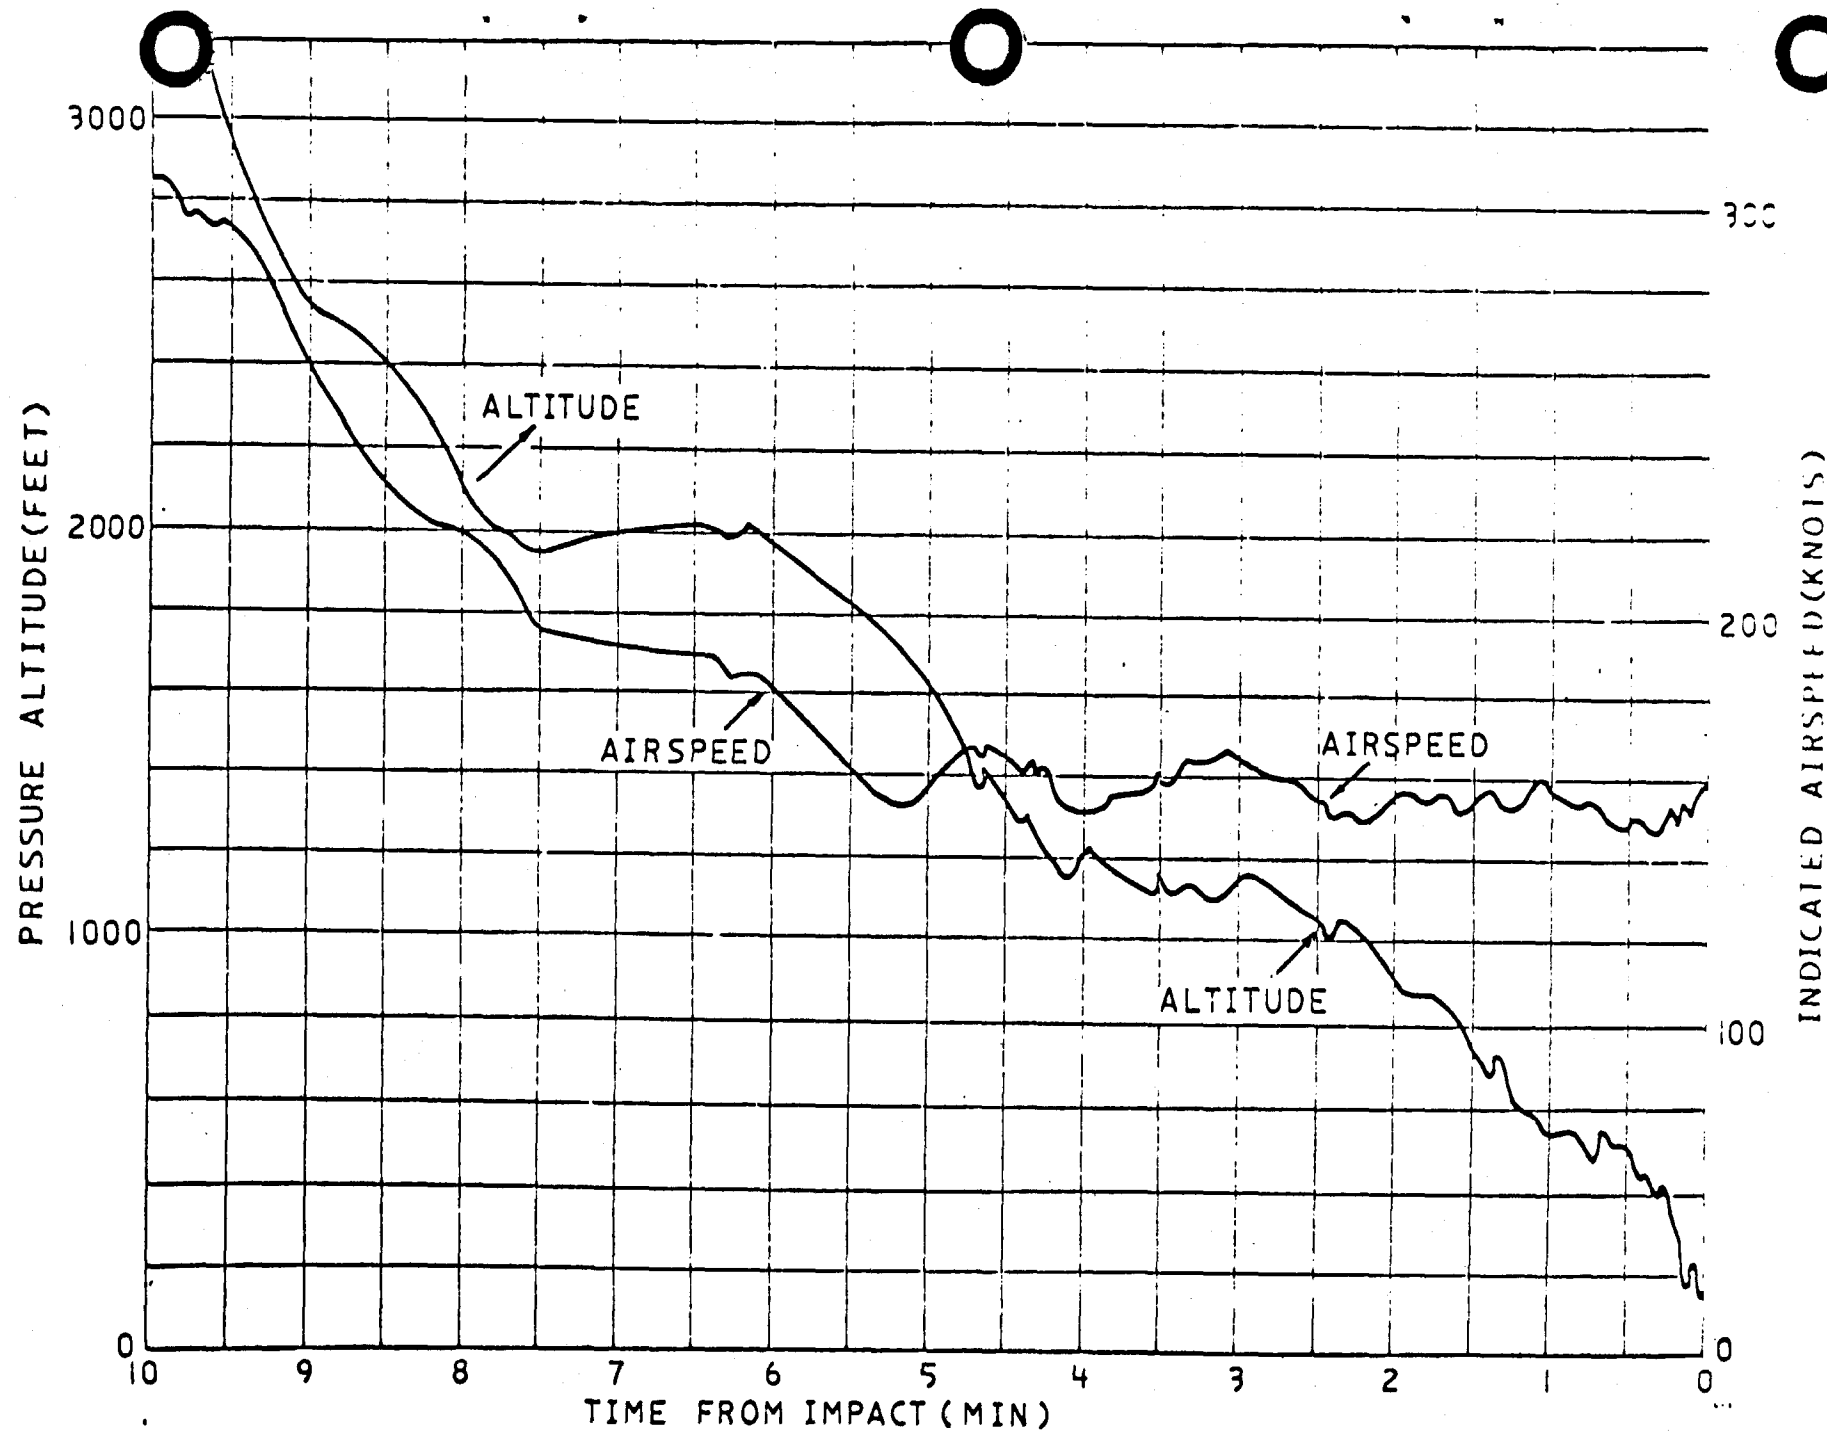
ALTITUDE & AIRSPEED DATA OVER LAST 10 MINUTES OF FLIGHT

The immediate cause of the crash was the action of the crew when at an altitude of 300 feet above sea level and approximately three miles DME the plane was put into a nose down position and power reduced, thus increasing the rate of descent and making impact with the sea ice, far short of the runway, virtually inevitable.

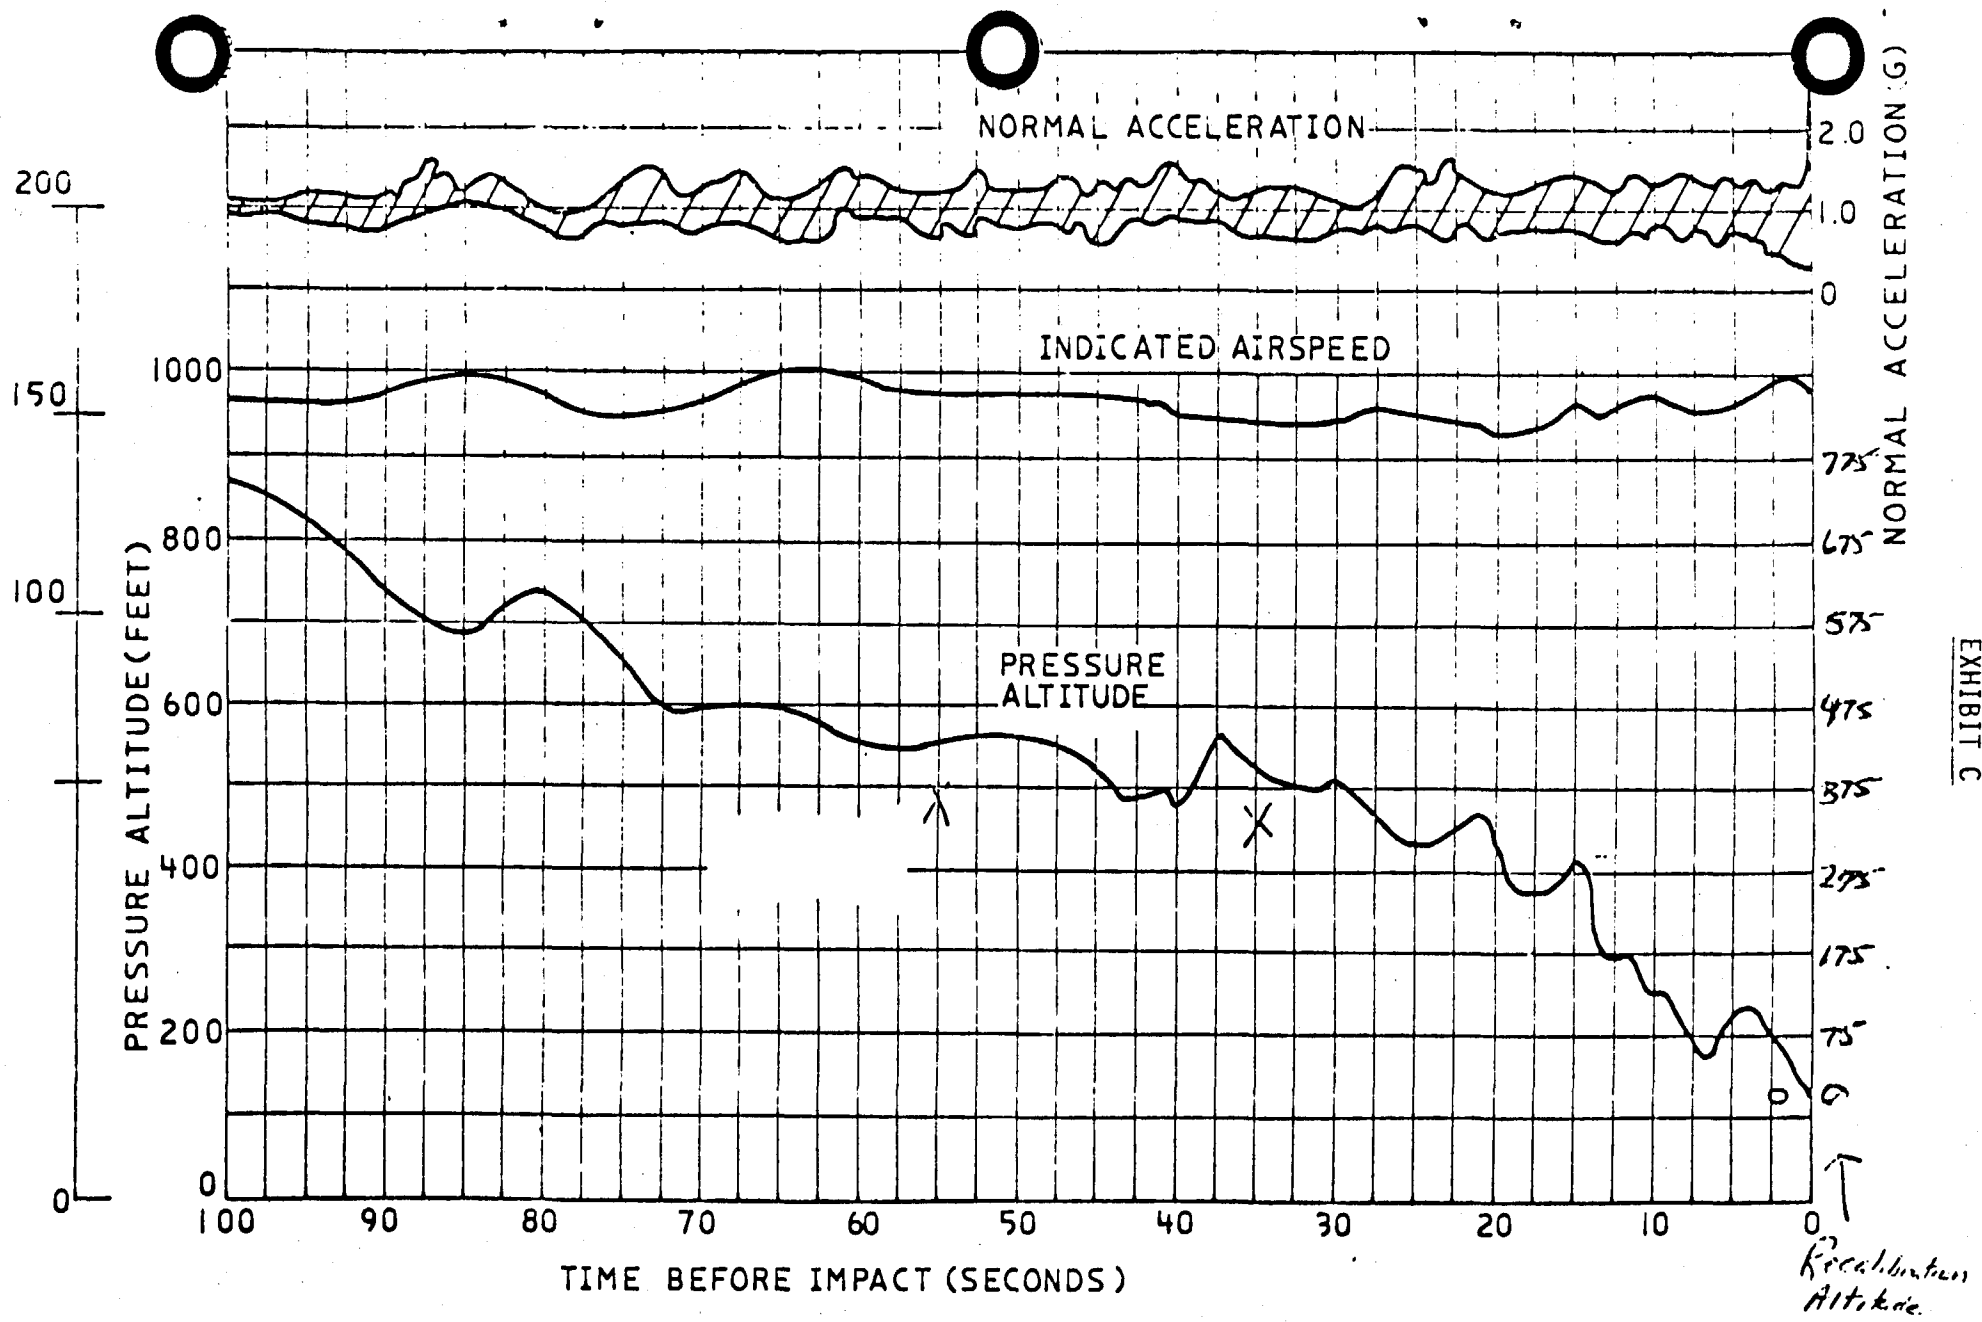
EXHIBIT C

TIME HISTORIES OF FLIGHT RECORDER DATA OVER LAST 100 SECONDS
