TECHNICAL EVIDENCE

CHAPTER SIX TECHNICAL EVIDENCE

DIVING SURVEY

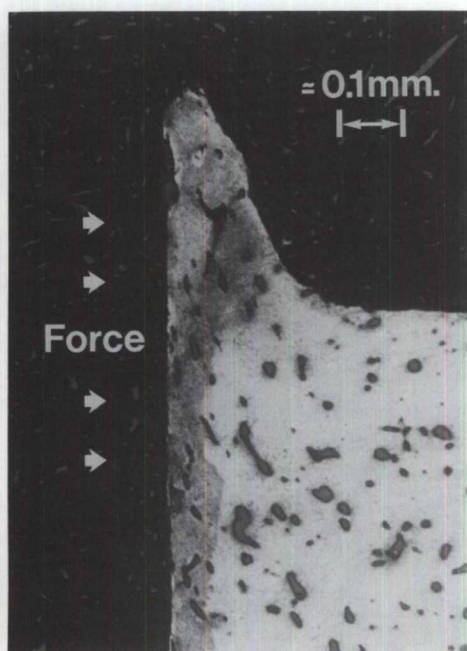
6.2 This photomicrograph shows the distinctive lip of metal discovered around the entire circumference of the locking ring from porthole #4. The lip and the pattern of deformation at its base indicate that the portlight was broken in the inboard direction by high impact loading evenly distributed over the entire glass surface.

The size of the lip on the locking ring of portlight #4, which broke before the capsize, was approximately twice the size of the lip on portlight #2, which was recovered intact, after the latter was tested to glass failure at 68 psi. Testimony was given that the pressure necessary to produce a lip of the magnitude found on portlight #4 would be at least twice that amount. It was suggested by counsel for ODECO that the force of a wave alone was unlikely to approach that pressure and argued that the portlight was broken by heavy wave-borne debris. He argued that since the debris would necessarily be carried at or near the water surface, the portlight would not be subject to a large head of water and therefore, little water would enter the control room. The technical examination of the portholes recovered does not support this argument. Research on shock pressures generated by breaking waves indicates that dynamic pressures in excess of 140 psi are possible for short durations.² Examination of the recovered portlight confirmed that the glass was broken by the application of uniform pressure over its entire surface and not by debris impact.

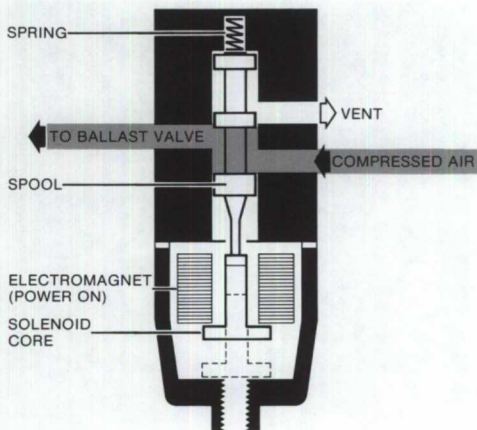
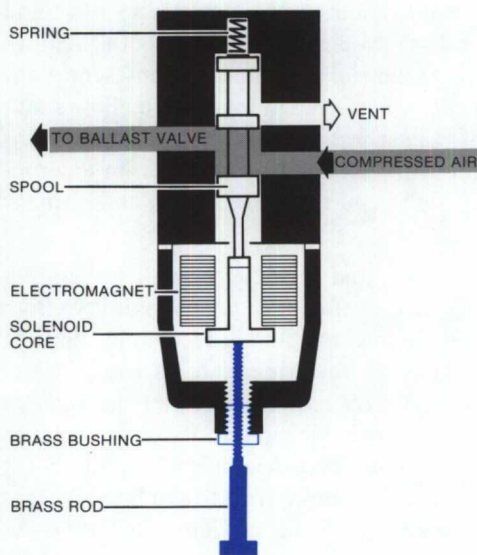
6.3 The solenoid valves could be activated both electrically and manually; a circular pattern of brass residue was found on the core faces of the 18 manually-activated valves recovered from the wreck.

The solenoid cores were examined. In each of the 18 activated valves the core face was marked with a circular deposit of brass corresponding to the diameter of the brass rods. Of the other cores, 4 showed circular indentations and deformations but did not exhibit any brass residue, indicating that a non-brass tool had caused the markings. It is probable that these marks were made during the construction and testing of the rig and were unrelated to the loss. The remaining 42 cores were not marked in any way. It is concluded that all 18 solenoid valves found with bushings had been opened with rods and that the brass rods had not been used to activate any other valves.

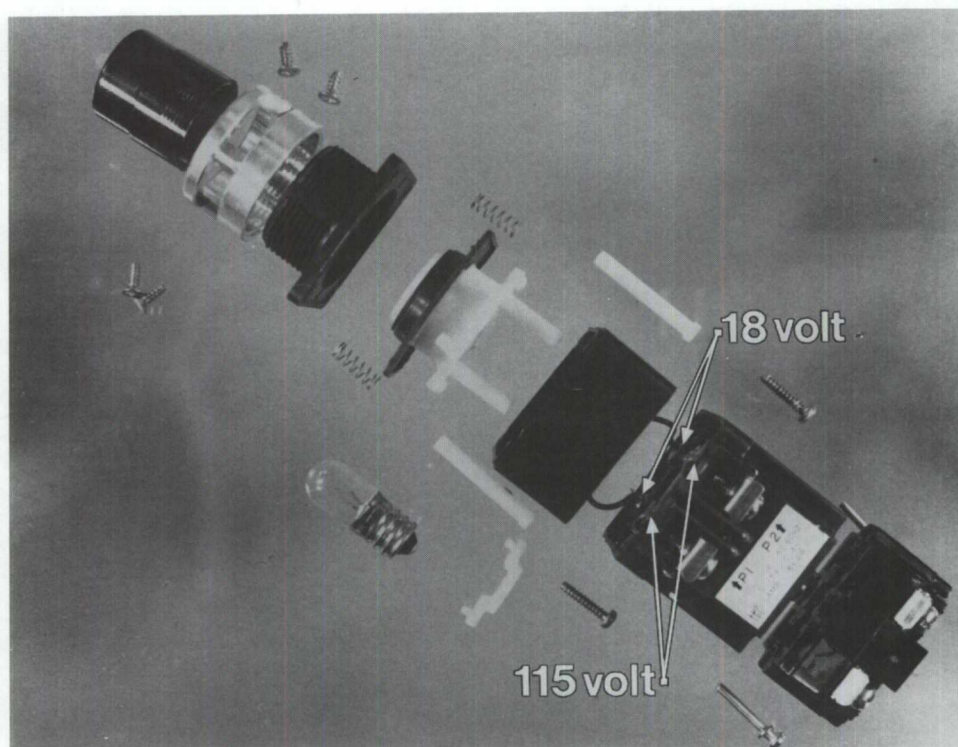
6.5 A disassembled pump switch identical to those used in the mimic panel. The failure of some of the indicator lamps in these switches was caused by sea water entering the transformer housing near the base of the switch, and short-circuiting the primary 115-volt and secondary 18-volt terminals.

The failure of the pump switch indicator lights, which were connected to a separate 115-volt circuit through a 115-volt/18-volt transformer in the body of each pump switch, was attributed to short circuiting of these transformer terminals. Each pump switch was equipped with a rubber gasket that prevented sea water on the surface of the mimic panel from entering the switch housing. Tests showed, however, that water could seep from the surface of the mimic panel through the valve switch

openings and enter the pump switch housings, short-circuiting the transformers and causing the bulbs to fail because of excessive voltage.

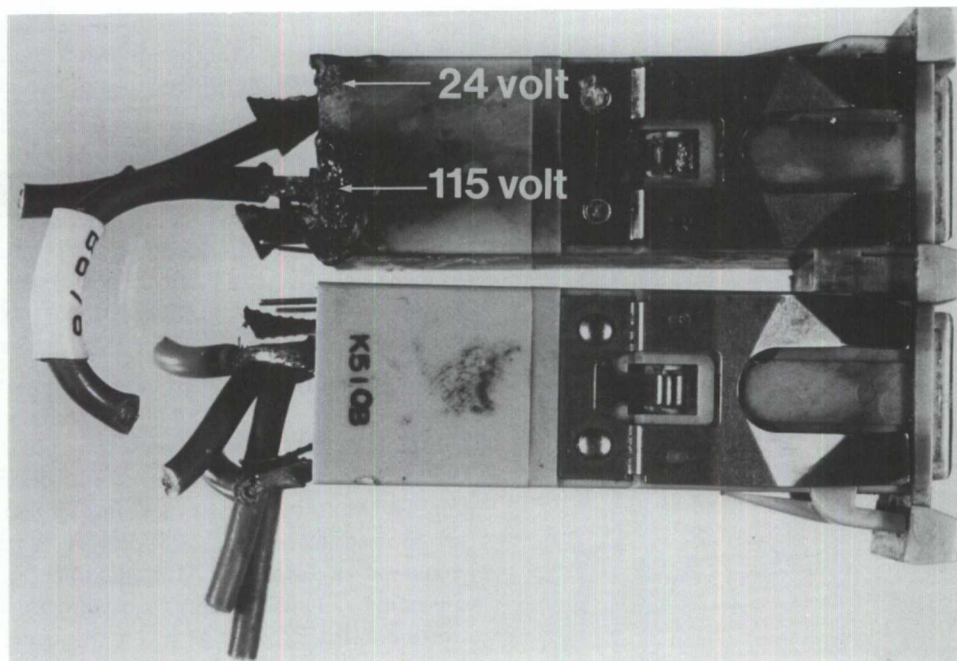
The mimic panel components were examined visually for any signs of damage that may have resulted from an electrical malfunction. Only one component, valve control switch P-19, was found to be damaged; the lower portion of its housing showed evidence of arcing and burning. This was consistent with short-circuiting of the 115-volt terminals at the base of the switch from an accumulation of sea water.

In assessing the damage to switch P-19 and the valve position indicator lights, the investigators noted that the 24-volt indicator circuit terminals and the 115-volt control circuit terminals were located close together at the base of the switch housing. They concluded that sea water entering switch P-19 had created a conductive bridge between the 24-volt and the 115-volt circuits⁵, causing many of the indicator lights in the 24-volt circuit to fail because of overvoltage. The distribution of undamaged bulbs indicated that sea water had entered a large number of valve control switches, causing in some cases short circuits, *preventing* current from passing through the bulb filaments and consequently protecting them from damage. The result was a random distribution of damaged and undamaged bulbs.

6.6 Valve control switch P-19 was the only mimic panel component which was visibly damaged. The melted area near the base of the housing was caused by a short circuit between the 24-volt and 115-volt terminals.

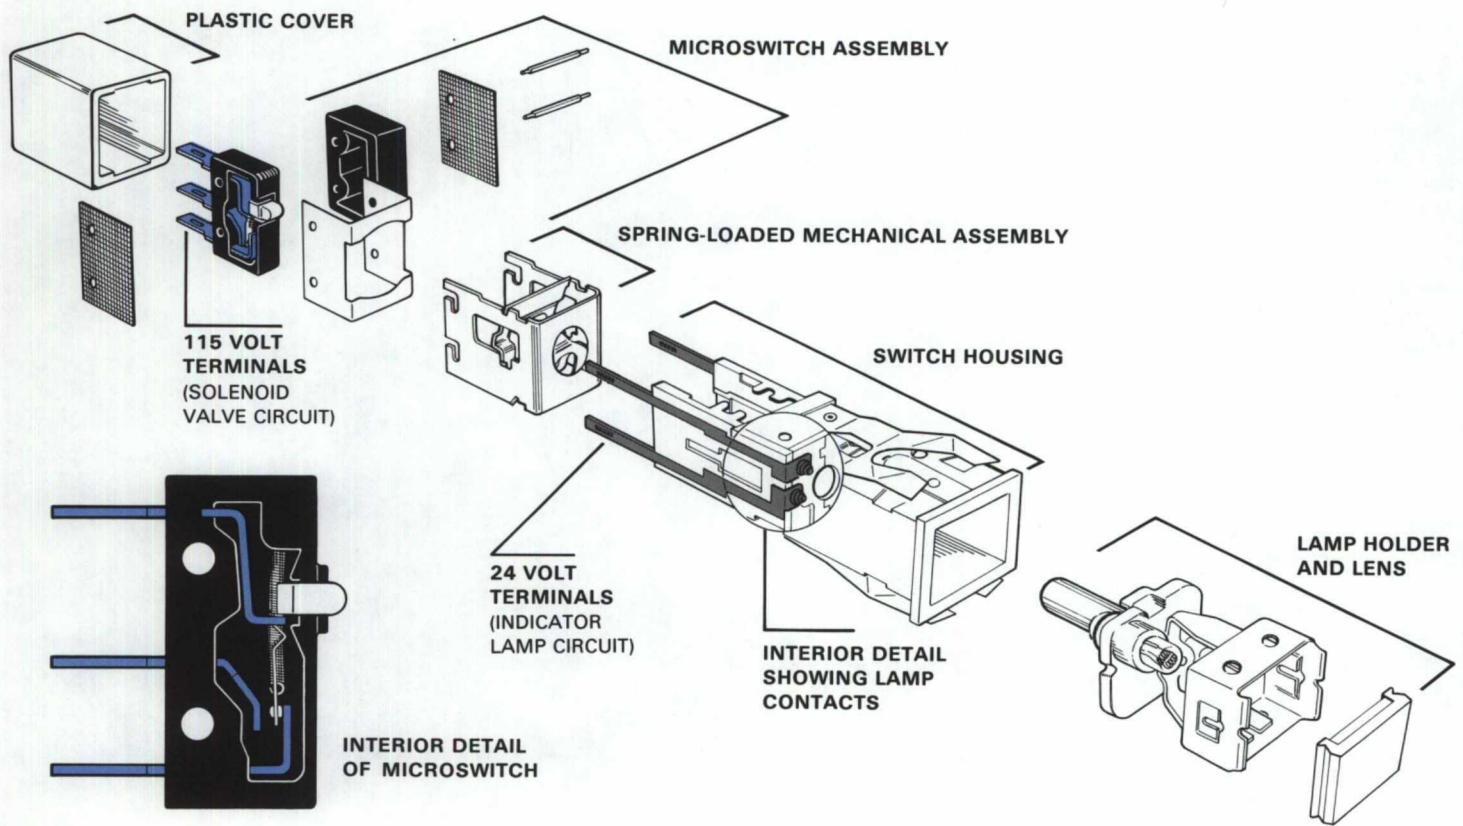
6.7 This illustration shows the components of the valve control switch used in the mimic panel. Short circuiting was found to occur: between the lamp contacts; between the leads connecting the lamp contacts to the base of the switch; between the 24-volt and the 115-volt terminals at the base of the switch; and within the microswitch itself.

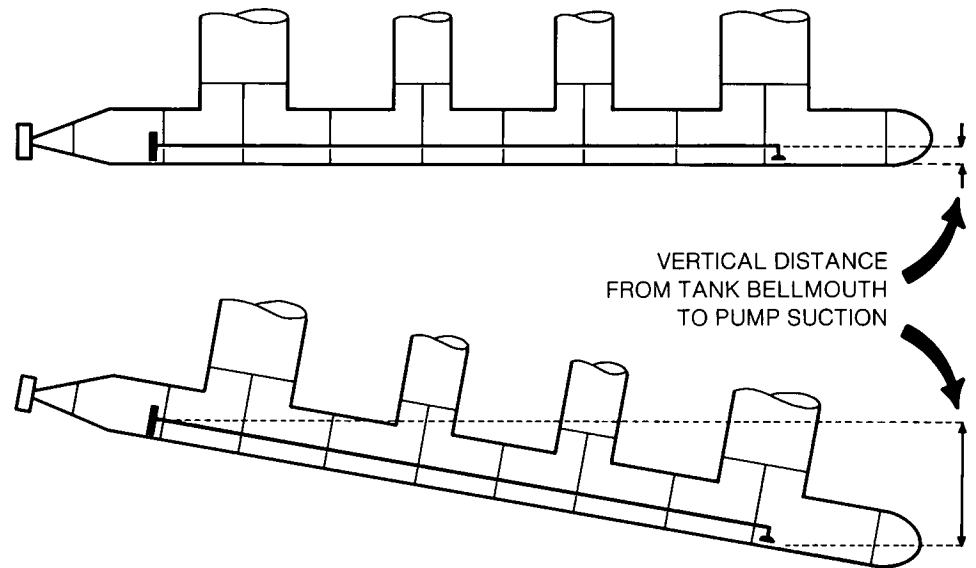
6.8 As the rig trimmed to the bow the vertical distance between the suction inlet in the tank and the suction inlet at the pump increased, reducing the ability of the system to pump out the forward tanks.

The effect of these design weaknesses on the rig's ballast system would have seriously hampered any attempts to right the rig from the severe trim reported on the night of the loss. The rate at which ballast could be pumped from the bow tanks would be reduced to zero as the trim progressed. In normal operations, the rate of flow from a given tank is unimportant; under the circumstances which existed on the night of the loss, the flow rate from the bow tanks was a critical factor.

diameter suction lines in the system would also have helped. ODECO has indicated that this consideration is included in all of their current designs.

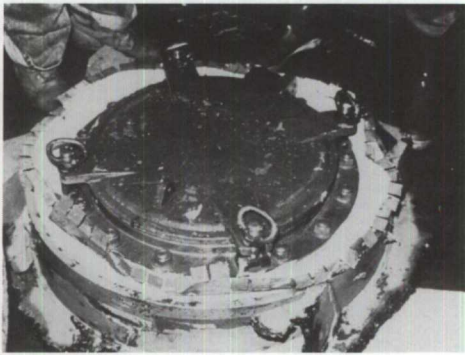
7.1 One of the three portholes removed from the wreck. The deadlight was closed and dogged.

Each porthole, as designed and installed, included on the inside a metal deadlight which could be lowered and secured over the glass when it was anticipated that waves might break on the portlight, but there were no instructions for the use of these deadlights and no standing orders that they be closed during storm conditions. Testimony indicated that appropriate instructions have now been included where relevant in all ODECO manuals. Notwithstanding the absence of instructions, if the crew, acting in accordance with good seamanship and common sense, had closed the deadlights in the ballast control room before 7:45 p.m. on February 14 the first link in the chain of events would not have been forged and the loss of the *Ocean Ranger* and its crew would have been prevented. It must be recognized, nevertheless, that if full consideration had been given in the design of the rig to the severe environmental conditions under which the rig might be operating, several other links in the chain of events which led to the capsize would not have been forged. For if the control console had been waterproof; or if it had been protected from any sea water that might come in through a broken portlight; or if the portlights themselves had been impregnable to the force of waves under predictable environmental conditions; or if the ballast control room had been located at a higher level on the upper deck and a system more sophisticated than draft marks attached to the columns had been provided for checking the draft, then, again, there would have been no chain of events and no loss.

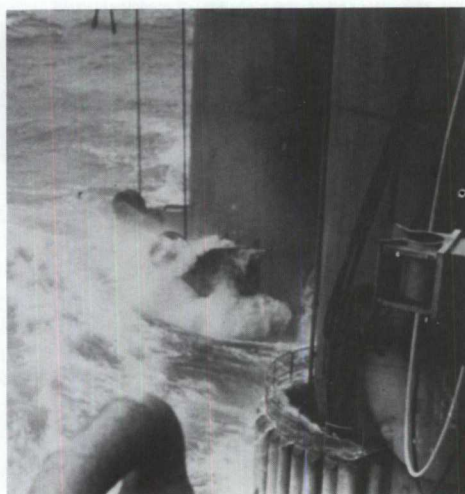
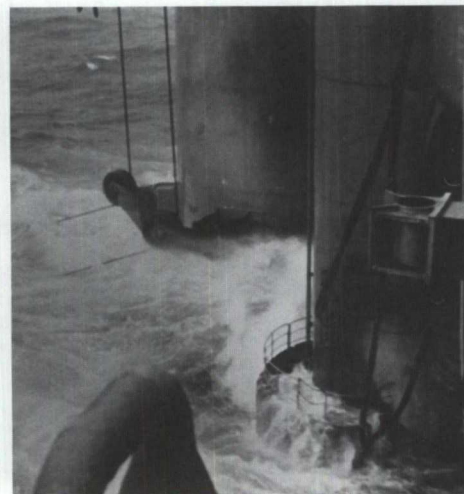
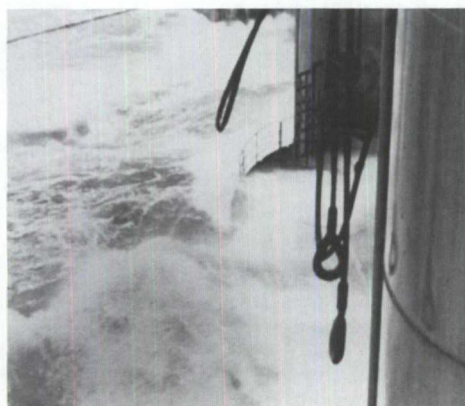
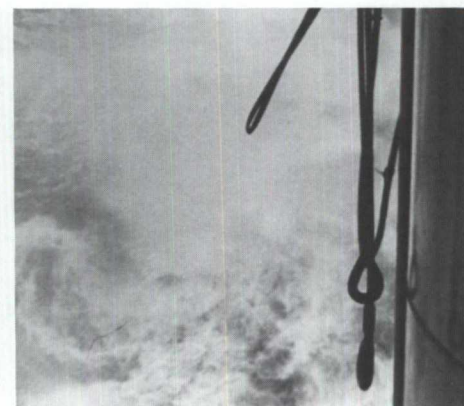
7.3 This sequence of photographs shows the ballast control room portholes obscured by spray during relatively light sea conditions. The photographs were taken from the windlass control house at the mooring platform on the starboard bow.

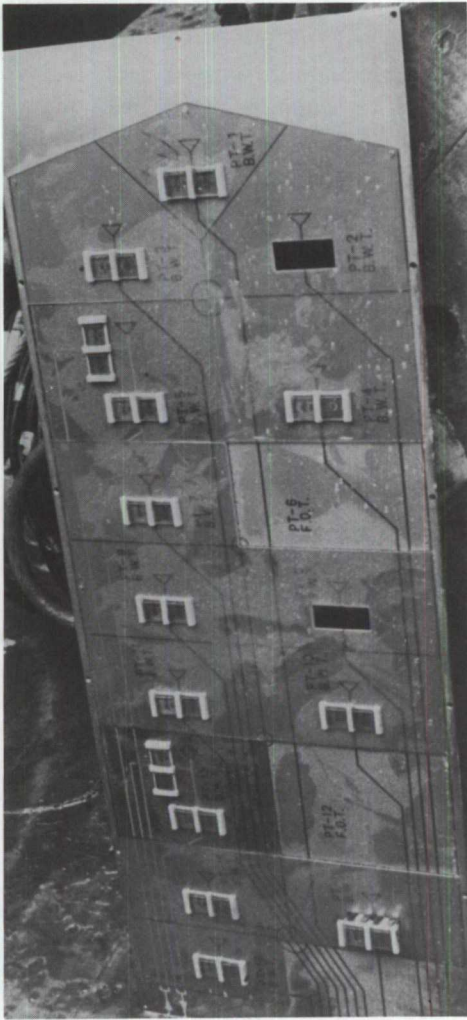
7.4 One of four mimic panel sections recovered from the wreck. Several of the plexiglass insets from the panels were dislodged and lost during salvage.

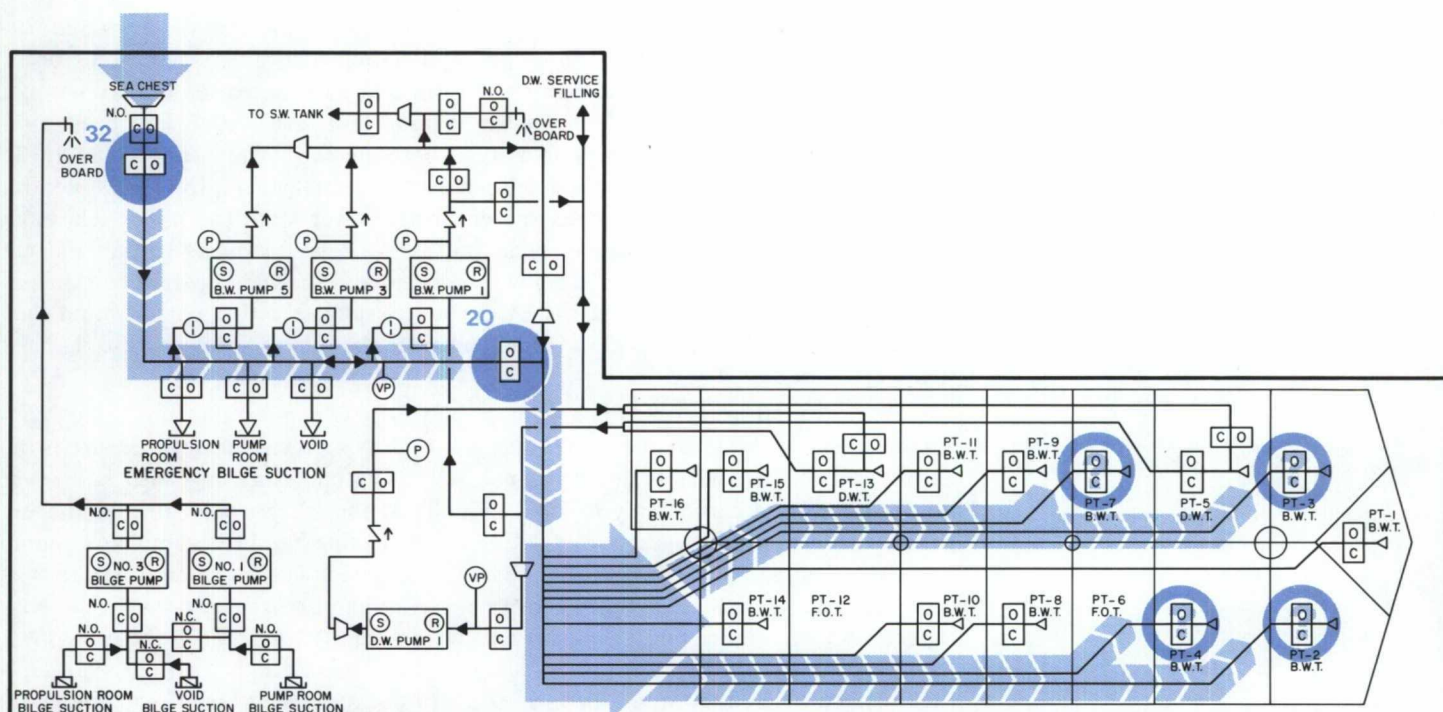
7.5 The accidental opening of ballast valves P-32 and P-20 allowed sea water to enter the common manifold leading to the port pontoon tanks. Open valves leading to one or more forward tanks rapidly lead to a 4-5 degree list by the port bow.

pontoon. For this to have happened, the short-circuited microswitches must have included at least P-32 (the remotely operated sea chest valve), P-20 (the cross-over or manifold valve) and at least one forward ballast tank in the port pontoon. The opening of these three valves would lead to an immediate ingress of water from the sea into a forward port ballast tank. The incident of February 6 involved inadvertent flooding from the sea during pumping and an adverse port heel of 6 degrees resulted within minutes.⁷ Without the countervailing pumping the reaction of the rig to an ingress from the sea would of course be significantly faster.

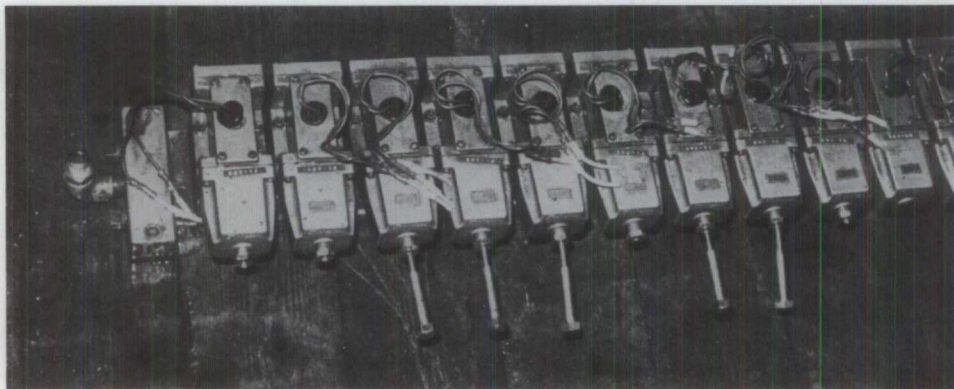
7.6 One of the six banks of solenoid valves recovered from the ballast control console. Many of the brass rods were broken during salvage, leaving only the brass bushing and a section of the threaded rod at the front of the valve housing. The valve on the extreme right is fitted with a plastic dust cap.

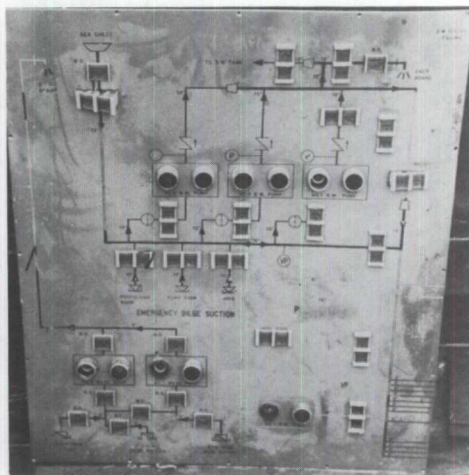
7.7 One of the four mimic panel sections recovered from the ballast control console. Only the pump switches for port pumps #3 and #5 had been reassembled.

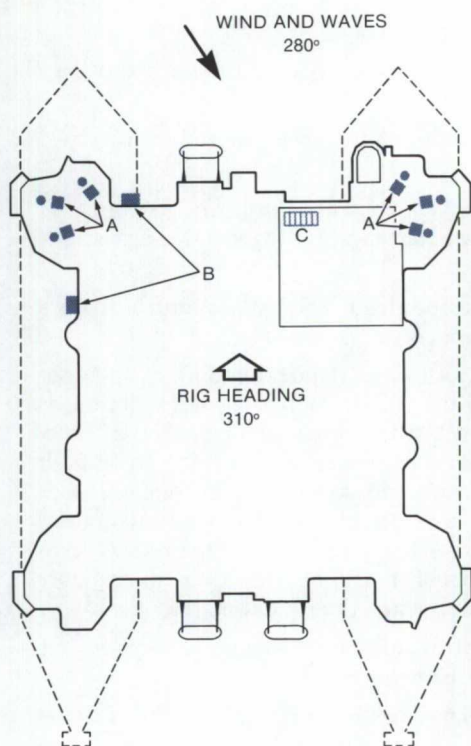
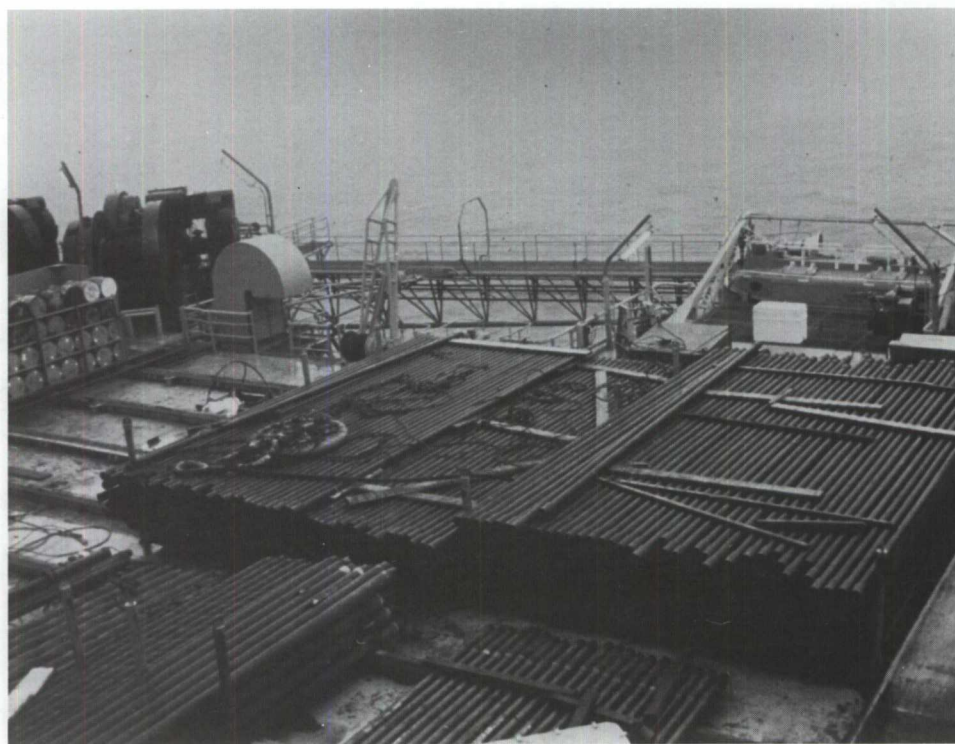
7.8 The illustration shows the location of the chain locker openings (A), the ventilators (B) and the accommodations area stairwell (C); the photograph shows one of the large bow ventilators which led to the sack storage area below. With a severe port bow list, drill pipe and deck cargo would have shifted, causing damage to the ventilator and allowing sea water to flood the lower deck.
