EVACUATION AND EMERGENCY RESPONSE

CHAPTER EIGHT EVACUATION AND EMERGENCY RESPONSE

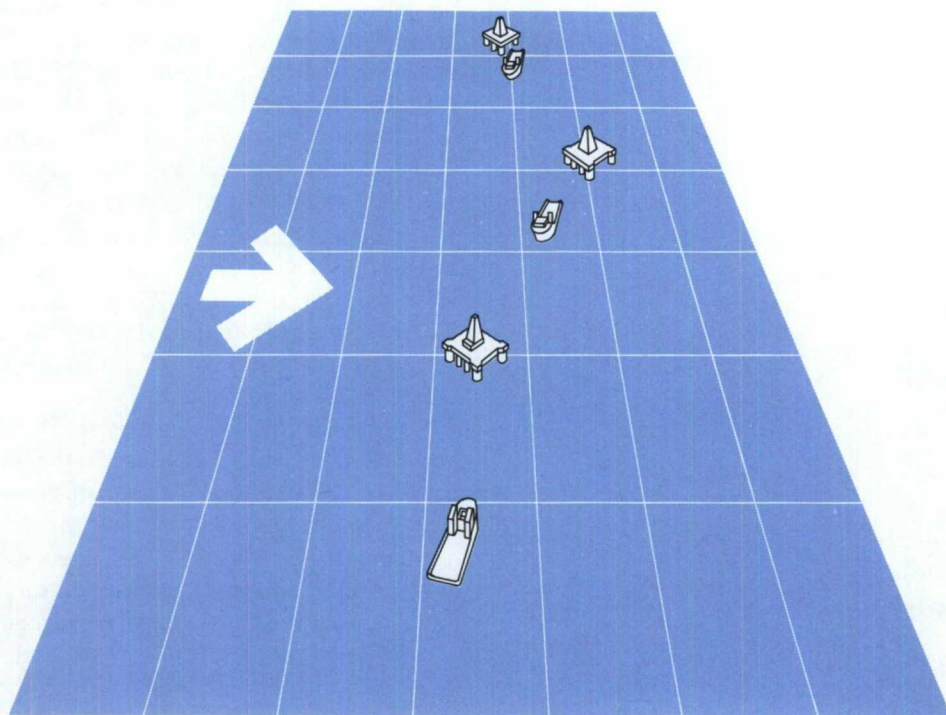
8.1 By 1:30 a.m. all three vessels had been directed to assist the *Ocean Ranger*. The *Nordertor* (top), dispatched from the *Zapata Ugland* at 0122 NST, was approximately 20 miles away, and the *Boltentor* (centre), dispatched from the *SEDCO 706* at 0121 NST, was approximately 9 miles away. The *Seaforth Highlander* (bottom) had been called to close standby at 1:05 a.m., and was approximately 6 miles from the rig.

The telex connection with the *Ocean Ranger* is broken.

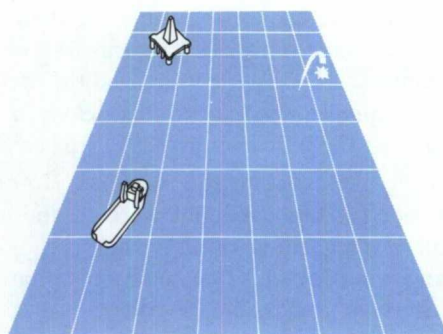
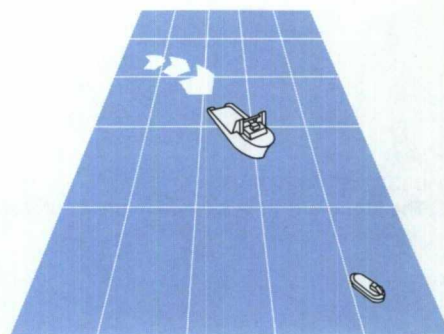
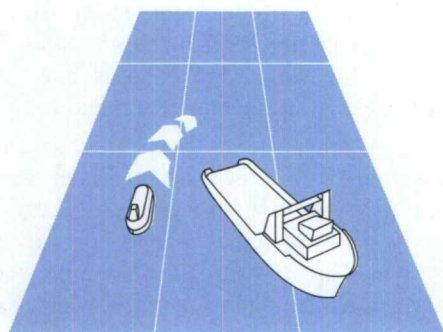
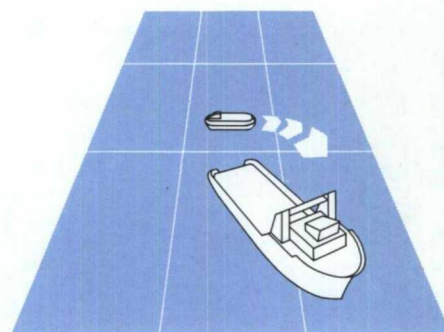
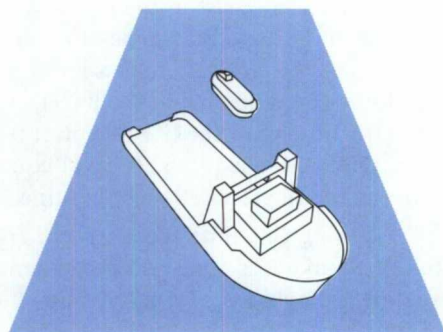
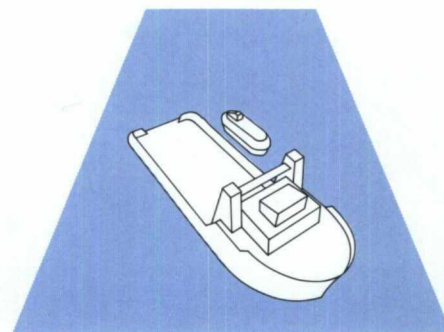
0221 NST (0551Z)
The *Seaforth Highlander* spots a lifeboat and proceeds towards it.

8.2 The *Seaforth Highlander* approached the port stern of the *Ocean Ranger* and subsequently manoeuvred to the assistance of a lifeboat.

The lifeboat capsizes.

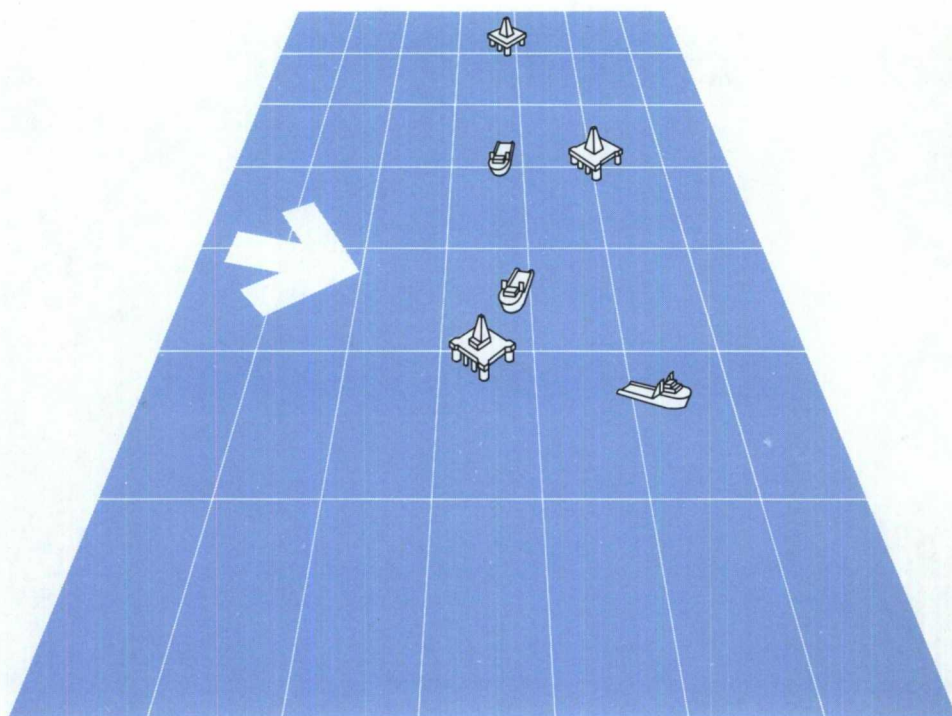
8.3 The *Boltentor* arrived at the *Ocean Ranger* at 2:45 a.m. and reported that helicopters could land on the rig. Approximately fifteen minutes later the *Nordertor* lost radar contact with the *Ocean Ranger*.

The *Boltentor* makes visual contact with the *Ocean Ranger*.

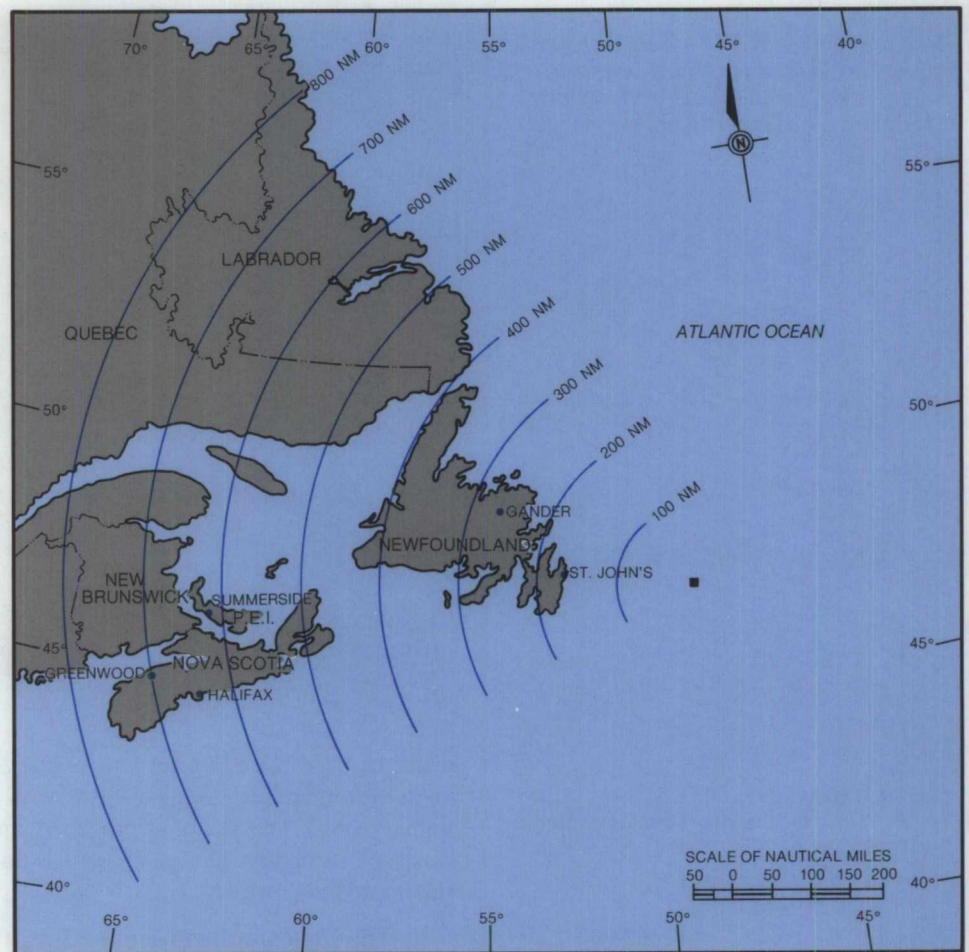
8.4 The locations of the Search and Rescue aircraft tasked to the *Ocean Ranger* site by the Rescue Co-ordination Centre in Halifax.

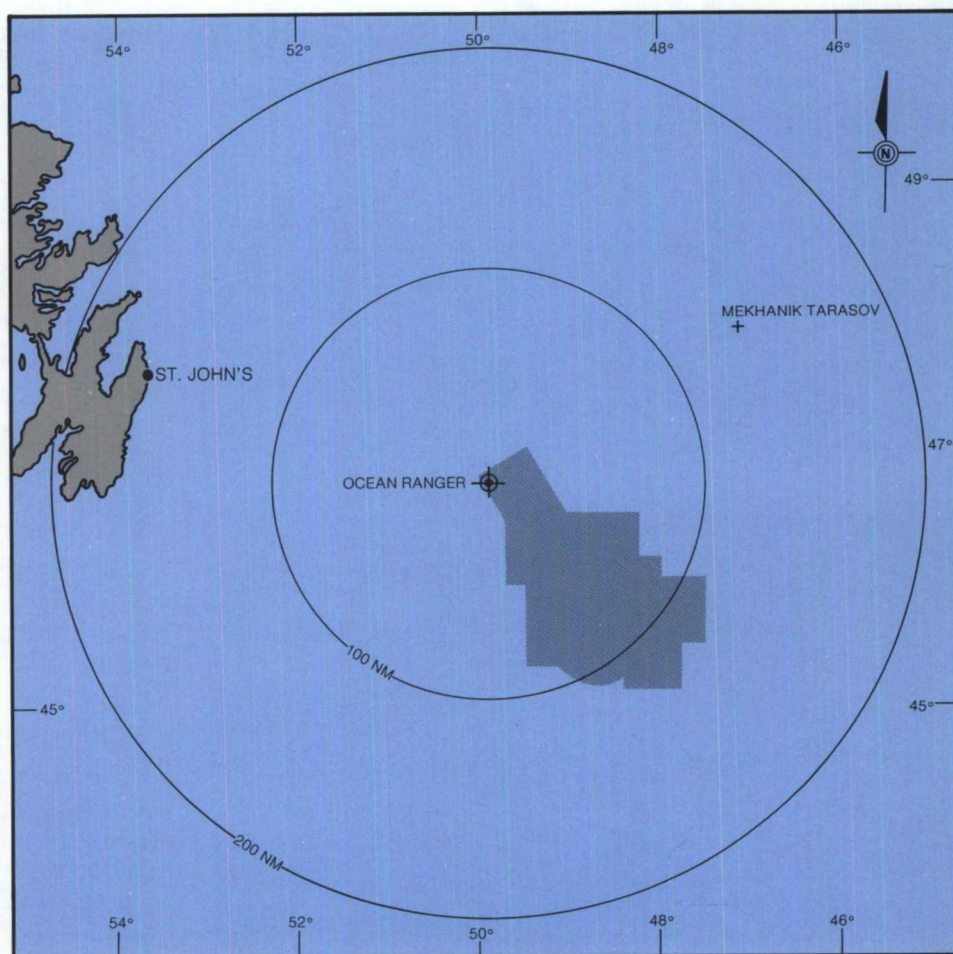
8.5 A search area of over 6000 square miles was covered during the four days after the loss, through the combined efforts of both industry and government aircraft and vessels.

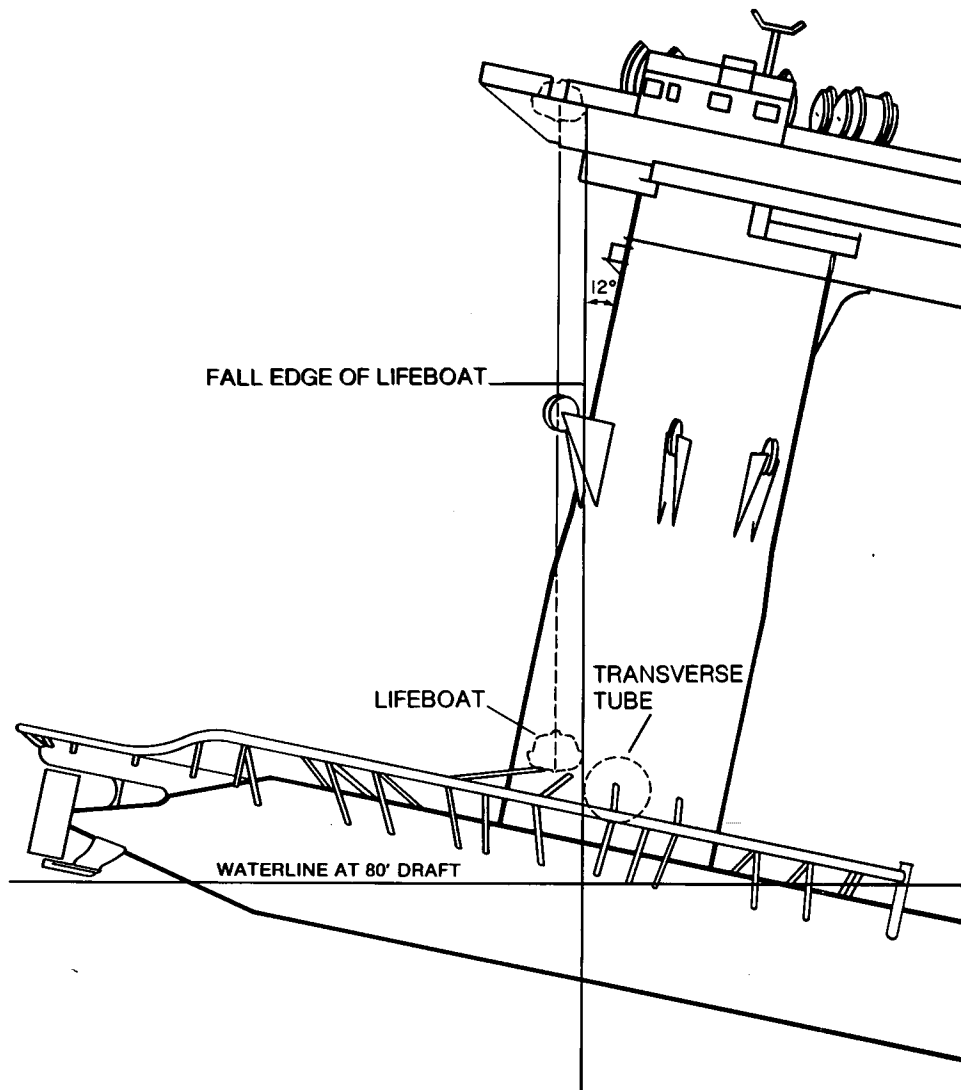
9.1 This illustration is taken from the ODECO installation plans for the Watercraft lifeboats. The design limitation for safe launching is illustrated at a 12 degree bow trim. The pitch and roll of the rig in heavy seas would restrict safe launching to a much smaller angle.

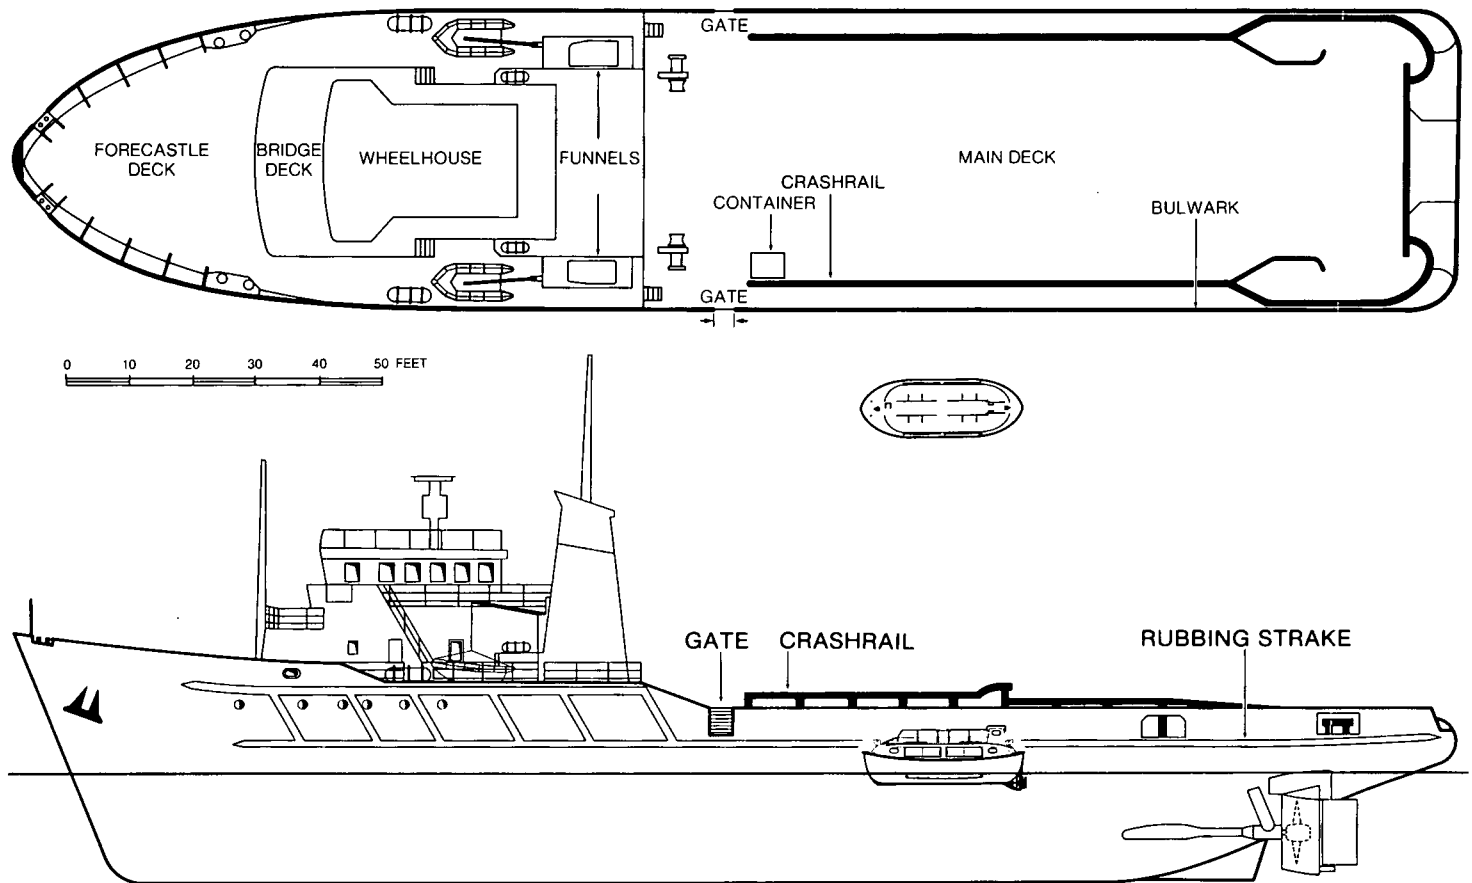
9.2 This is a plan and elevation view of the *Seaforth Highlander* and the Harding lifeboat in stillwater. On February 15, 1982, the severe sea conditions seriously hampered rescue attempts.

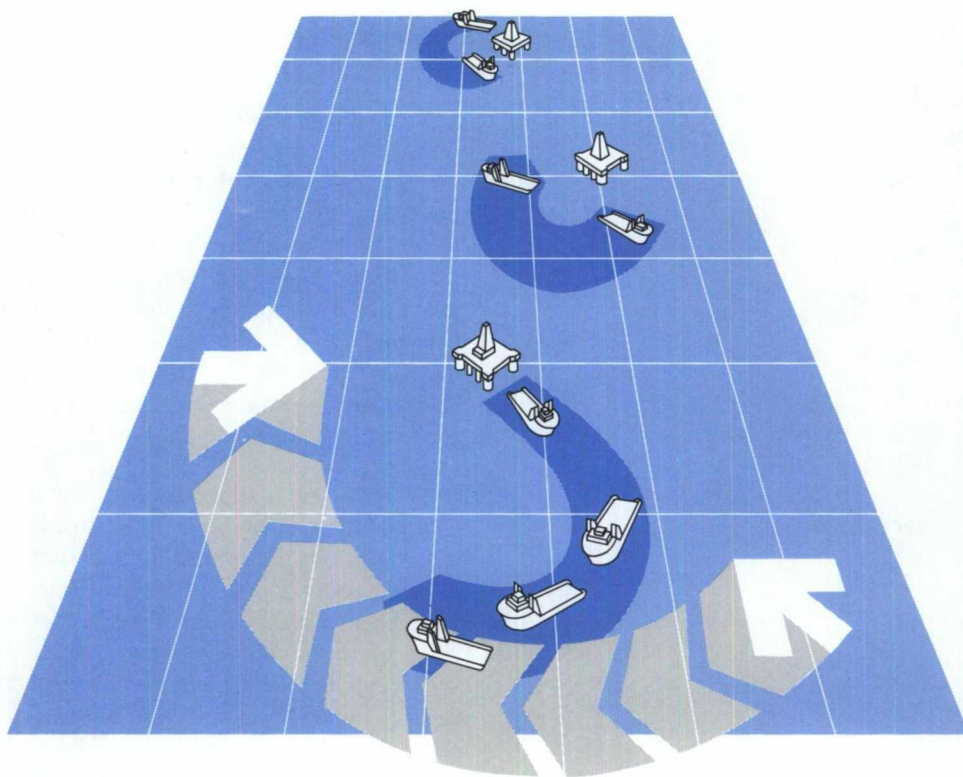
9.3 As the storm centre passed to the east of the Hibernia Field during the evening of February 14, the wind veered from the southeast to the west. The *Seaforth Highlander* proceeded into the wind and followed a course which led to a position approximately eight miles south of the *Ocean Ranger*. The *Boltentor* (centre) and the *Nordertor* (top) maintained dodging patterns upwind of their respective rigs.

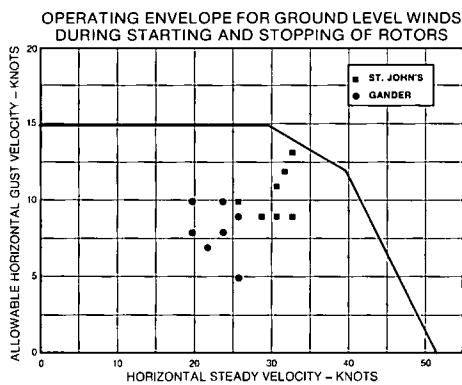
TIME	ST. JOHN'S		GANDER	
0130	33	gusting to 42	26	gusting to 35
0230	31	" " 42	26	" " 31
0330	33	" " 46	24	" " 34
0430	31	" " 40	22	" " 29
0530	26	" " 36	24	" " 32
0630	29	" " 38	20	" " 28
0730	32	" " 44	20	" " 30

9.7 A comparison of the actual wind velocities at Gander and St. John's shows that at neither place did they exceed the start-up limitations imposed on the Search and Rescue helicopters.
