REPORT "F"
ENGINEERING REPORT EP 333/83
BALLAST CONTROL PANEL TESTS
8 September 1983

REPORT "G"
ENGINEERING REPORT 195/82
BALLAST CONTROL ELECTRICAL
SYSTEM
AND OVERALL ANALYSIS
8 September 1983

REPORT "H" ENGINEERING REPORT EP 72/84 PUMP SWITCH FAILURE DEMONSTRATION 01 March 1984

REPORT "I"
ENGINEERING REPORT EP 73/84
MICROSWITCH FAILURE ANALYSIS
01 March, 1984

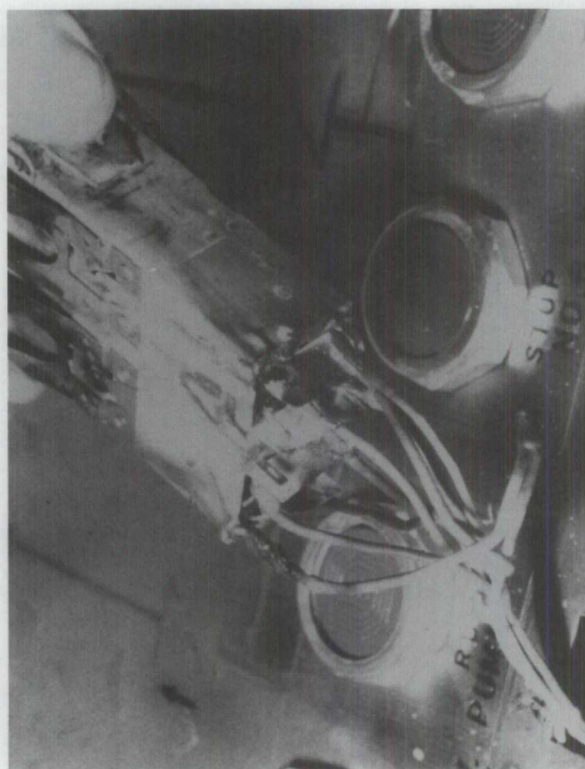
4.1 After the power was cut, some switches were removed from the panel and it was noted that the burning damage was similar to, but more extensive than, the damage observed on switch P-19 of the *Ocean Ranger* panel.

4.2 Analysis of the switches determined that shorts created by sea water between the 115 volt circuit and ground (via the leaf spring and the panel) caused more sparking, which provided sufficient heat energy to burn and melt the plastic housing of the switch.

4.3 The 115 volt circuit also leaked in a similar manner into the 24 volt circuit, causing the same burning damage on the manual valve indicator light housing. The damage to nearly all switches and indicators was severe, as is evident from Photo 8.

PHOTO 8 Micro command switch showing arcing damage after test.

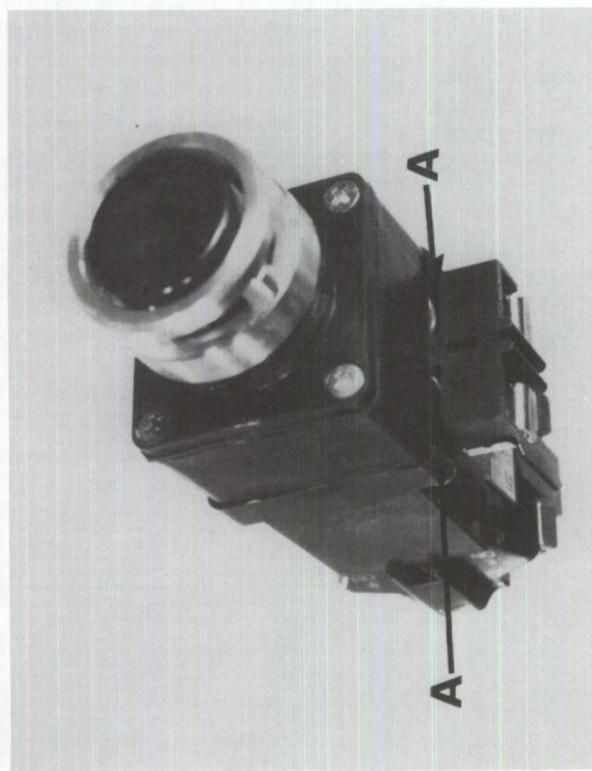
3.1 It has been demonstrated that sea water could easily have (and most likely did) run along the underside of the ballast control panel and entered the pump switch bodies near the light terminals.

PHOTO 1 Pump switch green or run, showing the cavity on the side of the body where water can enter at A.

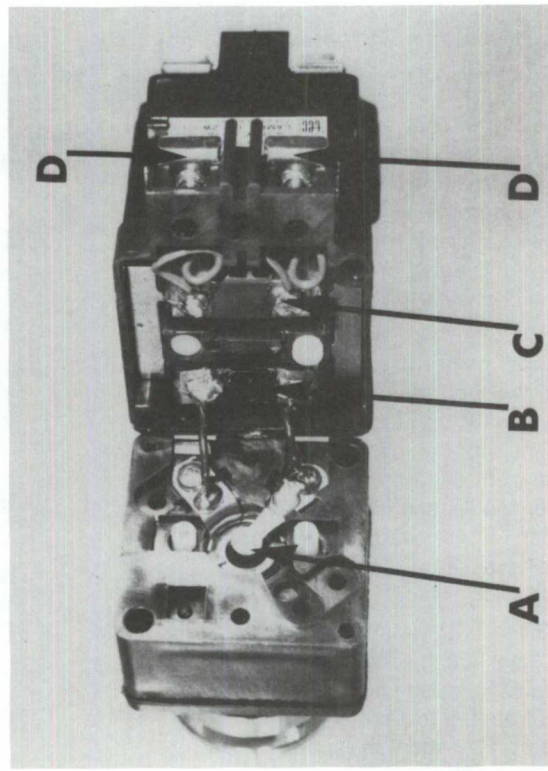
2.6 The transformer terminals of the primary windings "C" and the light bulb socket "A" are in very close proximity, as is evident from Photo 3. This close proximity would facilitate the leakage of the "primary" 115 volts into the "secondary" light bulb contacts, if sea water were to enter the transformer area within the switch body.

PHOTO 3 The same switch split at the transformer and button light interface. A is the bottom of the light bulb socket, B secondary winding, C is the primary winding and D is the external transformer connections.

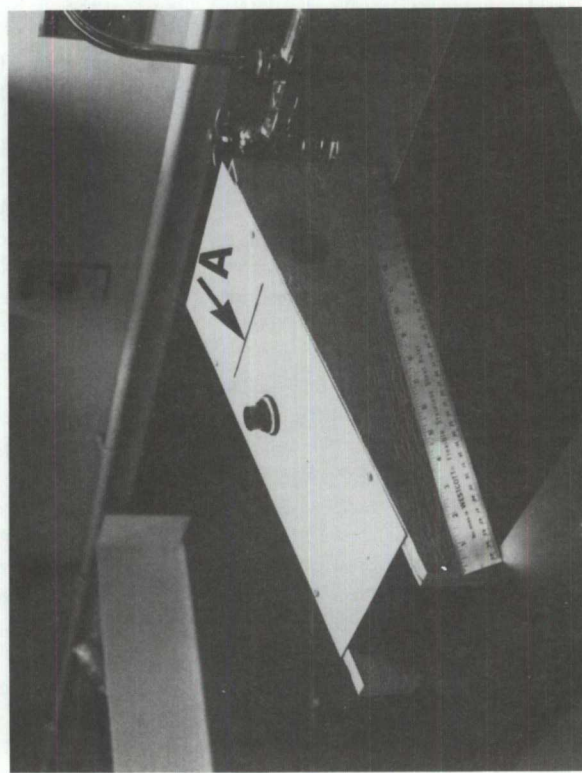
2.9 The slot in the test panel was considered to be an acceptable simulation of the small gaps between the rectangular valve switches and the ballast control panel mounting holes that were noted to exist in the ballast control panel assembly.

PHOTO 4 The test fixture for water ingestion test, showing the slot at A.

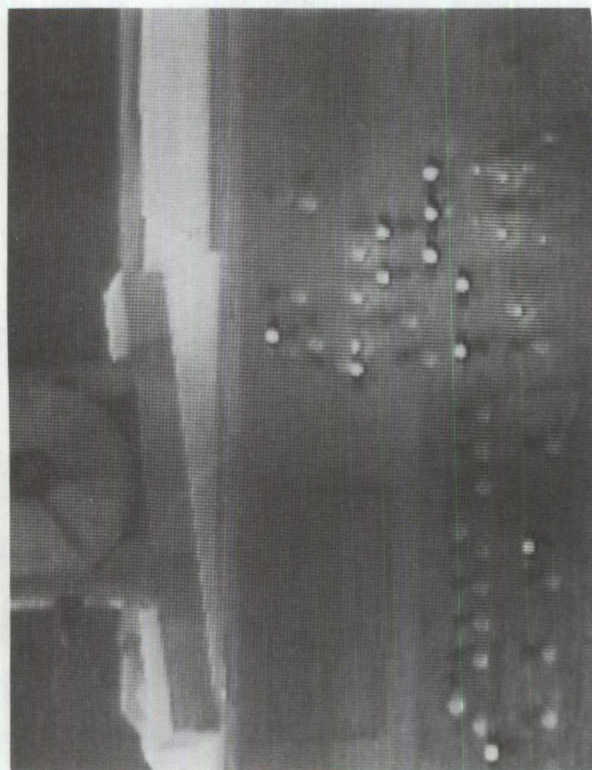
1.2 These tests and analyses were completed and the results were submitted to the Royal Commission in September 1983 in ASE Reports "A" through "G". ASE's Report "F", (EP 333/83) titled "Ballast Control Panel Tests", covered testing of a reconstructed ballast control panel for its susceptibility to electrical damage and failure, when doused with sea water. During this test ten control valve "open" (green) switches failed, as is evident from Photo 1 and paragraph 3.4 in ASE Report "F".

1.3 The green light display on the special monitoring panel shown in Photo 1 was the basic evidence that these switches had failed at the time of the test. The manner of failure of these 10 switches, as postulated in paragraph 3.4 of ASE Report "F", was a logical deduction from indirect evidence. At the time of this test it was decided not to open the microswitches to look for sea water, because of the risk of losing the evidence (i.e., the sea water) in the process of opening the switches.

PHOTO 1 The test panel at the time that the monitor panel showed the 10 green lights, indicating switch failures.

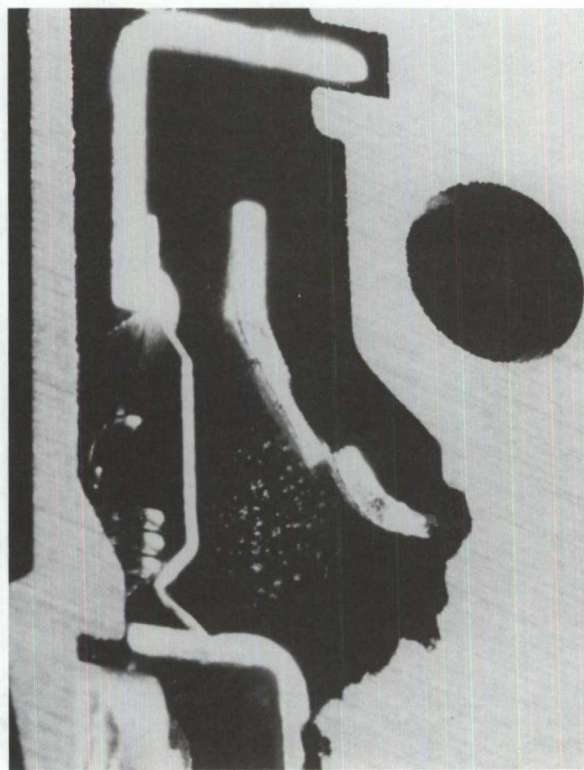
PHOTO 3 Detail of the microswitch mechanism showing the white specks deposited on the gold plated contact bar.

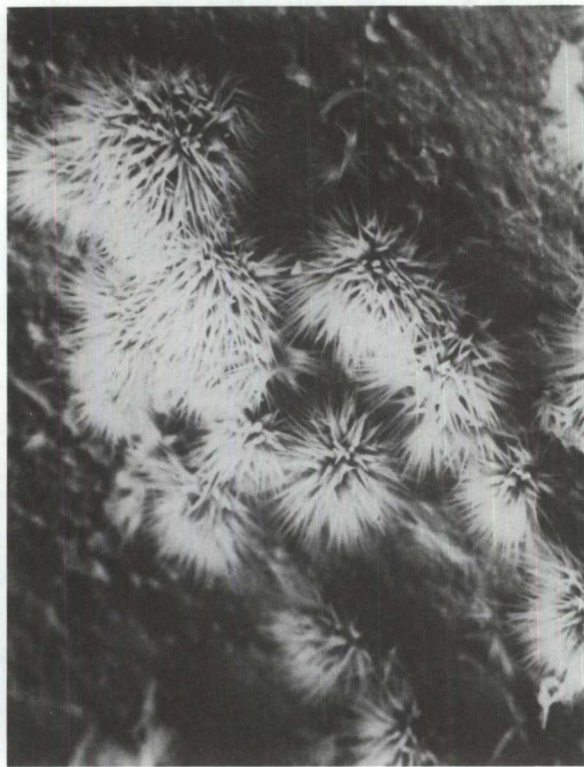
PHOTO 4 Micrograph of the white specks found to be sodium compound crystal clusters.

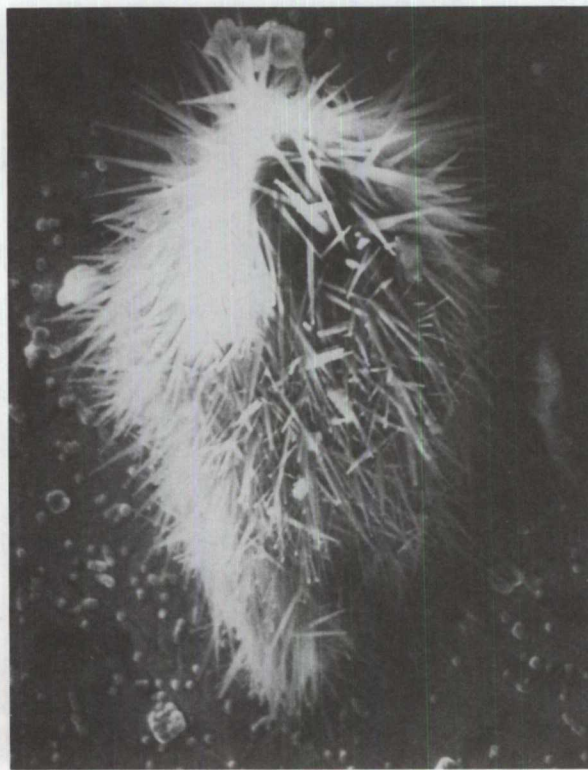
PHOTO 5 Micrograph of a sodium compound crystal cluster surrounded by small sodium chloride crystals.

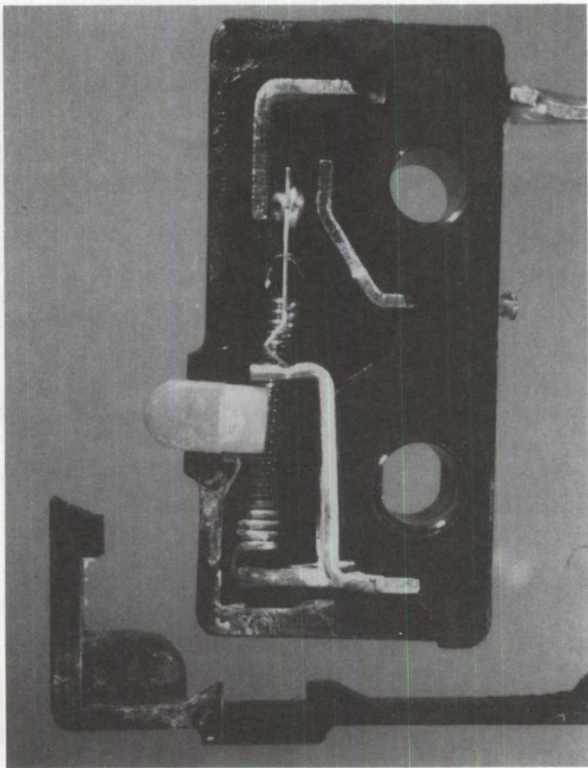
PHOTO 6 Microswitch showing evidence of sea water having entered through a separation in the casing halves.

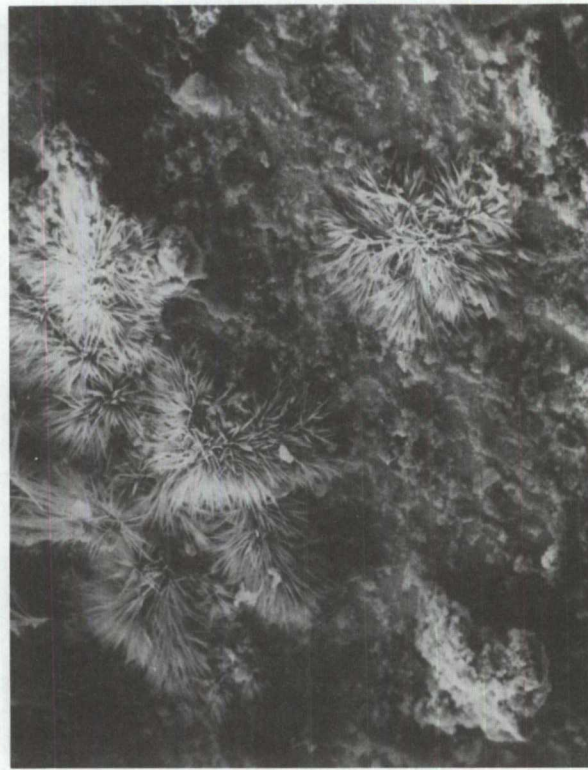
PHOTO 7 Micrograph showing the various crystalline deposits on a switch component.

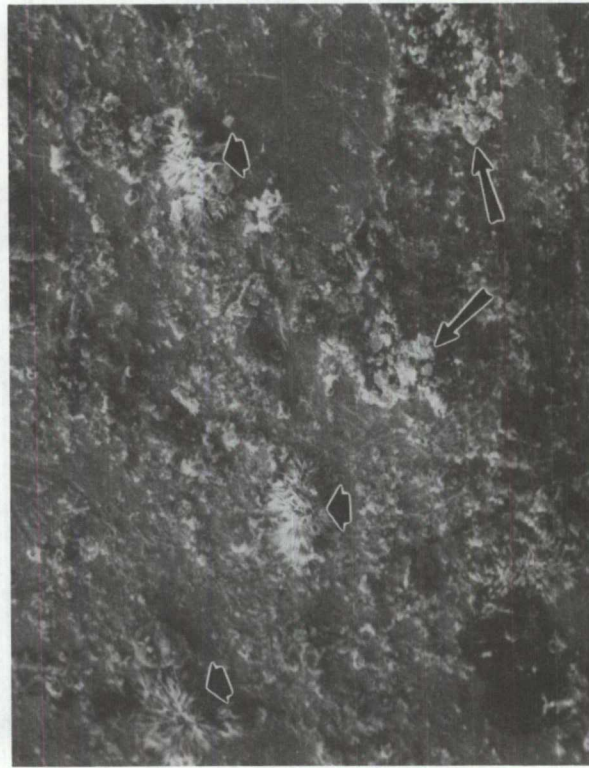
PHOTO 8 Micrograph details of some typical spikey crystalline deposits.

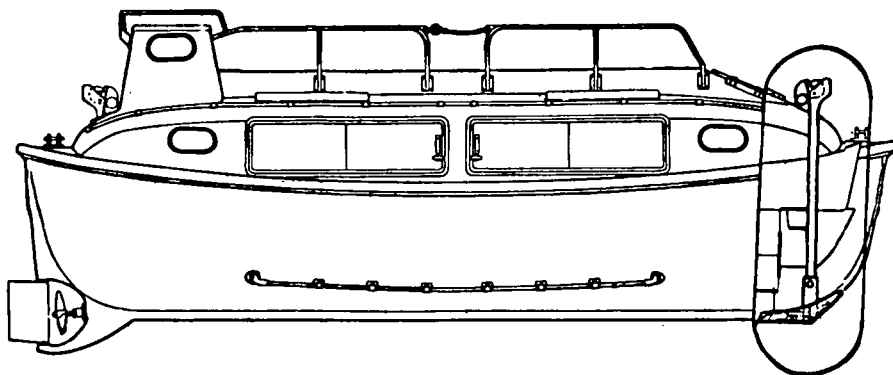
In the process of recovering the boat with cables, the boat suffered additional damage. This is apparently when the cover was crushed and the hull damaged in a number of places (reference 11d). In addition to the damage caused by the release gear, there were two other areas of damage that apparently did not occur during recovery. These are two "L" shaped inward fractures on either side of the hull several feet aft of the bow. These fractures match the position of the davit chocks on the launching platform and indicate that the launching sequence for this boat may not have begun, or had just begun when it was separated from the launching platform. The boat and its release gear arrangement are shown in Figure 1.

FIGURE 1 Harding 26 ft. totally enclosed lifeboat. Internal view at forward end shows release gear arrangement. The hook is attached to a support bar which is in turn attached to the keel shoe by a pin joint. The keel shoe is "glassed in" at the keel and is the means of transferring the load of the boat to the release gear. The support bar is held vertically by a flange bolted to the fiberglass at the point where the support bar penetrates the cover.

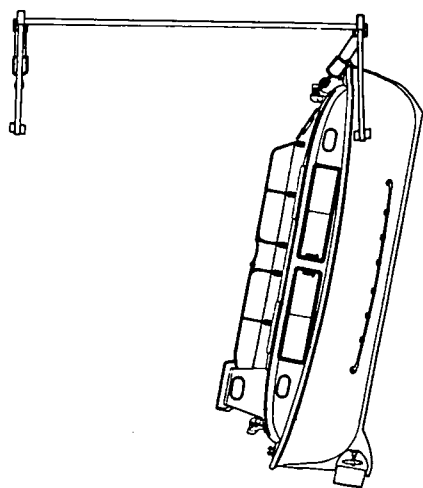
FIGURE 2B Aft release hook has been opened, allowing aft end of boat to fall. Davit chocks at forward end normally in contact with gunwale dig into hull, leaving "L" shaped inward fractures on both sides of the hull.
