AVIATION INVESTIGATION REPORT A13H0001

**CONTROLLED FLIGHT INTO TERRAIN
7506406 CANADA INC.
SIKORSKY S-76A (HELICOPTER), C-GIMY
MOOSONEE, ONTARIO
31 MAY 2013**

Aviation Investigation Report A13H0001

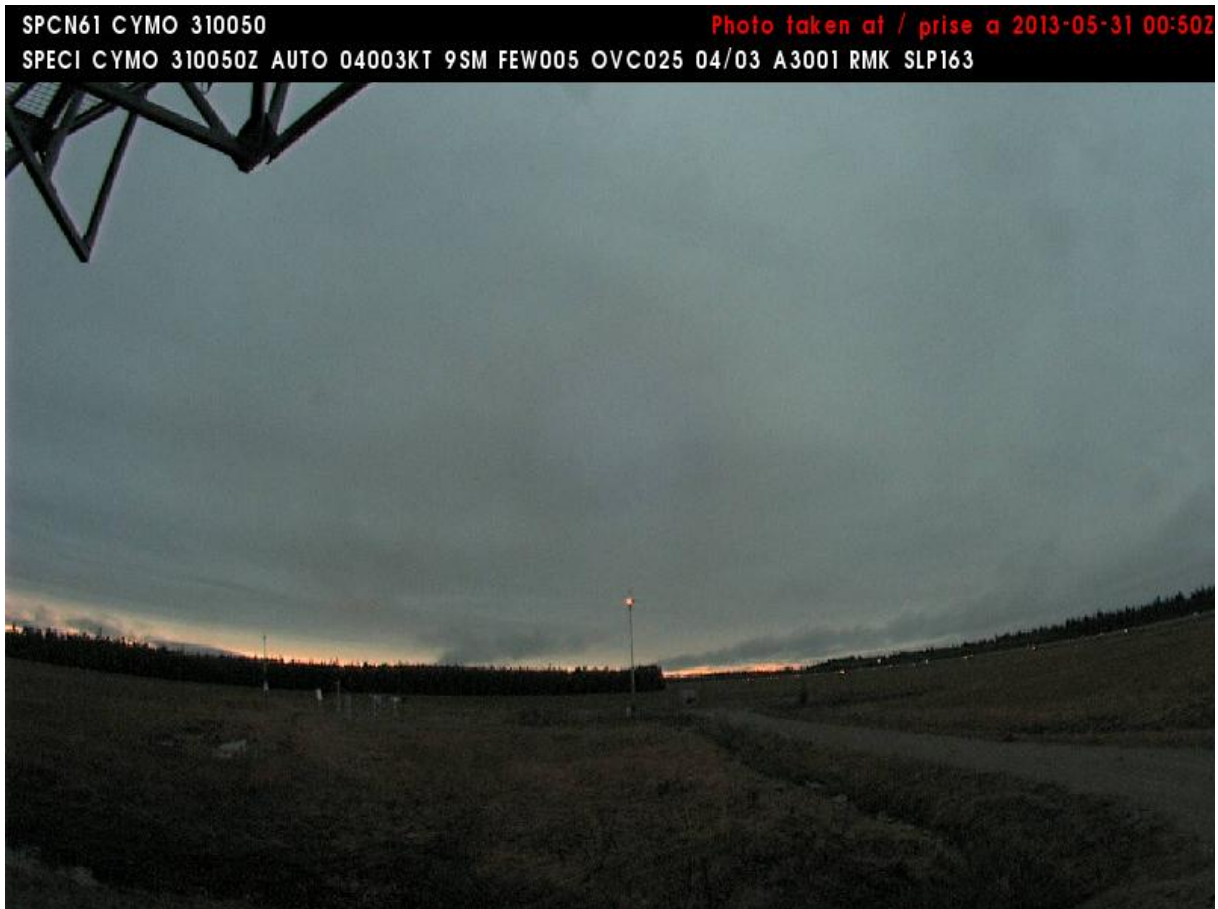
The airport is equipped with 2 weather cameras that take still images every 10 minutes. One of the cameras points to the northeast and the other points to the southwest. The camera pointing to the northeast is oriented in the general direction of Runway 06, paralleling it to the north. In the daylight image from this camera, it is possible to see a lit tower on the airfield and the treeline to the north of Runway 06. Images taken hours before the occurrence clearly show the tower and the treeline (Photo 1). In contrast, the only thing visible in a photograph from approximately the same time as the accident is the single light from the tower located on the airfield (Photo 2). No other cultural lighting, or ambient lighting from stars, is visible in the image.

Photo 1. Image taken by the northeast-oriented weather camera showing the lit tower and the treeline at Moosonee Airport at 2050 on 30 May 2013 (Source: NAV CANADA)

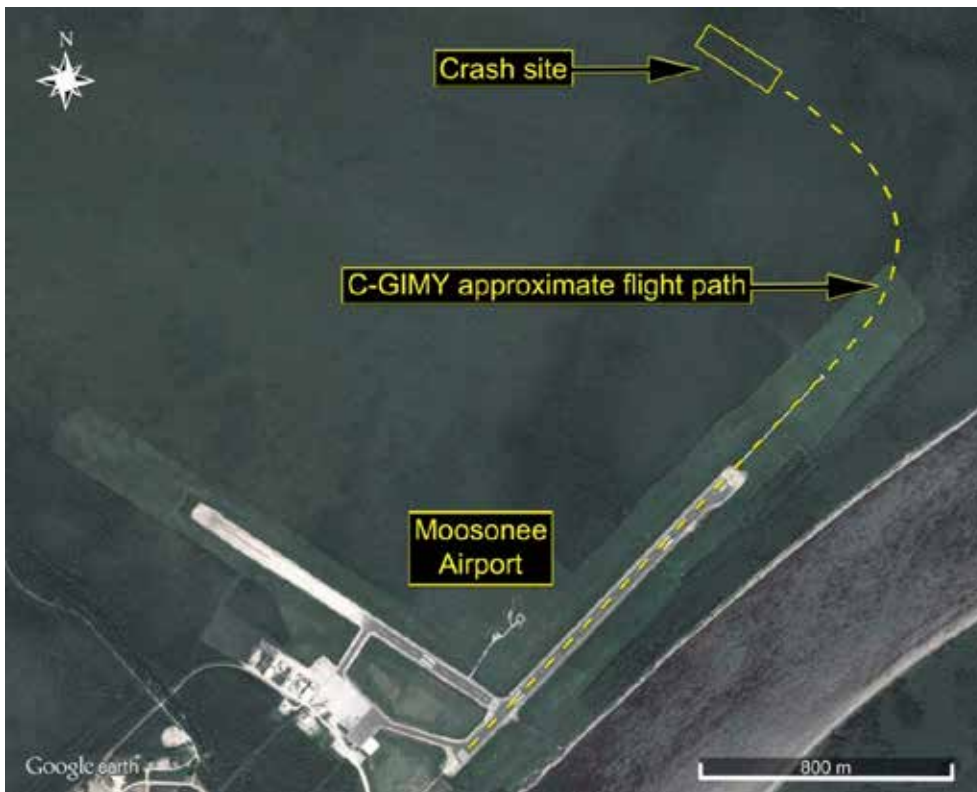
The wreckage was located in densely wooded, swampy terrain approximately 0.8 sm from the end of Runway 06, on a bearing of 020°M (Figure 1). Based on damage to surrounding trees and ground scars, investigators determined that the aircraft collided with the ground in a steady, shallow descent angle (approximately 9 degrees), in a left-banked (approximately 20 degrees) attitude (Figure 2 and Figure 3). Although it was not possible to determine the exact speed of the helicopter at the time of the accident, the damage to the surrounding terrain and trees, length of the wreckage trail, and extent of aircraft breakup during the impact sequence indicated a high-energy state (consistent with the helicopter being at or near cruise speed) upon impact with the ground.

Figure 1. Approximate flight path of the occurrence helicopter, C-GIMY (Source: Google Earth, with TSB annotations)

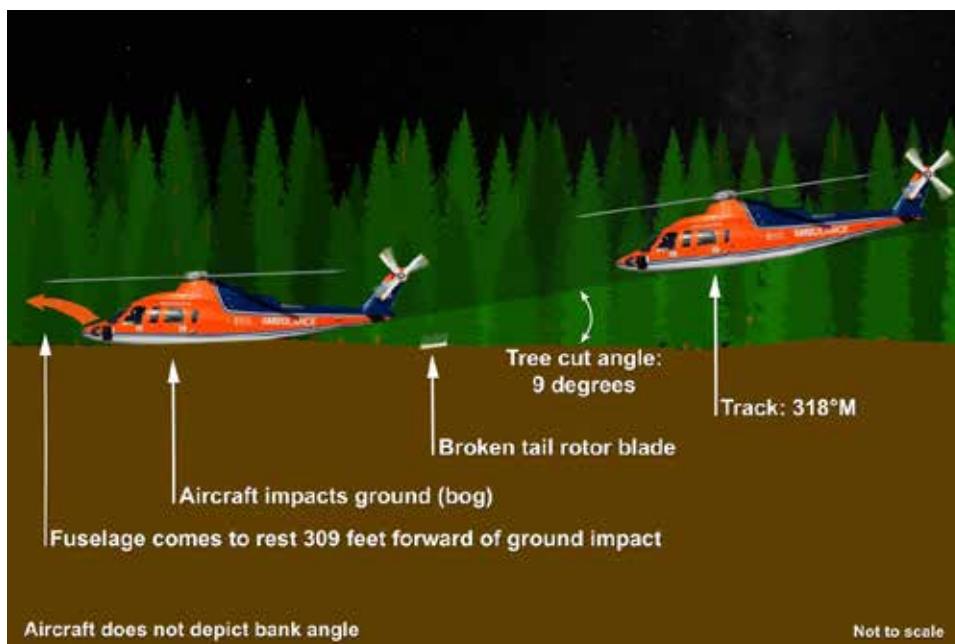
Figure 2. Depiction of C-GIMY's descent (side view)

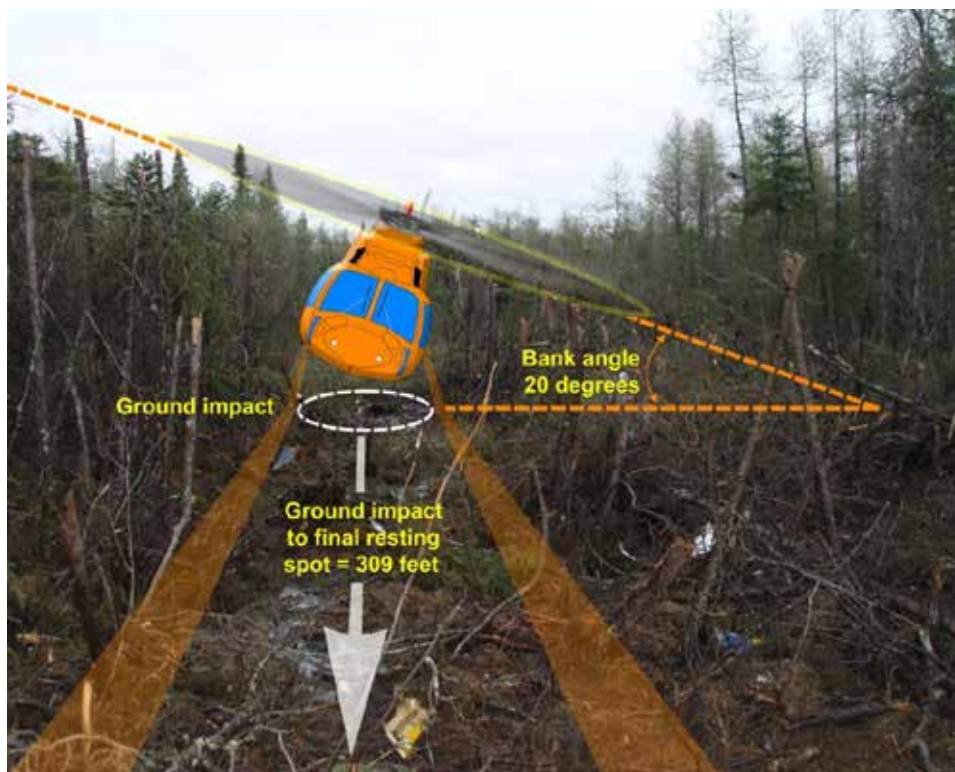
Figure 3. Depiction of C-GIMY's descent (nose-on view)

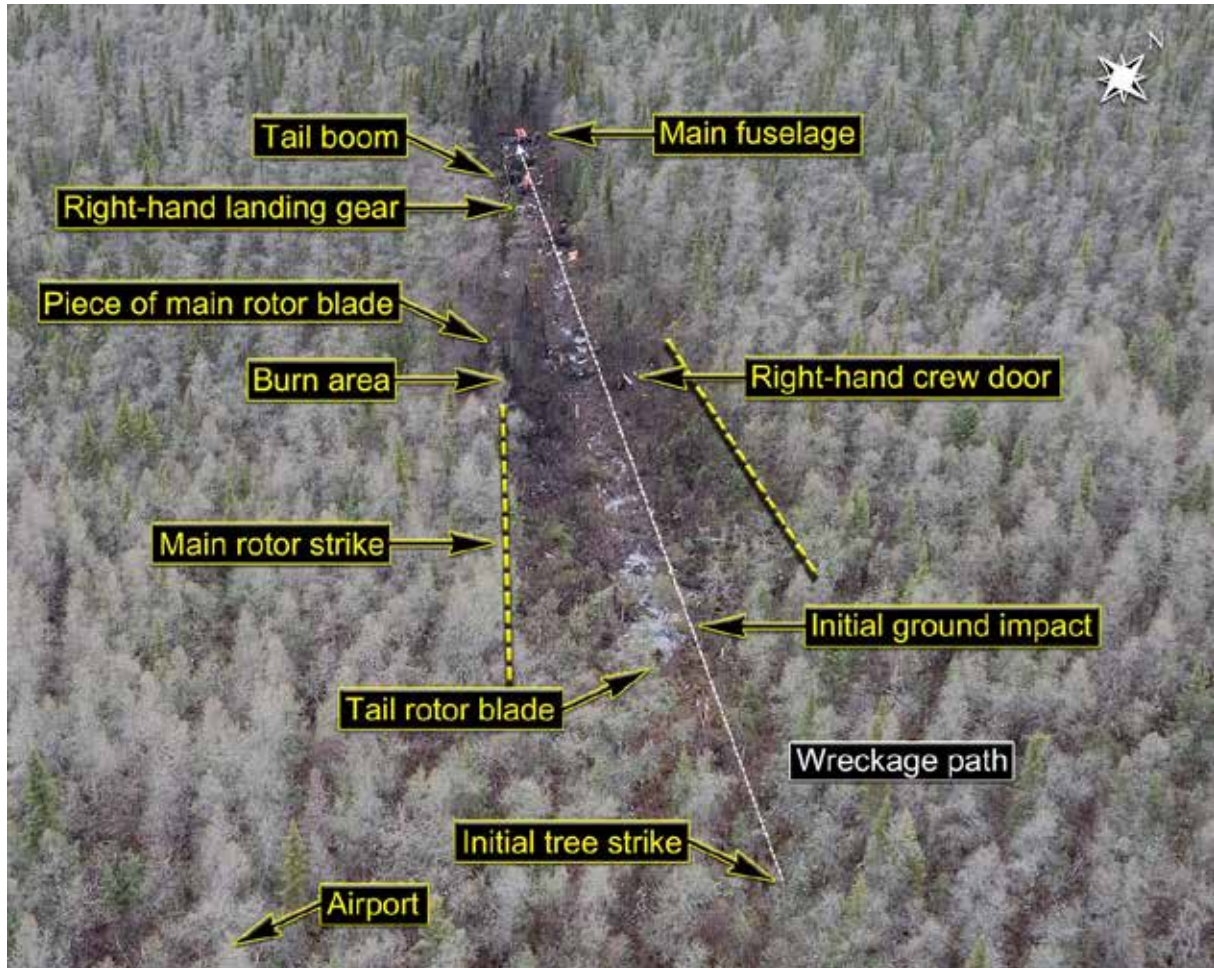
The length of the crash swath path, from the first indication of contact with the trees to the location of the main wreckage, was approximately 405 feet. At the point of ground impact, the swath path was approximately 40 feet wide, gradually narrowing to approximately 20

feet, and then widening out again to form a circular, burned-out area approximately 35 feet in diameter (Figure 4).

Figure 4. Overhead view of the wreckage path: 405 feet, 318°M track

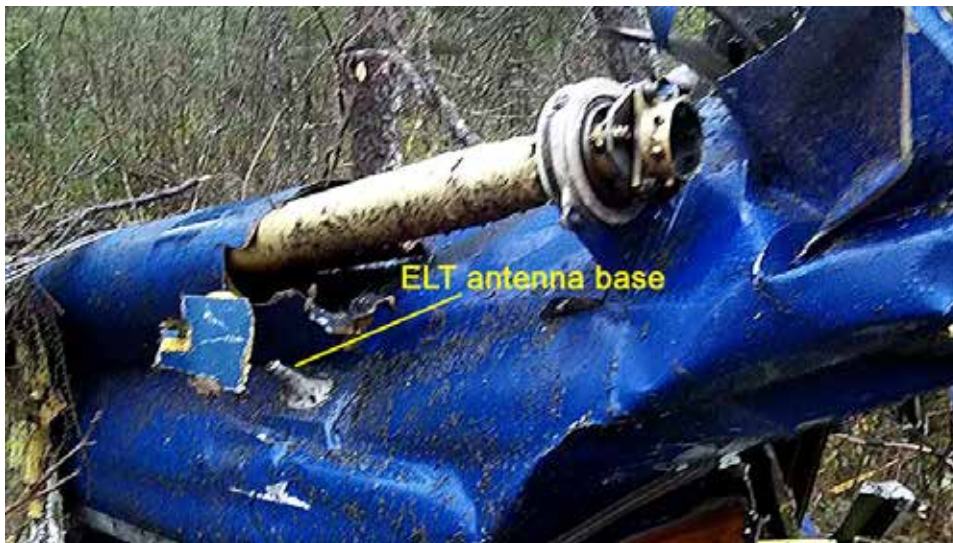
In addition to the detachment of the unit from its mounting tray, the external antenna located on the tailboom had been severed due to ground impact forces (Figure 6).

Figure 6. A frame grab from a field video of the wreckage showing the severed emergency locator transmitter (ELT) antenna

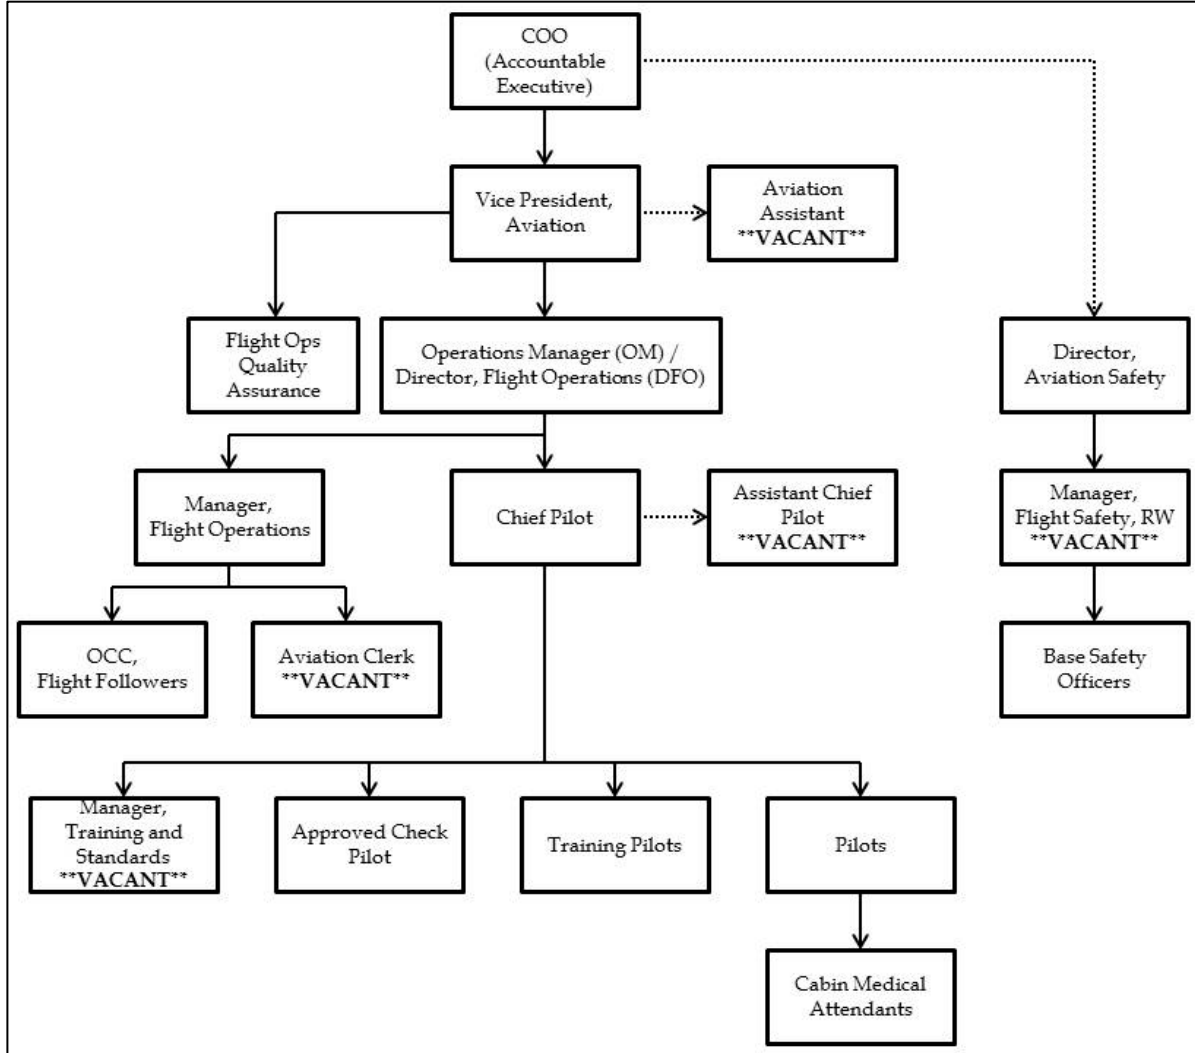
Figure 7. Ornge Rotor-Wing's organizational structure at the time of the accident (Source: Ornge RW, *Company Operations Manual*, with TSB annotations)

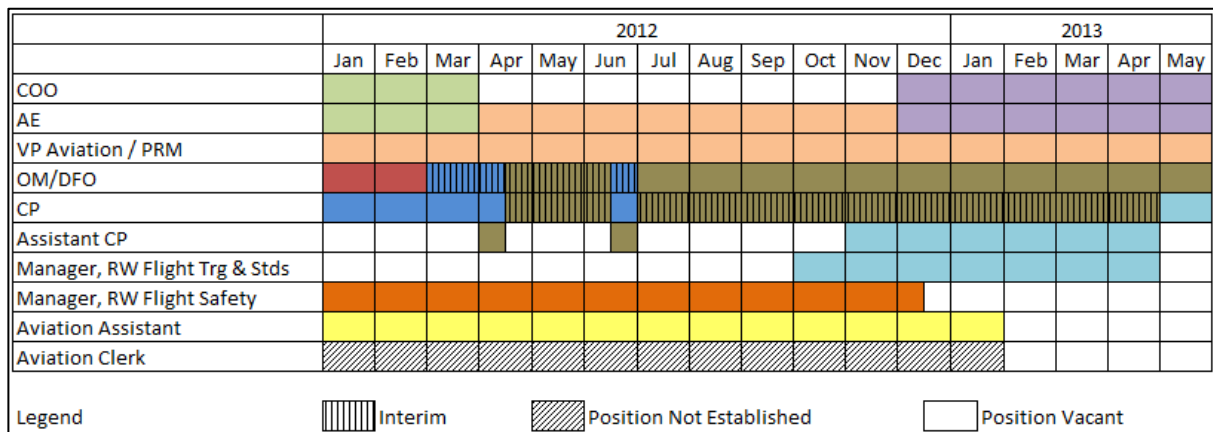
In December 2012, a new COO/AE was hired. During the period of April 2012 to December 2012, in the absence of a COO/AE, the Vice President (VP) of Aviation, acting as the AE, reported directly to the Acting CEO. Then in January 2013, a CEO/President was hired. Figure 8 depicts the staff changes within some of the key management positions at Ornge RW. Each colour represents a different individual. Interim positions are represented by vertical stripes.

Figure 8. Timeline of staff changes at Ornge Rotor-Wing
