**AVIATION INVESTIGATION REPORT
A13H0002**

COLLISION WITH WATER

**GOVERNMENT OF CANADA, DEPARTMENT OF TRANSPORT
MBB BO 105 S CDN-BS-4 (HELICOPTER) C-GCFU
M'CLURE STRAIT, NORTHWEST TERRITORIES
09 SEPTEMBER 2013**

On 09 September 2013, at 1638 Mountain Daylight Time, the Canadian Coast Guard Messerschmitt-Bölkow-Blohm BO 105 S CDN-BS-4 helicopter (registration C-GCFU, serial number S 727) operated by the Government of Canada, Department of Transport, call sign CCG364, took off from the Canadian Coast Guard Ship (CCGS) *Amundsen* with 1 pilot, the vessel's master and a scientist on board for a combined ice measurement and reconnaissance mission in the M'Clure Strait, Northwest Territories.

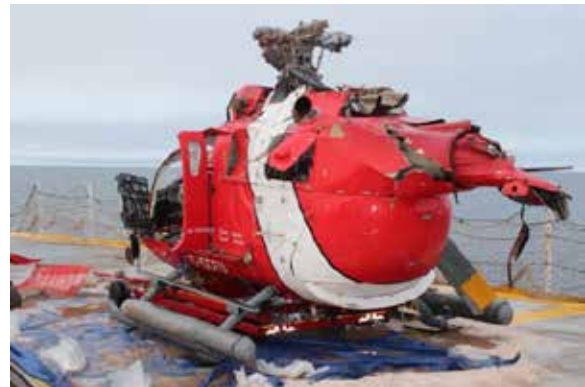
Photo 1. Wreckage of helicopter C-GCFU on deck

The helicopter was substantially damaged on impact with the surface of the water. There was severe upper frontal damage of the windshield and instrument panel. The tail boom was separated near the front of the tail boom and 3 main rotor blades had been torn off at their roots (Photo 1).

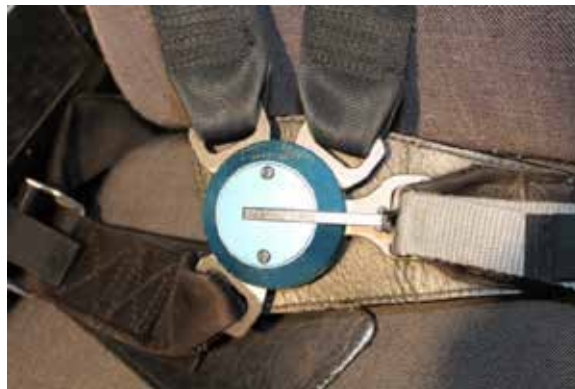
Photo 2. Front seat 4-point safety harness

Each front seat was longitudinally adjustable and equipped with a 4-point safety harness consisting of a lap belt and automatic locking shoulder harnesses (Photo 2). The 3-person fixed-position rear bench seat was equipped with a 3-point safety harness for each seat, the shoulder harness was not an automatic locking type. The design of the front and rear seat belt system was such that the seat belt buckle latch had to be raised to insert the metal tongues on the lap belt and shoulder straps. Closing the buckle latch locked the 4 belts together. Lifting the buckle latch released the seat belt system.

When the helicopter was recovered, it was noted that all of the occupants' seat harnesses were released. There was no indication that any of the lap belt or shoulder harness tongues had been forced from the buckle assembly. Examination of occupants' safety harnesses did not identify any discrepancies that would have prevented normal operation.

The pilot's seat had been pushed back to the end of the right (outboard) rail and slightly short of the left rail end. The seat frame was deformed and buckled in a way that was consistent with the back having been forced backward. These observations suggest that a backward force had been applied to the upper body of the occupant and transmitted to the back of the seat. The left front seat was found secured with no sign that it had been displaced during the occurrence. No deformation of the seat frame was observed. The absence of significant damage to the left front seat suggests it had not been exposed to the same rapid ingress of water that the pilot's seat had. The rear bench seat's left supporting strut had fractured and was deformed forward. It is considered likely, therefore, that the left-front vertical strut fractured due to the dynamic loading caused by the vertical deceleration of the occupant at the time of impact.

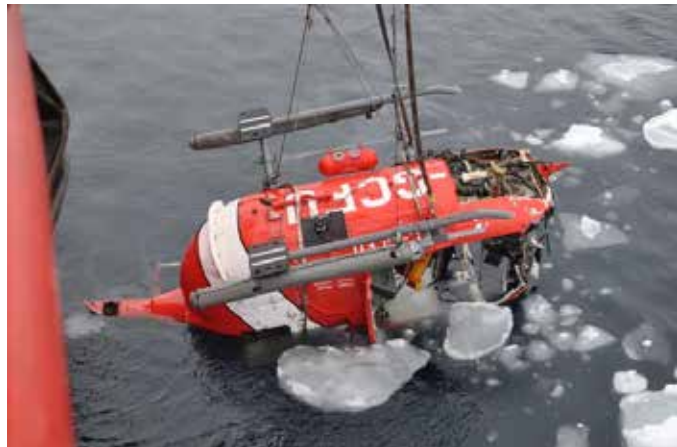
Photo 8. Wreckage recovery

search and recovery operation. During the search for the wreckage using a remotely operated vehicle (ROV), several other pieces of wreckage were located. However, due to the weather and deteriorating ice conditions, only the main wreckage was recovered. The recovered wreckage consisted of the cockpit, fuselage, landing skids, main transmission, rotor head (with one of the 4 rotor blades remaining), and both engines. The tail boom, severed just aft of the fuselage, was not recovered; the cockpit was compromised and missing several window and door sections.
