**AVIATION INVESTIGATION REPORT
A14A0067**

COLLISION WITH TERRAIN

**MANAN AIR SERVICES (dba ATLANTIC CHARTERS)
PIPER PA-31 NAVAJO, C-GKWE
GRAND MANAN, NEW BRUNSWICK
16 AUGUST 2014**

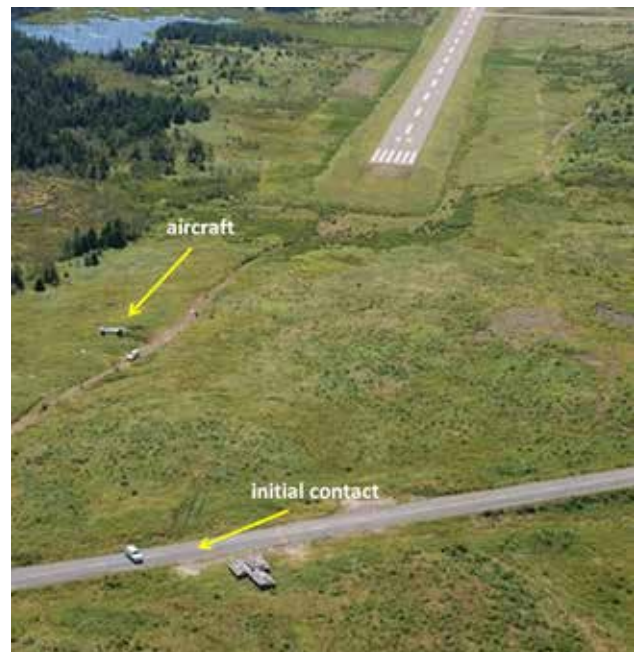
The aircraft continued across the approximately 25-foot-wide road and straight through 100 feet of brush and uneven terrain. All 3 tires made distinctive marks on the road and as the aircraft continued through the brush. The left outboard landing gear door

Photo 1. Occurrence site (Source: Royal Canadian Mounted Police, with TSB annotations)

separated, a portion of the nose landing gear strut fractured, and the left main wheel contacted a tree stump before the terrain dropped off. The aircraft became airborne and began to bank to the left, then the lower portion of the nose landing gear strut and wheel assembly separated from the aircraft.

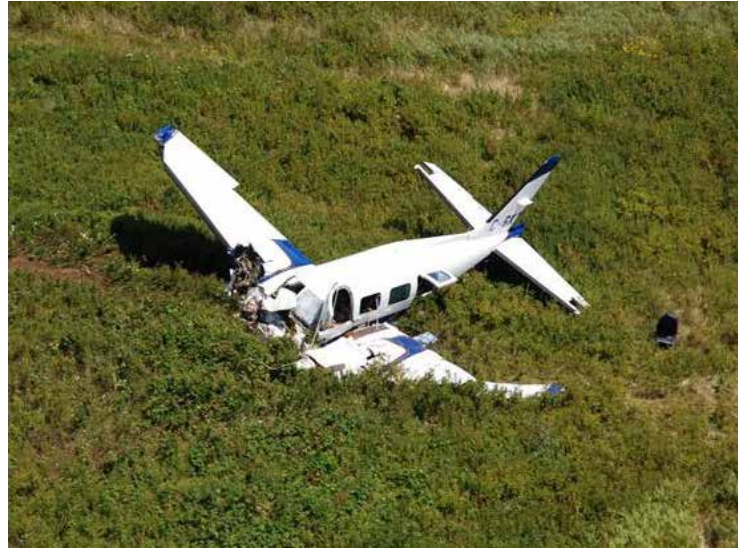
The aircraft nose structure forward of the cockpit instrument panel was crushed and displaced to the right. The instrument panel and cockpit floor were buckled so that the cockpit volume was reduced. The fuselage structure was buckled between the cockpit and cabin sections and deformed such that the cockpit door could not be closed and latched. The cockpit door support rod had separated at the fuselage, allowing the door to travel beyond its normal range.

Photo 2. Occurrence aircraft (Source: Royal Canadian Mounted Police)

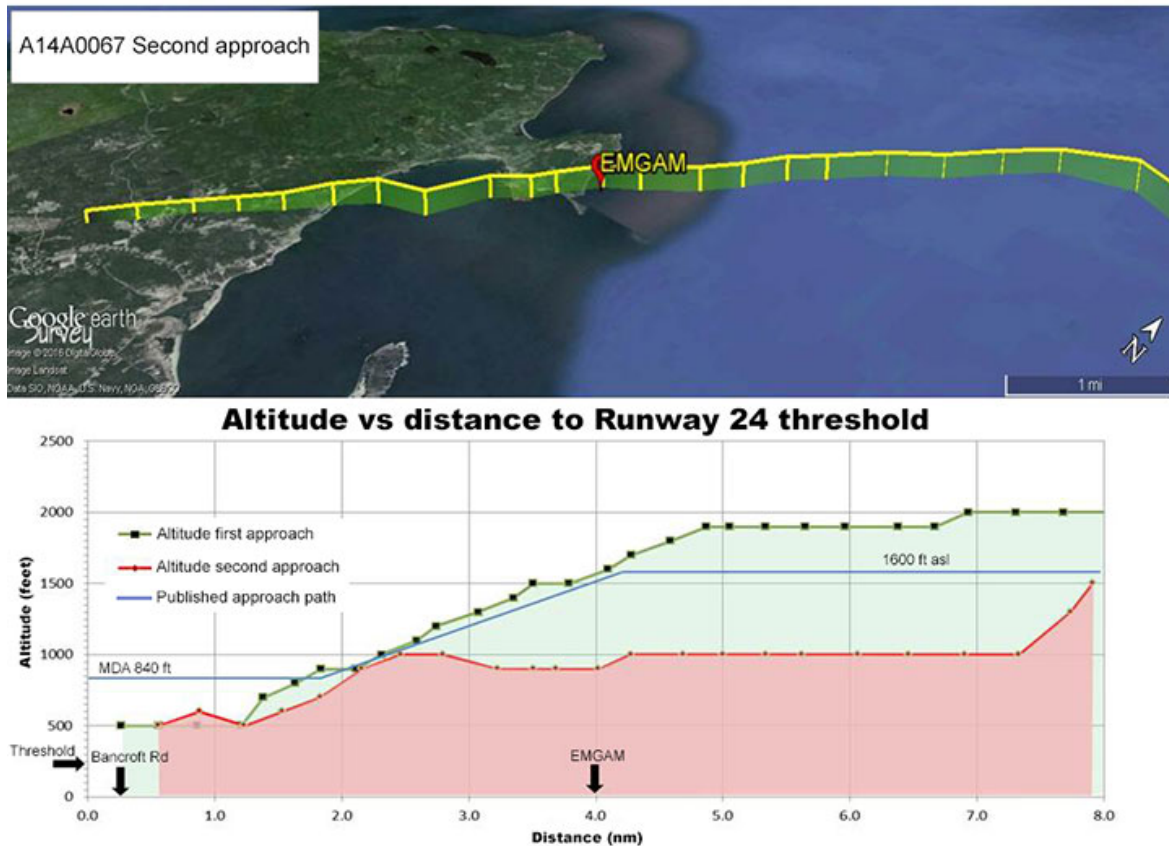
Figure 1. Altitude vs distance, first and second approach (Source: GoogleEarth, with TSB annotations)

The aircraft began its approach from 1900 feet asl, 4.87 nm from the threshold. The aircraft continued on a constant descent until it was at 500 feet asl, at 1.2 nm from the threshold. The aircraft’s ground speed was 90 knots. At this ground speed, the descent rate would have been approximately 470 fpm. This rate of descent is consistent with what the CAP identifies for a constant descent angle for a GPS approach.
