**AVIATION INVESTIGATION REPORT
A14P0132**

**STALL AT TAKEOFF AND COLLISION WITH WATER
CONAIR GROUP INC. (DBA CONAIR)
AIR TRACTOR AT-802A FIRE BOSS AMPHIBIAN, C-GXNX
CHANTSLAR LAKE, BRITISH COLUMBIA
14 AUGUST 2014**

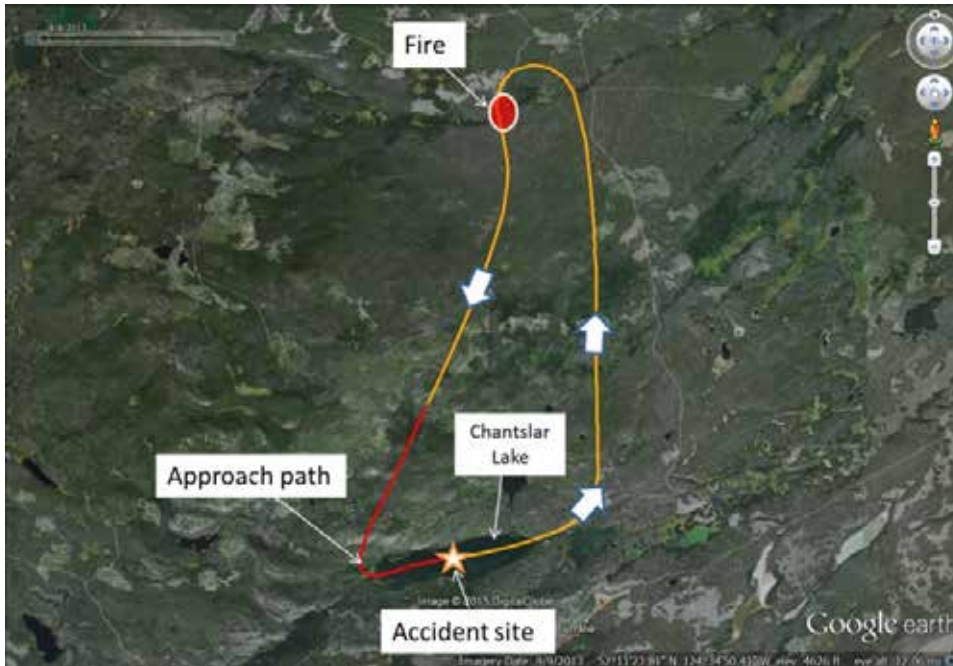
Figure 1. Circuit and accident site (Source: Google Earth, with TSB annotations)

Global positioning system (GPS) data showed that T685 touched down for the accident scooping run at 0.25 nm from the southwest end of the lake (Figure 1) and maintained an average heading of 076° magnetic (M) for 0.75 nm. The ground speed gradually increased and remained steady at 71 knots for about 4 seconds before the aircraft decelerated and came to a near stop 2 seconds later. The accident occurred halfway down the lake, after the aircraft had been on the water for approximately 44 seconds.

Moments after liftoff, control of the aircraft was lost as the aircraft rolled to the right, and the right-hand wing tip contacted the water. The aircraft then yawed further to the right, rolled to the left, and pitched down before the front outboard side of the left float contacted the water again. The aircraft remained right-side-up and came to rest on a northerly heading.

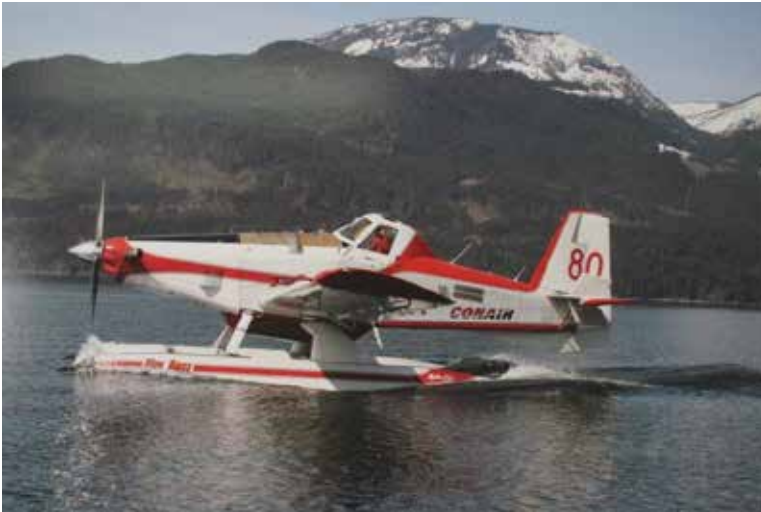
Photo 1. Fire Boss (Source: Conair)

- the Fire Boss conversion (Photo 1), which included the installation of the amphibious floats and stall performance enhancements (known as a stall improvement array); and
- a power upgrade, which increased the maximum takeoff power to 1600 SHP.

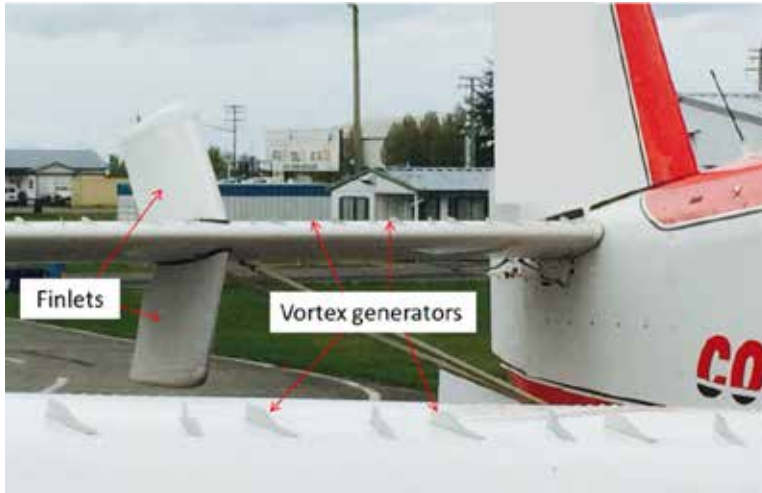
Photo 2. Finlets and vortex generators (Source: Conair)

Additional airframe modifications were found to be necessary to return the aircraft flight performance characteristics to regulatory standards in the restricted category. These modifications, collectively known as a stall improvement array, principally included the installation of finlets on the top and bottom of the horizontal stabilizers, a ventral fin under the empennage, and vortex generators on the wings and horizontal stabilizers (Photo 2). In addition, the pitot tube was relocated further outboard and the stall warning vane was repositioned.

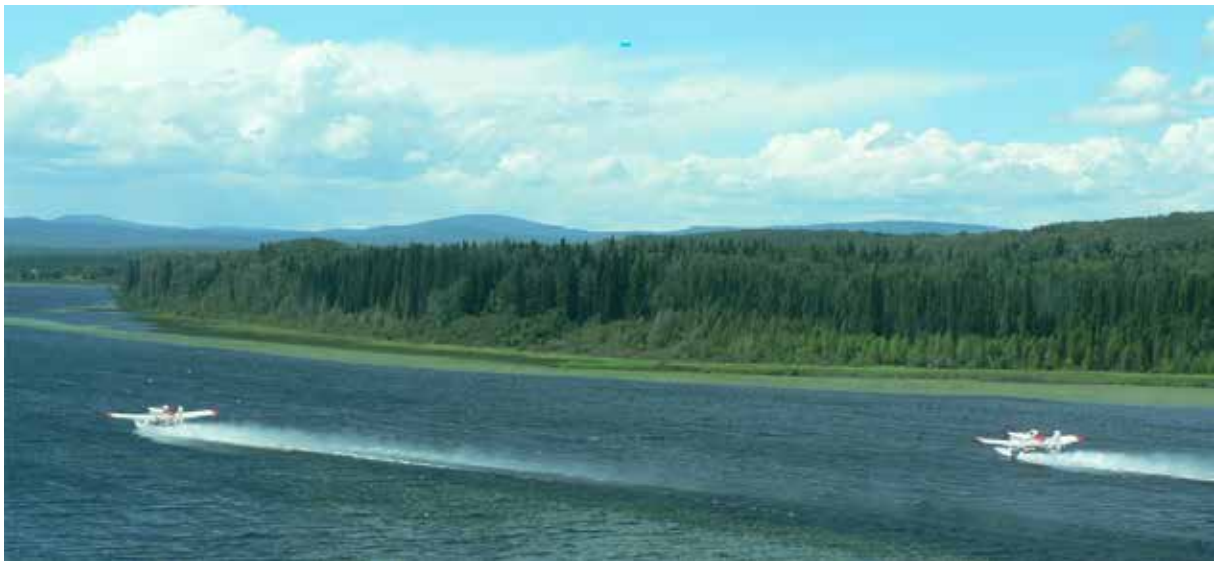
Photo 3. Fire Boss echelon-formation scooping operation

When firefighting with the Fire Boss, Conair normally operates in teams of 4 aircraft, in a loose line-astern arrangement. During scooping operations, the pilots adjust their relative positions to suit local conditions such as the lake dimensions, wind, and terrain in relation to the target fire. Scooping in an echelon or upside-down “V” formation, as they were on the accident flight, is common (Photo 3). At the fire (drop site), the aircraft are at minimum 10 seconds apart, normally line astern.

In the second scenario, wing-tip vortices may have been encountered. This phenomenon is always present somewhere behind an aircraft in flight and is well known to Fire Boss pilots, who usually operate in groups. Wing-tip vortices are unpredictable, and the light and variable wind on the lake produced conditions that were ideal for vortices to linger over the water. Given T685's position behind and to the right of the lead aircraft, it is not likely that T685 encountered the lead aircraft's left wing-tip vortex. However, it is possible that T685 overtook the lead aircraft's right wing-tip vortex at, or beyond, the lead aircraft's liftoff point. T685's right-hand wing may have encountered the down-flowing side, or the left-hand wing may have encountered the up-flowing side of the counter-clockwise-rotating vortex generated by the lead aircraft's right-hand wing, resulting in a roll to the right leading, in turn, to the right-hand wingtip making contact with the water.
