**AVIATION INVESTIGATION REPORT
A14O0165**

**LOSS OF CONTROL
EXPRESSJET AIRLINES
EMBRAER EMB-145LR, N16954
LONDON, ONTARIO, 53 NM W
05 SEPTEMBER 2014**

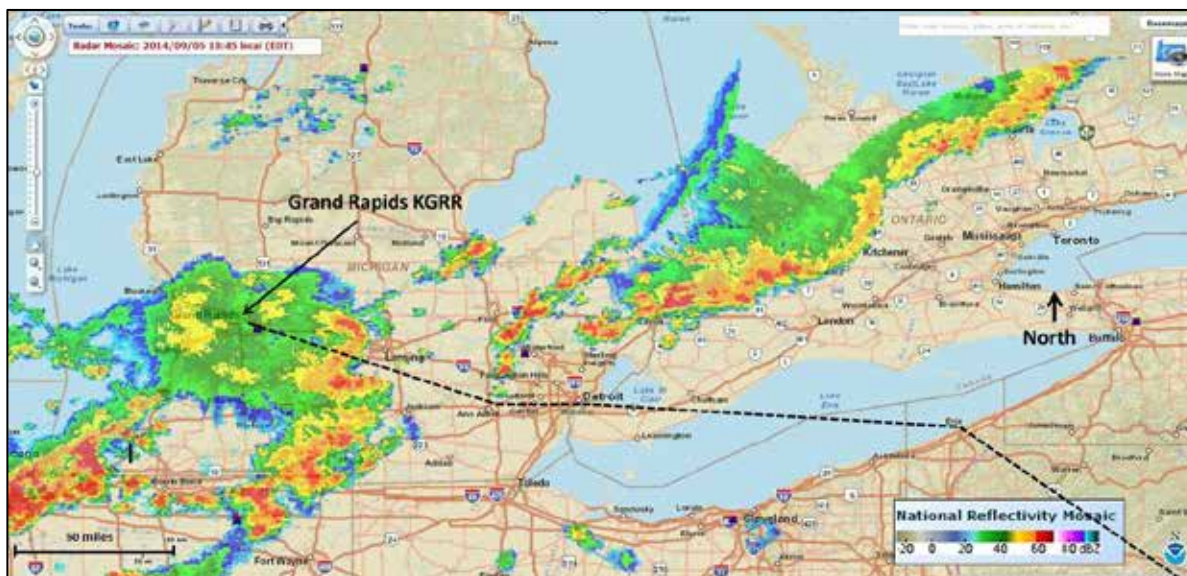
The flight crew decided that the line of thunderstorms appeared to be fragmented enough, with sufficient openings, to allow them to deviate from their planned route (Figure 1) around the weather system. At 1845, the aircraft departed and deviated 50 nautical miles (nm) north-northeast of KGRR. After its initial deviation, the aircraft turned east, paralleling a line of thunderstorms south of its position. The aircraft was in visual meteorological conditions (VMC).

Figure 1. Depiction of weather at time of departure (1845) and the aircraft's planned flight route (dashed line) (Source: National Oceanic and Atmospheric Administration [NOAA], National Weather Service, with TSB annotations)

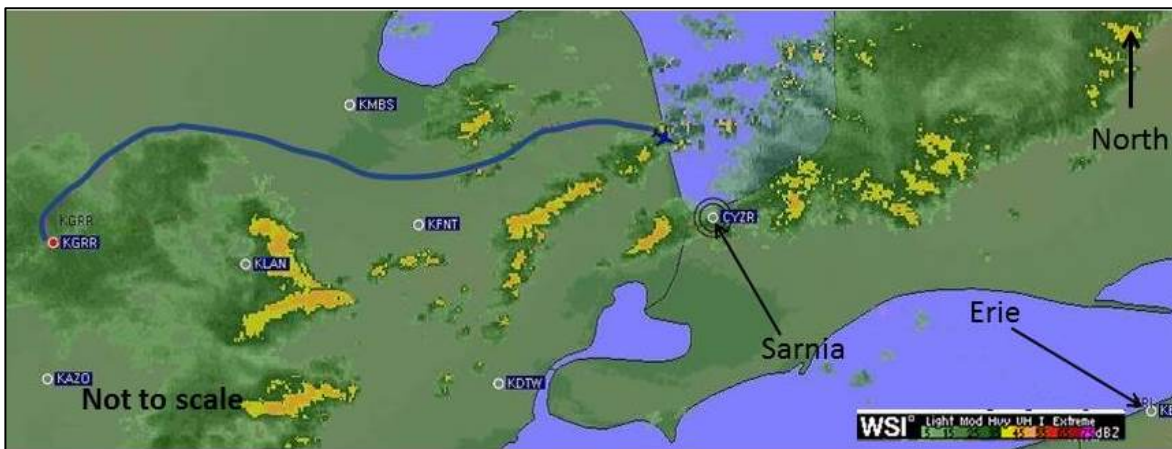
At approximately 1914, the dispatcher, viewing the company flight-following/weather software⁵ (Figure 2), suggested that the flight crew proceed directly to Chris Hadfield Airport (CYZR), Sarnia, Ontario, and then to Erie International Tom Ridge Field Airport (KERI), Erie, Pennsylvania. The crew then turned the aircraft southbound toward Sarnia.

Figure 2. Dispatcher's view of the aircraft's flight track at approximately 1915, showing the actual flight path (blue line) and weather. The weather depiction was generated by a base reflectivity radar source, using the lowest of the reflectivity angles. (Source: ExpressJet, with TSB annotations)

The dispatcher provided an opinion on which route to take, based on what he observed on his display and his assessment of the weather. According to his display (Figure 2), the route was feasible, given the aircraft position and the location of the adverse weather.

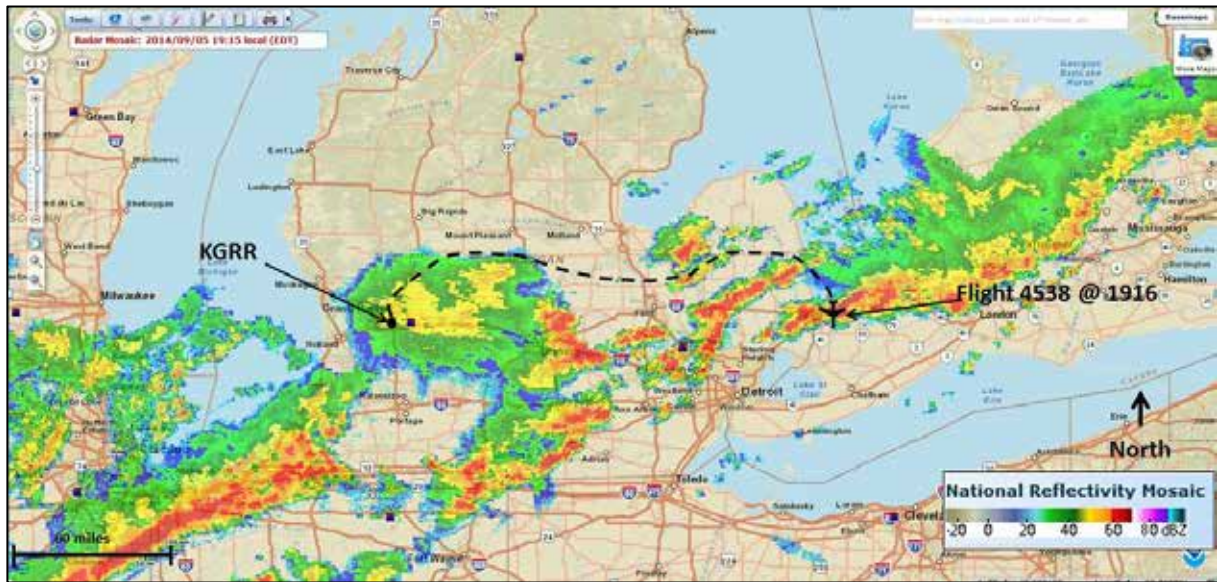
Radar data obtained after the occurrence indicated that, at 1916, the aircraft was flying in a southerly direction, through a line of thunderstorms (Figure 3).

Figure 3. Flight path (dashed line), weather, and aircraft location at 1916. The weather depiction was generated by a composite reflectivity radar source, using the maximum reflectivity from all of the multiple elevation angles. (Source: National Oceanic and Atmospheric Administration [NOAA], National Weather Service, with TSB annotations)

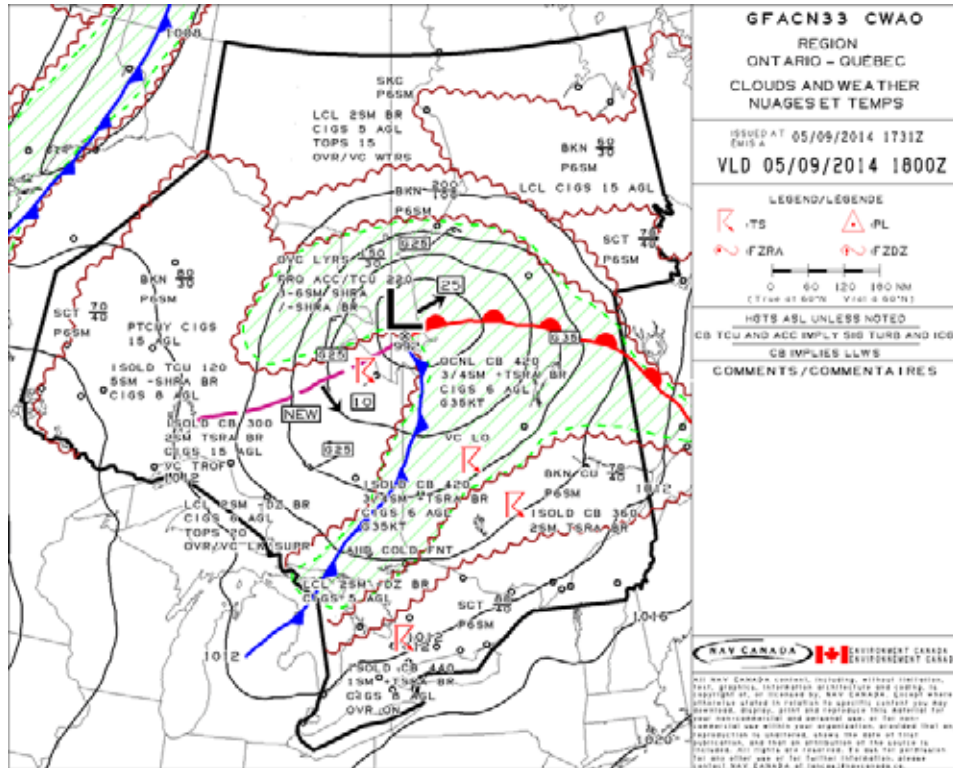
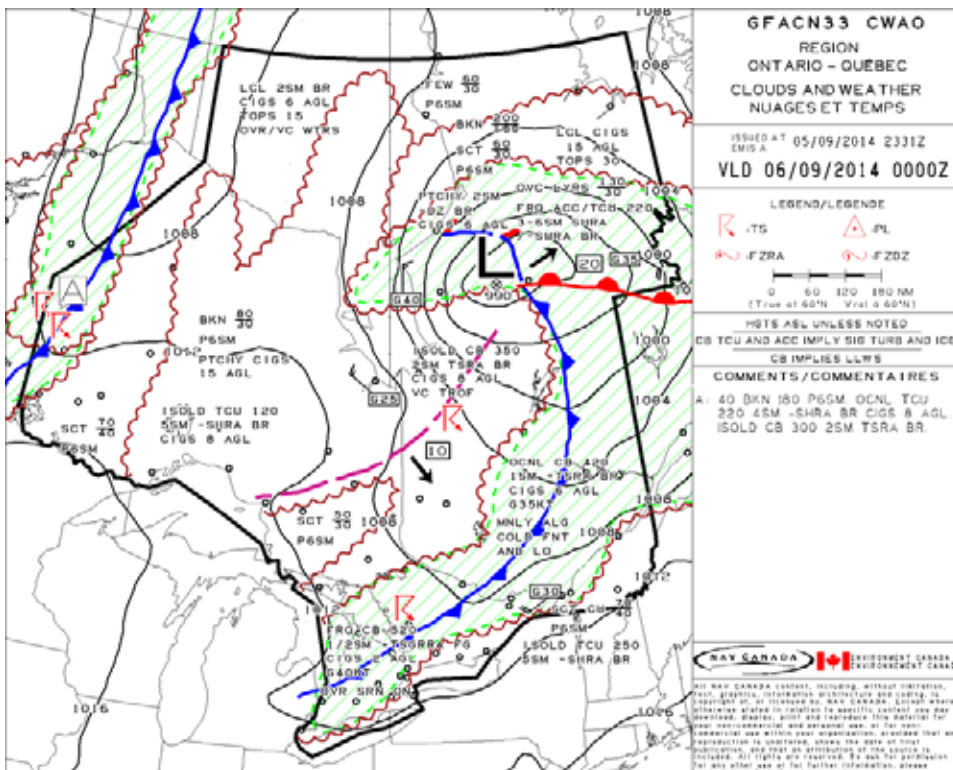
Appendix A – Graphical area forecasts

A line of thunderstorms, associated with a cold front, progressed from west to east through southern Ontario during the afternoon and evening on the day of the occurrence. The graphical area forecasts (GFA) covering southern Ontario (GFACN33) issued for the occurrence day (Appendix A) indicated potential for occasional widespread thunderstorms, with tops of 42 000 to 44 000 feet above sea level (asl) at 1400 (1800Z). The GFACN33 issued at 2000 (0000Z) forecasted the following weather along the cold front: frequent cumulonimbus clouds with tops of 52 000 feet asl, heavy thunderstorms, rain, and hail, with winds gusting to 40 knots.
