**AVIATION INVESTIGATION REPORT  
A15C0005**

**COLLISION WITH TERRAIN  
AIRSPAN HELICOPTERS LTD.  
EUROCOPTER AS350 B2 (HELICOPTER)  
C-GJPW  
KEY LAKE, SASKATCHEWAN, 11 NM SE  
21 JANUARY 2015**

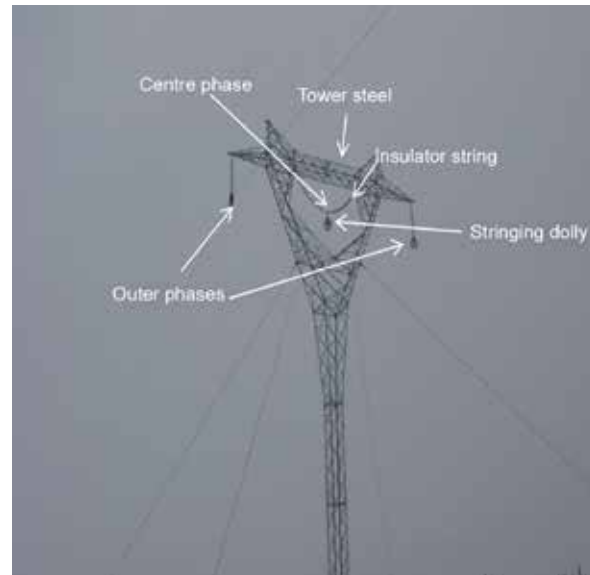
Figure 1. The steel hydro tower involved in the occurrence

An inspection of the occurrence tower structure did not reveal any deformation around the area where the needle would contact the tower during stringing. An inspection of the previous tower found markings and paint transfer comparable to that on the occurrence tower.

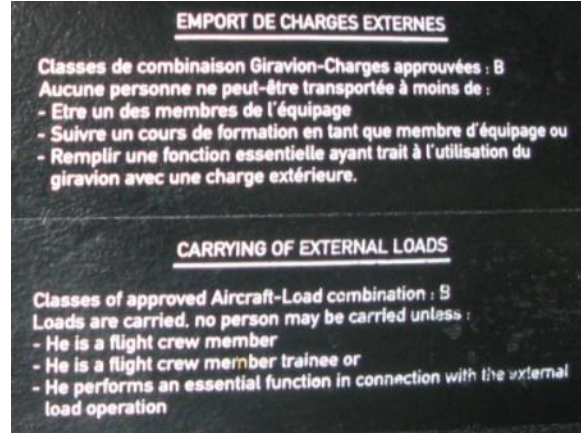
Photo 1. External loads placard

The AS350-series helicopter is approved for Class B external load operations in accordance with the Eurocopter Flight Manual AS350 B2 Supplement.<sup>8</sup> A placard was installed in the cockpit to identify the class of approved load combination as Class B (Photo 1).

The helicopter was conducting Class C aerial work at the time of the accident; however, it was approved for Class B aerial operations only. A statement in the *Rotorcraft Flight Manual Supplement* that the cargo hook was approved for both Class B and C helicopter load operations was likely misinterpreted to suggest that the helicopter was approved for Class C operations as well. The Supplemental Type Certificate (STC) does not have any provisions to recertify the AS350 B2 to conduct Class C external loads. Specific approval for Class C loads need to be included in the flight manual or STC supplement before Class C operations are conducted. If approved flight manual supplements are not complete and clear, there is a risk that operators will unknowingly conduct operations that are not approved.

On 28 April 2015, the TSB forwarded to Transport Canada Aviation Safety Advisory A15C0005-D1-A1: AS350 Series Helicopter – External Load Certification, which states:

The AS350 series of helicopter can be certified for class “B” external load operations under the authority of an STC. However, although this helicopter series is not certified for class “C” external load operations, discussions with TC and industry operators indicate that the AS 350 series of helicopters are currently being used for class “C” external load operations.

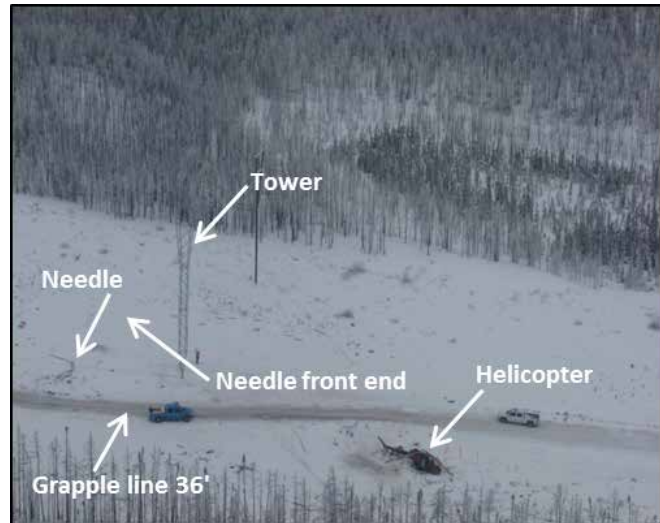
Figure 5. Accident site

The terrain at the accident site was uneven and consisted of recently cut trees, deadwood, and large boulders (Figure 5). The helicopter landed on top of a large boulder in a level attitude with very little forward speed, and it did not leave a wreckage trail. Most of the impact forces were absorbed by the aft portion of the cabin, where the helicopter had made contact with the boulder, causing the cabin floor to collapse. The remainder of the cabin and the cockpit sections were suspended in the air. There was no deformation to the pilot seat.

After the collision, the helicopter remained in an upright position facing northeast. The left skid was in contact with the ground, whereas the right skid was found collapsed. The investigation determined that the engine was producing power at the time of the impact, and there were no signs of pre-impact anomalies.

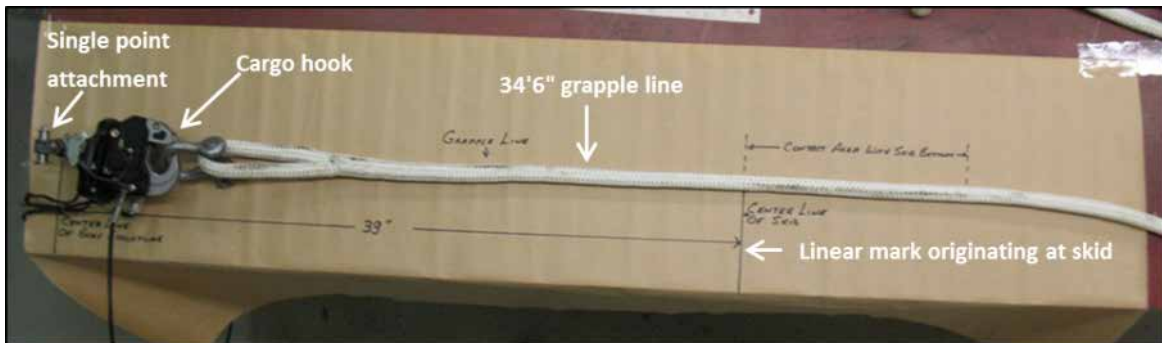
Figure 6. Cargo hook and grapple line

The needle and grapple line were found on the opposite side of the occurrence tower from the location where the helicopter had come to rest. The grapple line was no longer connected to the helicopter's cargo hook. The lead section of the needle was bent, and the horn was broken off. The feeder cable was still attached to the needle, and it was determined that the feeder cable was fully continuous to the cable drum.

An inspection of the grapple line used during the occurrence flight revealed a linear mark originating at a distance that corresponded with the bottom of the landing gear skid (Figure 6). The mark suggested that contact had been made between the grapple line and the bottom of the landing gear skid and that the angle achieved to make contact with the skid was as high as 74°.

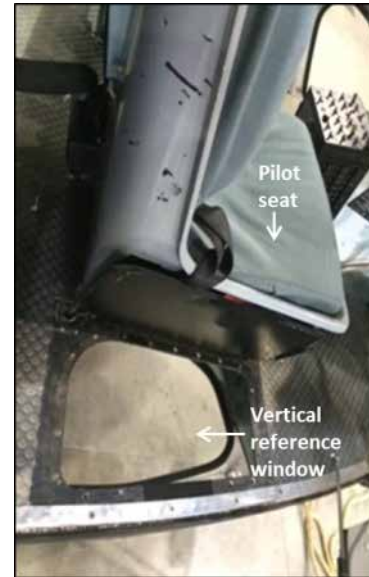
Figure 7. Vertical reference window

The helicopter was equipped with a 4-point restraint system.<sup>14</sup> The pilot wore a helmet and was restrained using the lap belt only. The pilot's helmet struck the windshield on impact, but the pilot did not sustain any head injury. The AS350 B2 has a vertical reference window in the floor that serves as a viewer window for the flight crew (Figure 7). This window is to the right of the right-hand pilot seat and has a narrow field of view when looking backward. Pilots can improve their line of sight through the window by undoing the shoulder harness and leaning forward. Although the pilot sustained serious injuries to his back, he was able to evacuate the helicopter without assistance. An inspection of the pilot seat determined that it did not collapse or exhibit any signs of deformation.

In this occurrence, most of the helicopter impact forces were absorbed at the rear of the cabin, owing to the fact that the helicopter landed on a large boulder. This likely significantly reduced the downward forces on the pilot, who was not wearing shoulder restraints. Despite this reduction of downward forces, the pilot's helmet struck the windshield during the impact sequence. If pilots do not use available shoulder restraints, there is an increased risk of injury in the event of an accident.

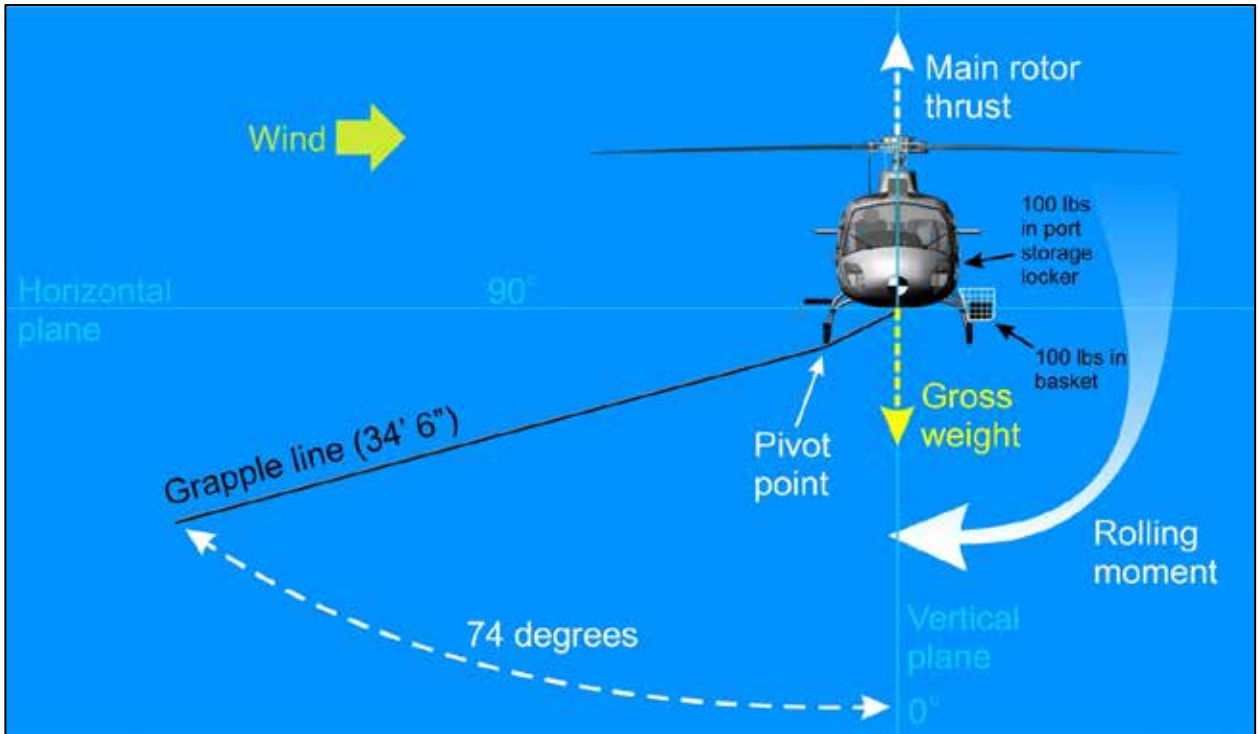
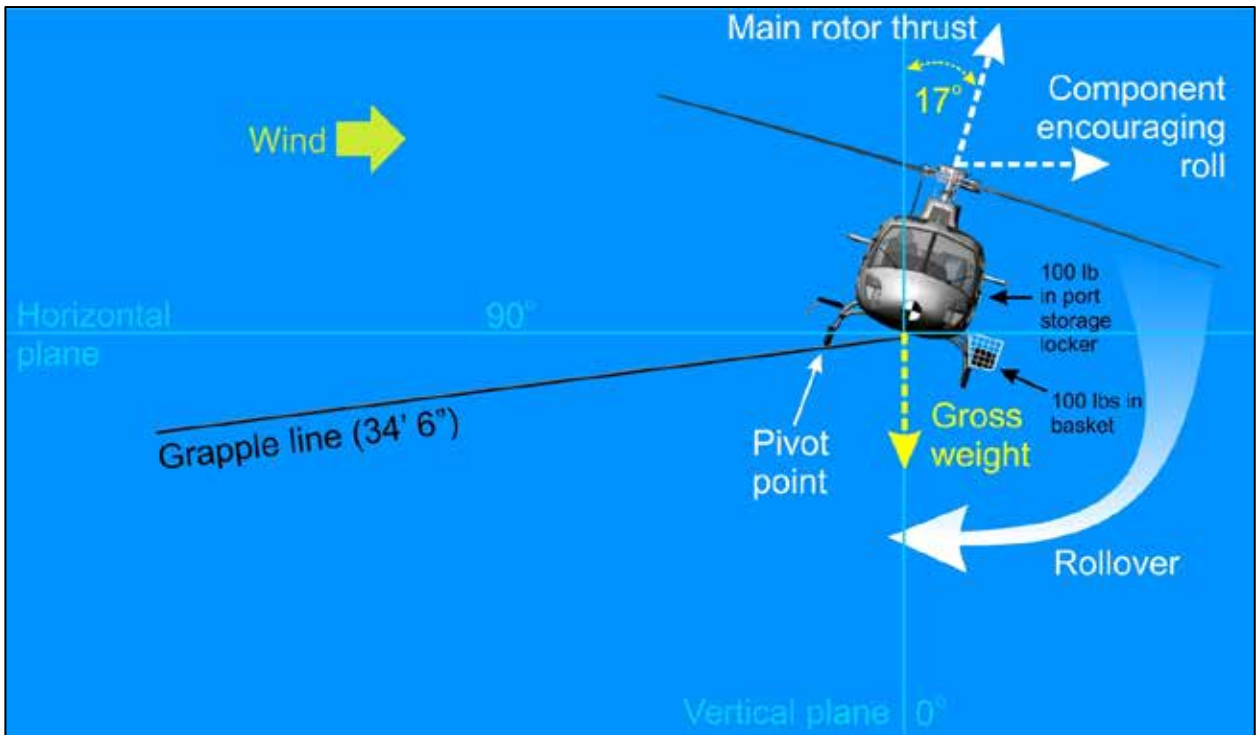
Appendix C – Dynamic rollover

Dynamic rollover can be exacerbated if there is a lateral centre of gravity on the same side as the direction of roll (e.g., dynamic rollover to the left with a left lateral centre of gravity). A crosswind in the same direction as the rollover may also increase the roll rate. In this occurrence, the helicopter rolled to the left, it had a left lateral centre of gravity, and there was a crosswind from the right side of the aircraft (Appendix C).

Dynamic rollover can occur at any phase of flight when external forces acting on the helicopter create a pivot around a point other than the centre of gravity, such as a snagged skid on take-off or, as in this occurrence, a cable being dragged (Appendix C). The 100 pounds of counterweight in the left side basket and 100 pounds in the left baggage compartment extended the lateral centre of gravity to the left. This additional weight of ballast and a right-hand crosswind would exacerbate the dynamic rollover. During the investigation, it was determined that the abrupt stop and skid contact with the grapple line, combined with the additional weight of ballast and the crosswind from the right, contributed to the onset of the dynamic rollover.
