**AVIATION INVESTIGATION REPORT
A15O0031**

**IN-FLIGHT BREAKUP
PIPER PA-32RT-300T, C-GDWA
FRENCH RIVER PROVINCIAL PARK, ONTARIO
17 MARCH 2015**

In-flight breakup

Piper PA-32RT-300T, C-GDWA

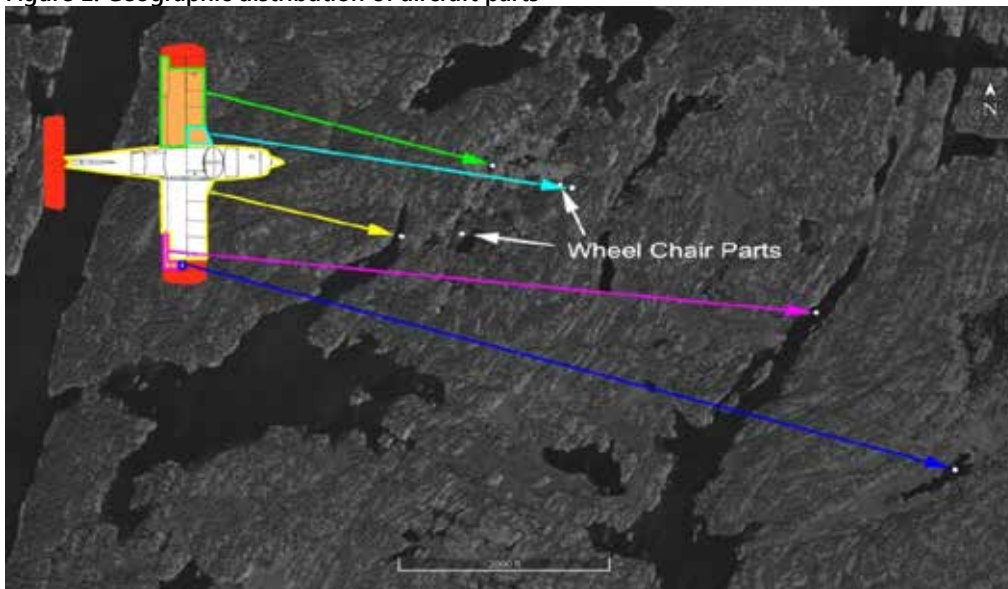
Figure 1. Geographic distribution of aircraft parts

Table 1 lists the aircraft parts and baggage items that were recovered, along with their respective distances and bearings from the main wreckage, and Figure 1 shows their distribution.

Aircraft pieces that the investigators did not locate included the 2 fiberglass wing tips, most of the outboard wing skins, and the horizontal stabilator⁸ (Appendix A).

Both wings' spars had failed as a result of instantaneous positive *g*-overload fractures; there was no indication of pre-existing fatigue or mechanical defect.

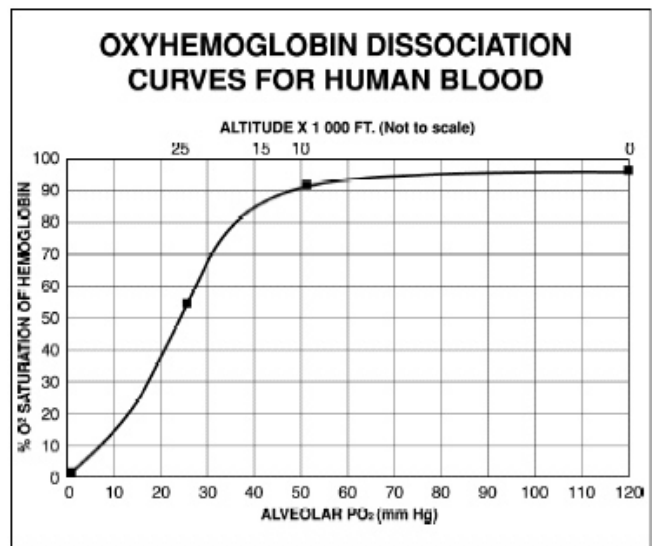
Figure 2. Oxyhemoglobin dissociation curves for human blood (Source: Transport Canada, TP 13312, *Handbook for Civil Aviation Medical Examiners*²⁰)

The oxyhemoglobin dissociation curve (Figure 2) reveals that the saturation of hemoglobin with oxygen drops significantly and rapidly above 10 000 feet (3000 metres) asl. Individuals who have a reduced PaO₂ even when on the ground due to illness and are then exposed to a further reduction in aircraft cabin pressure at altitude may be brought to the steep part of the oxyhemoglobin dissociation curve. As a result, they may have very low hemoglobin oxygen saturation, which would cause them to experience distress and exacerbation of their underlying illness.²¹

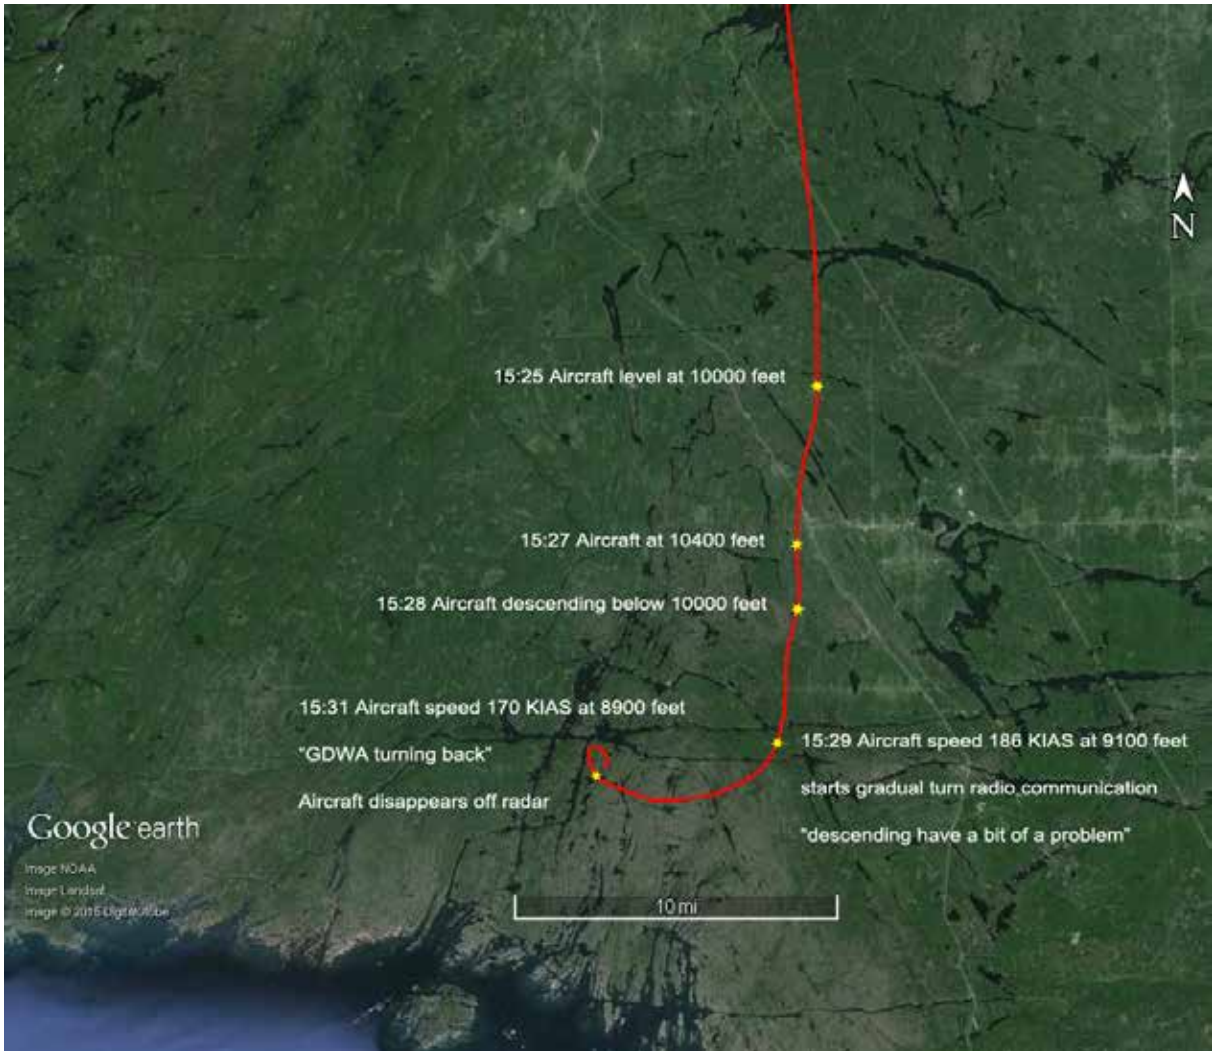
Appendix B – Flight path

The aircraft was not equipped with a flight data recorder or cockpit voice recorder, nor was either required by regulation. However, it was equipped with instruments capable of recording some data, such as engine performance. These, along with the remainder of the flight instruments and radios, were severely damaged by the fire, and no useful information could be recovered. The TSB Laboratory reconstructed the flight using the available radar, ATC radio communications, and weather data. The radar information for this area came from radars located in North Bay, Ontario, east of the accident site. Based on all available data, the information was compiled and a final flight path was reconstructed (Appendix B).
