Collision between OC Transpo bus and VIA passenger train: Executive summary

This summary of the Transportation Safety Board of Canada's (TSB) Railway Investigation Report R13T0192 contains a description of the accident, an overview of the analysis, findings, and safety action taken to date, as well as the five key recommendations that highlight what more needs to be done to help ensure an accident like this does not happen again.

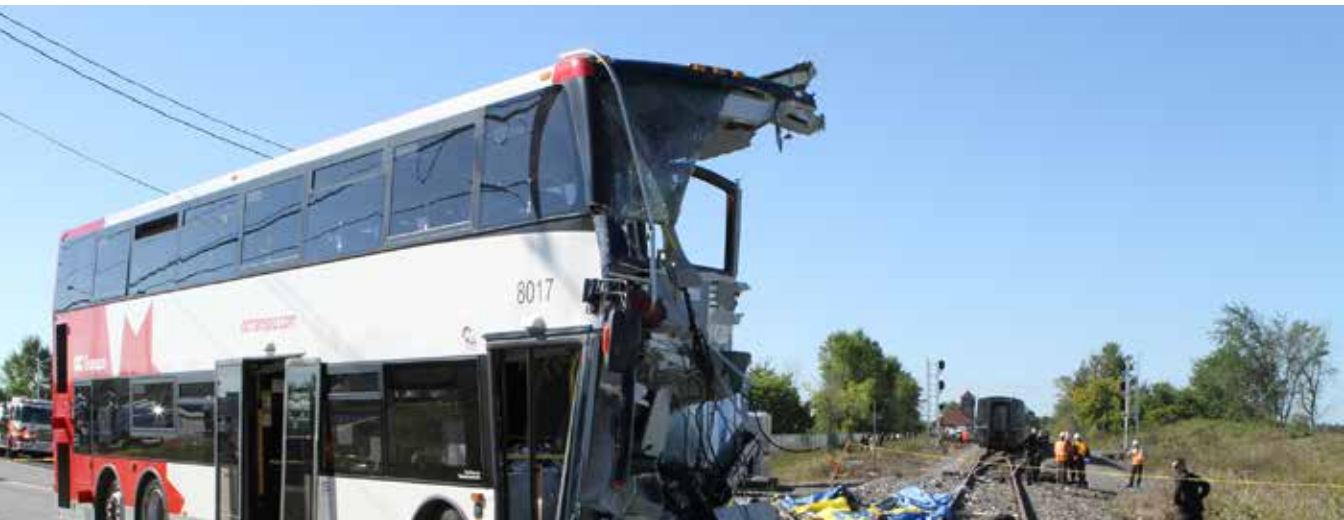
At about 0847:57, the driver was busy negotiating the left-hand curve ahead as some passengers continued conversations regarding the availability of seating on the upper deck. During this period, the driver looked upward and to the left toward the video monitor.

Meanwhile, VIA passenger train No. 51, which was heading west to Toronto, was approaching the Woodroffe Avenue and Transitway crossings. Although the crossing flashing lights, bells and gates had been activated more than 30 seconds earlier, the bells were not audible within the bus, and the driver's view of the gates and flashing lights was obstructed by trees, shrubs, foliage, Transitway signage, and the front corner pillars of the bus.

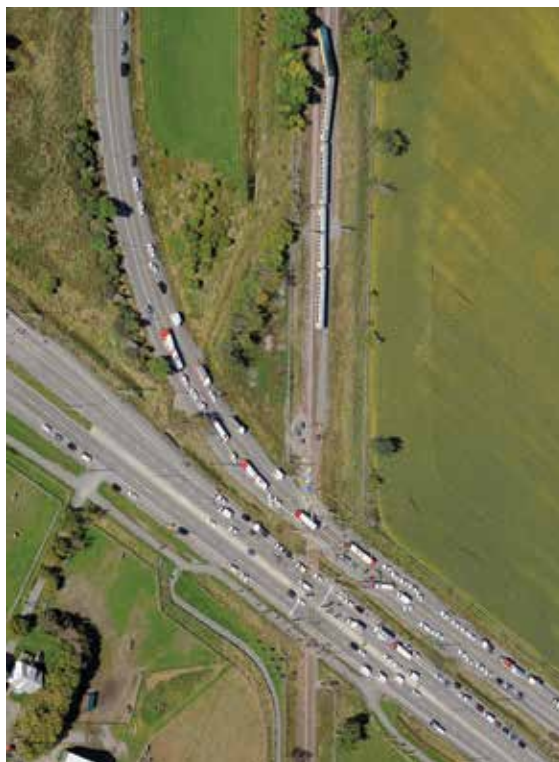
Source: Ottawa Police Service

As a result of the collision, the bus was extensively damaged. The driver and five passengers sustained fatal injuries, nine other passengers were seriously injured, and about 25 passengers incurred minor injuries. Although the train derailed, none of the VIA crew or passengers were injured.

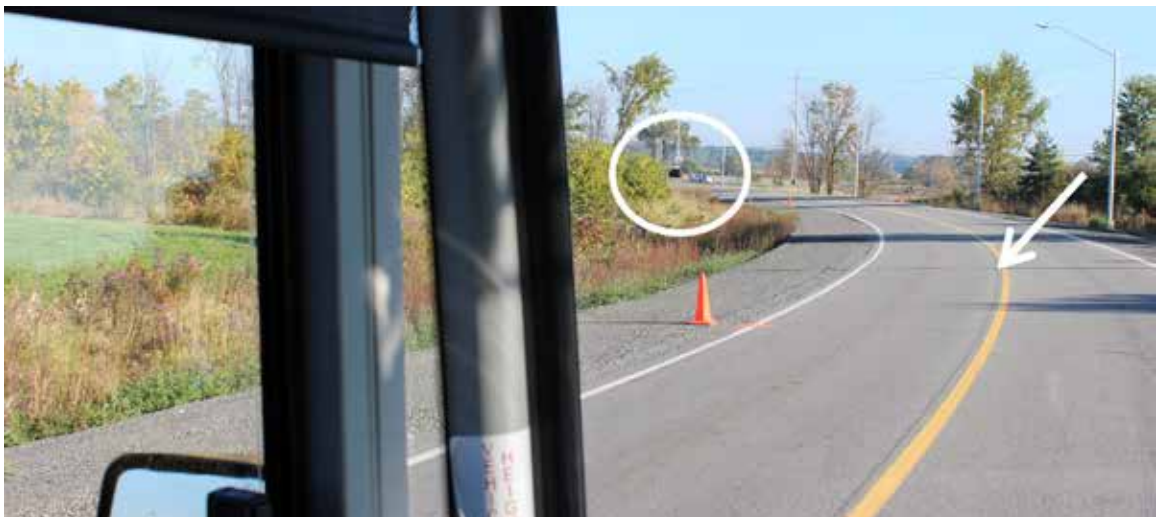
Moreover, studies measuring driver eye movements show that, when negotiating a curve, drivers tend to look in the direction that the vehicle is turning. Visually, they rely on a “tangent point” on the inside of the curve, and they tend to make only anticipatory glances toward the “occlusion point,” or the nearest point where the view of the road ahead is blocked. In this occurrence, this was an area that was obstructed by trees, shrubs, foliage, and Transitway signage, as well as by the frame of the bus itself.

View of the approach to the crossing on the Transitway. The arrow identifies the tangent point of the curve. The circle identifies the occlusion point toward which drivers would make anticipatory glances. Note the large sign in the occlusion point.

The City of Ottawa has since improved driver sightlines in the vicinity of the Transitway crossing by trimming or removing trees, shrubs and foliage. Signage has also been enhanced—including by the addition of an advance warning sign with a light that continuously flashes—and the posted speed limit in both directions approaching the crossing has been reduced to 50 km/h.

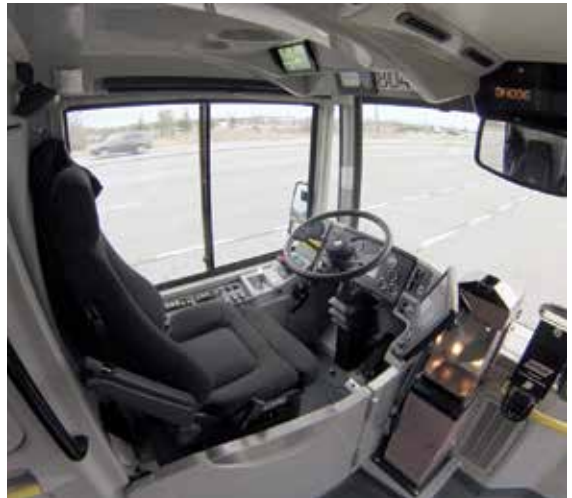
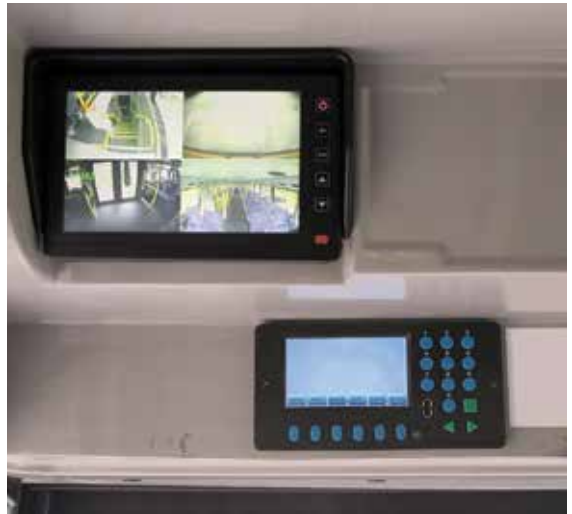
To monitor the video screen above and to the left of the driver's workstation, a driver has to periodically glance upward at a significant viewing angle. This task is made more difficult by the small size of the displayed images, likely resulting in prolonged glances away from the roadway ahead.

OC Transpo required drivers to monitor this screen at station stops and while in service, and to announce that no standing was permitted on the upper deck if they saw passengers standing. However, some passengers would remain moving or standing on the upper deck after the bus was in motion as they continued to look for a seat. Therefore, a driver would need to periodically glance at the screen while the bus was in motion to monitor the small image of the upper deck.

With respect to the risk of driver distraction, the City of Ottawa contracted consultants to review driver workload and other ergonomic aspects of bus operation. OC Transpo and the bus manufacturer are also exploring possible changes to the use and operation of video monitors on double-decker buses, and warning labels have been installed stating that standing is not permitted on the upper deck.

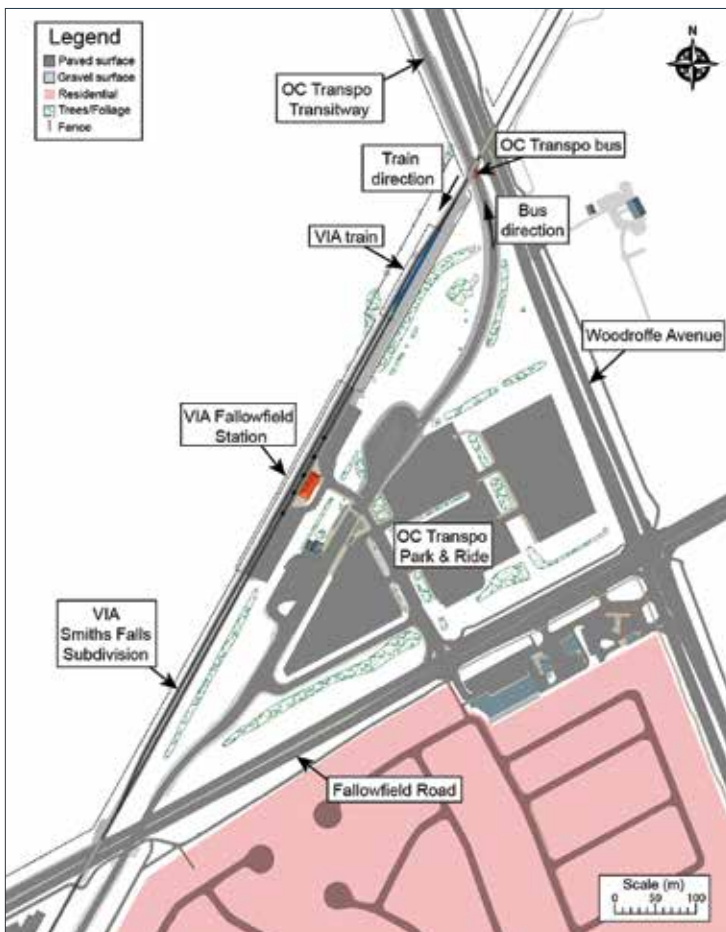
Although the Transitway was built in accordance with established standards, its configuration, with a significant left-hand curve and relatively short approach to the crossing, proved to be problematic. For a bus travelling at the posted speed limit of 60 km/h, the recommended stopping sight distance (SSD) was 130 m (426.5 feet). At the time of the accident, the flashing lights and gates—even though they were activated before the bus left OC Transpo's

Fallowfield Station—were obstructed by trees, shrubs, foliage, and Transitway signage. This reduced a northbound driver's SSD to 122.5 m (402 feet).

The new Transport Canada *Grade Crossings Regulations* (November 2014) now require that an approach with similarly reduced SSD be equipped with an active advance warning sign with lights that are interconnected with the crossing signals, to provide the driver advance warning of the train's approach.

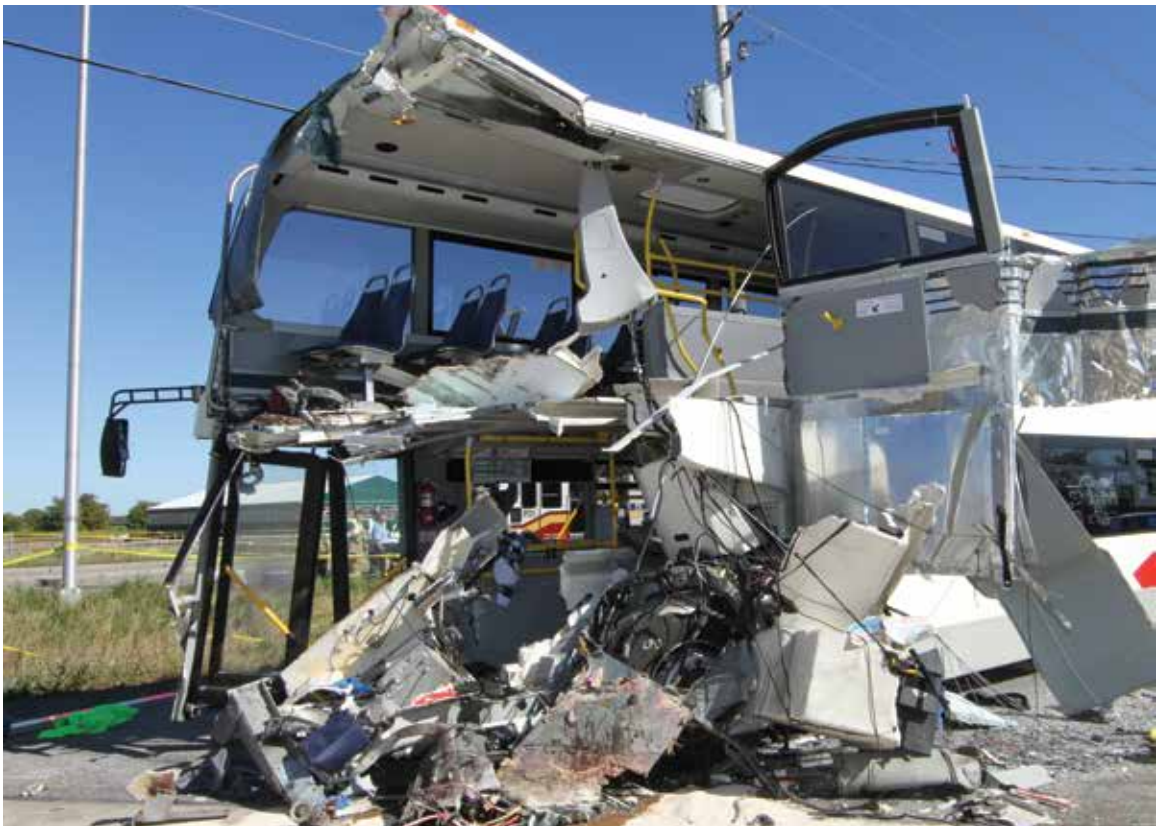
In this occurrence, the bus had no front bumper, and its front-end frame was not designed to provide impact protection. Unlike automobiles, which must meet stringent crashworthy performance testing requirements, the CMVSS contain no requirements for frontal impact, side impact, rollover, or crush protection for buses in this category. Although not required by regulation, a more robust front structure and crash energy management design might have reduced the damage to the bus and prevented the loss of a protective shell for the occupants.
