**RAILWAY INVESTIGATION REPORT
R14Q0047**

CROSSING COLLISION

**A VEHICLE AND
VIA RAIL CANADA INC.
PASSENGER TRAIN NUMBER P60321-05
MILE 120.18, ST-MAURICE SUBDIVISION
PARENT, QUEBEC
05 DECEMBER 2014**

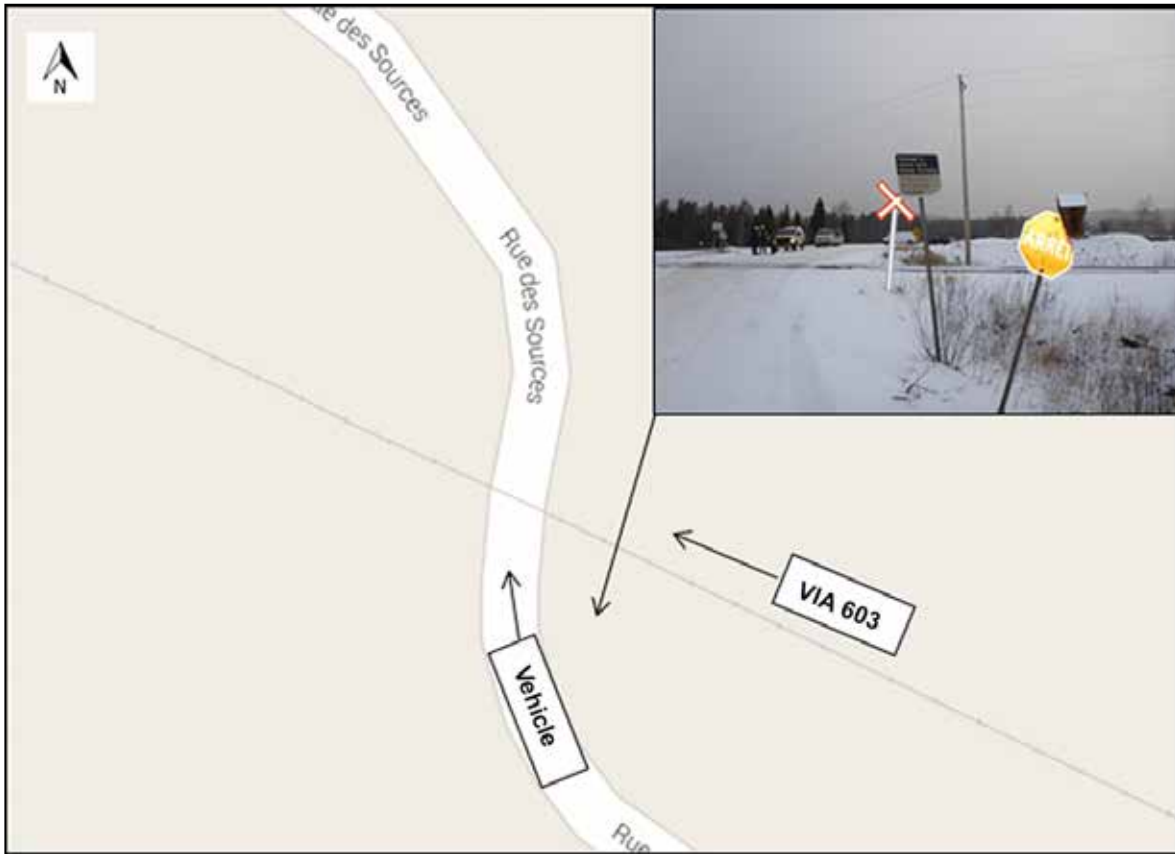
Figure 2. Path of vehicle in relation to the des Sources Street crossing and arrangement of road signs

The cross buck and stop sign on the south side of the track were visible to northbound vehicles from about 100 feet.³ The stop sign was bent and leaning and one of the cross buck arms was hidden by the private crossing sign (Figure 2).

The road signs were not maintained as per *Manual of Uniform Traffic Control Devices for Canada* (MUTCDC) standards. In addition, since the road surface was gravel, there were no markings to serve as a stop line. Such factors compromise driver compliance with signs at crossings. If road signs at a crossing are poorly maintained, vehicle driver compliance with crossing signs may be affected, which increases the risk of vehicle-train collisions.

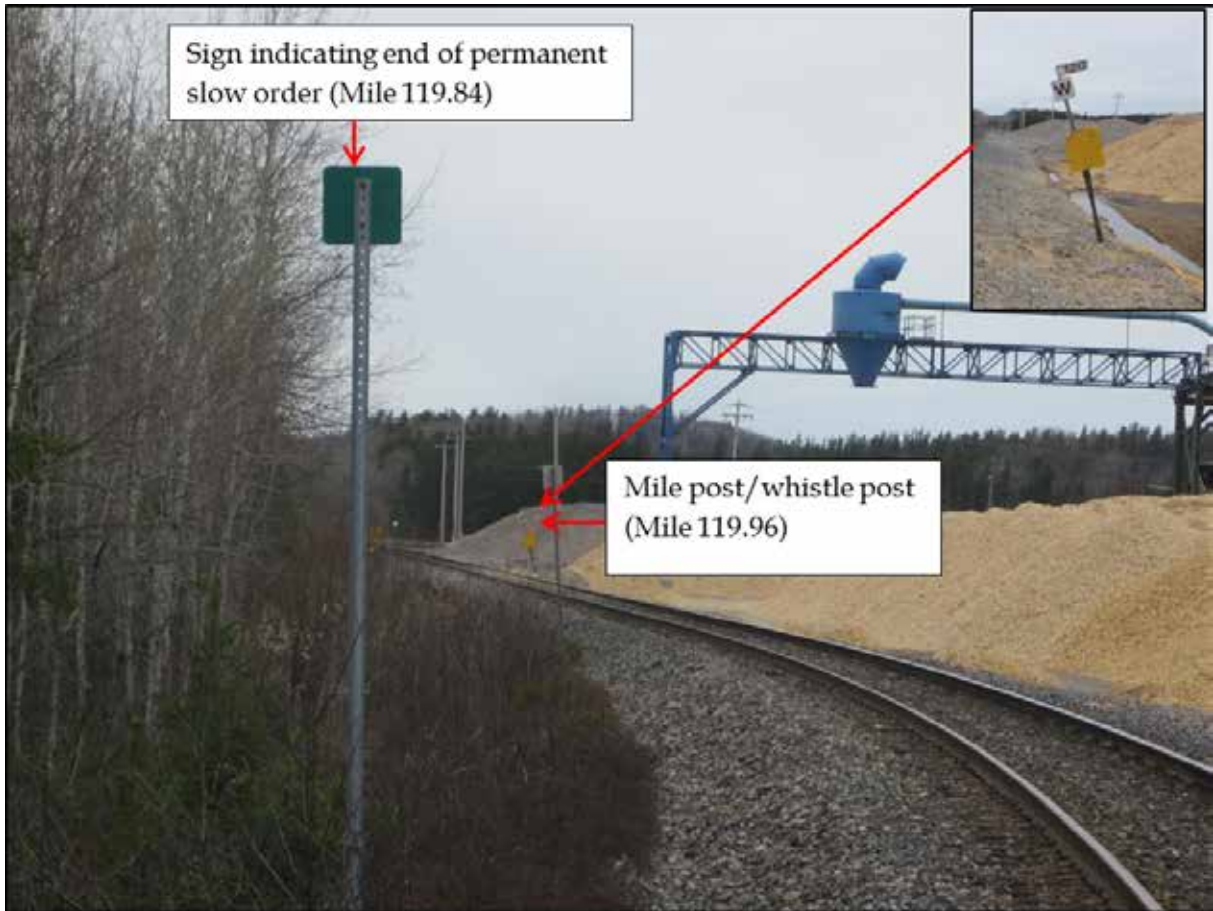
Photo 1. Westward view of sign indicating the end of the permanent slow order in relation to the whistle post (Source: VIA)

In this accident, the sign indicating the end of the permanent slow order (green square) was at Mile 119.84 and the whistle post, along with the Mile 120 sign, was positioned at Mile 119.96. The Mile 120 sign was somewhat bent and at an angle (Photo 1).

Given that the mile post and the sign indicating the end of the slow order should have been located at Mile 120 and that the whistle post should have been located at Mile 119.93, the incorrect location of these signs caused confusion among the crew members with respect to the train operation. As a result, the train was travelling at 37.1 mph when its tail end reached the end of the 10 mph slow order. To ensure the safe operation of trains, rail signs should be correctly placed and visible so they can be clearly identified. Rail signs that cannot be properly identified or that are not properly located can lead to confusion among train crew members and/or to an inconsistent application of the rules, which increases operating risks, especially in the vicinity of crossings.

Upon completion of the internal investigation into this accident, VIA Rail Canada Inc. (VIA) managers went to the site and noted that the signs were not properly located. VIA communicated this information to the track owner, Canadian National (CN).

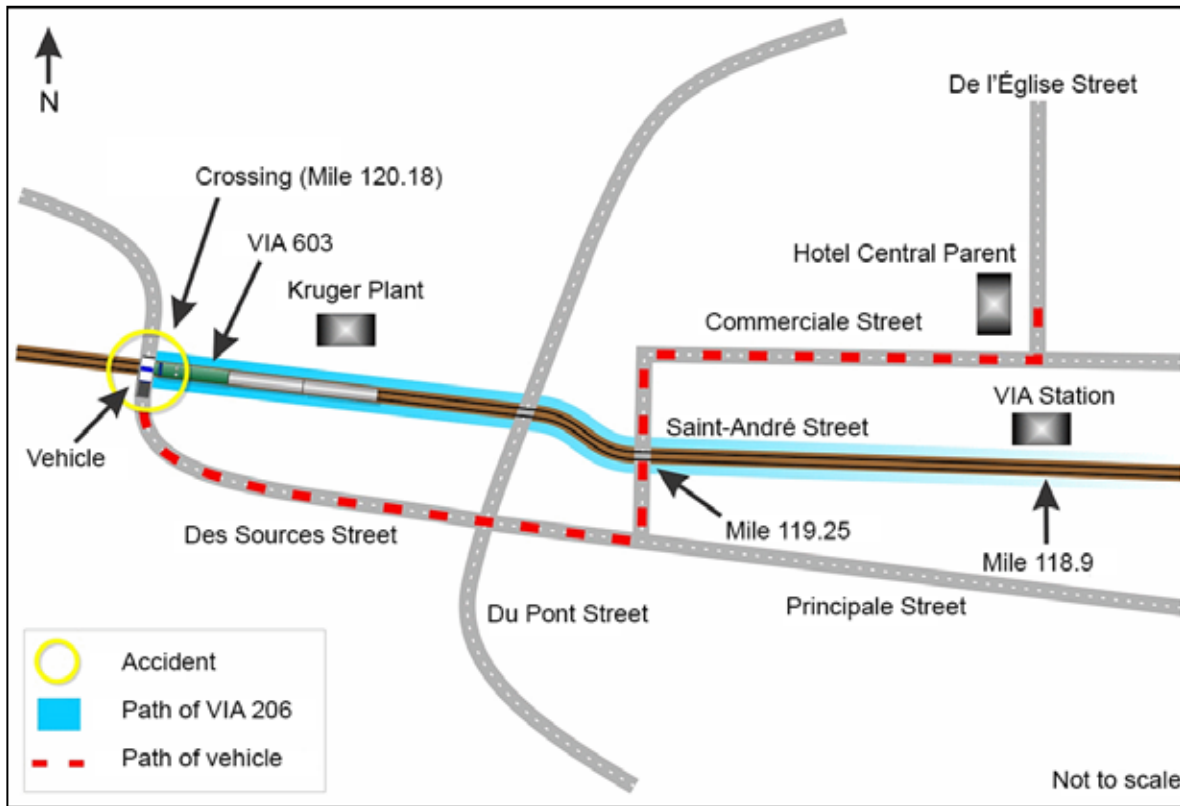
Figure 3. Path of VIA 603 and of the vehicle

Upon leaving the restaurant, only the driver buckled her seatbelt. The vehicle passed over the Saint-André Street crossing at Mile 119.25 and continued travelling westward (Figure 3). At the approach of the des Sources Street crossing, the vehicle slowed to 7 km/h. The front passenger would have looked to the east (right) and then told the driver that she had time to go over the crossing. The vehicle accelerated and reached a speed of 14 km/h at the time of the collision. The vehicle's windows were closed and the heating and radio were on. The driver had used this crossing about 4 times in the past, the last time being about 1 year ago.
