**RAILWAY INVESTIGATION REPORT
R14W0256**

**MAIN-TRACK DERAILMENT
CANADIAN NATIONAL RAILWAY
FREIGHT TRAIN A40541-05
MILE 74.58, MARGO SUBDIVISION
CLAIR, SASKATCHEWAN
07 OCTOBER 2014**

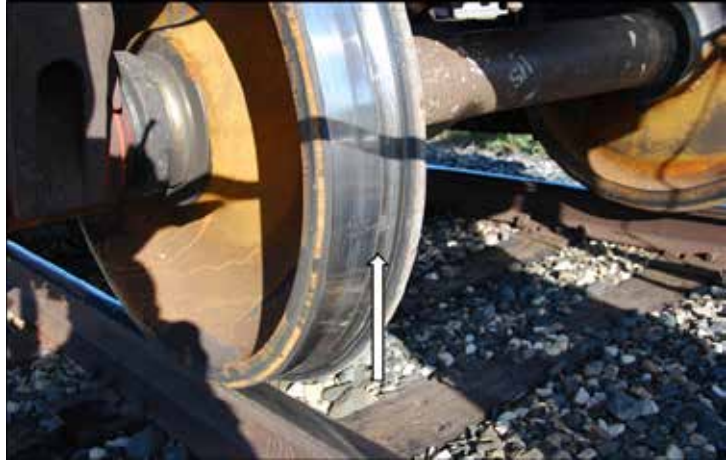
During the site examination, the wheels of the head end cars that did not derail were examined. The wheels of the 31st car, DOWX 3282, a DG tank car loaded with ethanolamine (UN 2491), exhibited impact marks on the wheel tread (Photo 2).

Photo 2. Impact mark on the wheel tread of the trailing wheel of the 31st car (DOWX 3282)

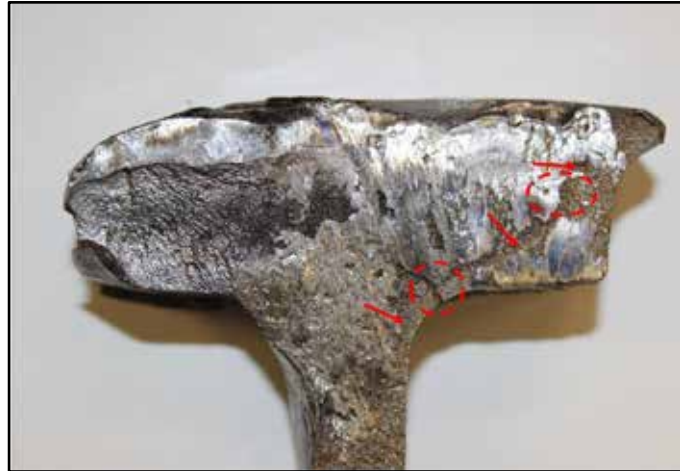
the head. The crack experienced recent growth to approximately 85% of the cross-sectional area of the rail head. The remaining rail section then failed in overstress (Photo 8).

5. Examination results indicate that the detail fracture occurred at the location where a 3.5 mm deep LSC had been detected on 18 July 2014, some 12 weeks before the occurrence.
6. Rail pieces No. 2, No. 3 and No. 4 had each fractured in overstress. These fractures likely occurred during the derailment, resulting in post-separation impact damage.
7. The gauge and field side head wear measurements showed that the rail head had been slightly deformed by compressive loading from passing rail cars.

Photo 8. West fracture face of rail piece No. 1 – (Note: Red arrows show the boundary of the detail fracture. Gauge is to the left, field to the right. Red circles indicate areas where fatigue striations were observed.)
