**RAILWAY INVESTIGATION REPORT
R15H0005**

**MAIN-TRACK DERAILMENT
CANADIAN PACIFIC RAILWAY
FREIGHT TRAIN 118-10
MILE 42.0, NIPIGON SUBDIVISION
DUBLIN, ONTARIO
13 JANUARY 2015**

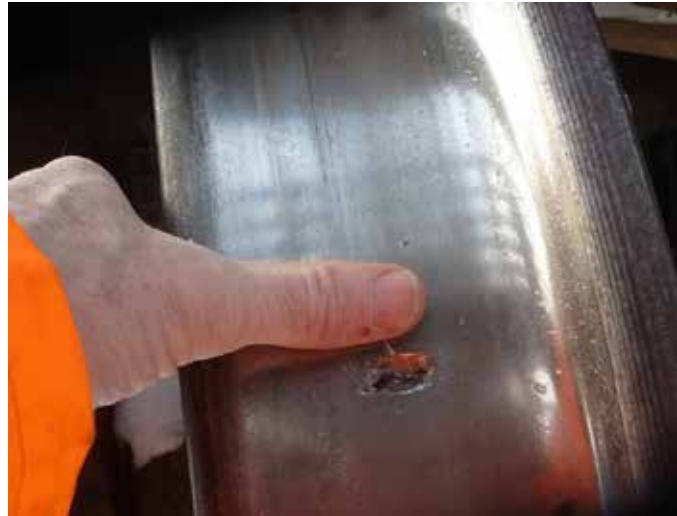
The lead locomotive came to rest at Mile 41.56 with 17 cars still attached. The first 10 cars did not derail. The R4 wheel on the 4th car from the head end, PROX 035435, exhibited damage on its tread consistent with that of a heavy rail impact against a fractured rail (Photo 1).

Photo 1. Damaged wheel surface on car PROX 035435

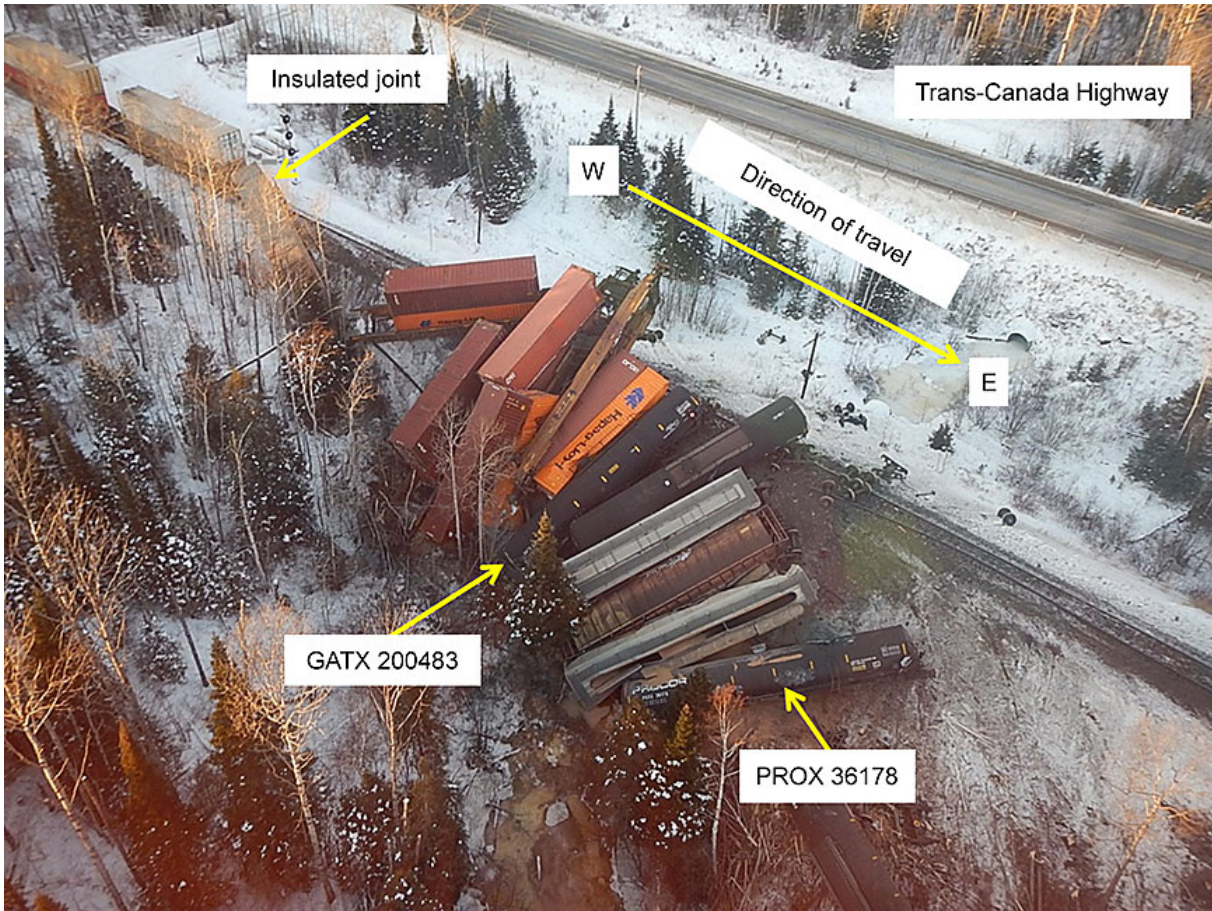
Figure 2. View of derailed cars just east of the insulated joint (Source: Canadian Pacific Railway)

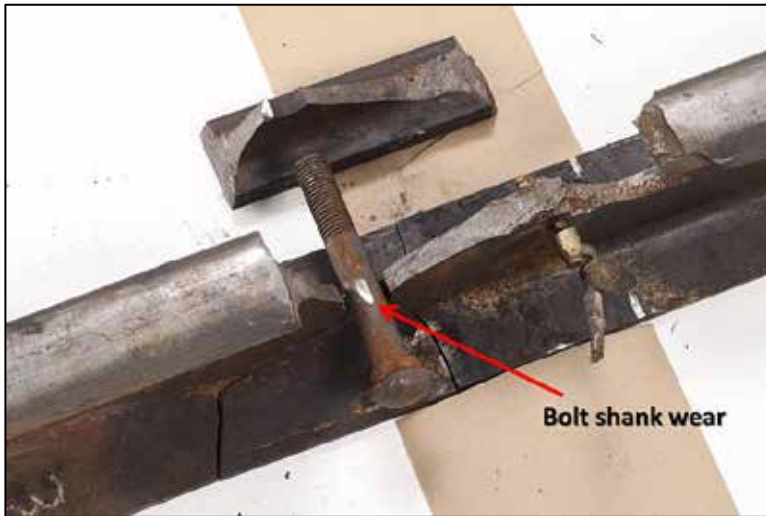
Photo 2. Bolt shank wear

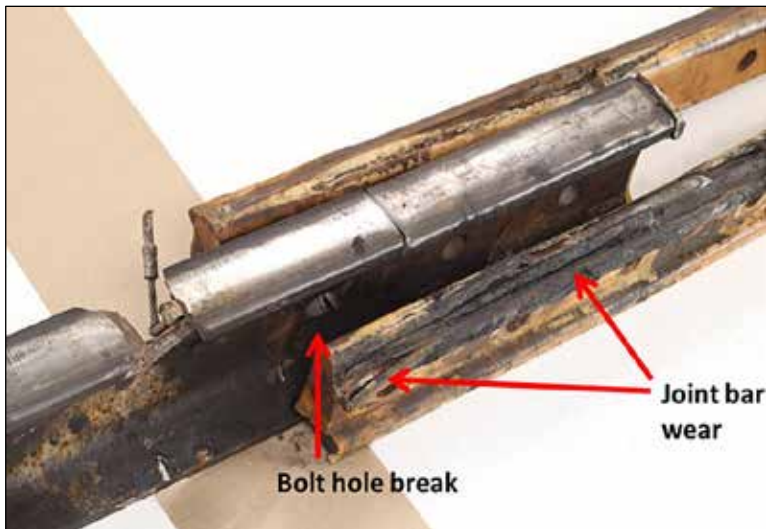
- The insulated joint bars were manufactured by PORTEC.
- Measurements of rail head wear, taken about 1 m from the fracture, were within allowable limits.
- Material hardness results were representative of intermediate-strength rail.
- Indications of joint movement were observed on the bolt shanks (Photo 2). The corresponding bolt holes were fractured and, at the top of the gauge side joint bar, the insulating polyurethane rubber coating of the bar had been worn through (Photo 3).

Photo 3. Worn insulation joint bars

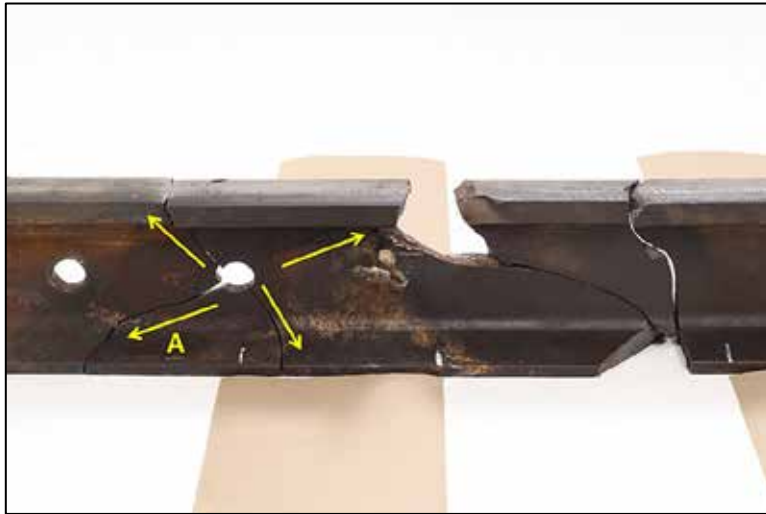
- The insulation had deteriorated primarily on the east half of both joint bars, but more significantly on the gauge side joint bar. This was consistent with the east end of the joint having been loose for an extended period of time. A loose joint changes the stress distribution of the joint and can overstress the rail.
- The parent rail had fractured at the eastern-most bolt hole of the joint. Four fractures emanated from this bolt hole, all of which had propagated away from the bolt hole (Figure 4).

Figure 4. Bolt hole fractures. Arrows indicate direction of crack propagation. Placement of brown construction paper is representative of tie spacing. The bolt hole that is the origin of primary Fracture A is located near the edge of a tie.

- Fracture A originated near the bottom of the eastern-most bolt hole and extended diagonally downward and westward from the bolt hole. The fracture surface of the base portion of Fracture A exhibited the most significant post-failure damage, indicating that it was likely the primary fracture, which had remained undetected. The other 3 fractures were likely secondary fractures.

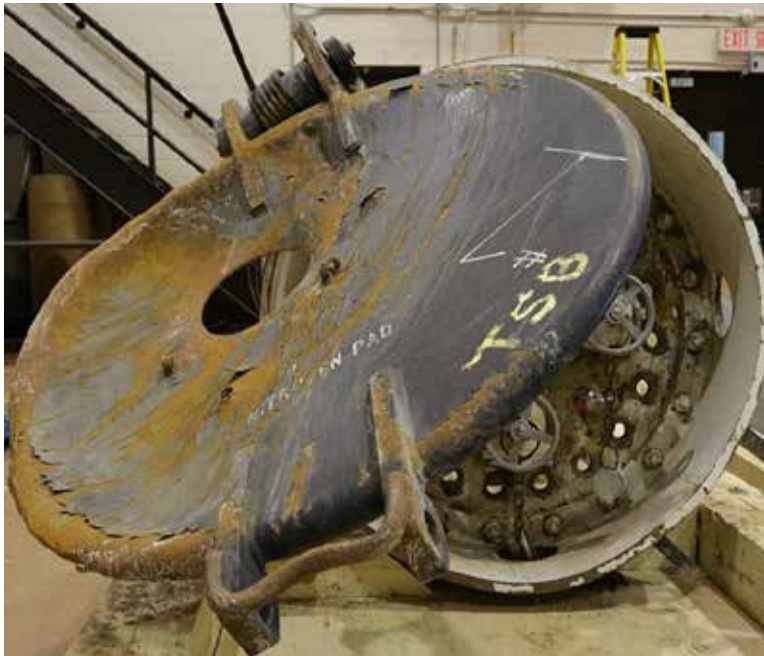
- The cover of the protective housing was deformed (Photo 4). One of the hinges was broken and the other was cracked, so that the cover would not close properly. The interior surface of the protective housing cover was dented and gouged from contact with the internal valve hand wheels. The walls of the protective housing had no visible deformation.

Photo 4. PROX 36178 protective housing and cover

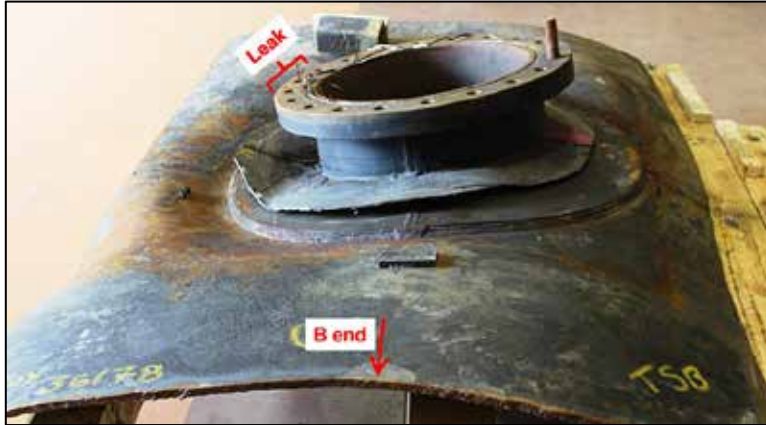
observed in this weld. The manway nozzle and its reinforcement were pushed down into the tank on the side where the leak was observed, causing significant deformation of the tank wall in this area (Figure 5).

Figure 5. Photograph taken after removing the tank jacket to expose the weld joining the manway nozzle reinforcement to the tank. Note tank deformation near the leak location.

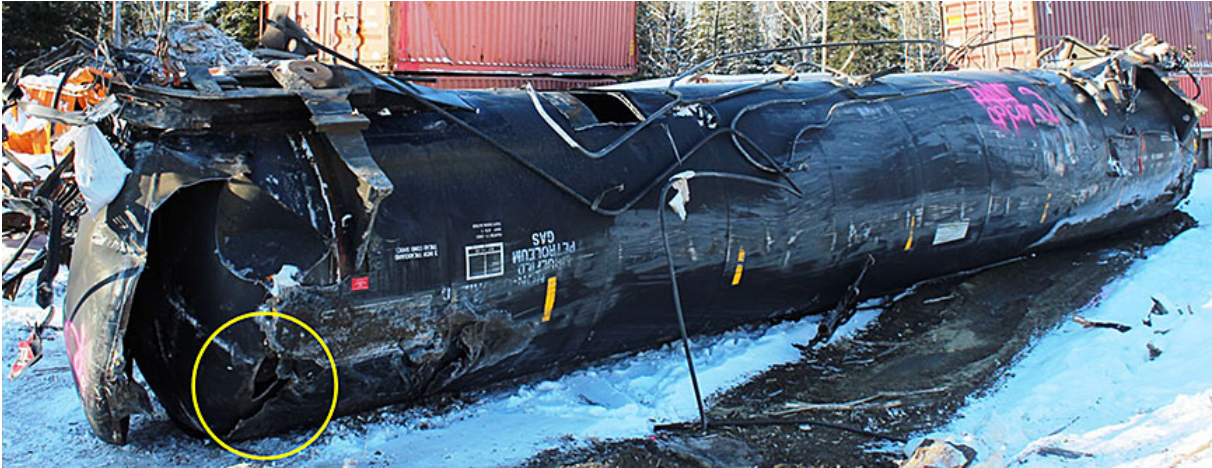
- The fracture initiated in the A-end head to shell weld and propagated in brittle mode into the head.
- Two small ductile tears extended on either side of the puncture origin into the shell.
- The object responsible for the puncture tore through the jacket and slipped under the edge of the head shield (Photo 5). This resulted in a significant localized impact at the A-end head-to-shell weld.

Photo 5. Puncture to tank GATX 200483
