# RAILWAY INVESTIGATION REPORT R15M0034

**MAIN-TRACK DERAILMENT  
CANADIAN NATIONAL RAILWAY  
FREIGHT TRAIN M30511-17  
MILE 212.8, NAPADOGAN SUBDIVISION  
SAINT-BASILE, NEW BRUNSWICK  
17 APRIL 2015**

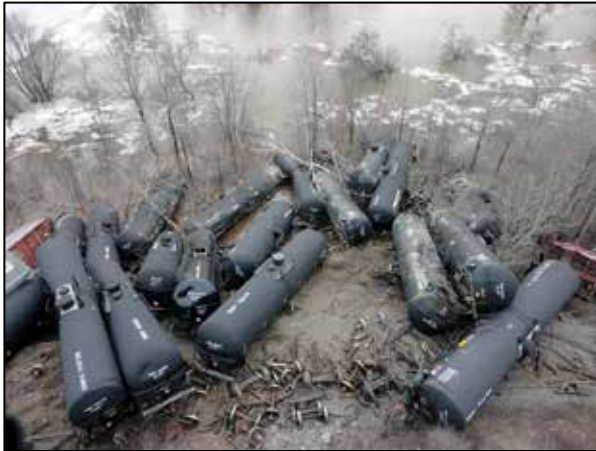
Photo 1. View of the derailed residue tank cars on the embankment toward the Saint John River (Source: Edmundston Fire Department)

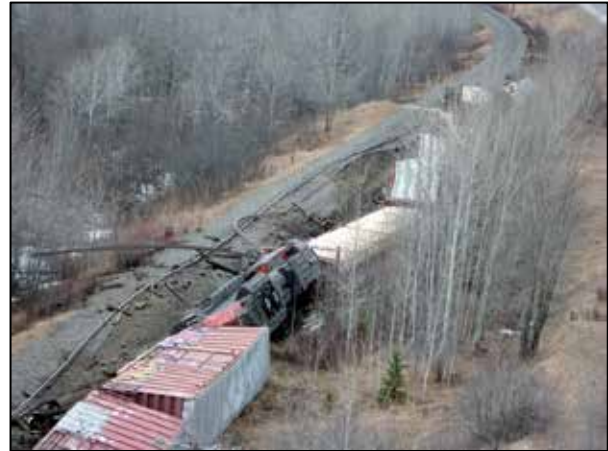
Photo 2. View toward front of train showing derailed equipment on the north side of the track (Source: Edmundston Fire Department)

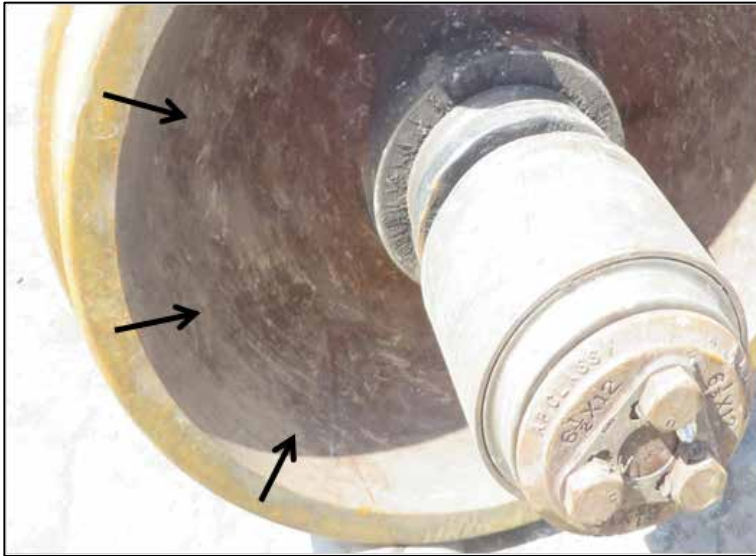
The 61st car (CN 624072) was travelling with its B-end leading. The leading truck was still attached to the car. There was a shiny contact area noted on the body side bearing at the same end, on the right side (BR location). Because the bearing surfaces are in contact, they will rub and wear; as a result, they can polish. The trailing truck (A-end) was located approximately 30 feet behind the car. Its components were still assembled. The coupler housing on the trailing end of the car was deformed, with the coupler rotated in a clockwise direction. The plates of the wheels in the trailing truck showed significant scuffing, typically associated with contact with track ballast (Photo 3).

Photo 3. Scuffing on wheel plate, trailing truck of the 61st car (CN 624072)

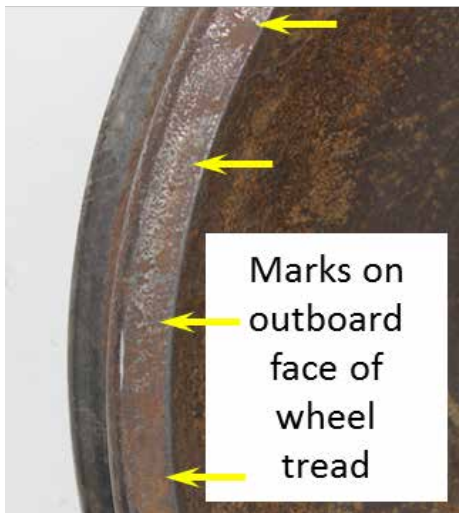
The 62nd car (DWC 627099) was travelling with its A-end leading. The car came to rest separated from the other cars. The trailing truck was behind the car on the same (north) side of the track. It was mostly disassembled, with its wheels, springs, and other truck parts strewn about the derailment site. The R-1 wheel had marks on the outboard face of the tread (Photo 4).

Photo 4. Wheel R-1 from the 62nd car (DWC 627099)

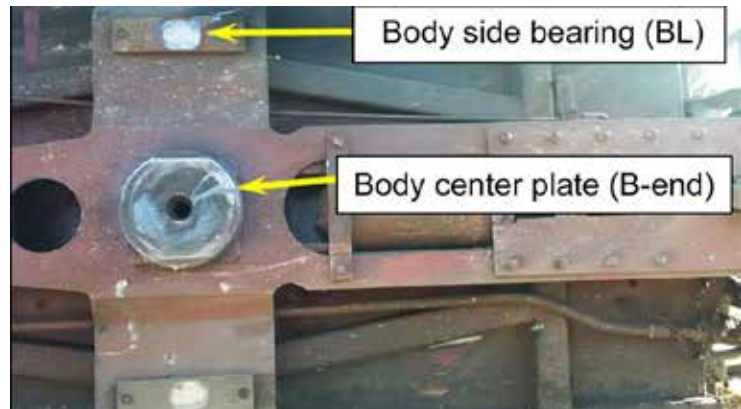
Photo 5. Bottom of the 62nd car, B-end, showing marks on body centre plate and uneven contact surface marks on BL body side bearing

There was a heavy mark on the body centre plate on the trailing end of the car (B-end). The marks extended from the centre-pin hole toward the end of the car and slightly toward the south (Photo 5). There were also uneven contact surface marks on the body side bearing at the same end, on the left side (BL location). The coupler housing on the trailing end was broken horizontally on the north side of the opening. There was no indication of significant coupler shank twist at this end.

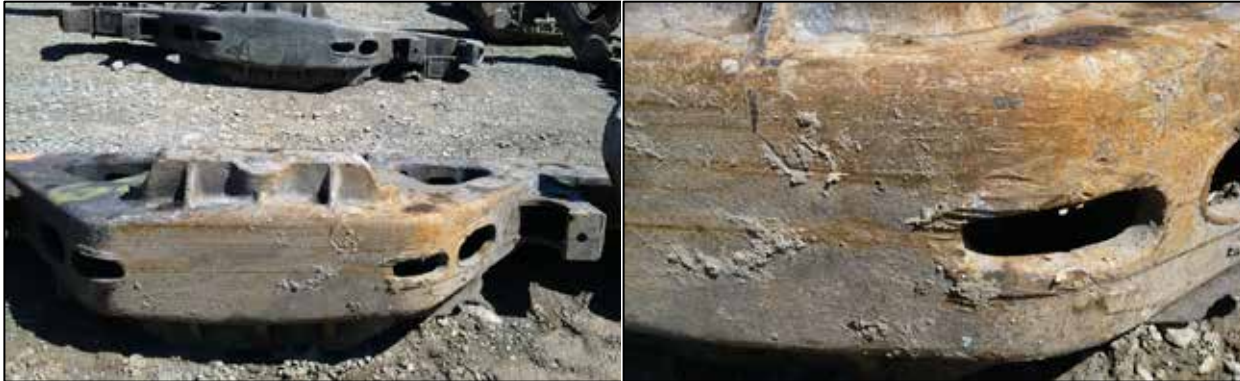
There were scratches on the bottom of the truck side frame on the B-end of the 62nd car (Photo 6 and Photo 7).

Photo 6. Scratches on bottom of one truck side frame from B-end of the 62nd car

Photo 7. Close-up view of bottom of truck side frame from the 62nd car

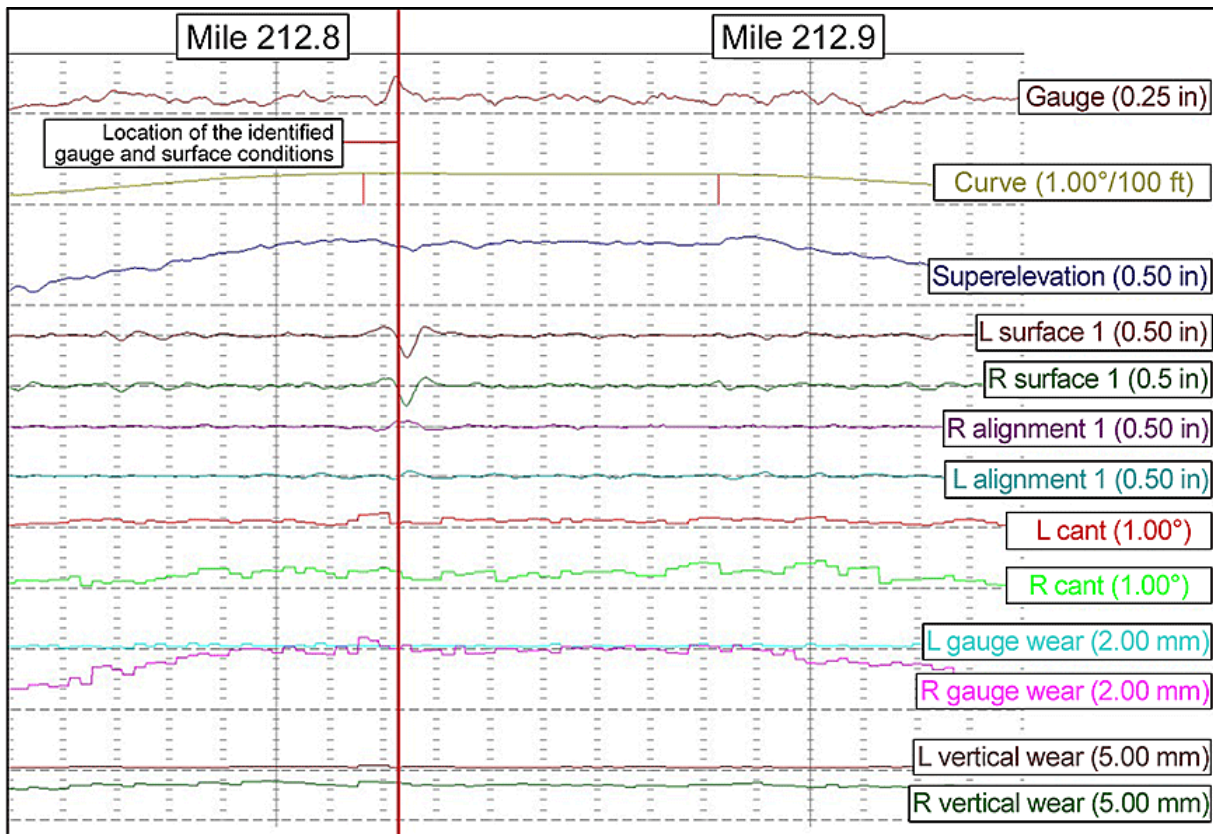
Figure 3. Track evaluation system (TEST) car measurements taken on 15 April 2015 for Mile 212.8 to Mile 212.9 (Source: Canadian National Railway TEST car, with TSB annotations)

During the April 15 inspection, the TEST car identified several defects in the derailment curve (Table 5), including a near-urgent<sup>5</sup> wide-gauge defect and 2 priority surface defects at Mile 212.82.

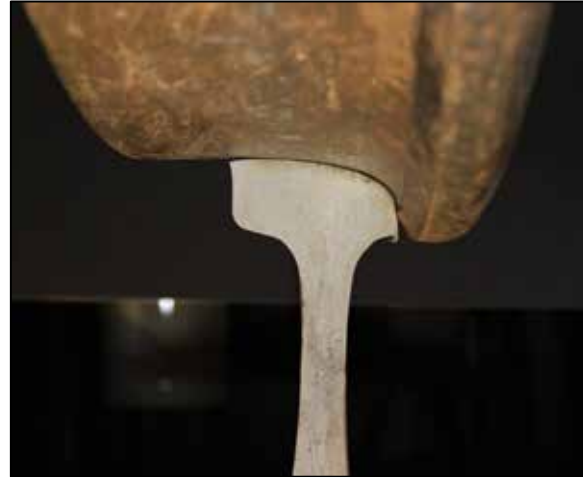
Photo 8. Actual wheel profile of L-1 wheel of the 62nd car compared with contour of high (south) rail. Note: The wheel-rail contact surface has shifted towards the field side of the rail.

- When there is wear on the gauge face of the high rail, 2-point contact between the wheel and the rail can occur when flanging around the curve. Wheel load that is shifted toward the field side of the rail reduces the lateral stability of the rail, lowering the L/V threshold for rail rotation or rollover.

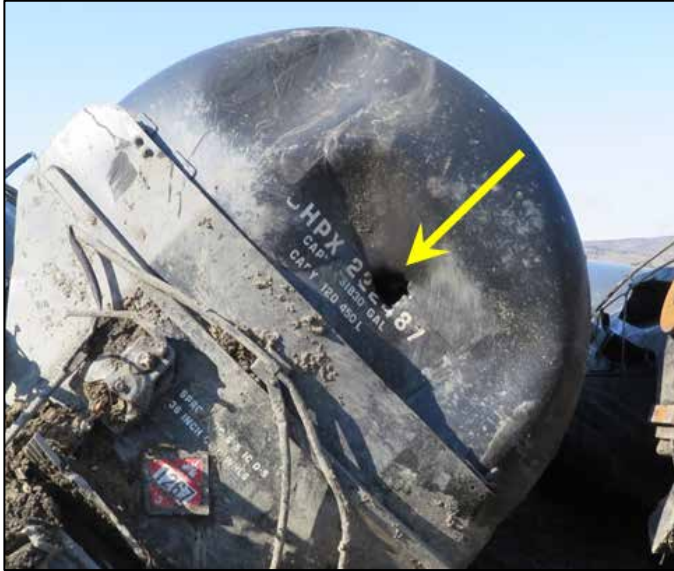
in their tank shells and heads as a result of these impacts. One of the tank cars equipped with a half-height head shield experienced a puncture in the unprotected part of the head (Photo 9). There were no leaks, as the derailed cars were not loaded.<sup>13</sup>

Photo 9. Puncture in unprotected portion of the upper head

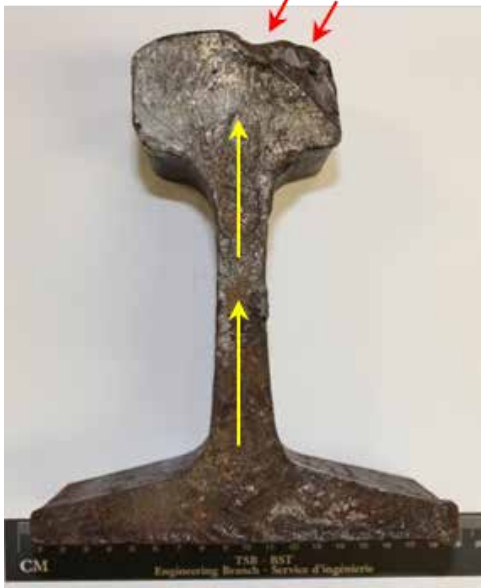
- Fractures on the subject rail pieces were consistent with sudden overstress rupture.
- The fracture surface on rail piece number 9 (Photo 10) indicated that it had broken at a flash butt weld. It exhibited a darker corrosion deposit and rounded edge at the base (Photo 11), suggesting that it had been partially fractured for some time.
- The orientation of chevrons and ridges on the fracture of rail piece number 9 indicated that it had started at the base of the rail and moved upward into the web and head.
- The Sydney rail had significant vertical and gauge wear (Figure 8).

Photo 10. Fracture surface on rail piece number 9 showing direction of fracture propagation (yellow) and impact marks on head (red)

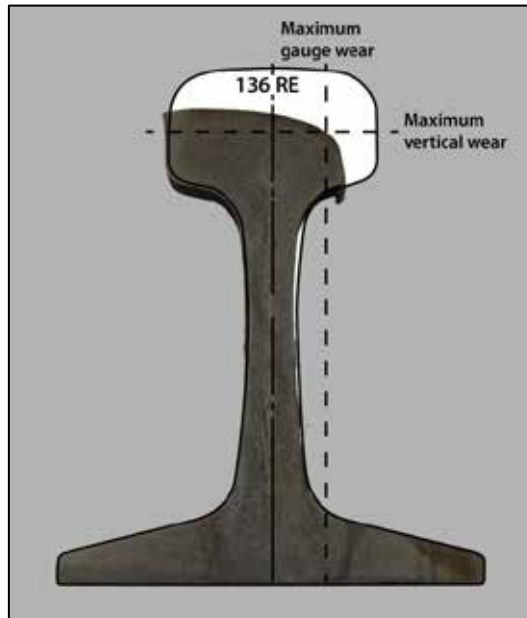
The rail on the north (low) side of the curve was HH VT Nippon, manufactured in December 2007. This rail had minimal wear. The rail on the south (high) side of the curve was RE Sydney, manufactured in January 1992. On the south rail, the maximum combined rail wear (that is, vertical wear as well as gauge wear) was 1 <sup>9</sup>/<sub>32</sub> inches (33 mm). Before the derailment, the south rail had been scheduled for replacement in summer 2015.

Figure 8. Comparison of the actual profile of the south rail with its original rail profile, showing the extent of vertical and gauge wear

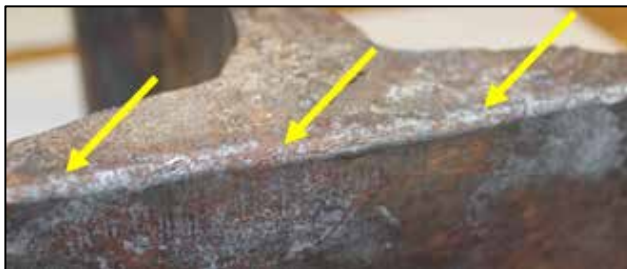
Photo 11. Rounded edge at base of rail piece number 9 (arrows)

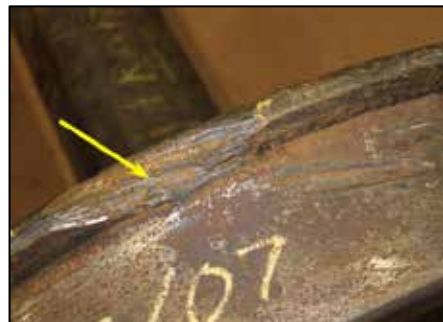
- shells observed on the wheel set from non-derailed car CRLE 19431 were within the AAR allowable limits, and
- impact damage that appeared to be fresh was observed on the wheel sets from derailed cars DWC 627099 (Photo 12) and AOK 27626. This damage had likely occurred during the derailment.

Photo 12. View of mechanical damage on wheel from car DWC 627099
