**RAIL INVESTIGATION REPORT  
R15T0245**

**RISK OF COLLISION  
VIA RAIL CANADA INC.  
PASSENGER TRAIN NO. 65  
MILE 304, GO TRANSIT KINGSTON SUBDIVISION  
WHITBY, ONTARIO  
25 OCTOBER 2015**

## Rail Investigation Report R15T0245

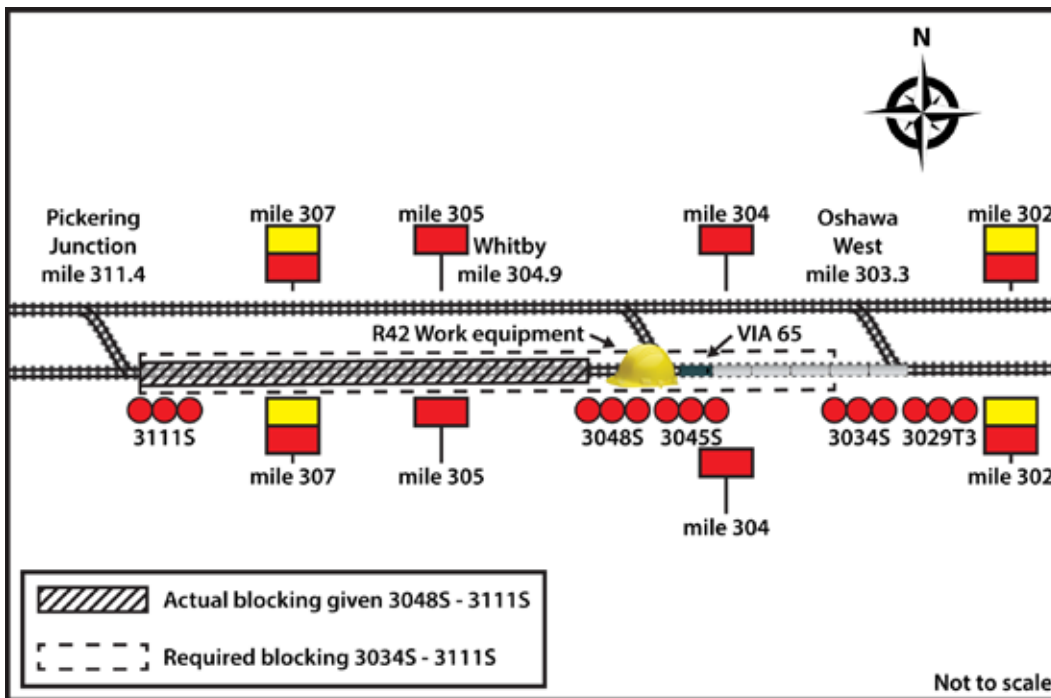
Figure 2. Site diagram

To protect the situation, the RTC had to block the south track between Signal 3034S (Mile 303.4, Oshawa West) and Signal 3111S (Mile 311.1, Pickering Junction). However, the RTC incorrectly entered signal blocking between Signal 3048S (located at Mile 304.8 at Whitby) and Signal 3111S on the south track. The RTC advised the foreman that the south track had been blocked between Whitby and Pickering Junction, excluding the crossovers on each side. The foreman did not make a record of this information, nor was he required to do so (Figure 2).

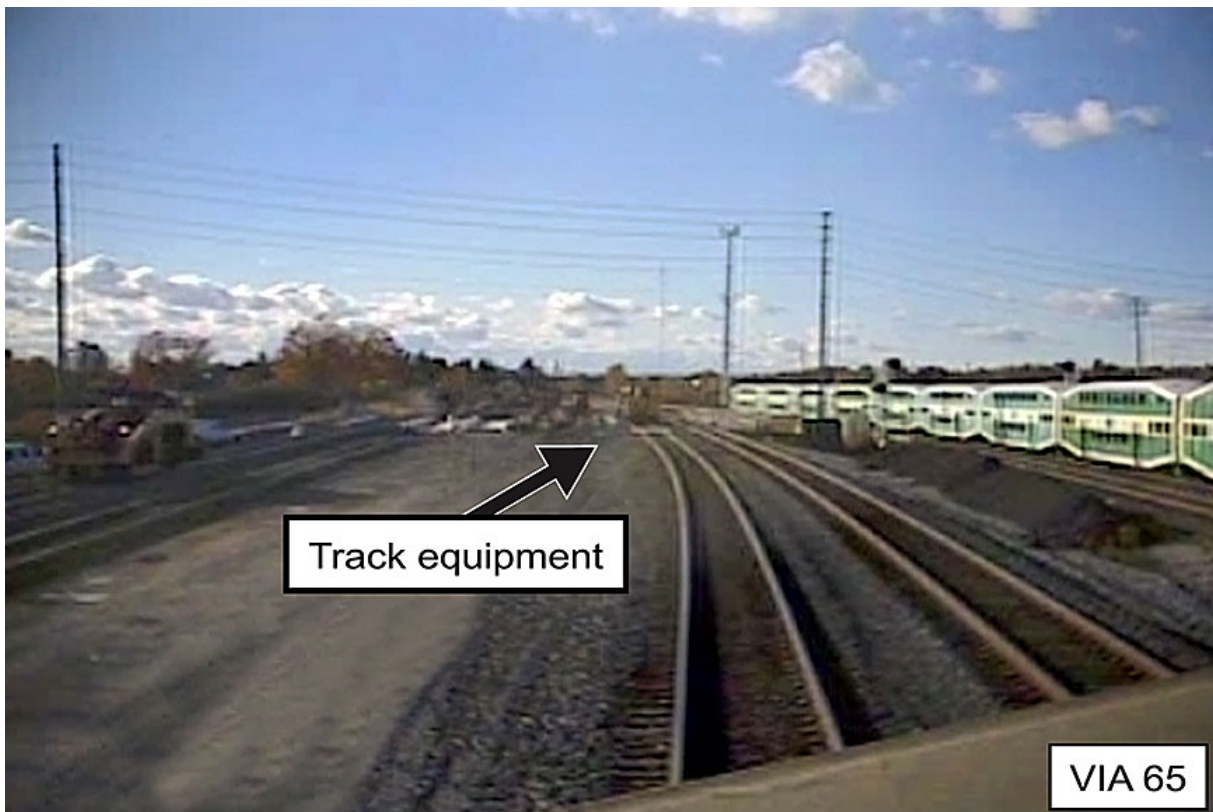
While preparing to cross over to the north track at Whitby, train speed was reduced to 38 mph. At approximately 1615, the train crew noticed maintenance equipment positioned on the south track fouling the crossover at Whitby. The brakes were immediately applied, safely stopping the train approximately 500 feet short of the maintenance equipment (Photo 1).

Photo 1. View from VIA 65 stopped, with work equipment approximately 500 feet ahead on the same track (Source: VIA Rail Canada Inc.)

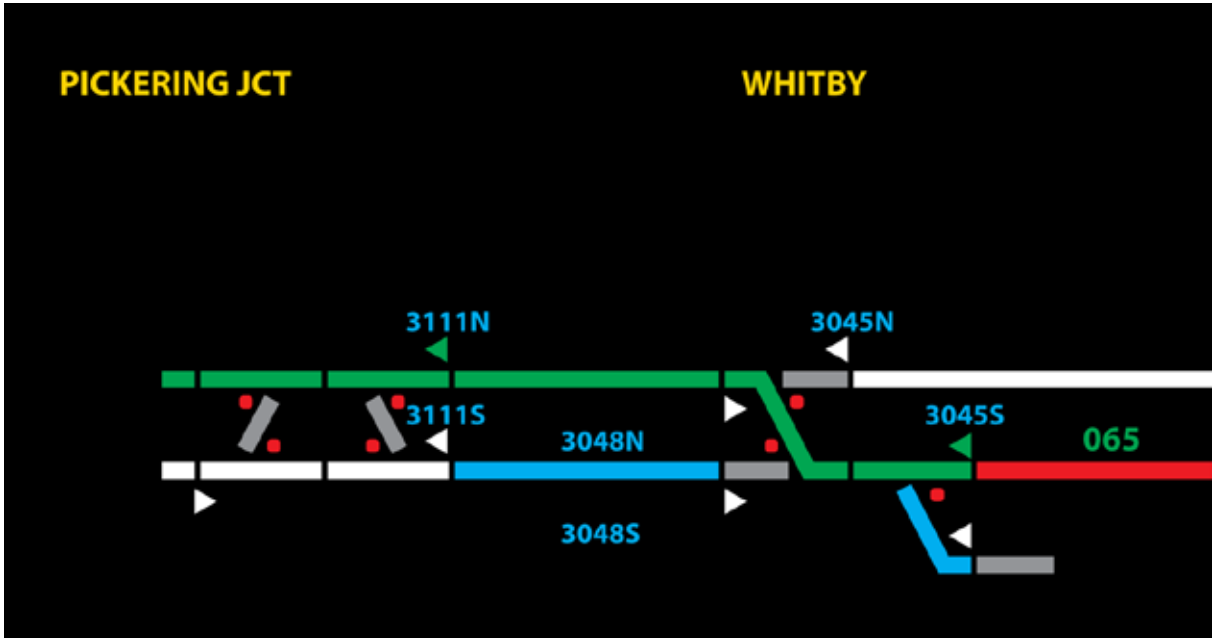
Photo 2. Rail traffic controller screen (Source: Canadian National Railway)

protection has been obtained from an RTC, the blocking given would be displayed on the electronic overview display. However, Rule 42 foremen do not usually have access to such laptops. The foreman did not have a laptop to display the RTC screen with him that day.

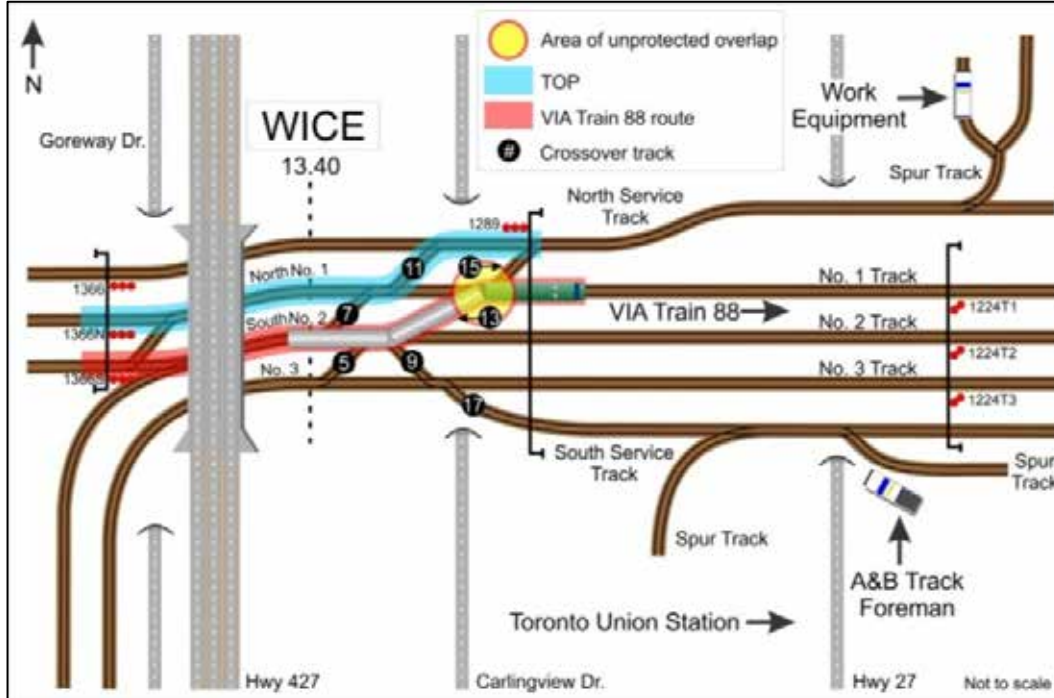
Figure 3. Site diagram for TSB Railway Occurrence R15T0121

At approximately 2250, VIA 88 was routed to cross over from the No. 2 track to the No. 1 track on a permissive signal indication using crossover No. 13. This crossover is in the vicinity of crossover No. 15, which was within the limits of the TOP (Figure 3). VIA 88’s crew was unaware of the TOP and unaware that they had entered a portion of the track foreman’s TOP, resulting in an unprotected overlap of authority (Figure 3).

When the RTC requested the initial TOP for the A&B track foreman, the RTC II system automatically lined crossover No. 11 in the reverse position and placed electronic blocking from signal 1289 on the North Service Track through crossover No. 11, and through the No. 1 track westward to signal 1366N. However, the RTC II system did not specifically block crossovers Nos. 13 and 15. Without these crossovers being blocked, a routing option was available to VIA 88, which resulted in overlapping a portion of the TOP.

The situation on the GO Transit Weston Subdivision was addressed through a software programming update. As well, other similar locations or circumstances on other subdivisions were checked to mitigate the potential of additional unprotected overlaps of authority where routing at other parallel crossover locations existed.

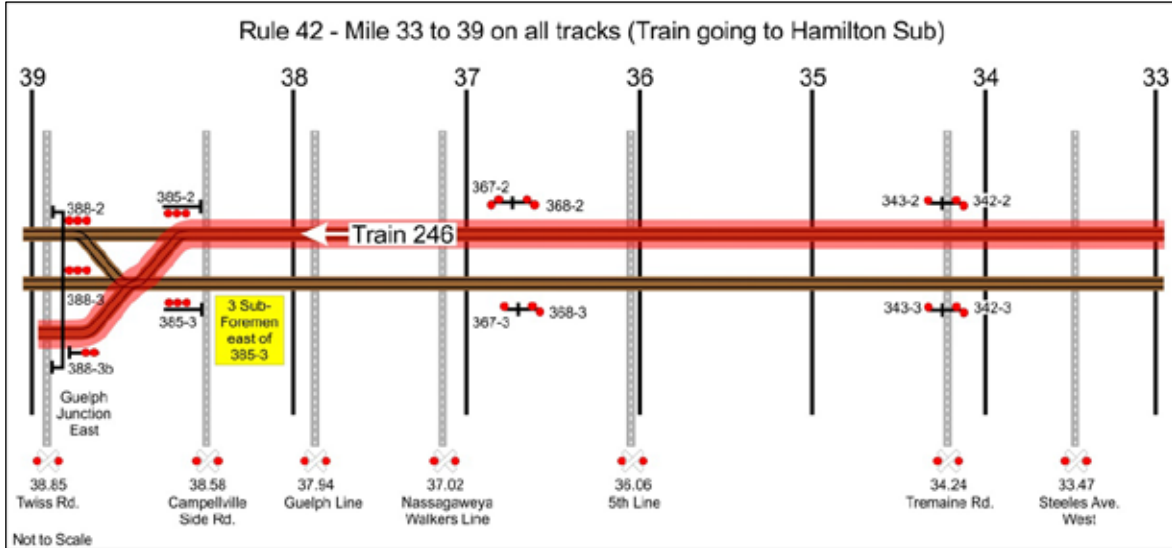
Figure 4. Site diagram for TSB Railway Occurrence R15T0258

The 3 sub-foremen were not advised by the foreman that the train would be crossing over to the south track at Signal 385-2. The foreman had assumed that the 3 sub-foremen were working east of Signal 385-3, clear of where the train would cross over. This created a risk of collision on the south track between the train and the 3 sub-foremen. Prior to lining the train to the south track, there had been no routing arrangement changes or discussions between the RTC and the foreman (Figure 4).

On 11 December 2015, the TSB sent Rail Safety Advisory Letter 16/15 to TC, indicating that to properly protect an evolving situation, routing arrangements need to be clear, concise, and consistent among all parties involved. Further, the letter suggested that given the risk to track workers from trains operating through Rule 42 limits, TC may wish to review the work procedures and training provided to RTCs relating to Rule 42 limits involving multiple tracks, and to review how routing arrangements are communicated to all track workers.
