**MARINE INVESTIGATION REPORT**  
**M15C0006**

**GROUNDING**

**SELF-DISCHARGING BULK CARRIER *ATLANTIC ERIE***  
**CHENAL DU HAVRE DE LA GRANDE ENTRÉE**  
**ÎLES DE LA MADELEINE, QUEBEC**  
**11 JANUARY 2015**

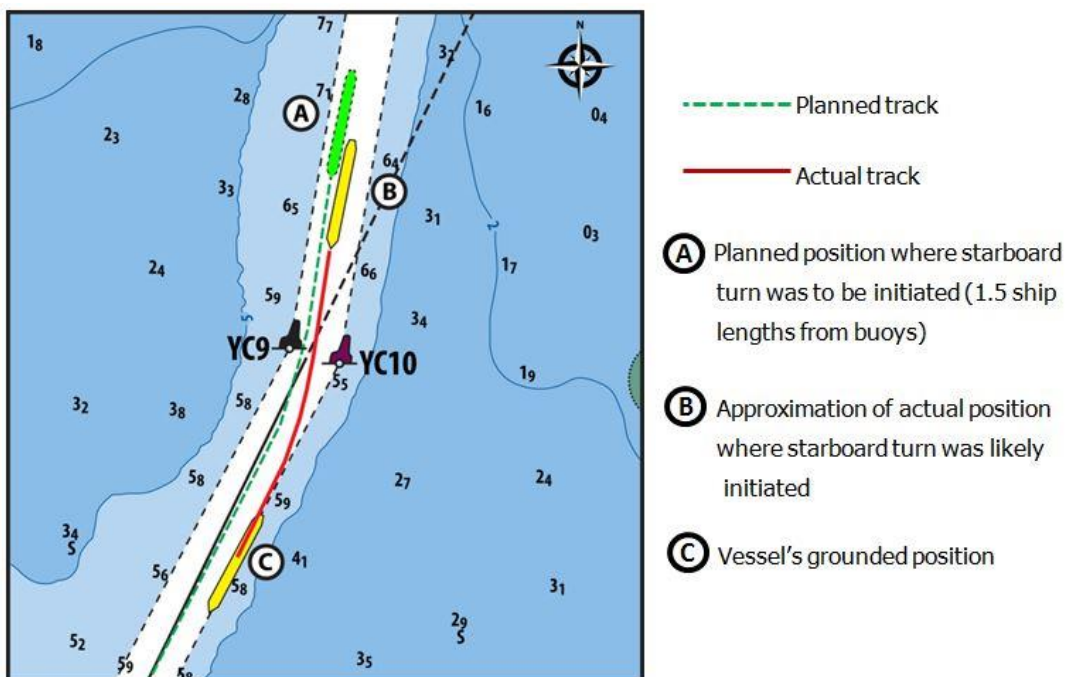
Figure 2. Vessel's planned position at time of turn compared to approximation of actual position

The outdated ECPINS chart was also displaying buoys YC9 and YC10 as being 125 m further south-southwest along the course line than their actual location in the channel. By using the buoy positions indicated on the ECPINS to verify the wheel-over position, the master likely initiated the turn when the vessel was only 213 m, or 0.9 ship length, from the actual buoy positions, later than intended (Figure 2).

The bridge team was not using all available bridge resources to monitor the vessel's position in the channel and lost situational awareness. Because the turn was initiated when the vessel was in the centre of the channel and further south than intended, there was not enough sea room to overcome the environmental conditions and complete the manoeuvre with the helm applied. However, the bridge team perceived the turn to be proceeding as intended while the *Atlantic Erie* crossed over to the port side of the channel and ran aground.

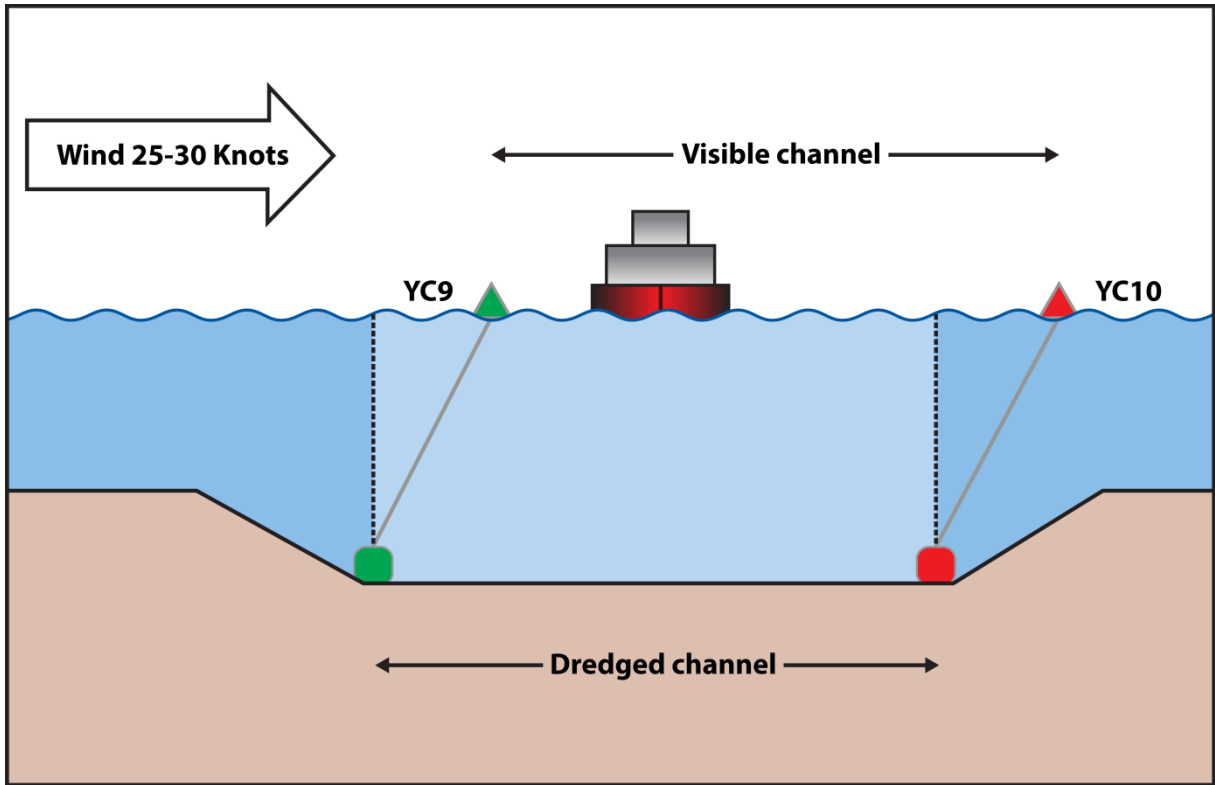
*Appendix D – Effect of environmental conditions on buoy positions*

On approach to the turn, the strong wind and cross current were setting the buoys to the east, giving the master the impression that the vessel was close to the starboard side of the channel when it was in fact near the centre (Appendix D). The outdated ECPINS chart likely corroborated the master's belief that the vessel was on the starboard side of the channel, because it no longer depicted the channel accurately and therefore showed the vessel on the starboard side, rather than near the centre where it actually was (Appendix E).
