MARINE INVESTIGATION REPORT
M15C0028

GROUNDING
BULK CARRIER *CWB MARQUIS*
BEAUHARNOIS, QUEBEC
03 APRIL 2015

Grounding

Bulk carrier *CWB Marquis*

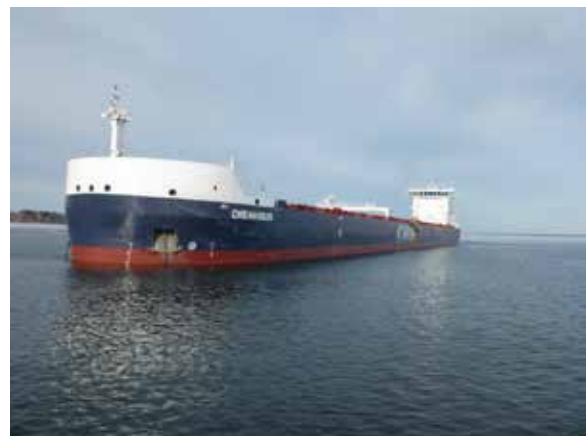
Photo 1. *CWB Marquis*

The *CWB Marquis* (Photo 1) is a dry bulk cargo vessel with 5 cargo holds. The machinery and accommodation spaces are located aft. Propulsion is provided by 1 five-cylinder diesel engine driving a controllable-pitch propeller. Electrical power is supplied by 3 generators, as well as an emergency generator. The vessel is fitted with a 1200 kW bow thruster situated in an enclosed space within the forepeak compartment. The vessel has 3 anchors: 2 forward and 1 at the stern.

The vessel sustained minor damage in way of the No. 2 starboard ballast tank. Two frames and some sections of shell plating were slightly distorted.

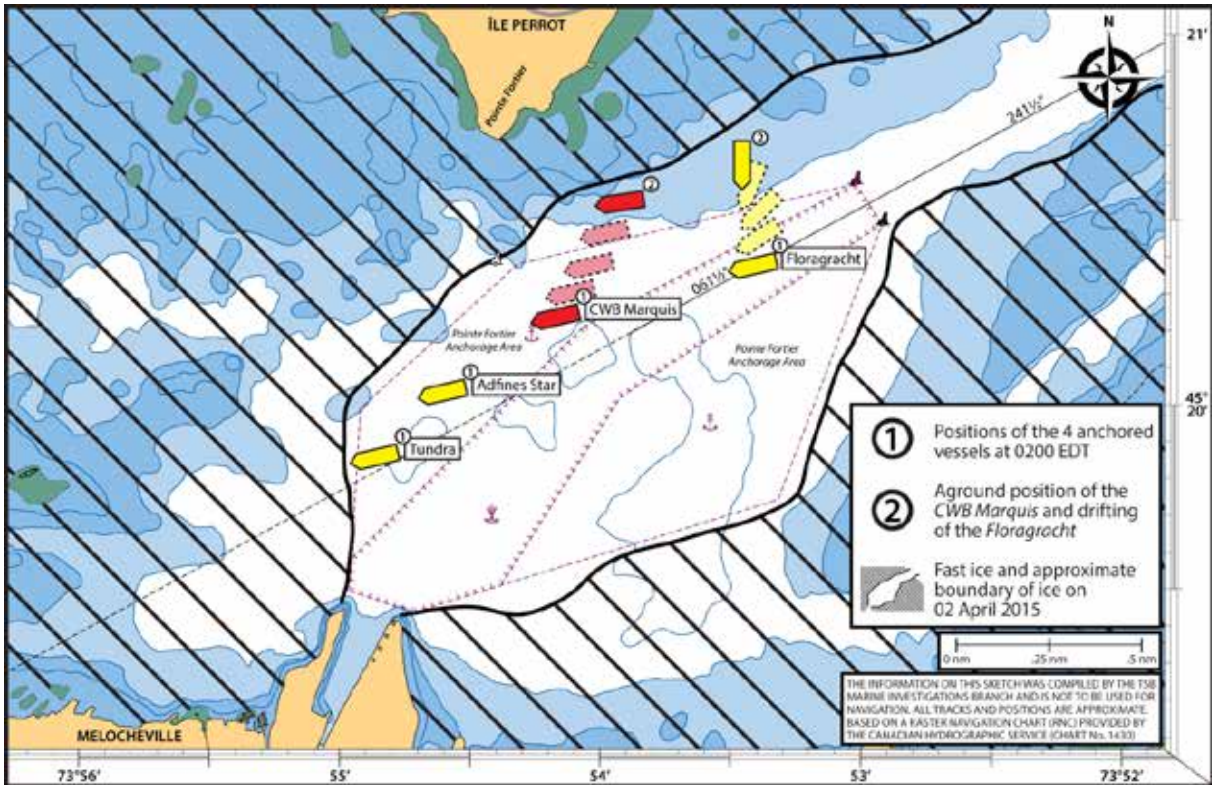
Appendix C – Area of occurrence (with vessel movement)

The *Tundra* arrived at 2051 and anchored 0.9 nm south-southwest of Pointe Fortier, closer to the entrance of the Lower Beauharnois lock. The *Floragracht* arrived at 2157 and dropped anchor in the navigation channel, 0.75 nm east-southeast of Pointe Fortier (Appendix C).

About 20 minutes later, an ice floe¹⁶ struck the *CWB Marquis*, causing it to drift eastward in line with the *Floragracht*, which was located 0.73 nm astern of the *CWB Marquis*. The OOW and the helmsman on the *CWB Marquis* felt the vessel shudder, and the OOW checked the vessel's position on the radar and ECDIS.

At 0237, having observed that the ice floe was pushing the *CWB Marquis* and that the vessel was dragging anchor, the OOW phoned the master in his cabin and advised him that a big floe of ice had struck the vessel and that the vessel was slowly dragging anchor. The OOW stated that the vessel was not in immediate danger and that it was dragging toward the navigation channel. The master acknowledged the OOW, and it was agreed that the master was to be advised if the situation changed. During this conversation, which lasted approximately 1 minute, the vessel changed direction, dragging anchor north-northeast at a speed of 0.4 knot.
