**MARINE INVESTIGATION REPORT  
M15P0035**

**FOUNDERING AND ABANDONMENT**

**SELF-PROPELLED BARGE *LASQUETI DAUGHTERS*  
SUTIL POINT, BRITISH COLUMBIA  
14 MARCH 2015**

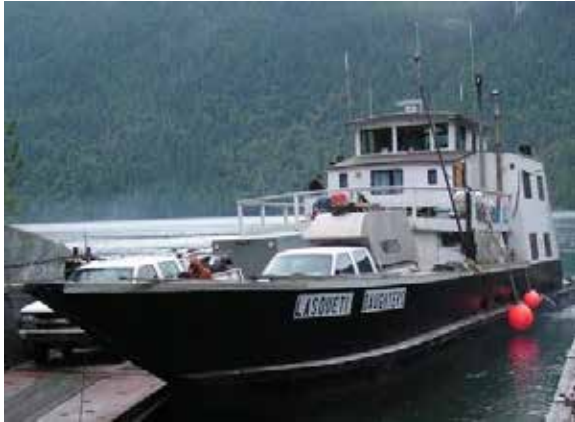
Photo 1. *Lasqueti Daughters*, Stuart Island, British Columbia, 2004

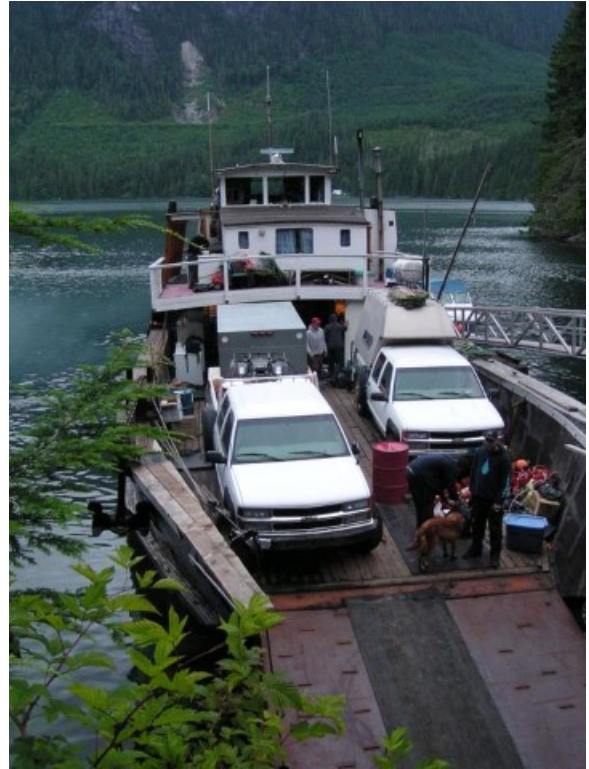
Photo 2. *Lasqueti Daughters* with bow ramp down, at Stuart Island, British Columbia, 2004

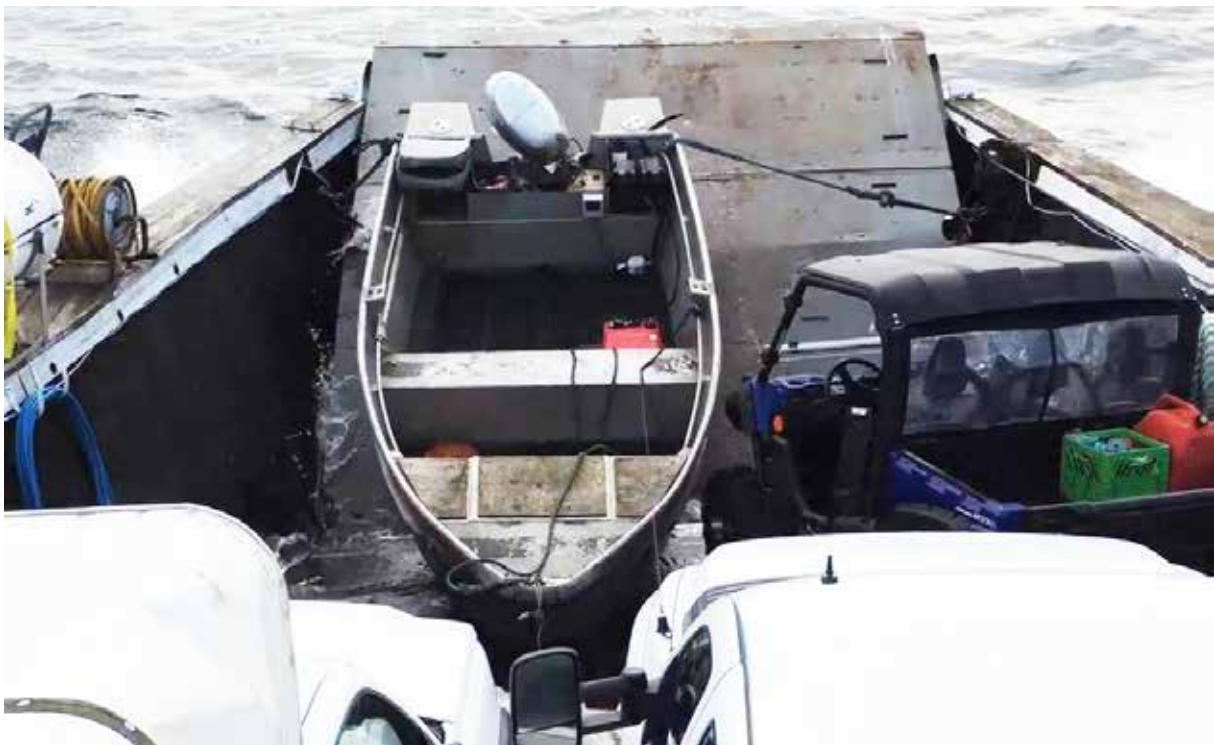
As the winds and waves increased, water began shipping on board via the spaces between the bow ramp, the bulwarks, and the main deck, and pooled near the base of the ramp (Photo 3), trimming the vessel by the bow. The master altered the vessel's speed and course to reduce the amount of water being shipped on board, while the AR went to the main deck to check the forward storage compartment and to determine why the vessel's trim had changed.

Photo 3. Water shipping on board the *Lasqueti Daughters* via the bow ramp

1. The weather conditions encountered by the *Lasqueti Daughters* resulted in water being shipped onto the main deck via the spaces between the bow ramp, the bulwarks, and the main deck.
