**MARINE INVESTIGATION REPORT**  
**M15P0037**

**SINKING**

**TUG SYRINGA**  
**OFF SECHELT, BRITISH COLUMBIA**  
**18 MARCH 2015**

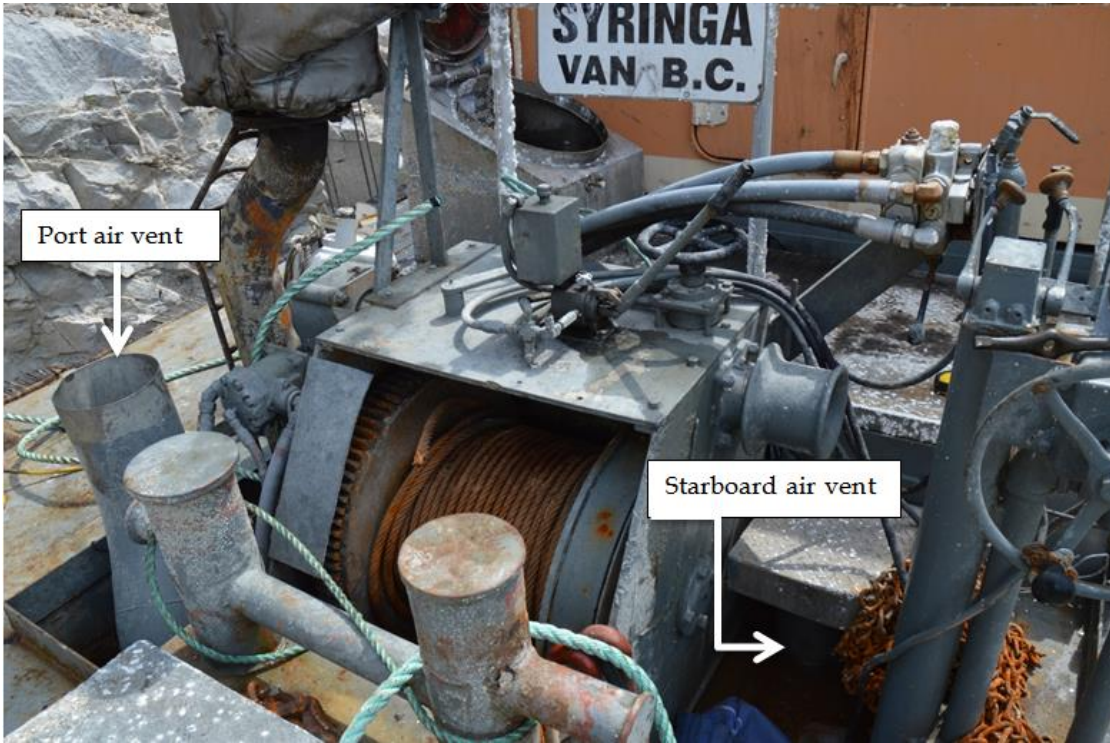
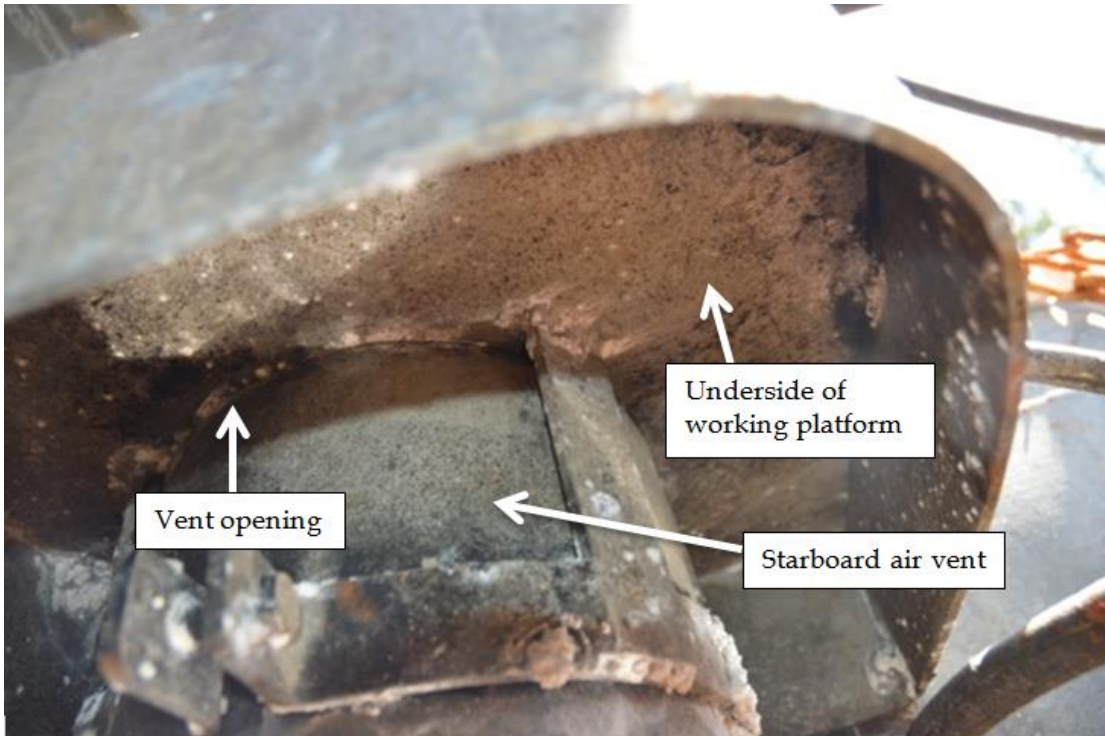
*Appendix C – Cropped starboard-side engine room air vent*

- The original steel wheelhouse was replaced with a smaller aluminum wheelhouse in 2006.
- A new diesel engine was installed around 1998.
- Sponsons<sup>11</sup> were installed on the port and starboard sides of the hull.
- An incision (approximately 270 mm by 100 mm) was made in the watertight bulkhead between the lazarette and the machinery spaces at main deck level for ventilation purposes<sup>12</sup> (Appendix B).
- The starboard-side engine room vent, which is located in the winch well, was cropped at deck level<sup>13</sup> to accommodate a working platform. The platform was installed on the vent opening without a sealing arrangement (Appendix C).

- the gap in the main deck plating in way of the lazarette coaming was temporarily repaired with materials that were not sufficient to withstand the conditions of the voyage;
- neither the cropped starboard-side air vent nor the cable glands in the winch well were protected against water ingress;

Location of port and starboard air vents within the towing winch well

Close-up of starboard air vent from underside of working platform

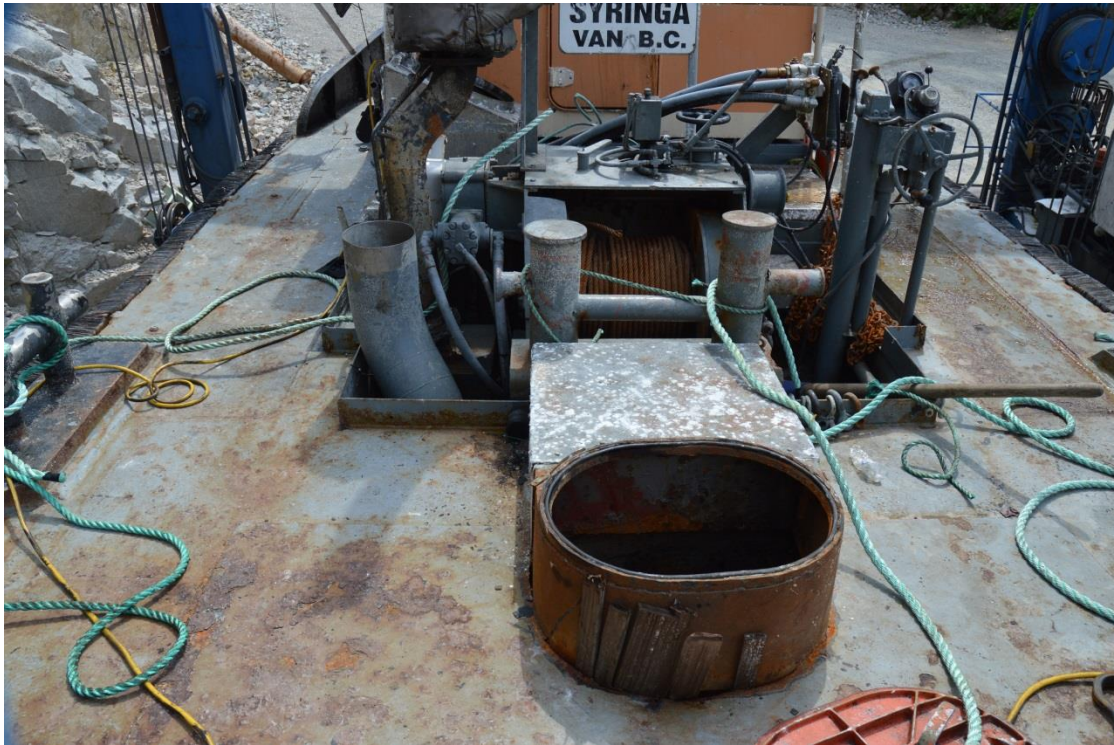
## *Appendix D – Gap in deck plating*

On the evening prior to the *Syringa's* scheduled departure, the master observed a gap in the deck plating that had resulted from the repairs, which had not been completed. The gap was approximately 2.5 cm wide by 60 cm long in way of the lazarette coaming. The master temporarily patched this gap with cedar wedges and waterproof sealant. On the morning of 17 March, the tug took on approximately 3000 litres of fuel and 1890 litres of water and, at approximately 1200,<sup>4</sup> departed Saltery Bay with the barge *Matcon 1* in tow. Manned by the master and a deckhand, the tug and barge arrived at Blackberry Point, British Columbia (Appendix A) at approximately 1600 and tied up to pilings for the night.

The *Syringa* departed Saltery Bay, British Columbia, with a gap in the deck plating as a result of repairs that were not completed. The master had temporarily filled the gap using cedar wedges and sealant prior to departure.

Gap in deck plating in way of the lazarette coaming

Close-up of incomplete repairs
