**MARINE INVESTIGATION REPORT
M15A0189**

**LOSS OF VESSEL AT SEA WITH 3 FATALITIES
SMALL FISHING VESSEL *CFV 130214*
PLACENTIA BAY, NEWFOUNDLAND AND LABRADOR
16 JUNE 2015**

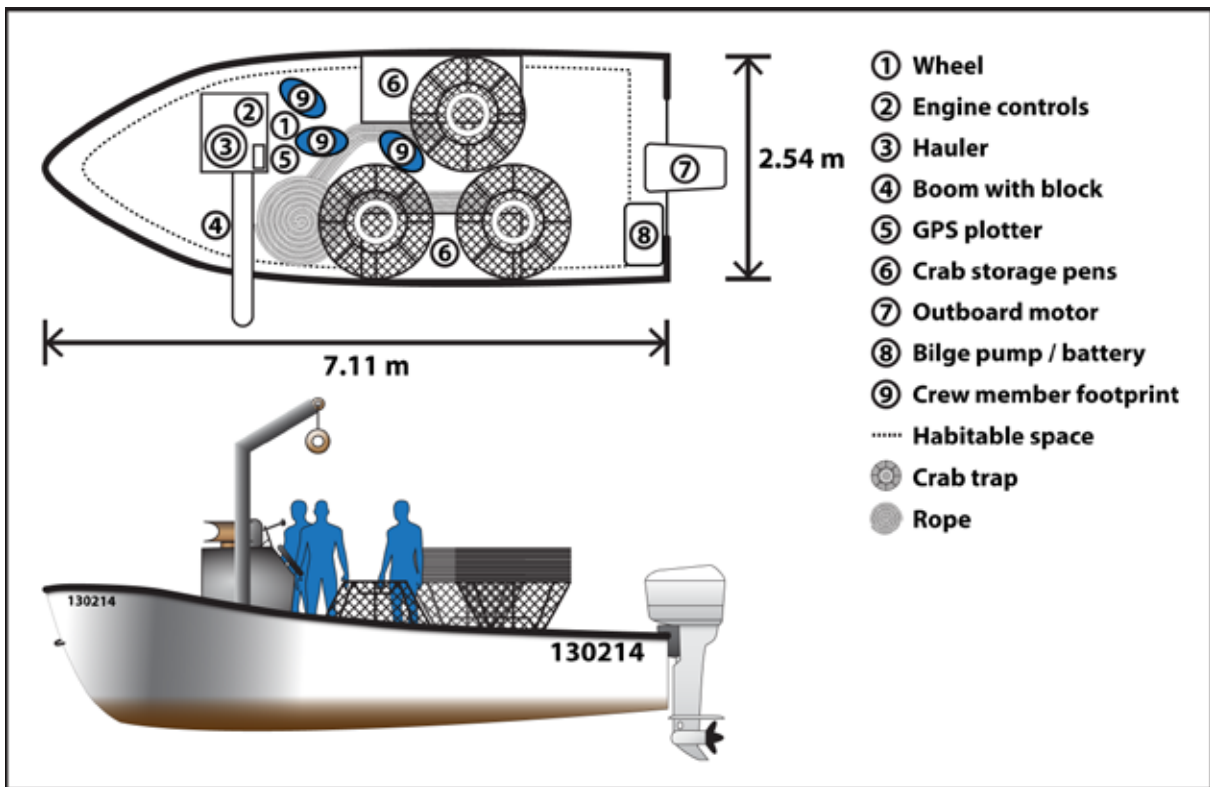
Figure 1. The open boat, overhead and profile views with 25 crab traps on board

The open boat in this occurrence was an undecked vessel. Buoyancy and stability on an undecked vessel is provided by the watertight hull, which extends to the top of the gunwale. This type of vessel is vulnerable to swamping as a result of water coming over the sides, especially if the vessel is loaded heavily. The risk of swamping may be mitigated by limiting operations to relatively calm waters, by incorporating built-in flotation to improve survivability, and by providing means to efficiently remove any water that is shipped over the side. Reducing the freeboard or the height of the downflooding point reduces the reserve buoyancy and stability, decreasing the margin of safety.

4. Given the time constraints, the master modified the secondary vessel for fishing. These modifications were not assessed or tested for stability.
5. The increased load on the small vessel caused by its modifications, the weight of the crew members, additional equipment, and cargo, would have lowered the freeboard and made it more challenging to operate in the weather and sea conditions present on the day of the occurrence.

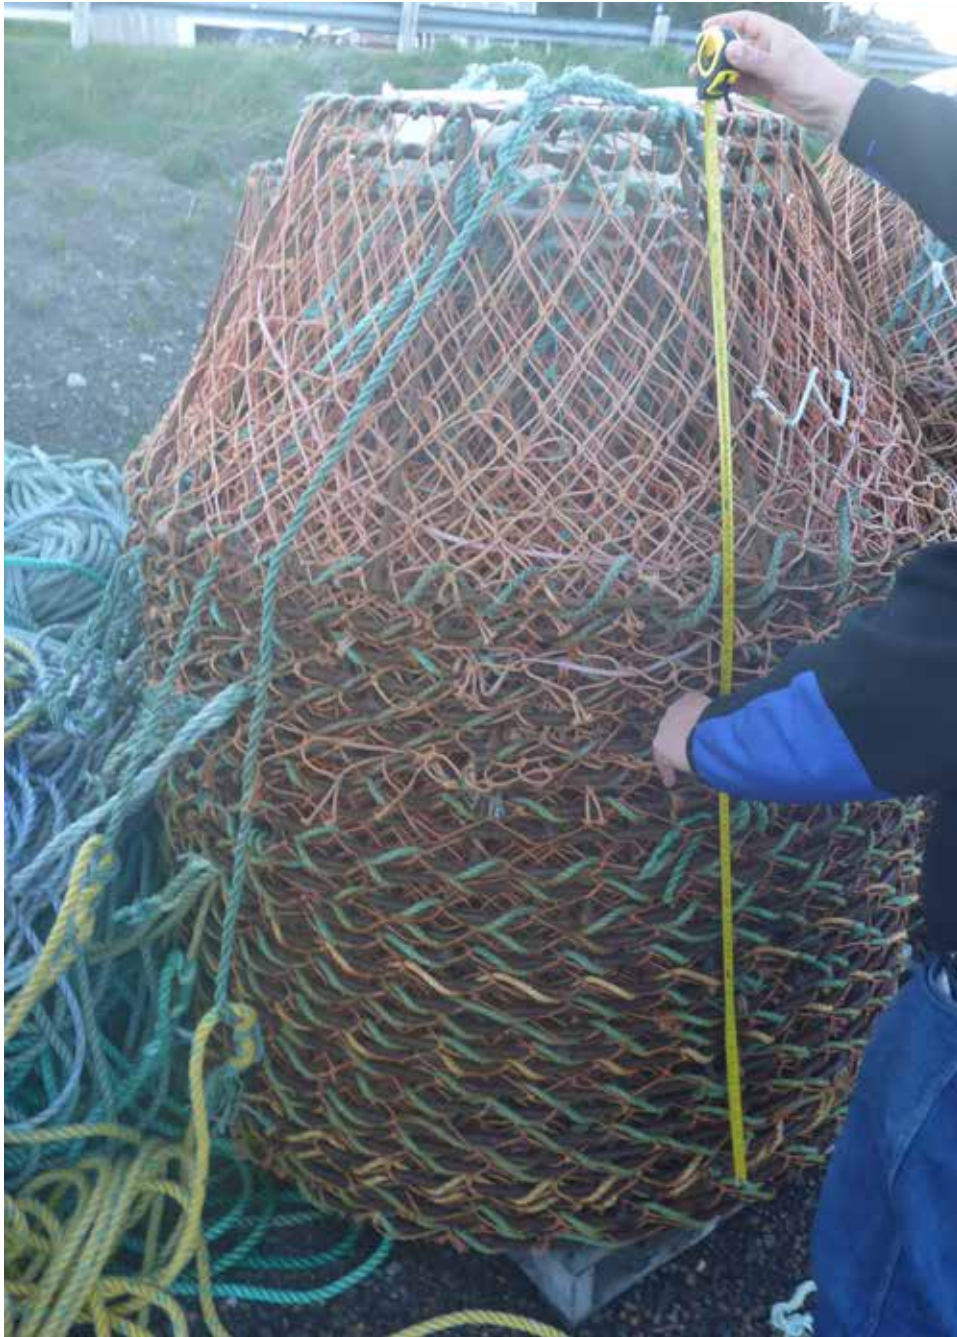
Appendix B – Stack of 25 snow crab traps

In order to get his 150 traps in the water and catch his quota in accordance with DFO policy before the end of the fishing season, the master chose to use the open boat. He used a vessel that was not ideally suited for fishing the crabs in the area of the occurrence, with its minimized freeboard due to its smaller size and loaded condition.
