Institute for
Research in
Construction

The 1989 Loma Prieta (San Francisco Area) Earthquake: Site Visit Report

Internal Report No. 594

Date of issue: May 1990

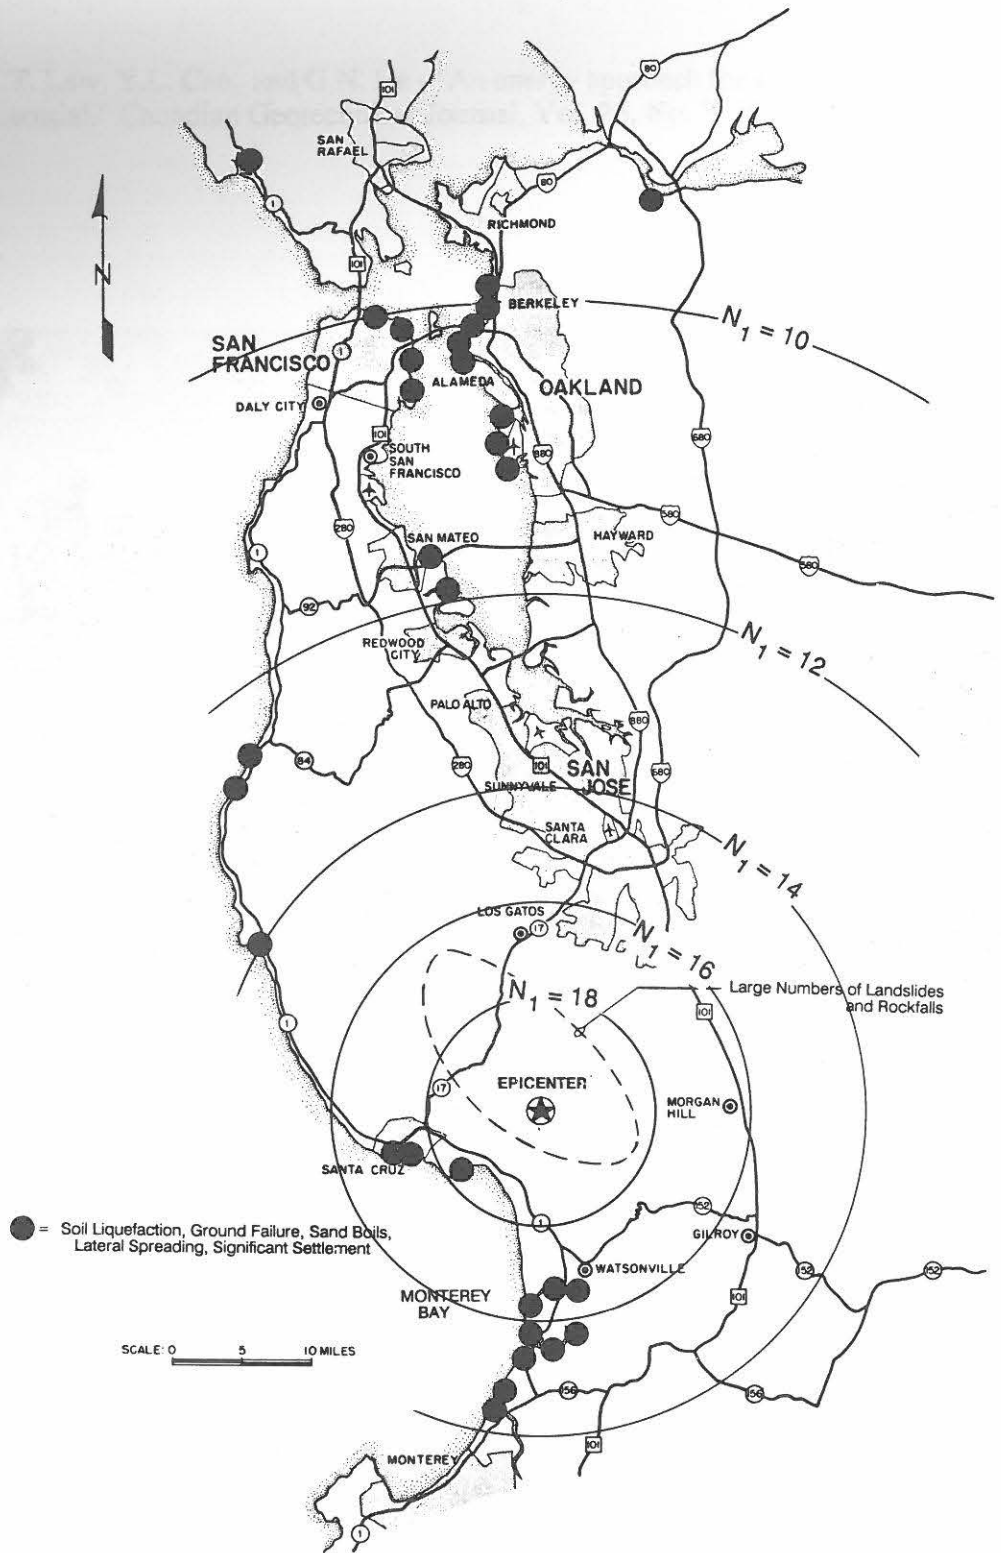
Fig. 2.2 Map of San Francisco Bay Area with location of soil failures and contours of standard penetration resistance (N_1) below which liquefaction will occur [3].

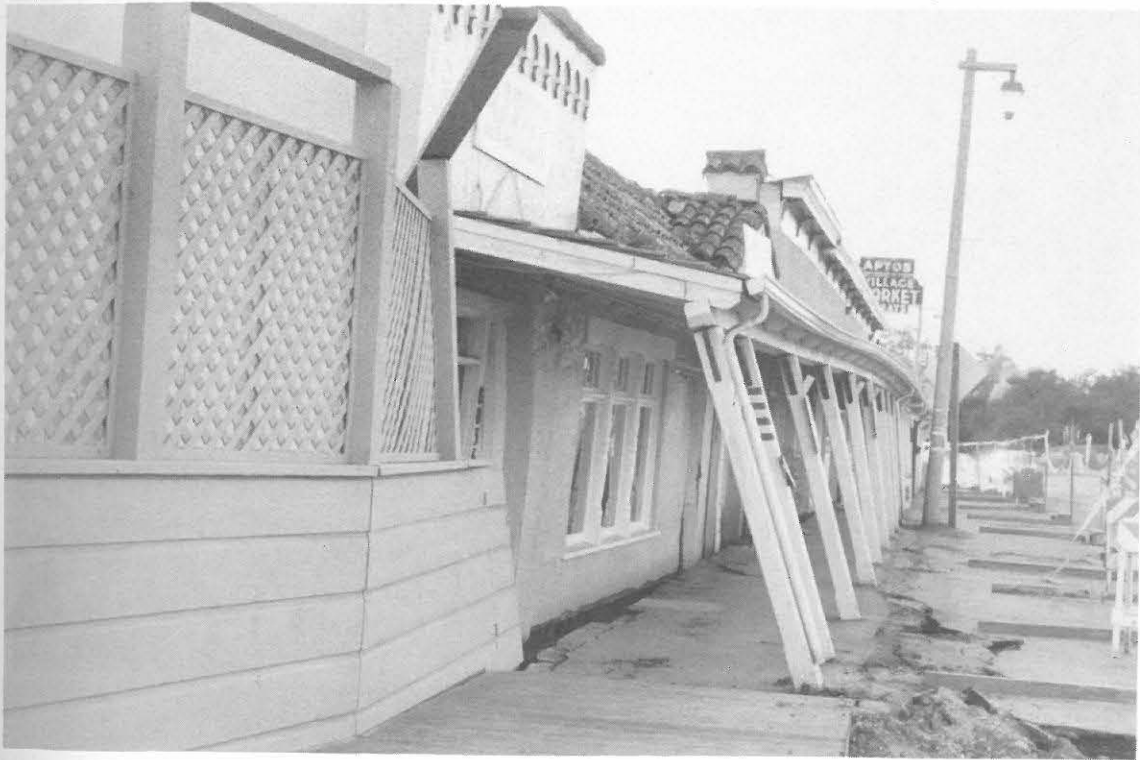
Liquefaction caused damage in the form of sand boils, ground cracks, ground heave, building collapse and differential settlement. Some examples are shown in Figs. 2.3 to 2.6. Near the epicentre such as Santa Cruz and Moss Landing, numerous sand boils were found. These sand boils had a typical conical shape with a crater in the centre. Outside Watsonville along the Pajaro River, 1.5 km of levee was damaged by soil liquefaction.

Fig. 2.3 Partially collapsed house due to liquefaction failure in Aptos, 9.5 km from epicenter

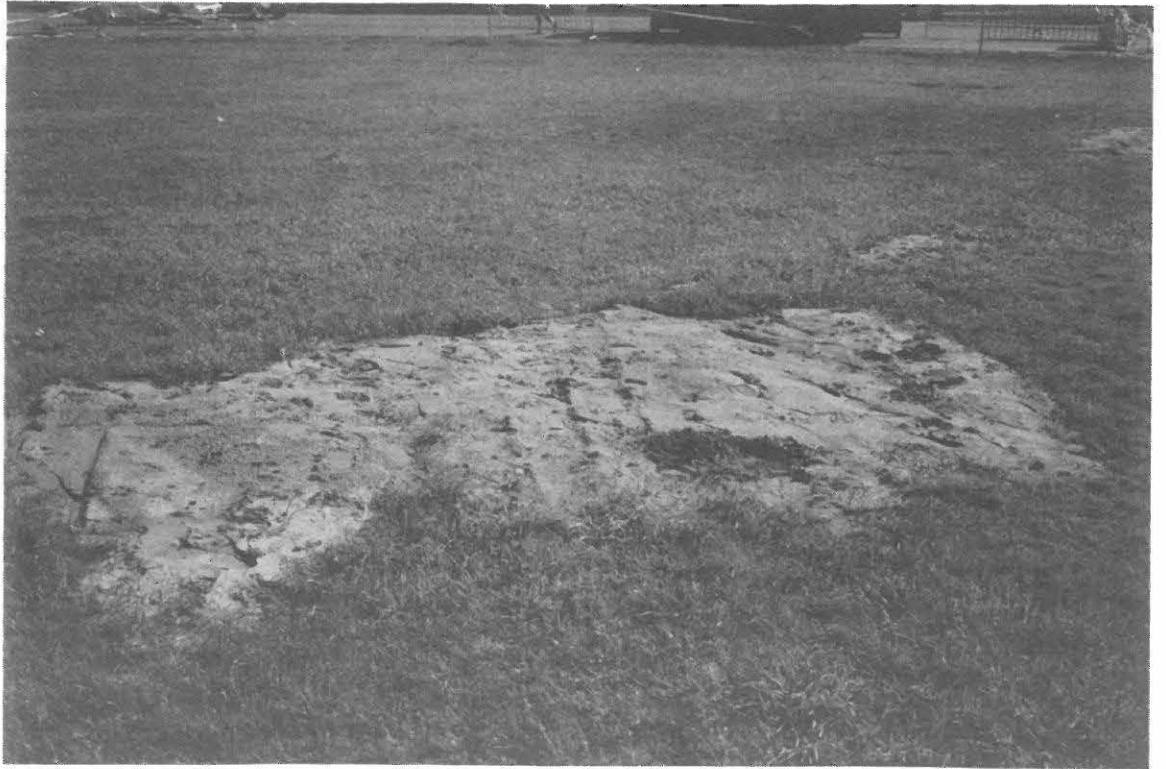
In the Marina District, liquefaction failure was widespread. More than 20 sand boils were noted by the visiting team. These sand boils did not possess the typical conical shape with a crater in the middle. Instead, they were simply patches of sand lying on the lawn (Fig. 2.4) or on the pavement. The sand was dark grey in colour, uniformly graded with occasional sea shells indicating that the hydraulic fill placed on the site had liquefied during the earthquake. Soil liquefaction resulted in the collapse of a three storey house and damage to a number of other houses by differential settlement (Fig. 2.5). Many sidewalks were buckled (Fig. 2.6) and ground cracks were found in several places. The large ground movements wrecked buried utilities including gas lines that led to a spectacular fire. The whole area was evacuated and public access was restricted.

Fig. 2.4 Sand boil in Marina District, San Francisco

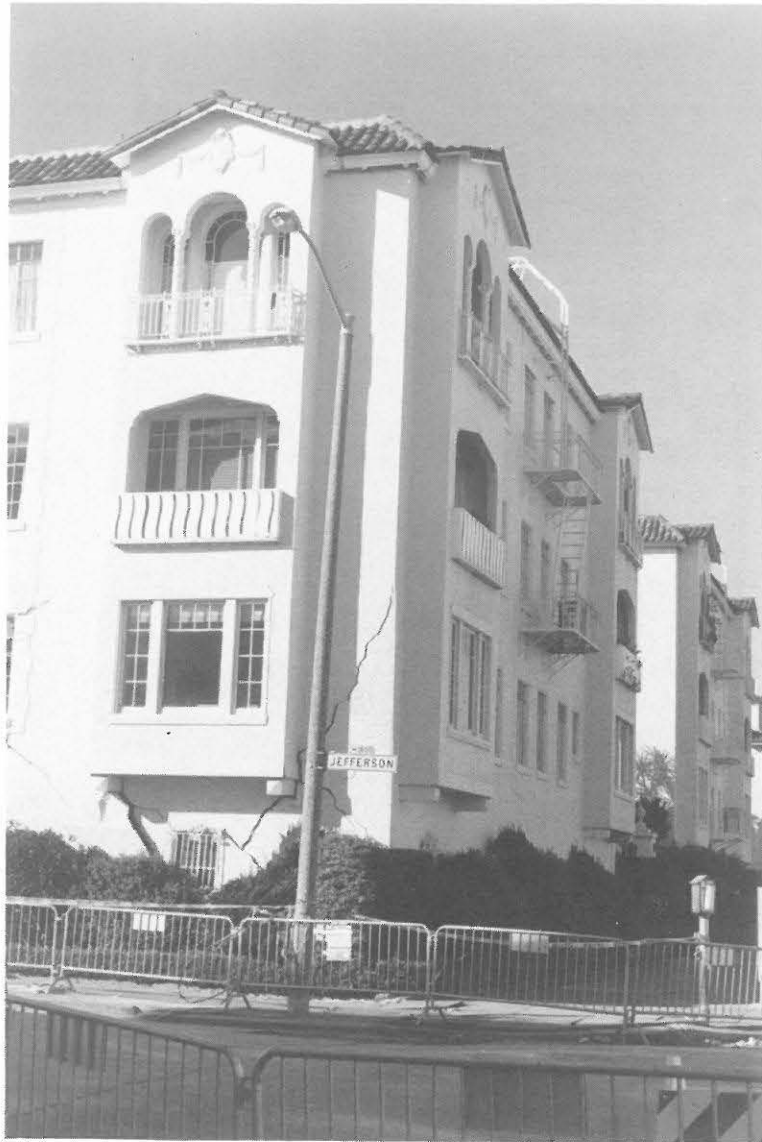
Fig. 2.5 House damaged by differential settlement due to soil liquefaction in Marina District, San Francisco

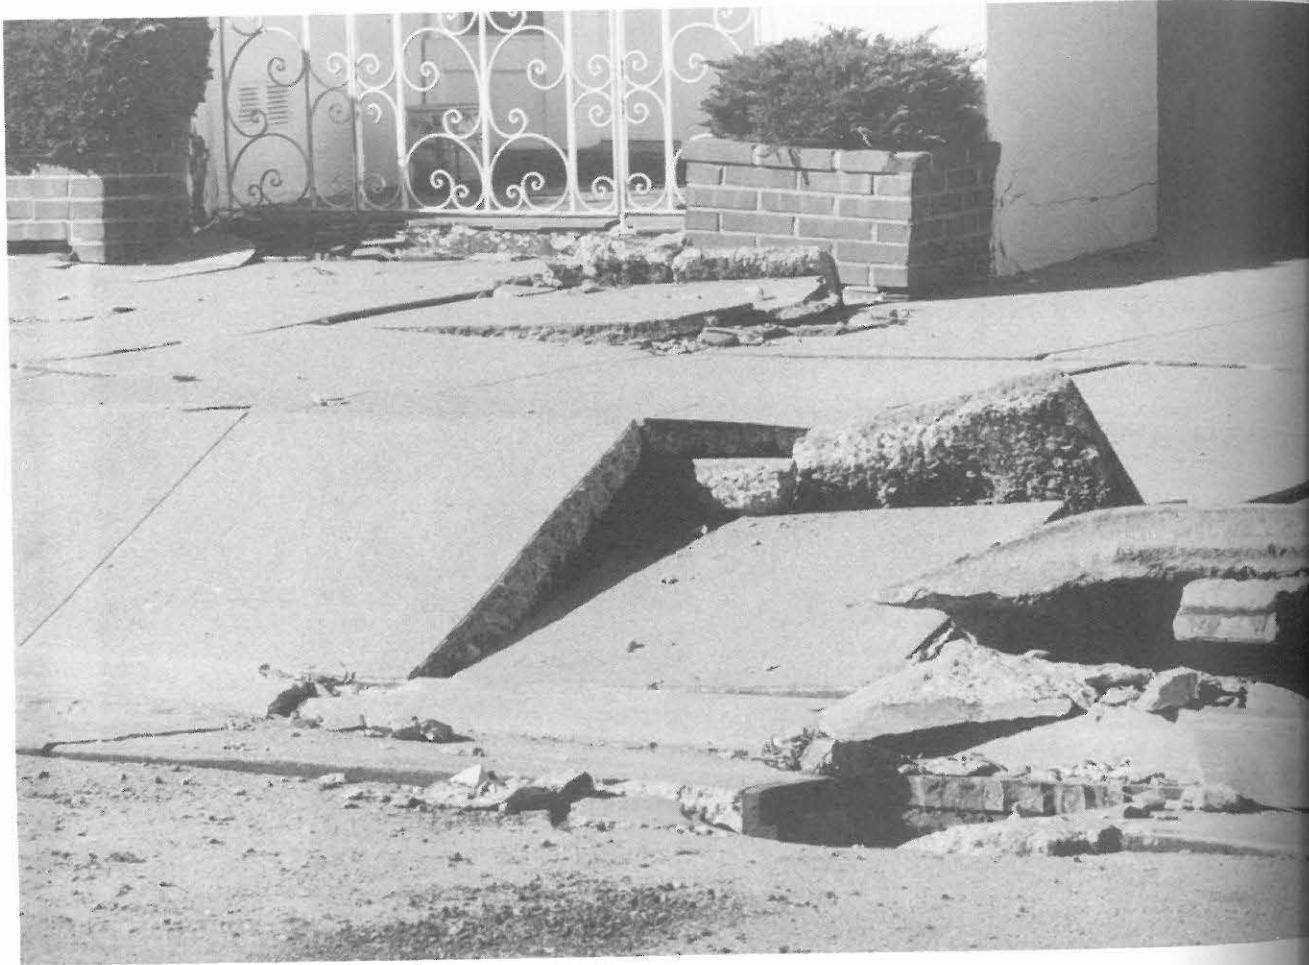
Fig. 2.6 Buckled sidewalk due to soil liquefaction in Marina District

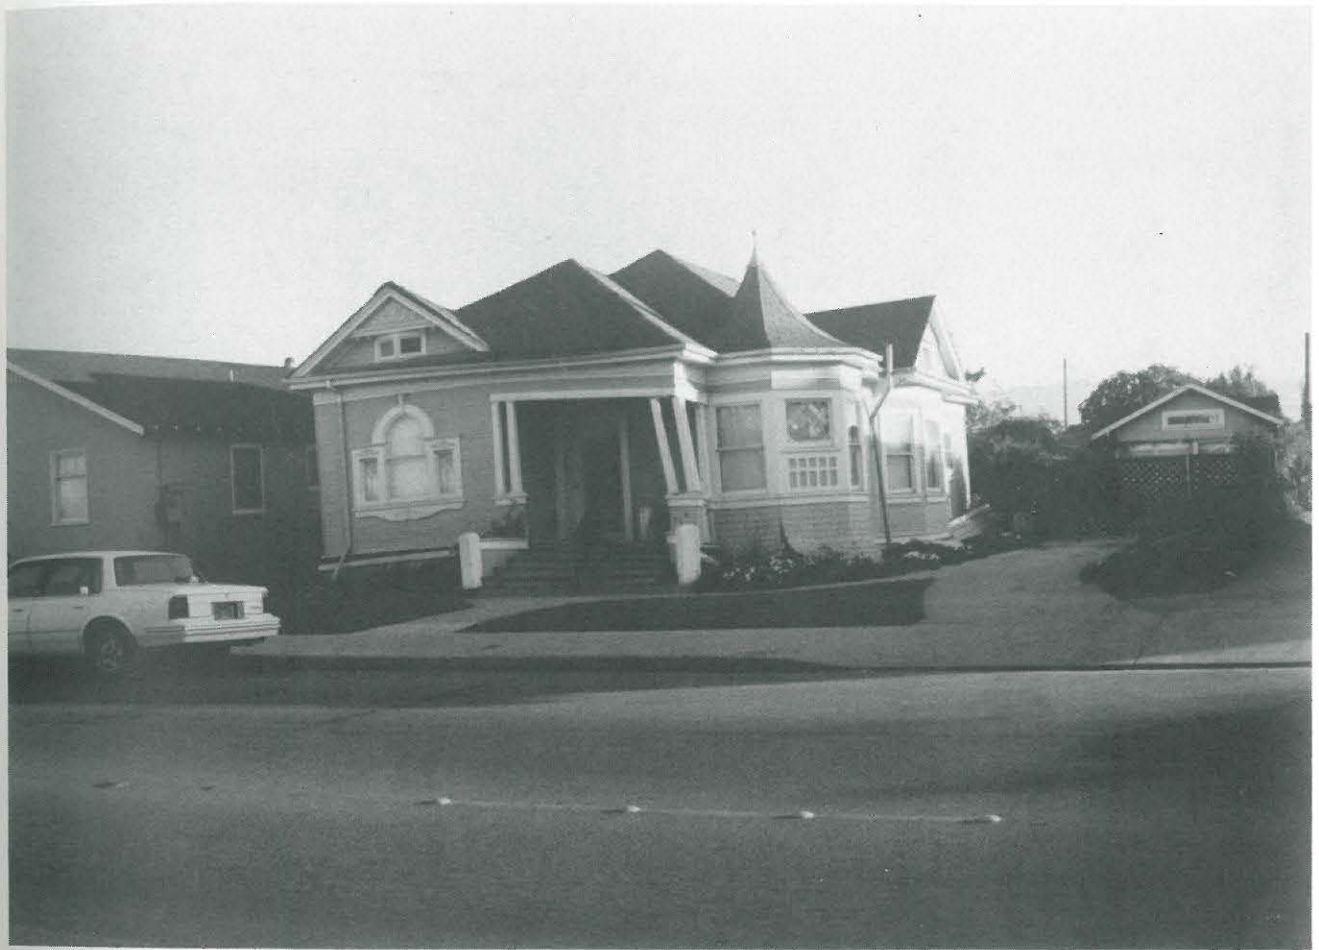
"Cripple" foundation walls, also called "pony" walls, failed in many old wood-frame single-family houses in the epicentral area (e.g., in Watsonville and in Los Gatos) causing serious damage. Cripple walls are stud type walls which connect the concrete or masonry foundations and the first floor framing. They are a typical feature in older buildings of 50 years or more in California. They are usually short (less than 14" (35.6 cm) high), but in some recently built modern wood houses could reach a height of one full storey. In many instances, the stud walls appeared not to have enough lateral resistance to withstand severe shaking. They were also poorly anchored to the foundations and sometimes were simply not connected at all.

Improper bracing (sheathing with plywood) and inadequate or missing connections to the foundations as well as to the first floor framing had caused them to be moved laterally off their foundations. In some cases, the cripple walls were lying flat on their side. The building frame lost its integrity and the house became unsafe for occupants. Examples of the cripple wall failure are presented in Figs. 3.1, 3.2, 3.3 and 3.4. These houses are in the city of Watsonville and about 12 km from the epicenter. This area experienced high frequency shaking with the horizontal acceleration reaching 0.33 g and the vertical one 0.66 g. The duration of strong shaking was approximately 16 seconds. A residence, approximately 60 years old, at Brennan Street in Watsonville is shown in Fig. 3.1. Failing cripple walls shifted the overall wood-frame structure off the foundations and caused partial loss of integrity. Although these walls were sometimes sheathed or sealed with horizontal boards, nailing was sparser than required by the present code. The panels could not provide the lateral resistance to prevent rocking and in some instances this led to the complete failure of cripple stud walls. Figure 3.2 presents this type of complete failure and also a destroyed entrance porch in an old residence at 130 Brennan Street in Watsonville. Another cripple wall failure is shown in Fig. 3.3 where the house at 113 Sudden Street in Watsonville was shifted by more than 1 ft (32 cm). Also, large openings (e.g., porches) collapsed due to lack of lateral resistance. Some examples of collapsed porches are shown in Figs. 3.4, 3.5 and 3.7. Figure 3.6 also shows a collapse of the cripple wall in the house as well as of the porch. The small staircase leading to the porch was destroyed and later removed. This is an old residence with a cripple wall on its perimeter. The cripple wall was moved about 18 in. (45 cm) laterally due to lack of anchorage to the foundation (Fig. 3.6). The collapsing porch also caused extensive damage to the ceilings (Figs. 3.5 and 3.7).

Fig. 3.1 An old residence with cripple wall failure affecting integrity - 114 Brennan Street in Watsonville

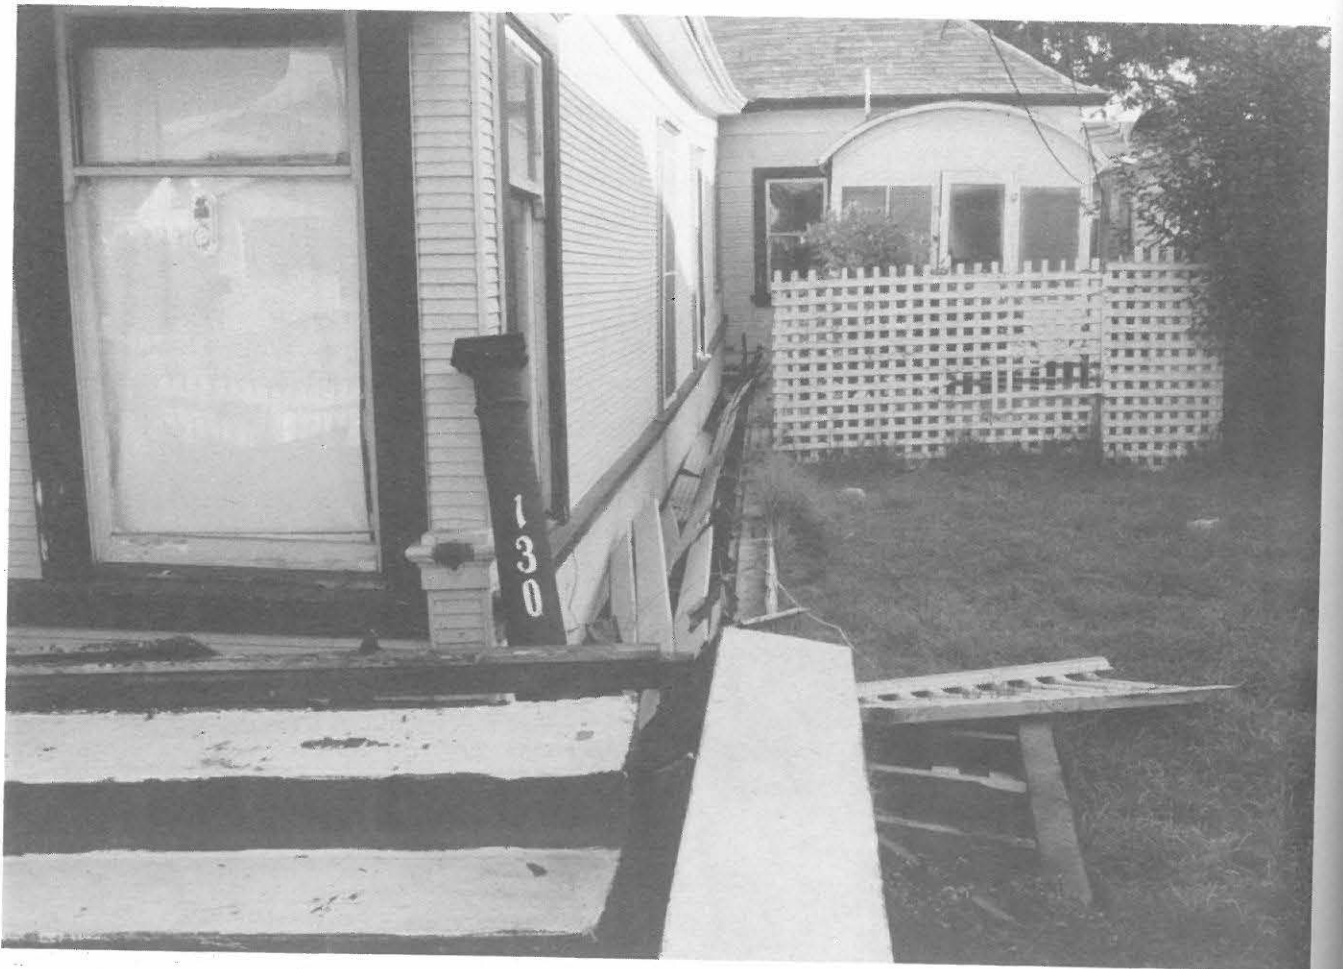
Fig. 3.2 Complete collapse of cripple wall (approx. 2' (64 cm) shift) and destroyed entrance porch due to foundation settlement - 130 Brennan Street in Watsonville

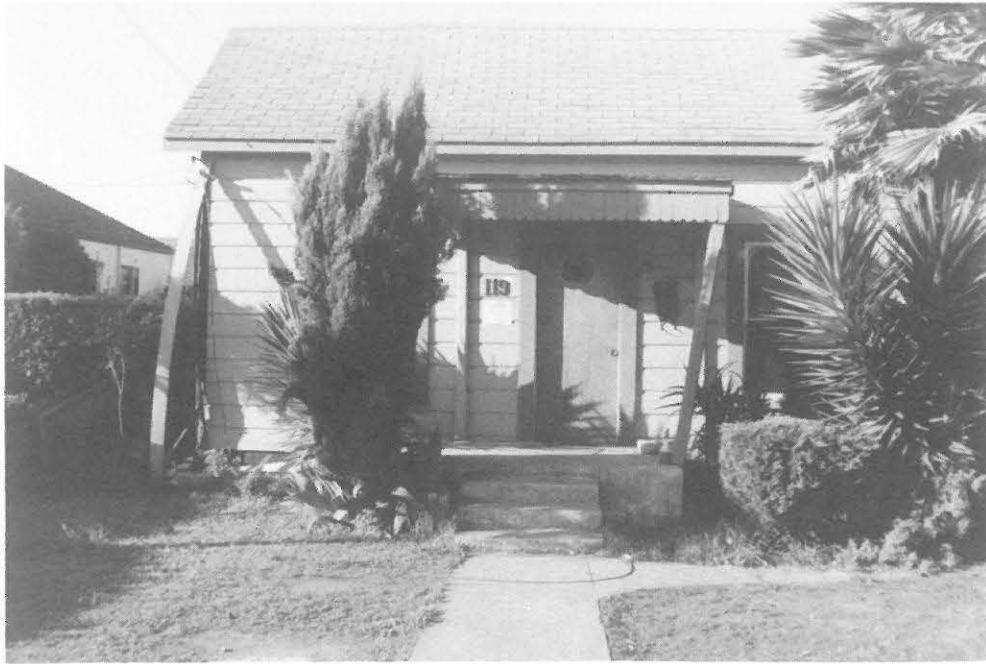
Fig. 3.3 The collapsed cripple wall shifted this house by more than 1' (32 cm) at 119 Sudden Street in Watsonville

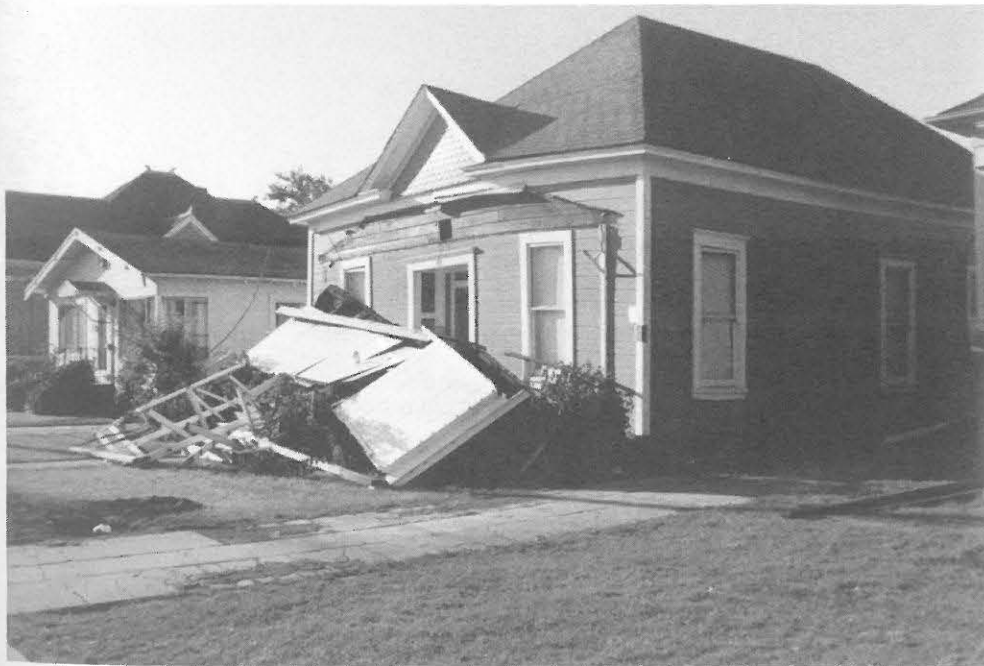
Fig. 3.4 Two houses on Sudden Street, one with cripple wall failure and collapsed entrance porch, and the other with no damage - City of Watsonville

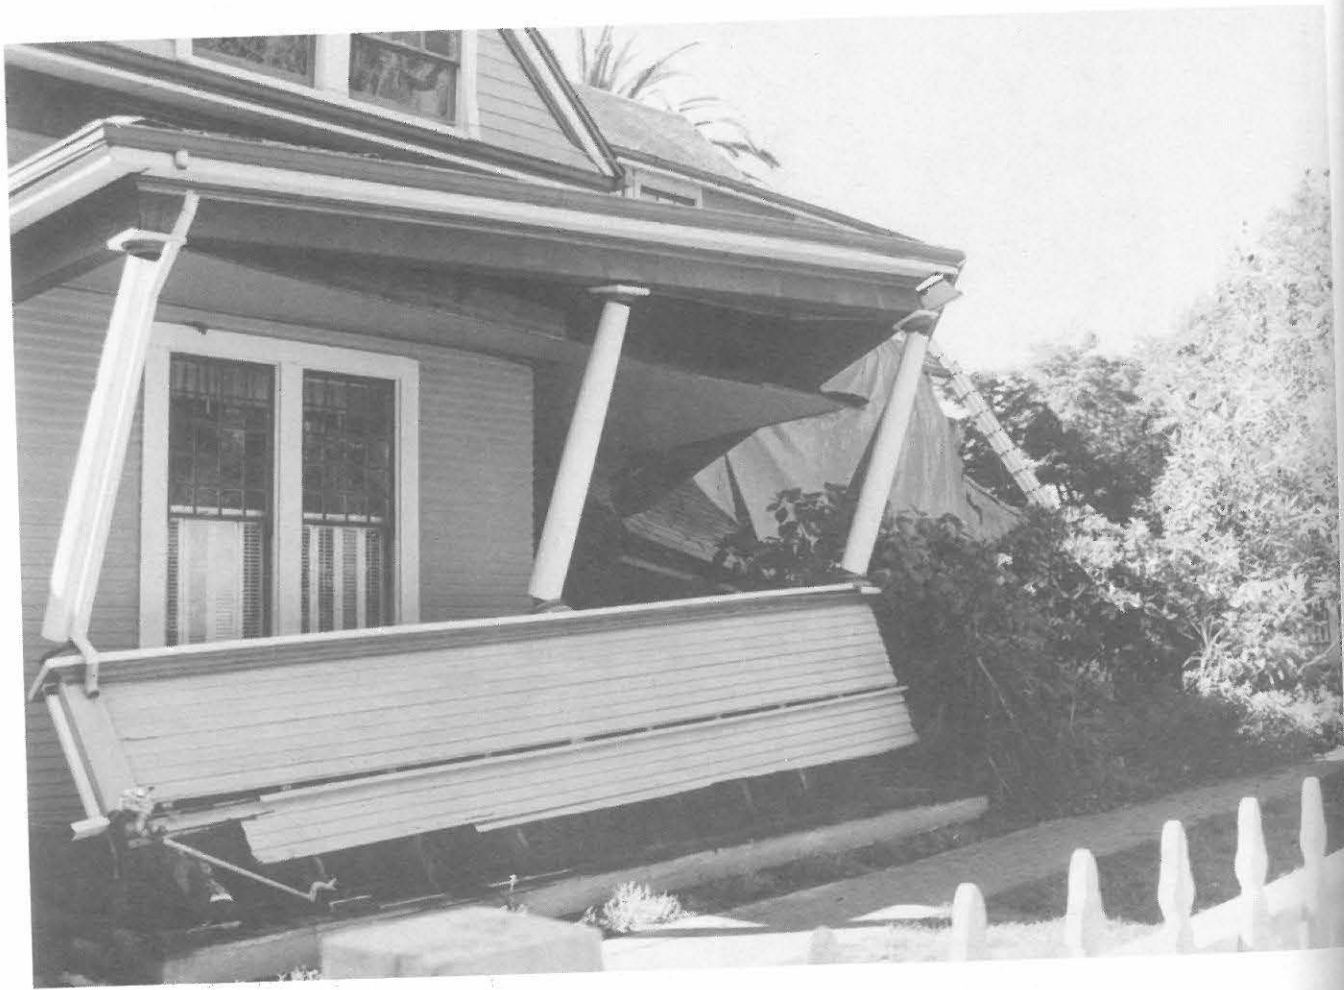
Fig. 3.5 Collapsed cripple wall and porch in an old residence at Main Street in Los Gatos

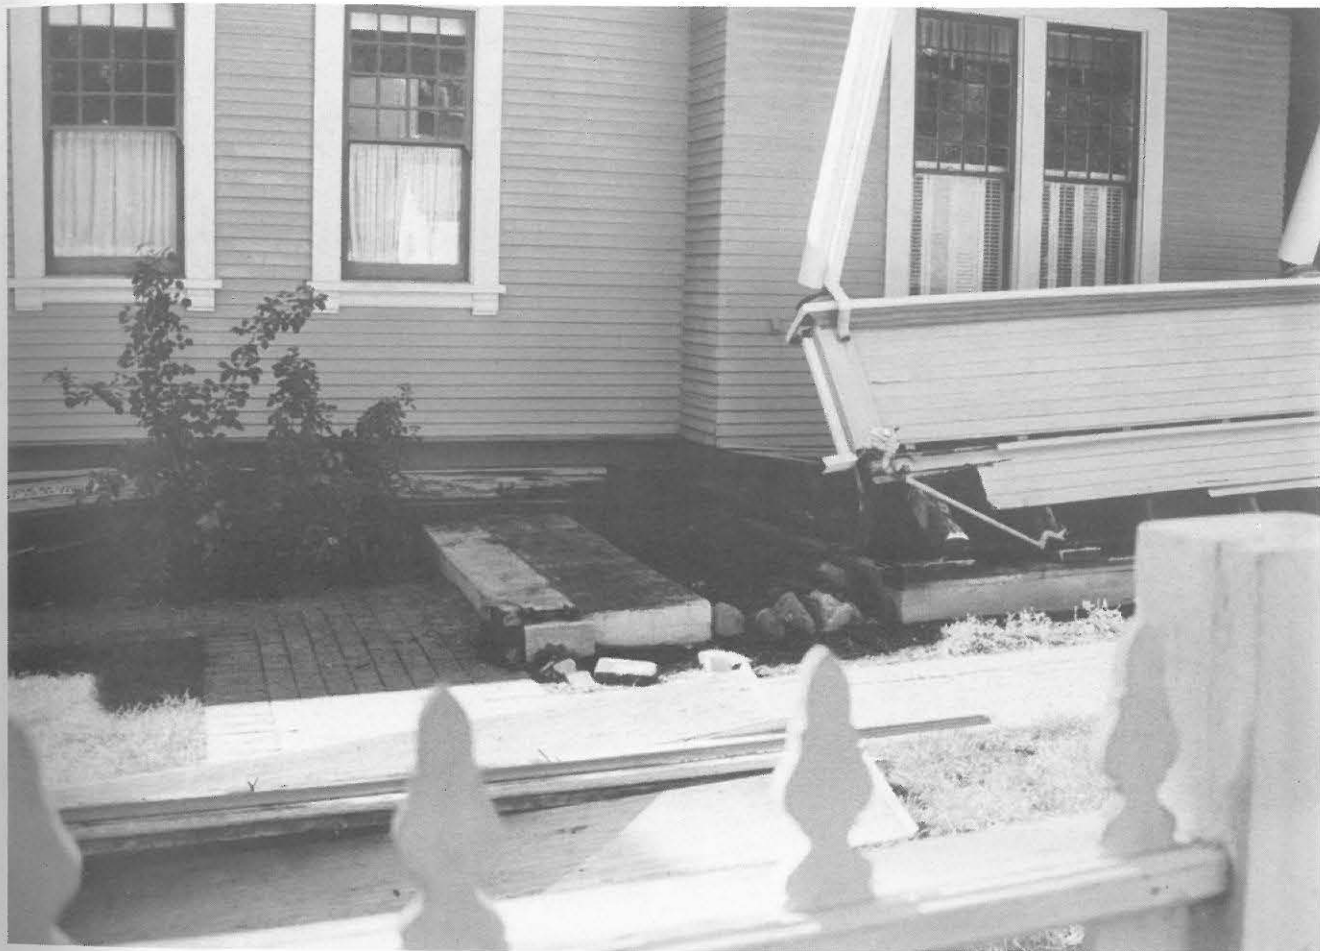
Fig. 3.6 House shifted from the foundation by approximately 18" (45 cm) and the small staircase to the porch destroyed and removed in a residence on Main Street in Los Gatos

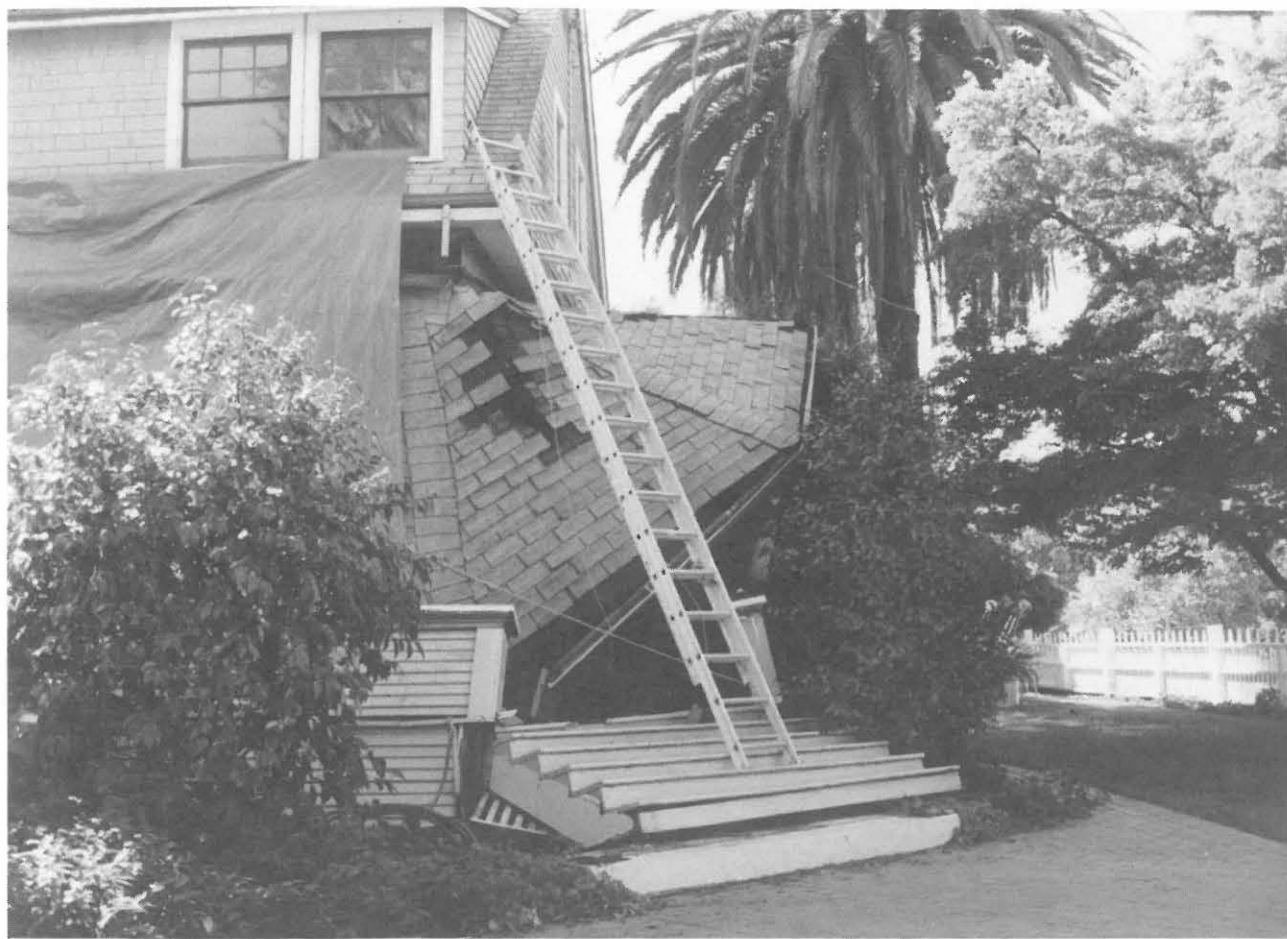
Fig. 3.7 Collapsed porch in an old residence on Main Street in Los Gatos

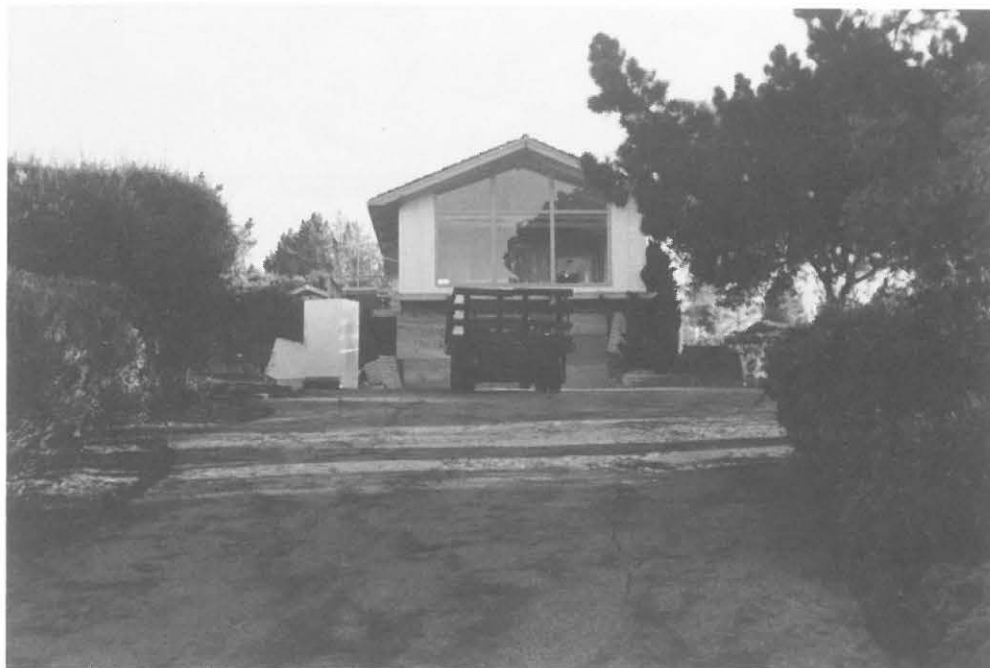
Fig. 3.8 Damage to a modern wood-frame house in Los Altos Hills

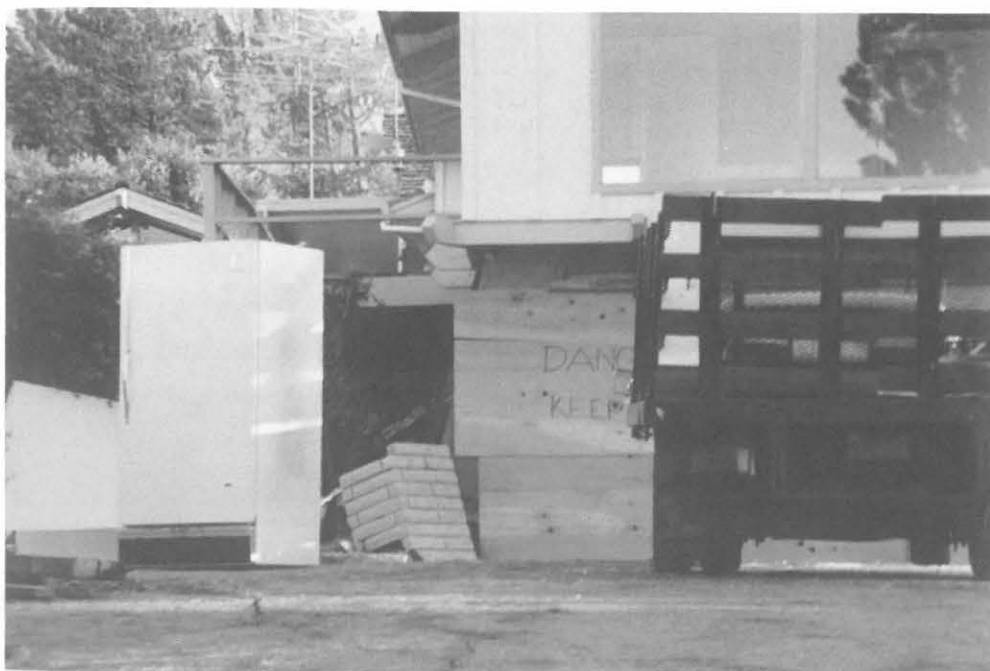
Fig. 3.9 Lack of lateral resistance and creation of two hinges in garage posts contributed to damage (note destroyed brick veneer wall)

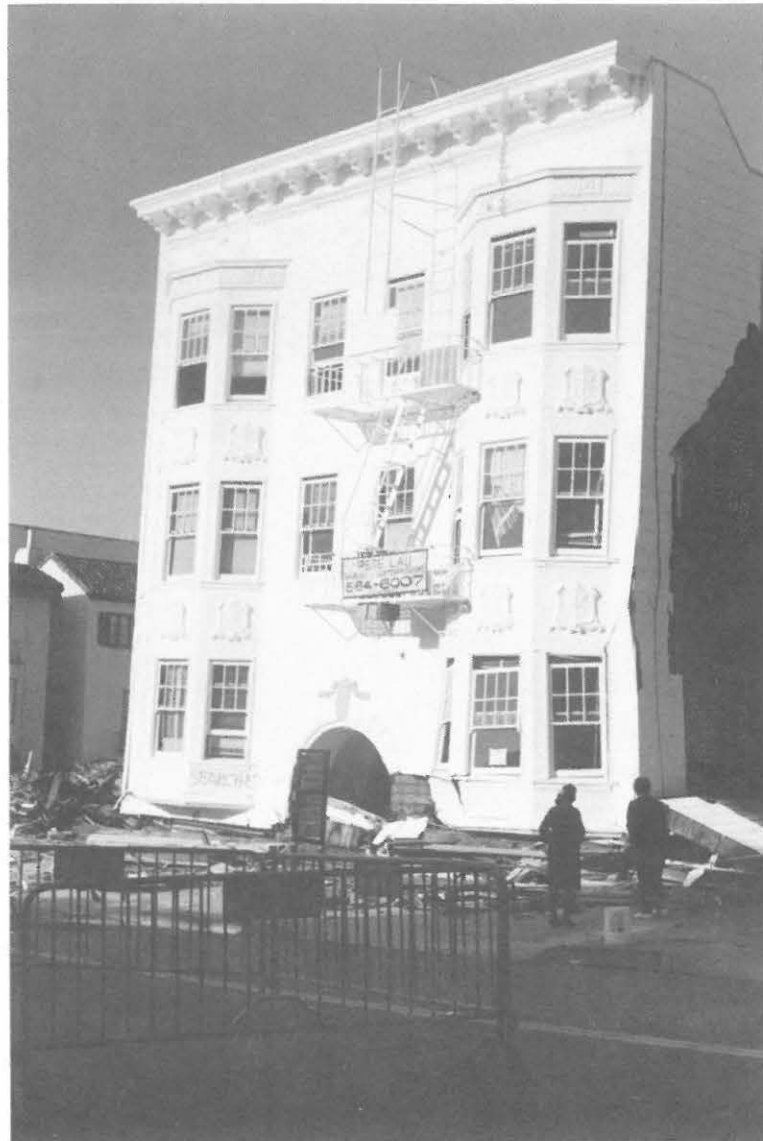
Fig. 3.10. A 4-storey wood-frame multi-apartment house reduced to 3-storey building in the Marina District, San Francisco

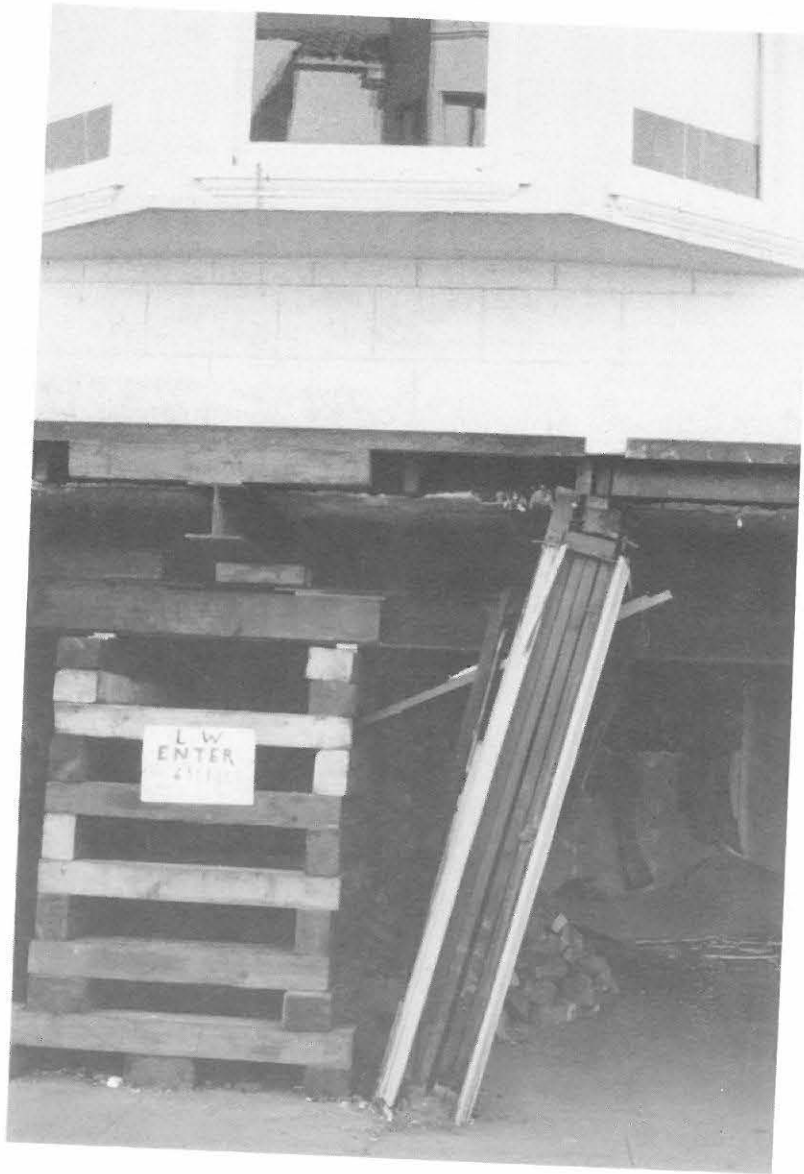
Fig. 3.14. Inadequate connection detail between post and floor framing in the corner 4-storey apartment building in Marina District, San Francisco

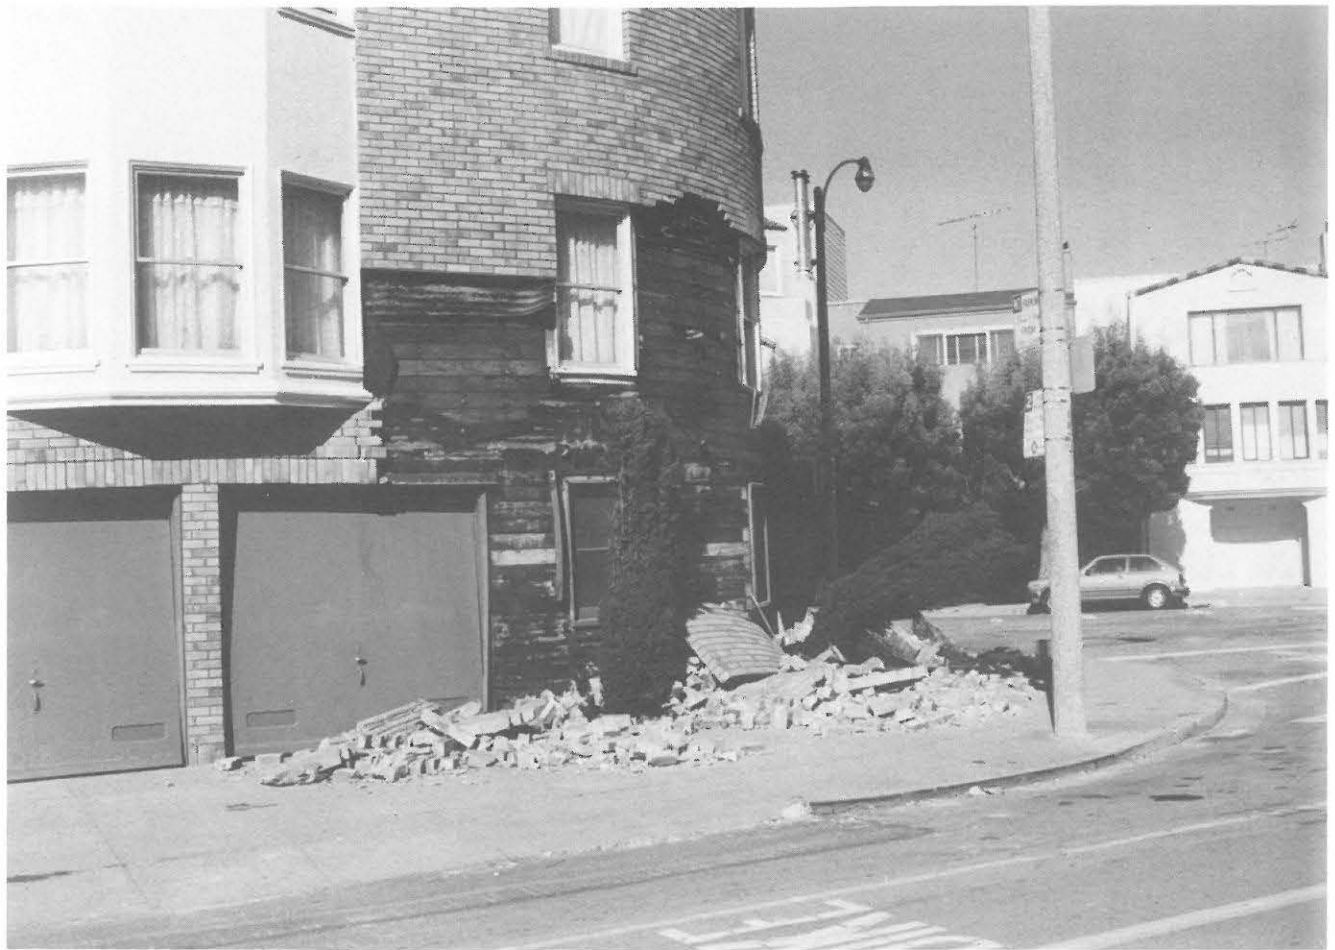
Fig. 3.15. 4-storey apartment building with more sheathed walls (horizontal boards) experienced less damage and much less horizontal shift - Marina District, San Francisco

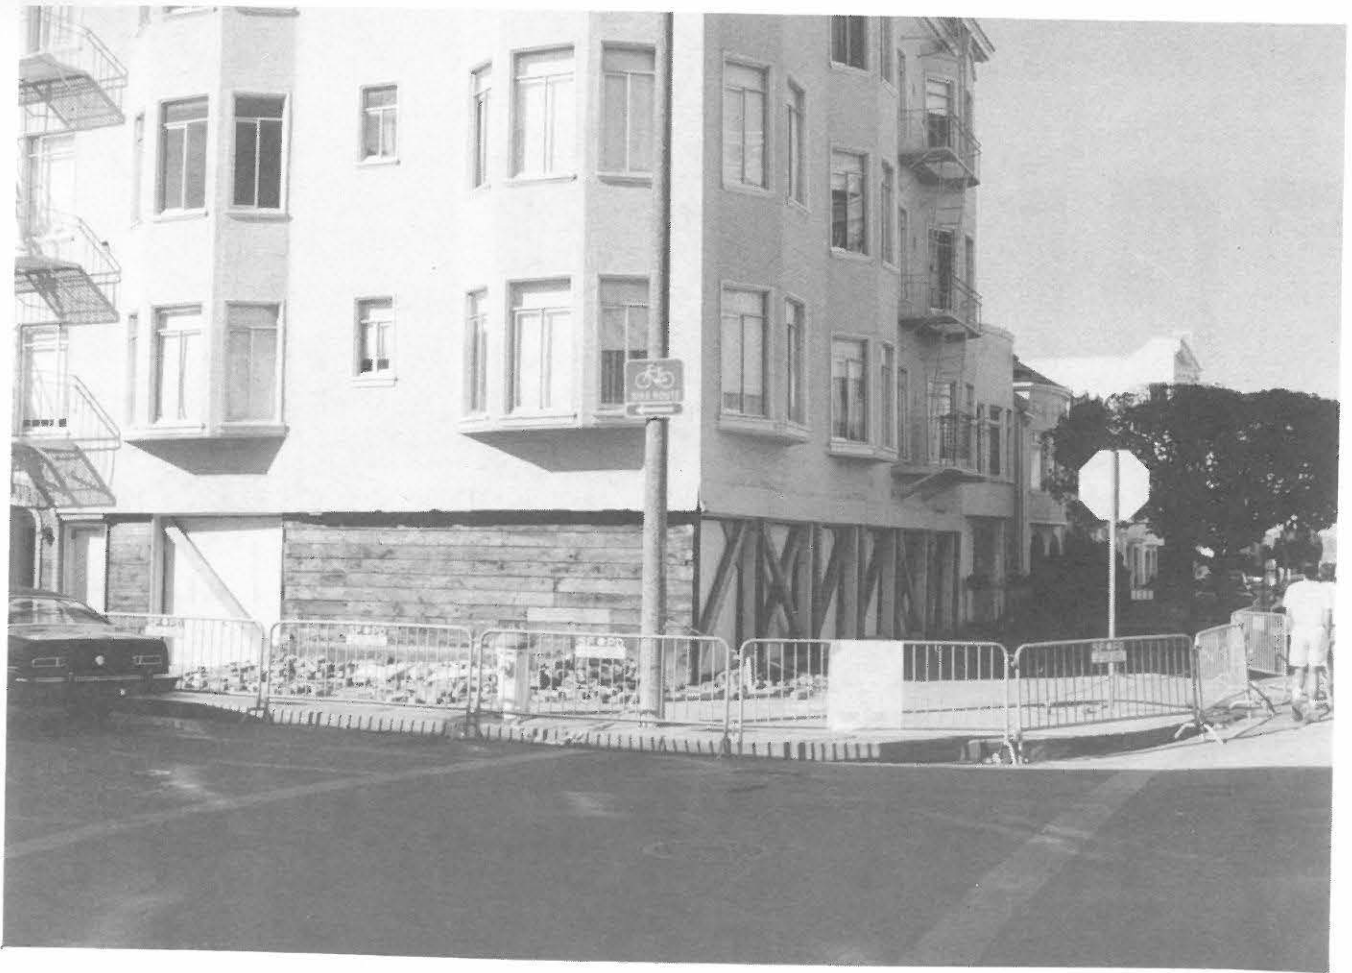
Fig. 3.16. 4-storey apartment building with destroyed brick wall - Marina District, San Francisco

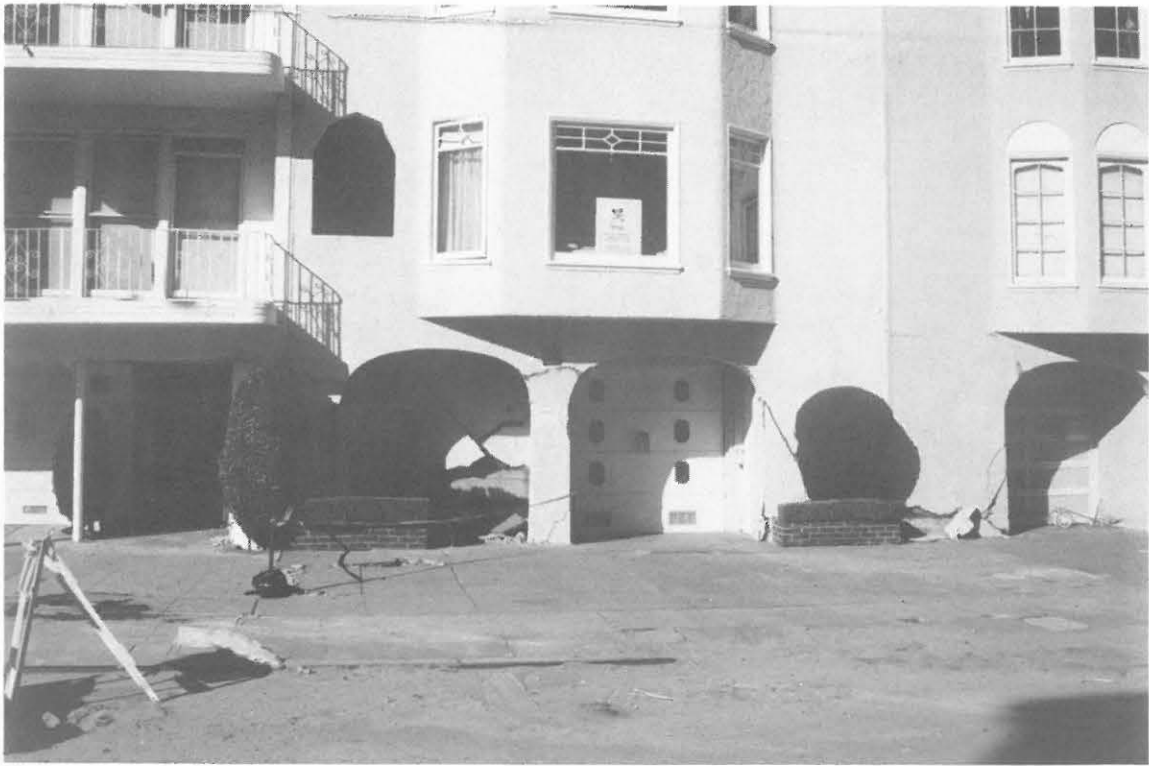
Fig. 3.17. An example of 3-storey building covered with stucco which experienced minor damage over openings at the first floor level - Marina District, San Francisco

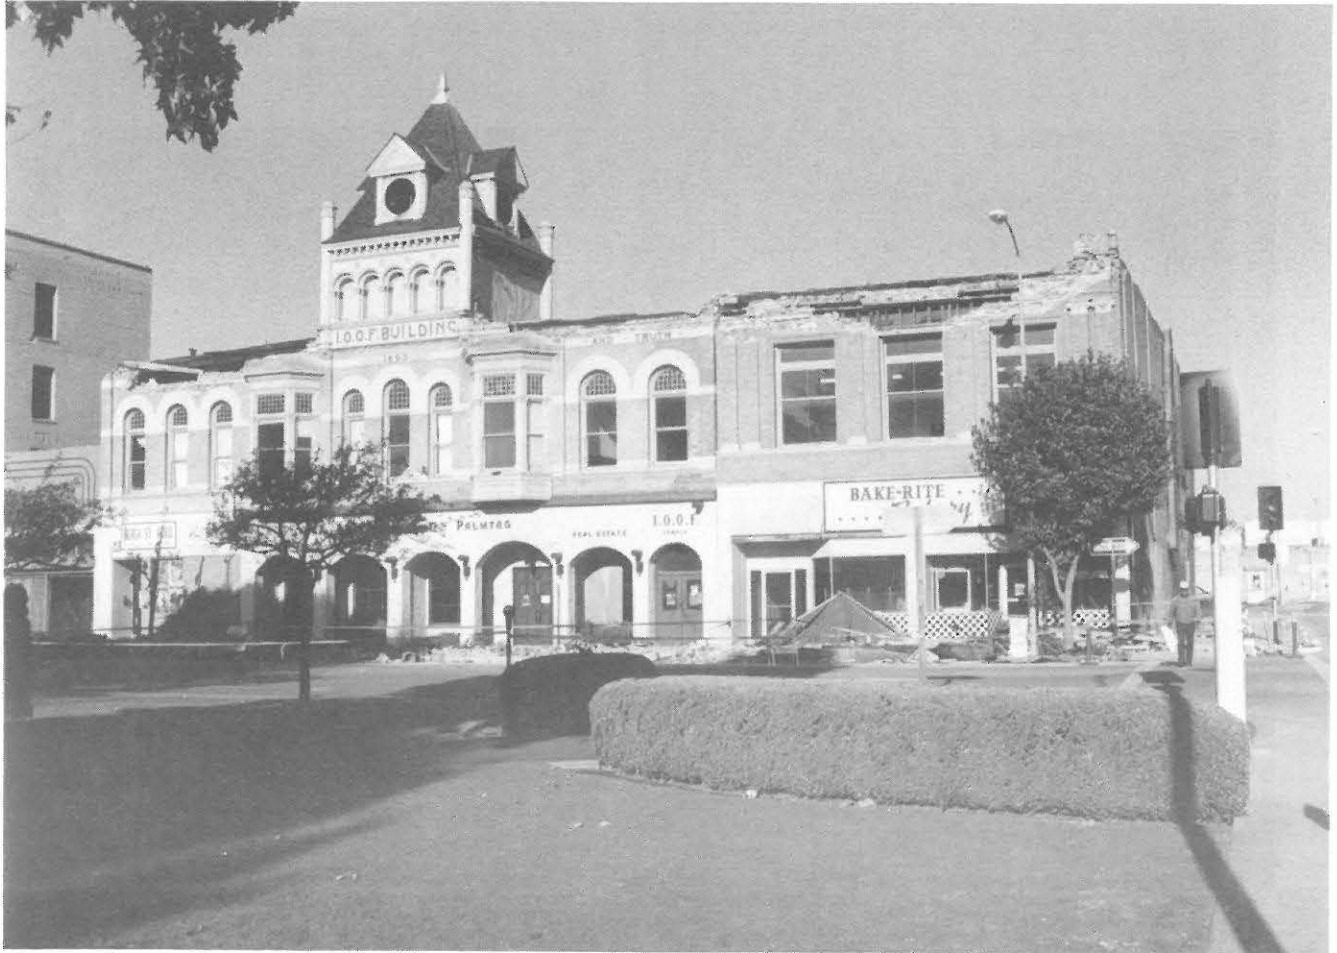
Fig. 3.18. Damage to an old unreinforced masonry building structure - I.O.O.F. Building built in 1893 on East Beach Street in Watsonville
