Institute for
Research in
Construction

The 1989 Loma Prieta (San Francisco Area) Earthquake: Site Visit Report

Internal Report No. 594

Date of issue: May 1990

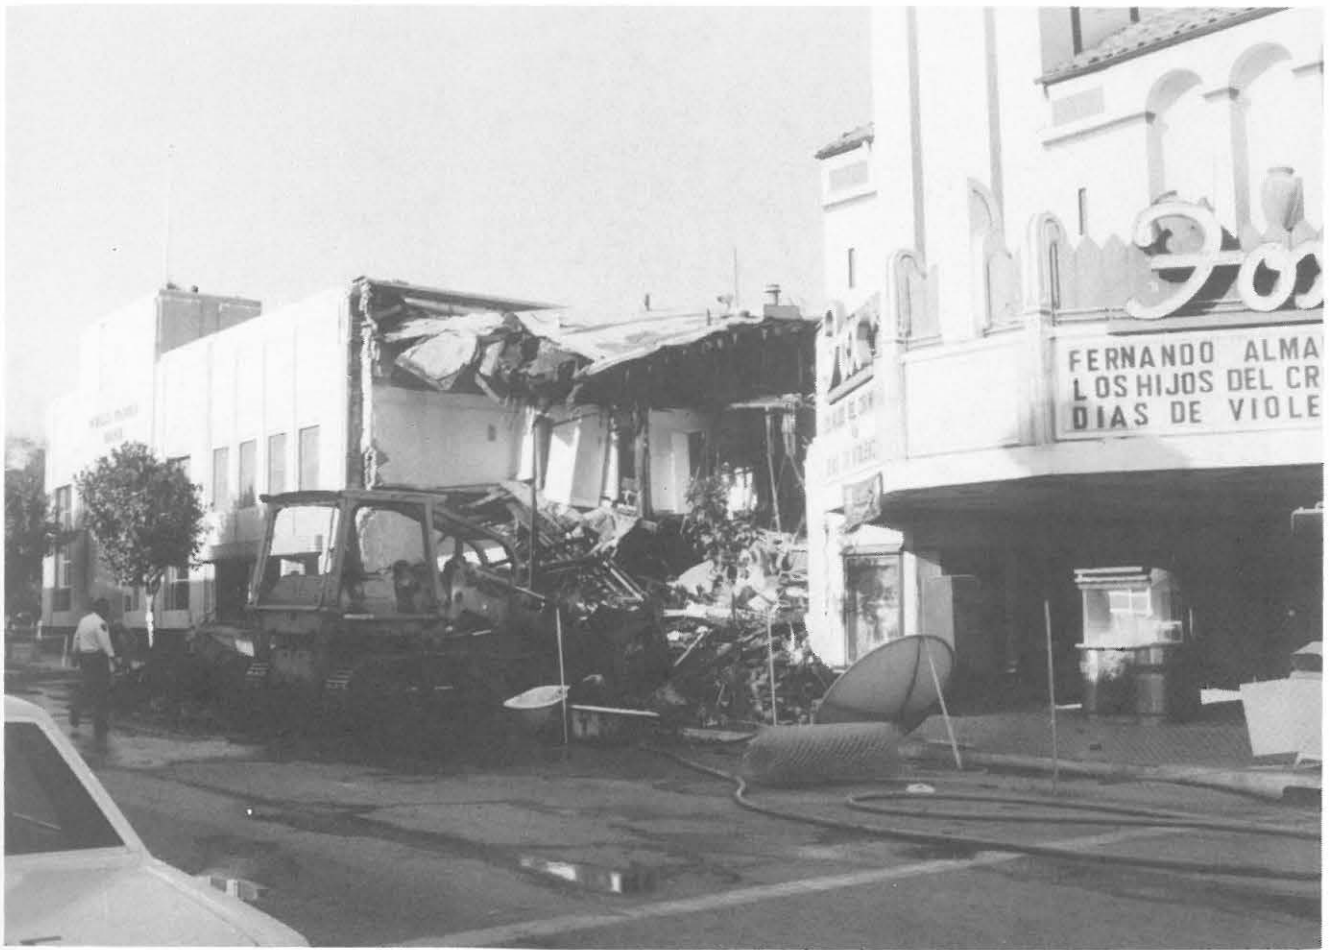
Fig. 3.19. Demolishing process of the heavily damaged unreinforced masonry building on Main Street in downtown Watsonville

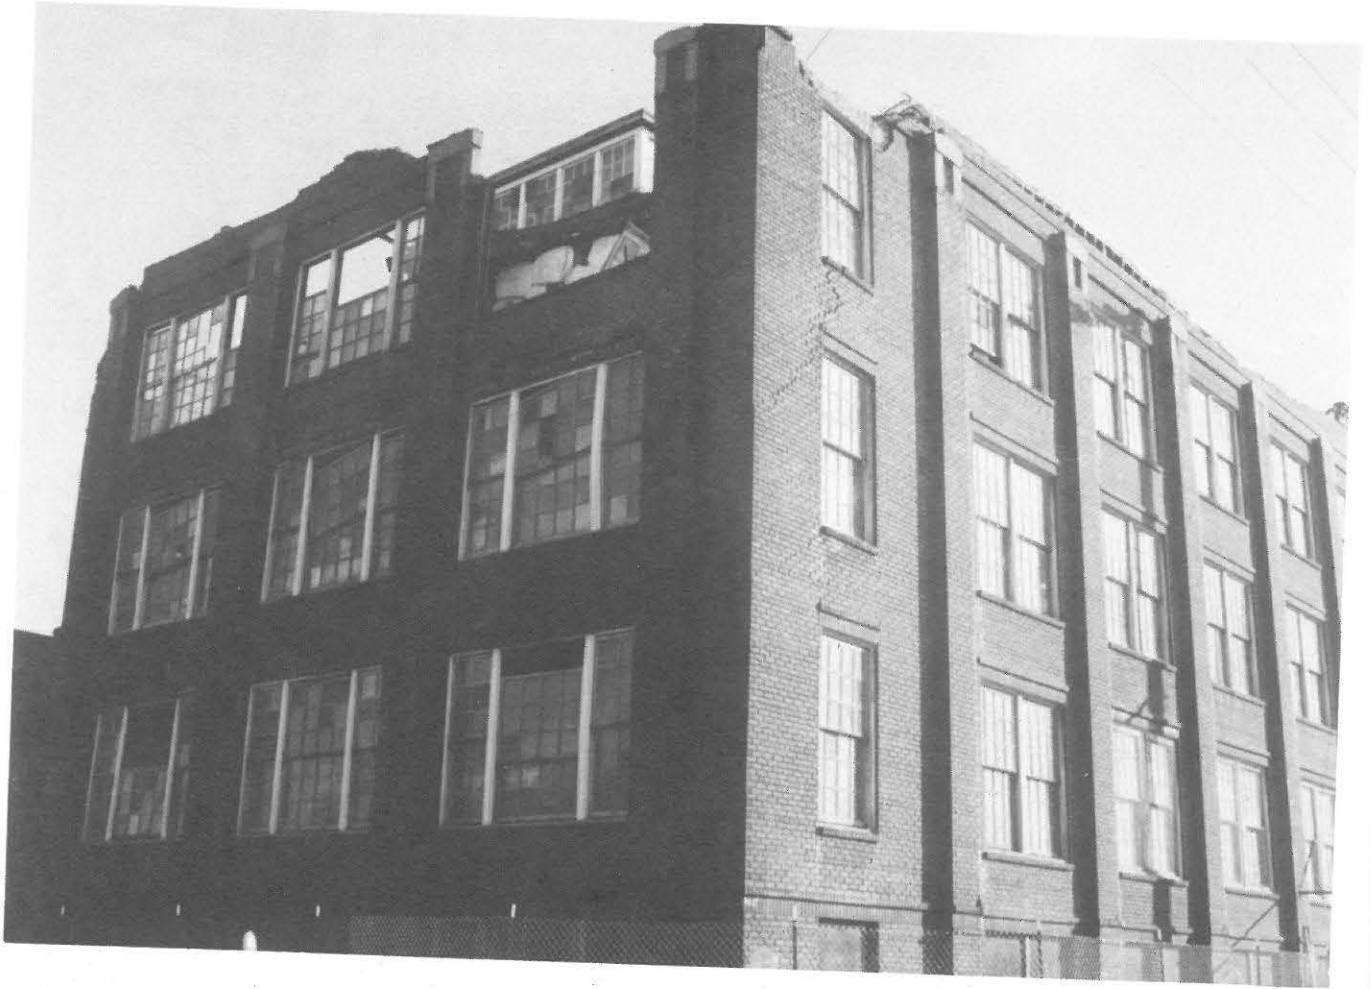
Fig. 3.20. A 4-storey storage building on Campbell Street in Oakland with damage to the parapet walls and collapsed roof

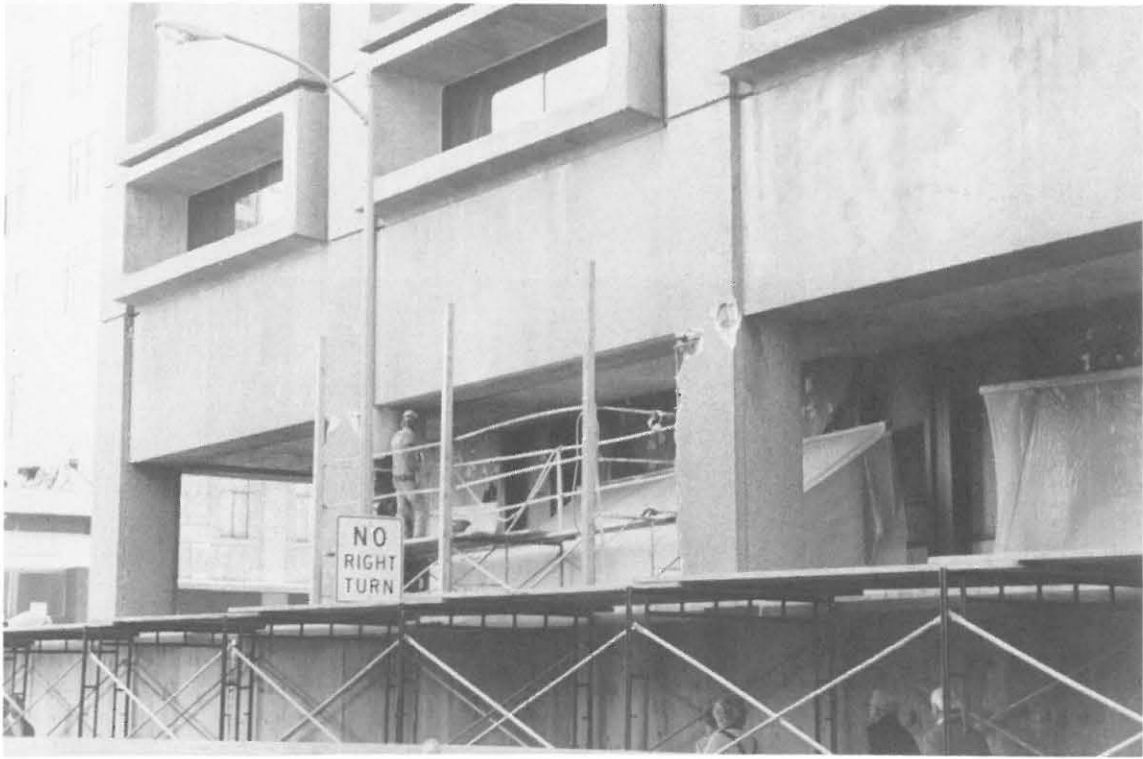
Fig. 3.21. Damage to first-level concrete columns and shear walls in high-rise building in downtown Oakland

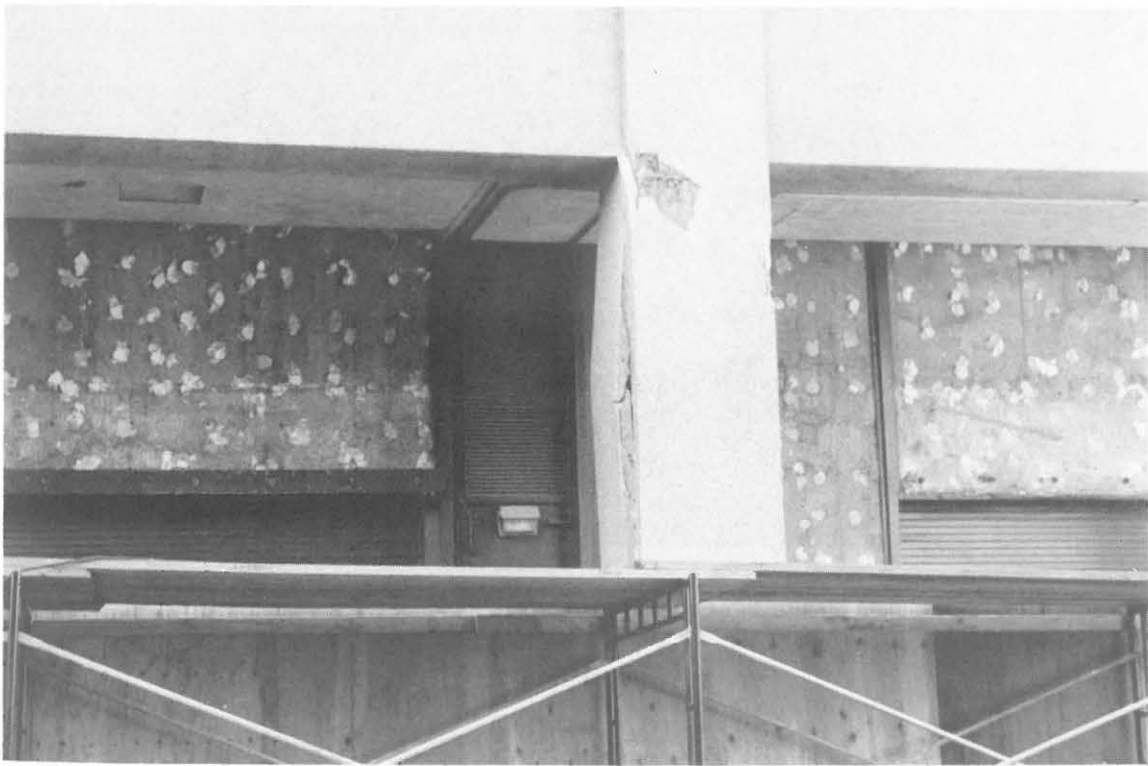
Fig. 3.22. Damage to column in high-rise building in downtown Oakland

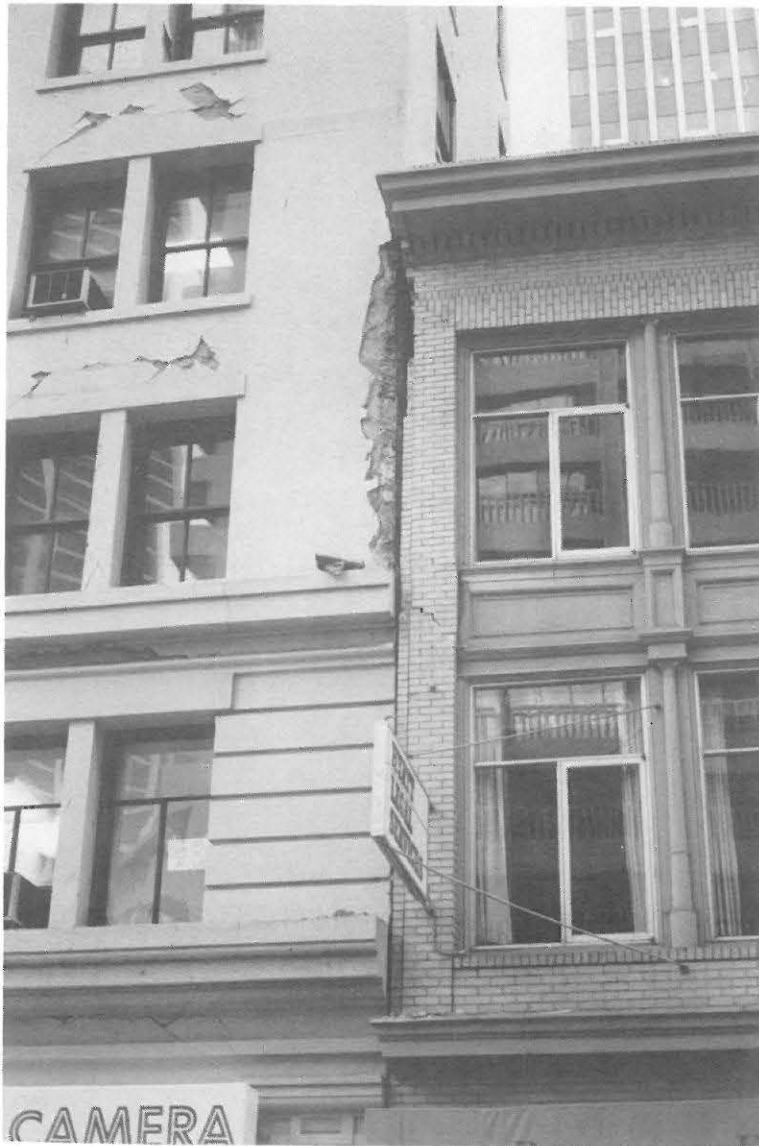
Fig. 3.23. An example of pounding between two adjacent buildings, Mission Street, San Francisco

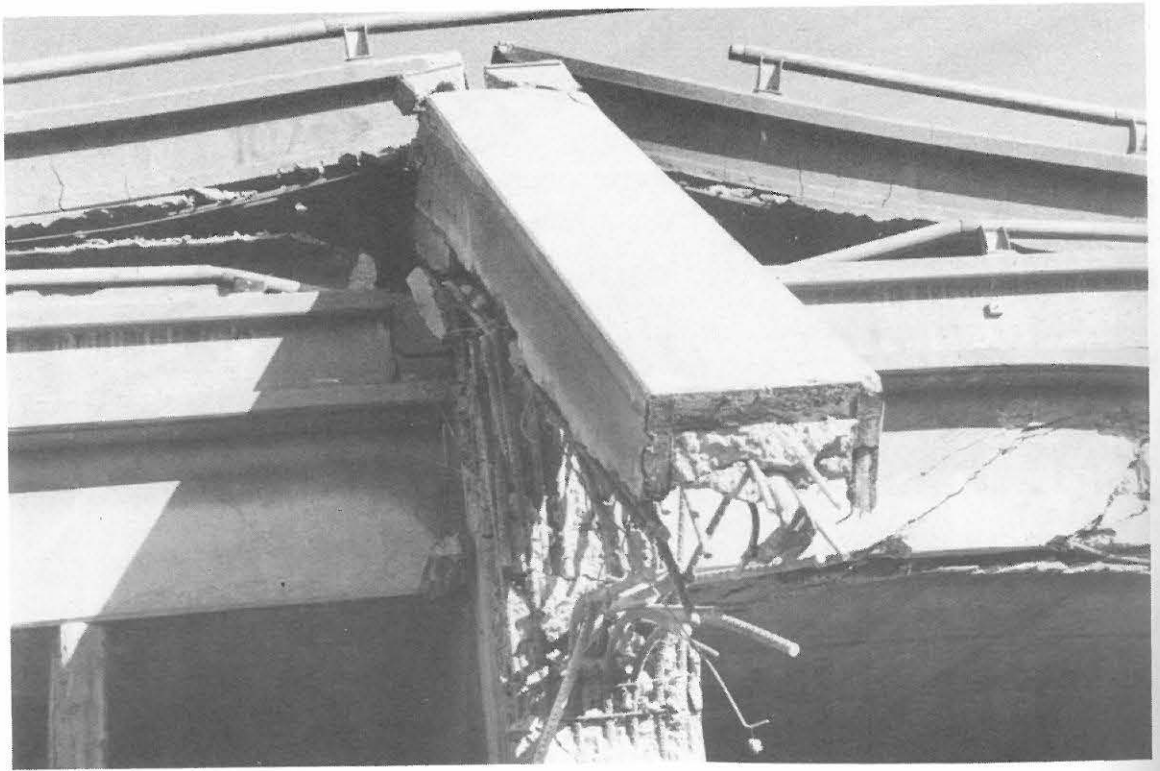
Fig. 4.5 Detail of upper column failure

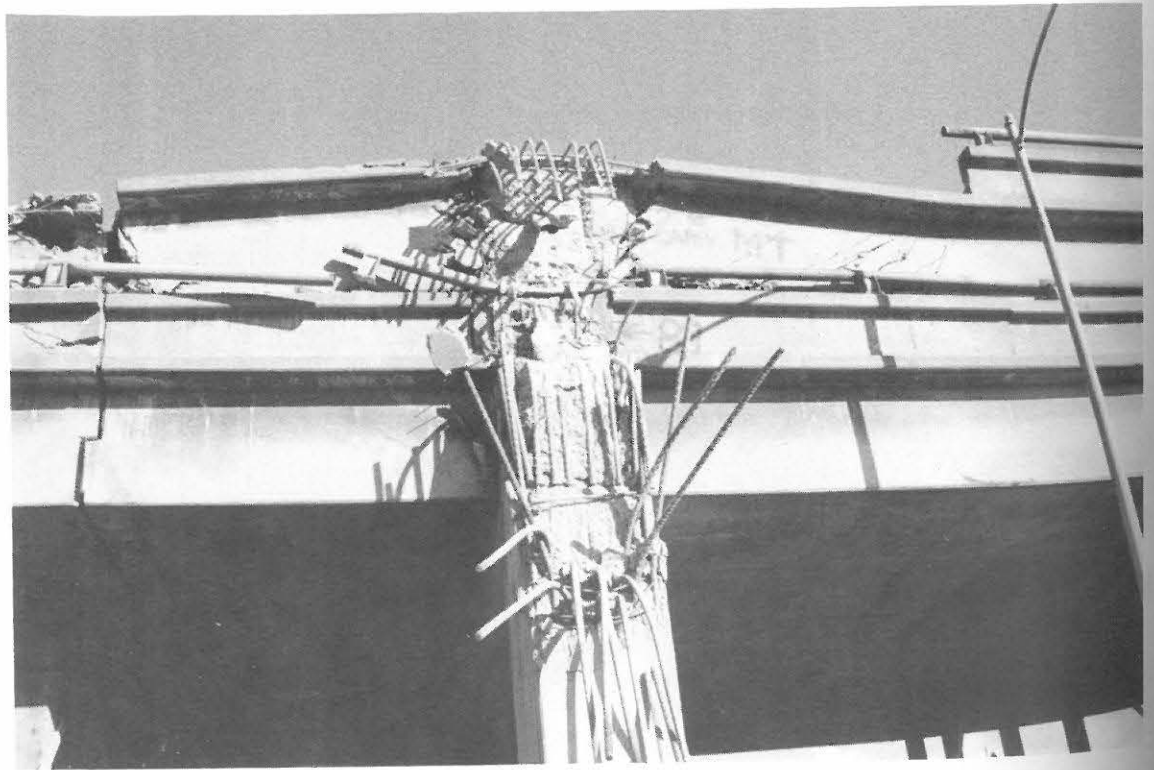
Fig. 4.6 Detail of lower column damage

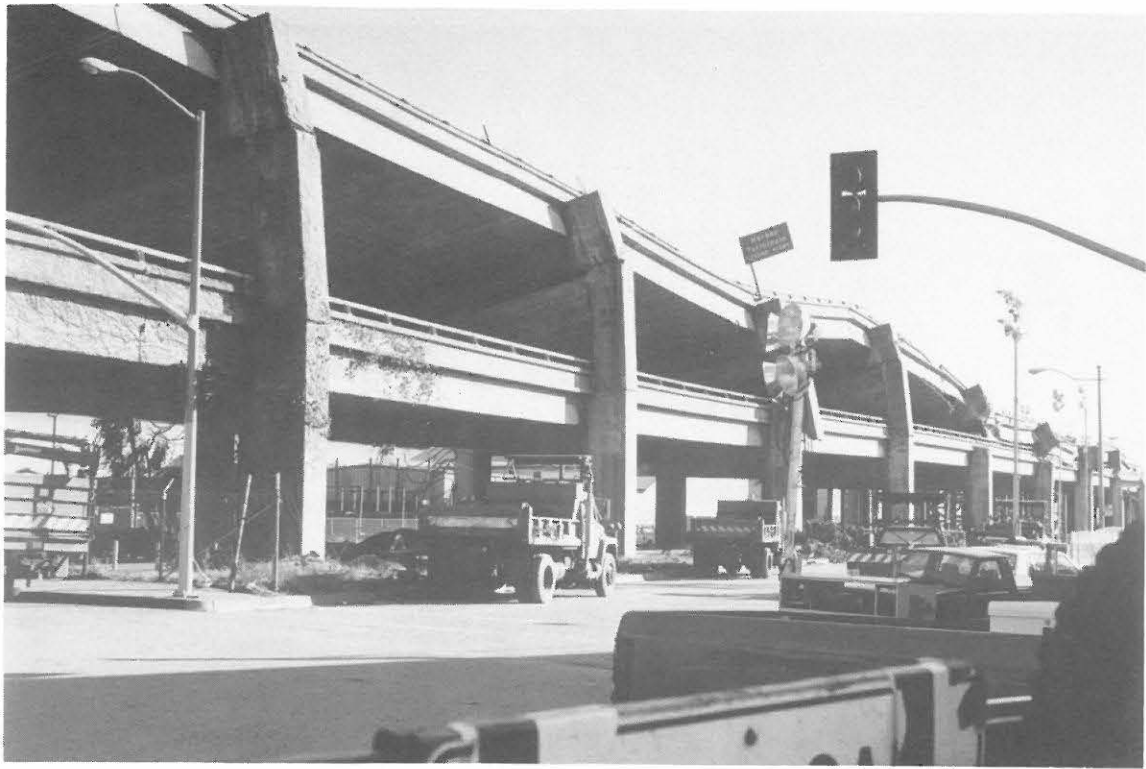
Fig. 4.7 Partial collapse of upper deck

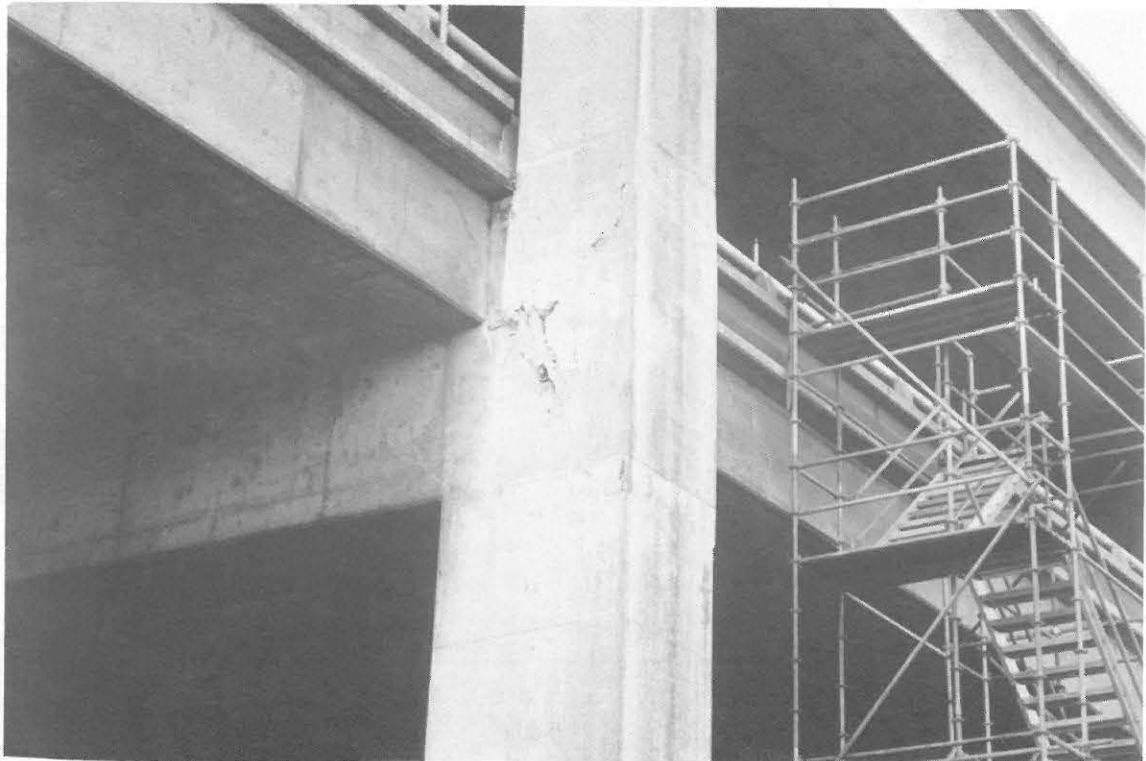
Fig. 4.8 Diagonal shear cracks in Embarcadero Freeway

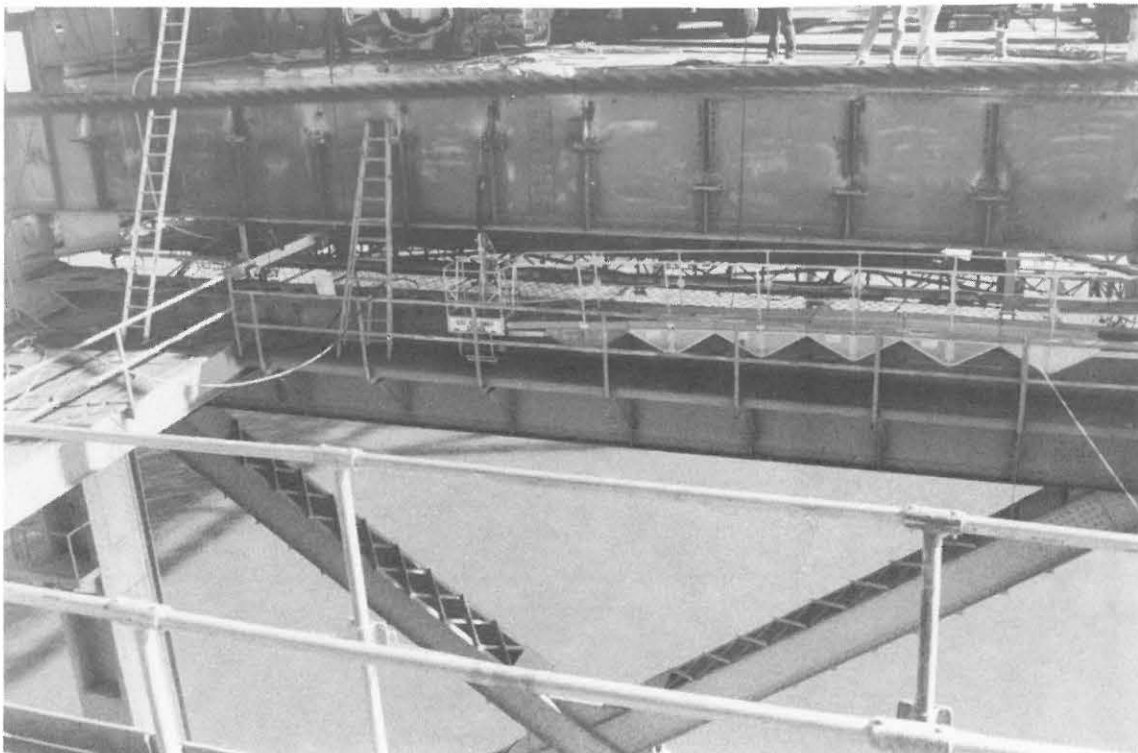
Fig. 4.11 The lower transverse girder with remaining parts of connectors which were destroyed during the earthquake

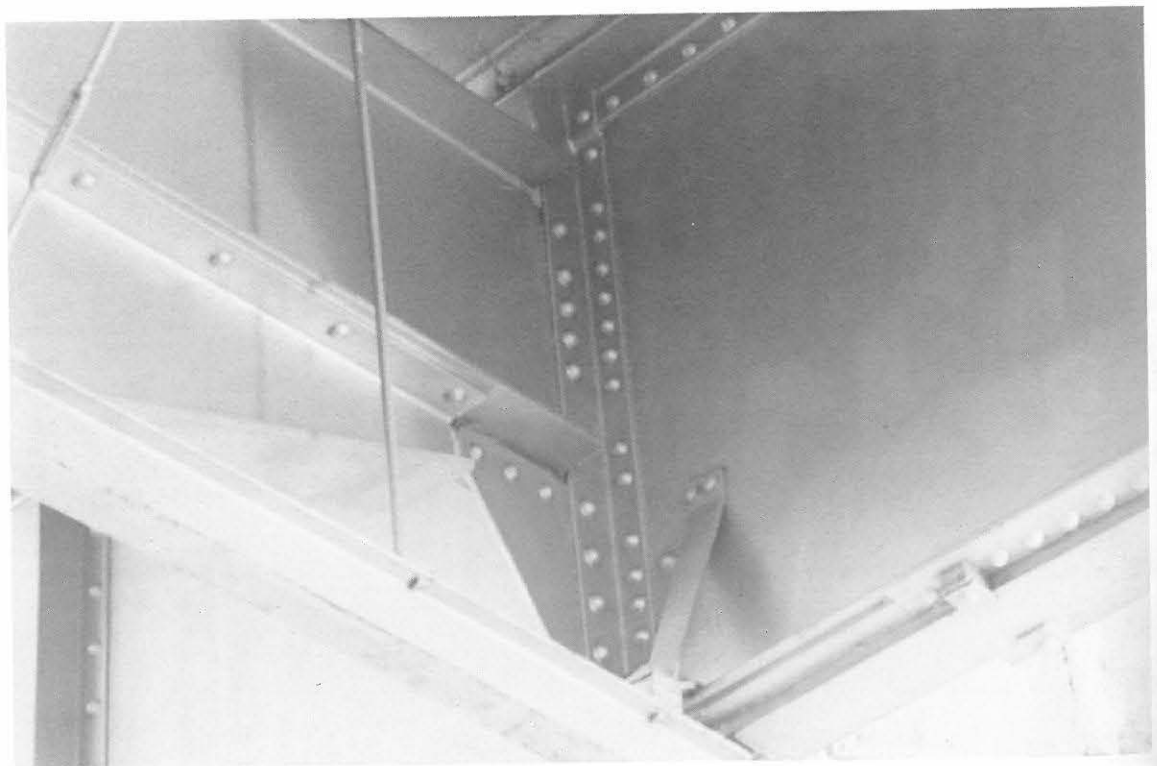
Fig. 4.13 Close-up of the detail similar to that which failed on the other side of the transverse girder

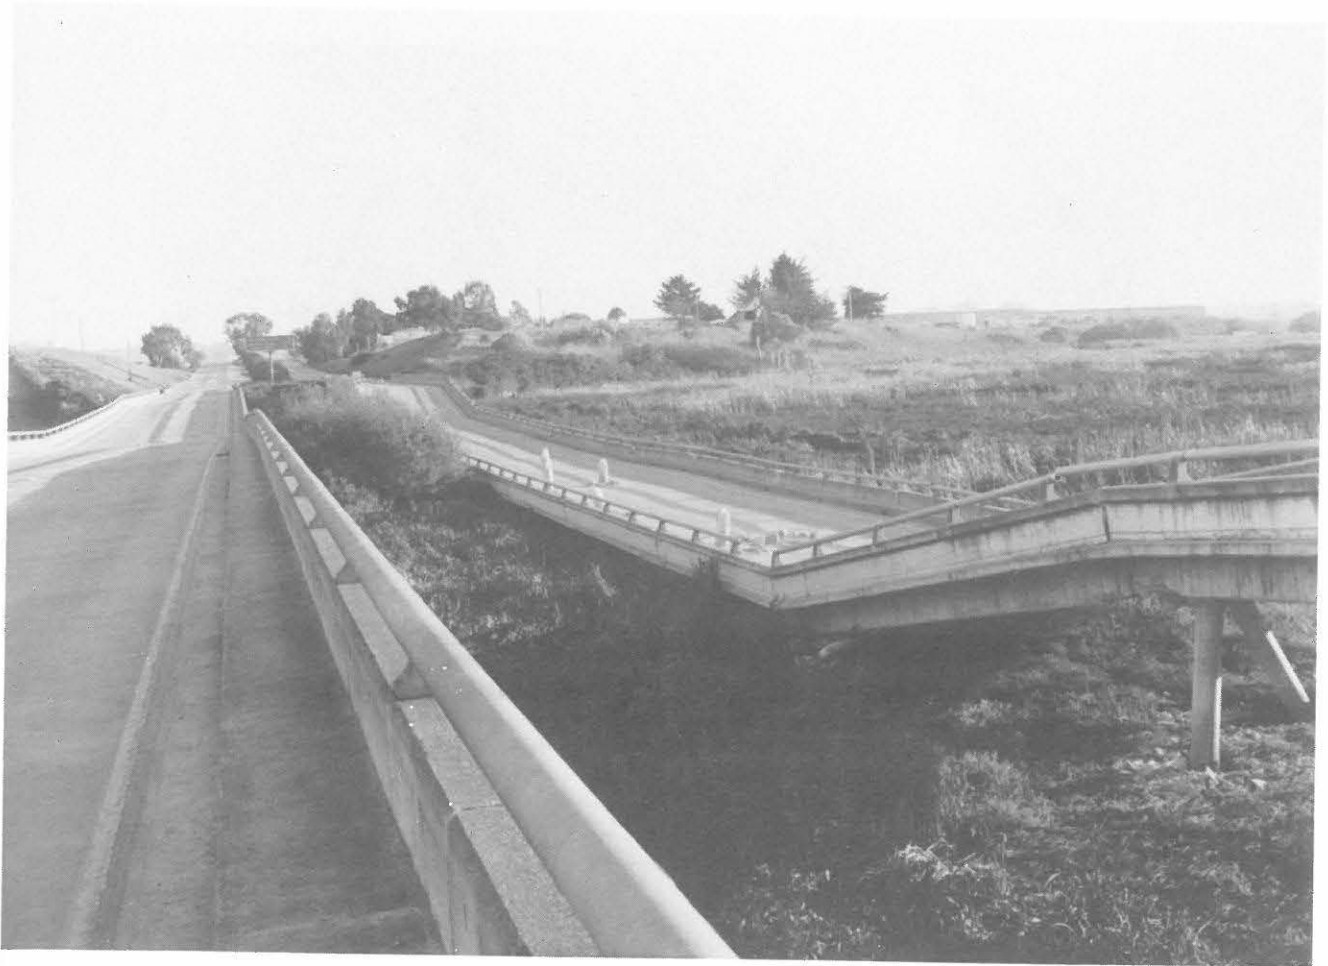
Fig. 4.14 The two heavily damaged lanes of the Struve Slough Bridge on Highway 1 near Watsonville

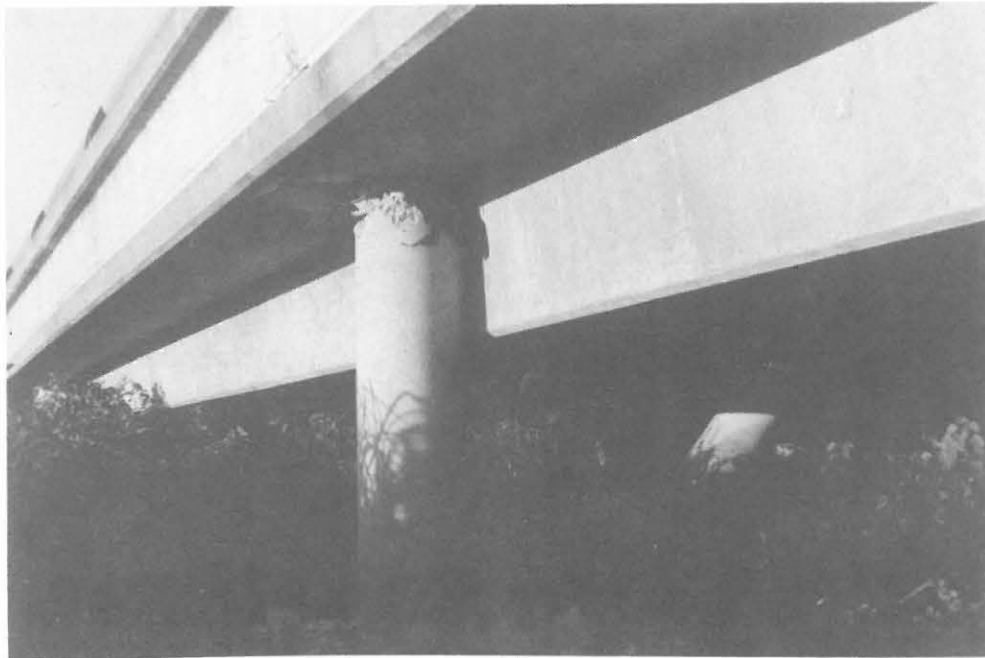
Fig. 4.15 A displaced column of the Struve Slough Bridge near Watsonville

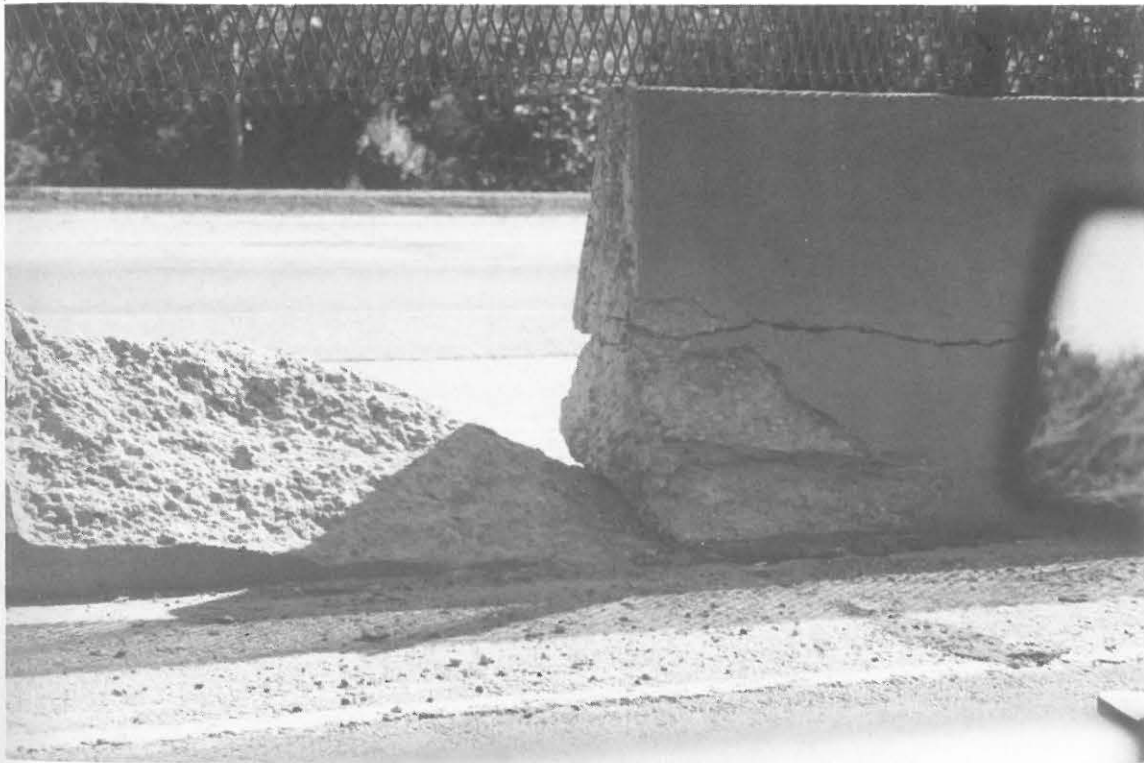
Fig. 4.22 A large horizontal displacement caused damage to the road barriers on Highway 17

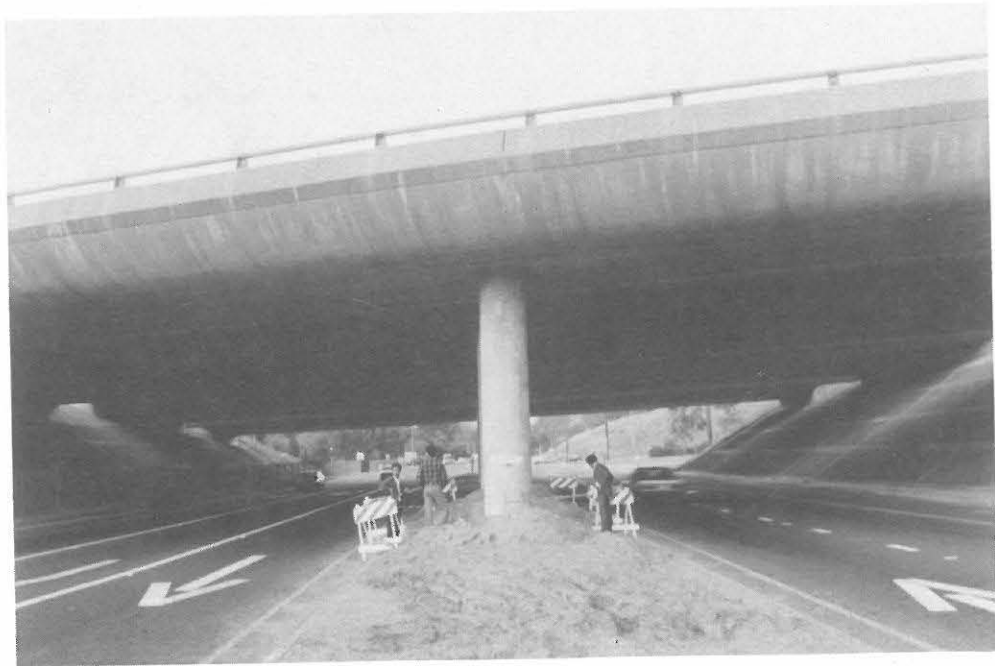
Fig. 4.23 The IRC team inspects a damaged column of the modern overpass (I-280 and G3) near Palo Alto

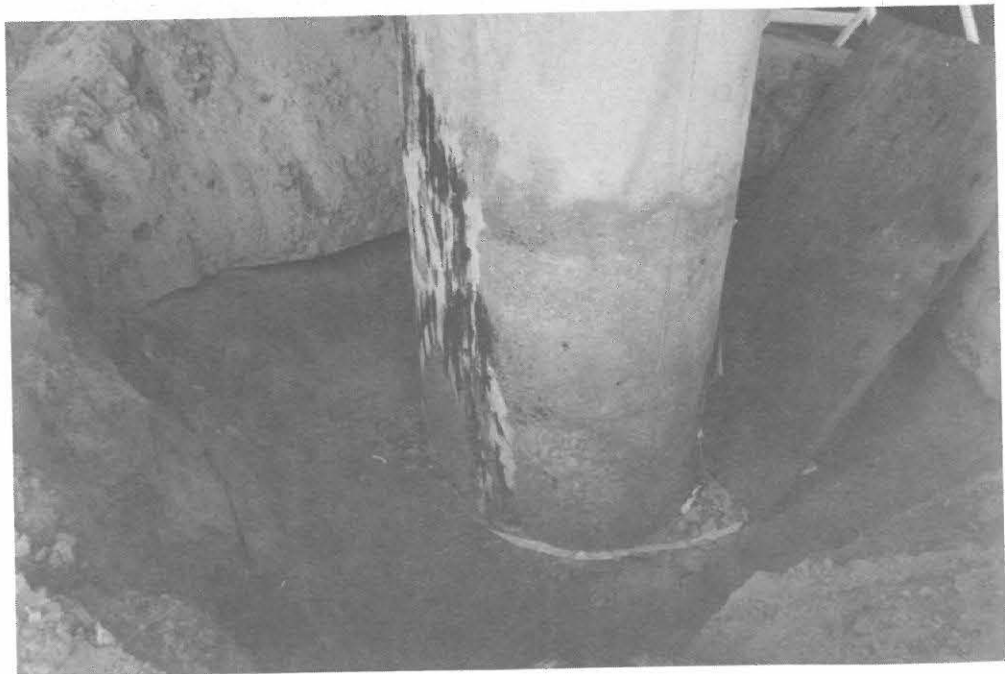
Fig. 4.24 A repaired crack showed the amount of distress experienced by the column (I-280 and G3 intersection)

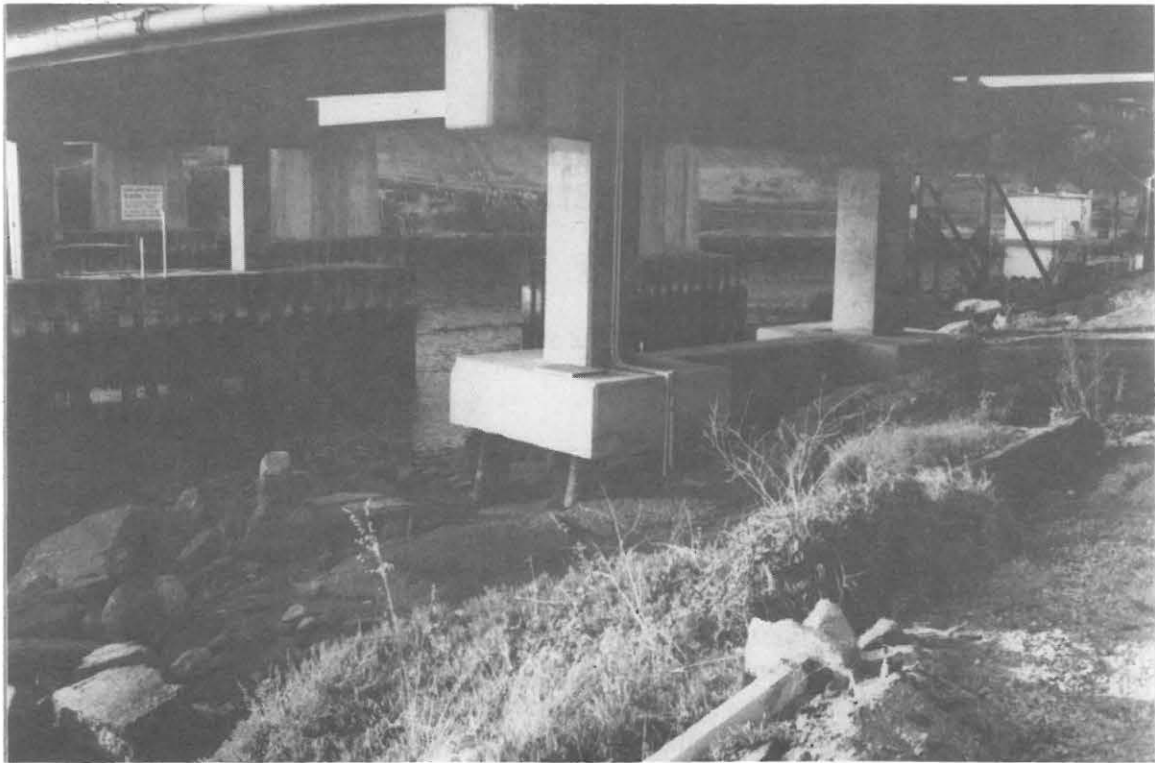
Fig. 4.25 Water from a broken pipe caused damage to the pier of the bridge on Eaton Street in Santa Cruz

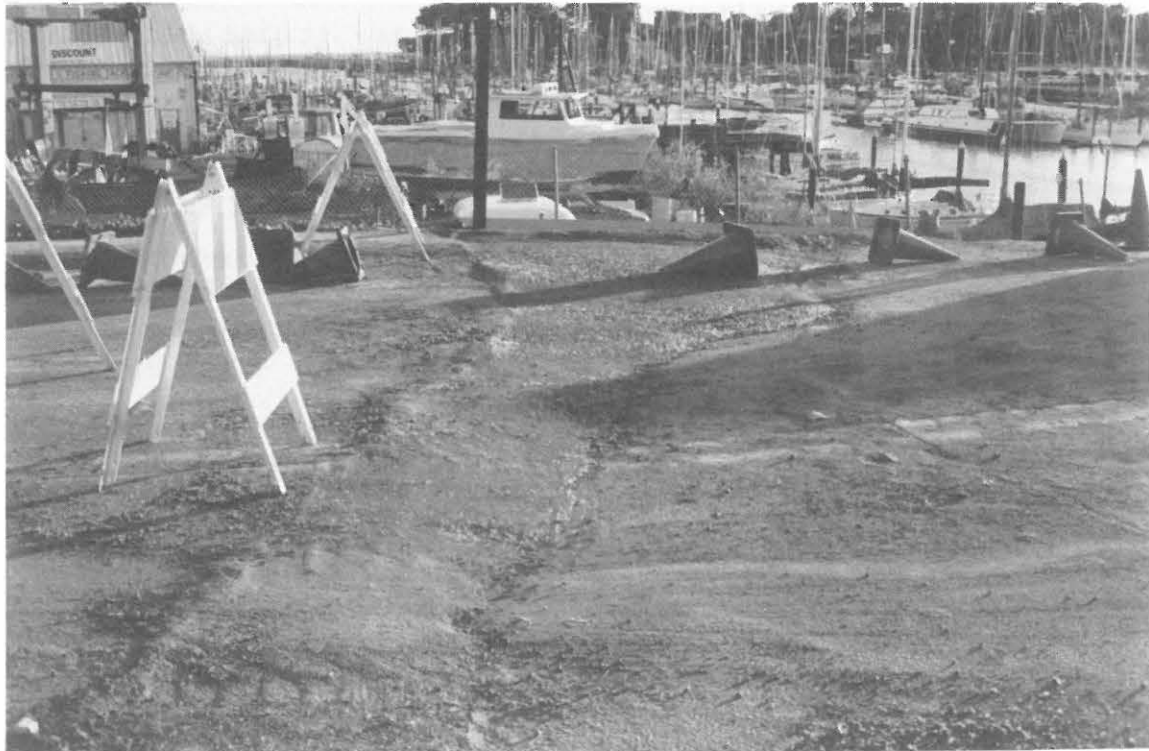
Fig. 4.26 Filled fissure which caused a break of the water pipe - bridge on Eaton Street in Santa Cruz

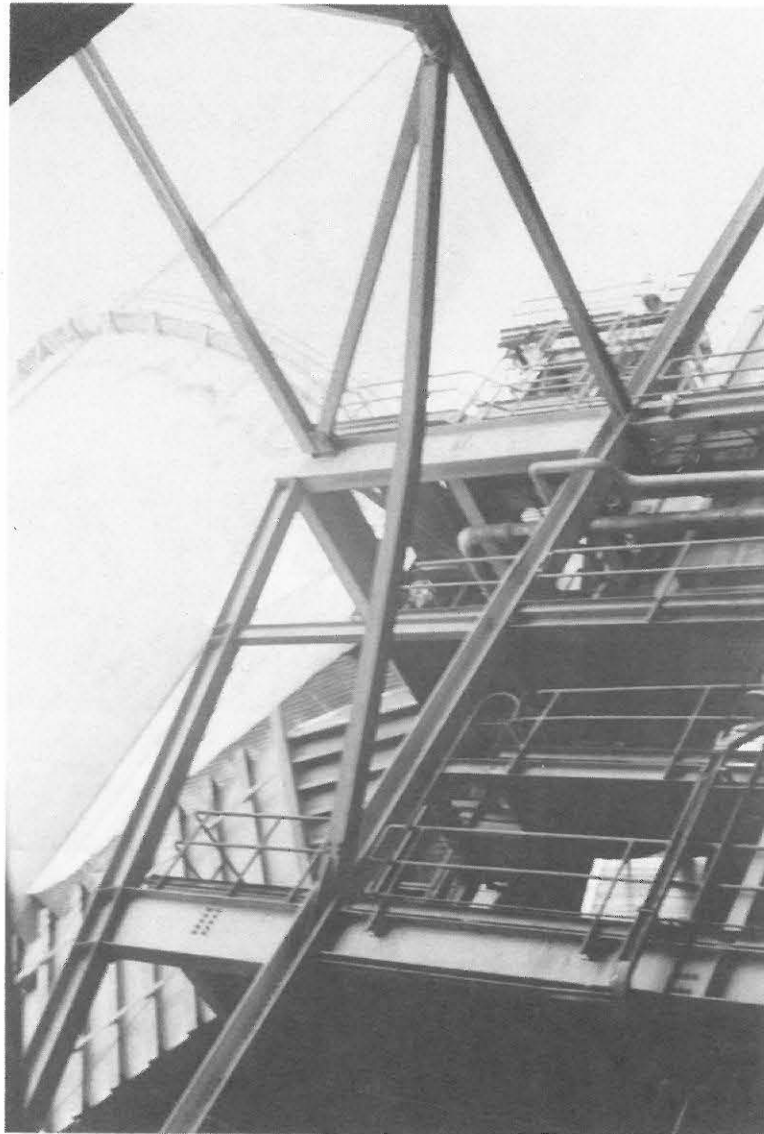
Fig. 5.3 Damage to two bracing members

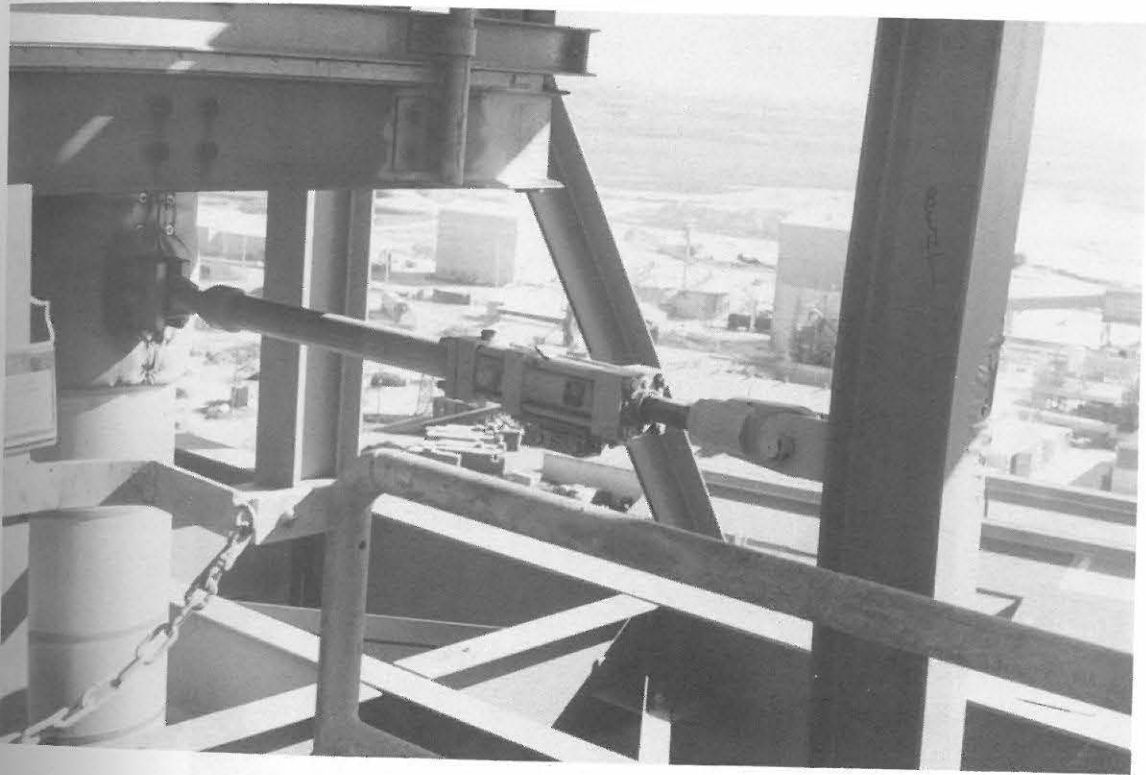
Fig. 5.4 Damage to a vertical strut supporting a horizontal snubber

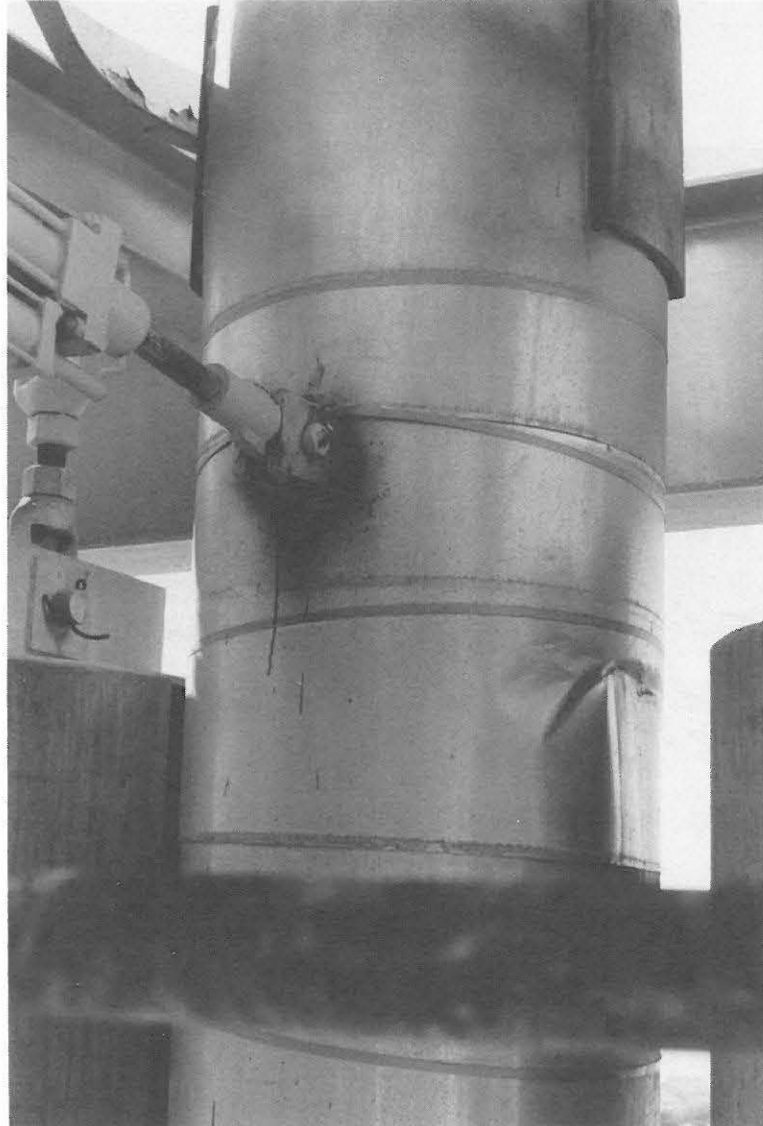
Fig. 5.5 Damage to horizontal lateral restraints

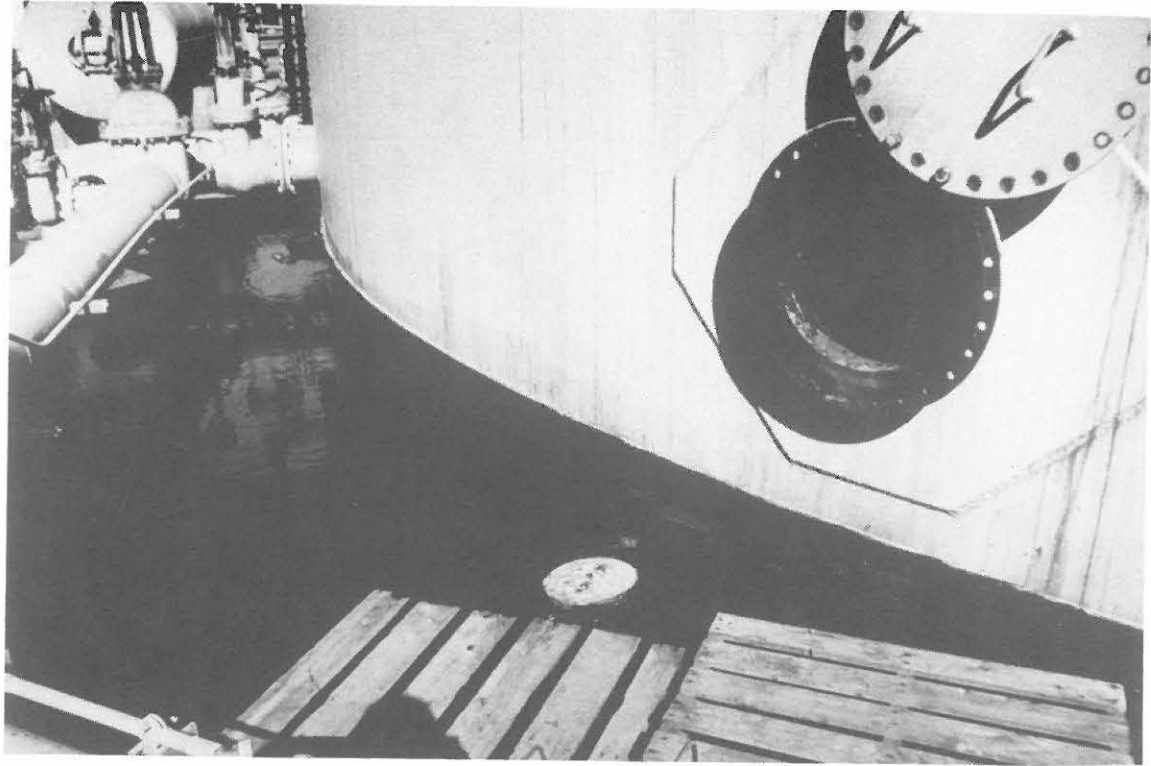
Fig. 5.8 Rupture of tank bottom

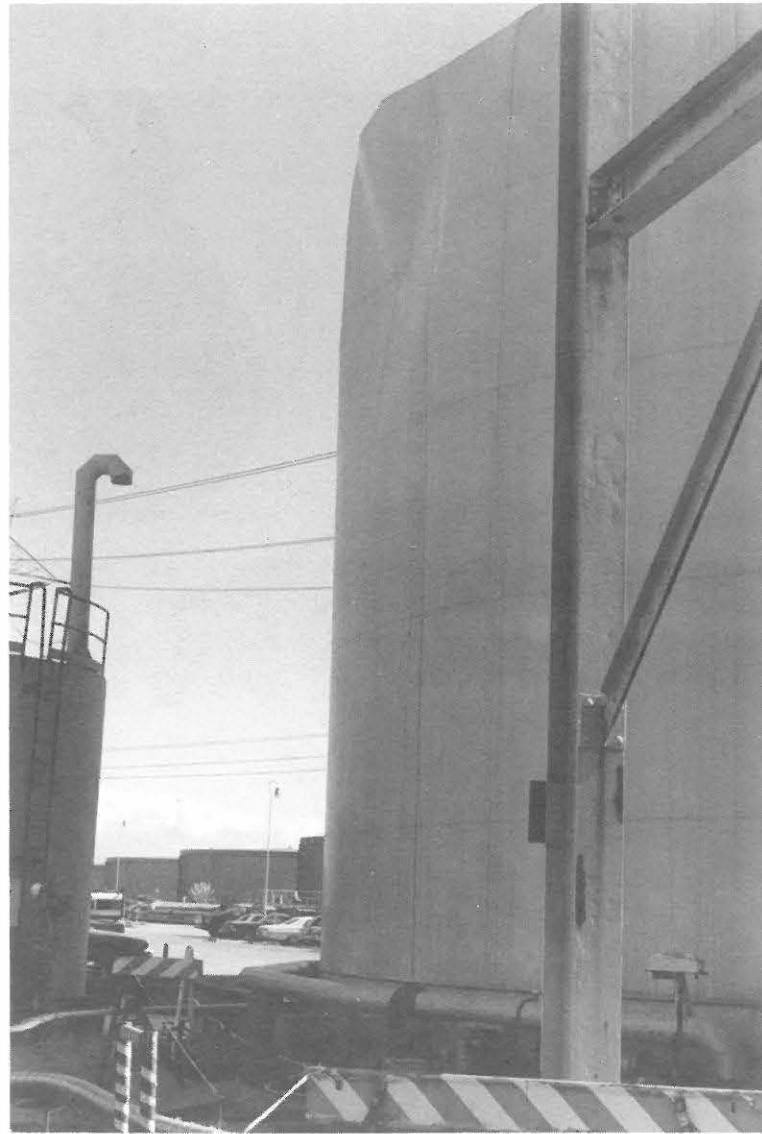
Fig. 5.9 A buckled tank shell - Moss Landing

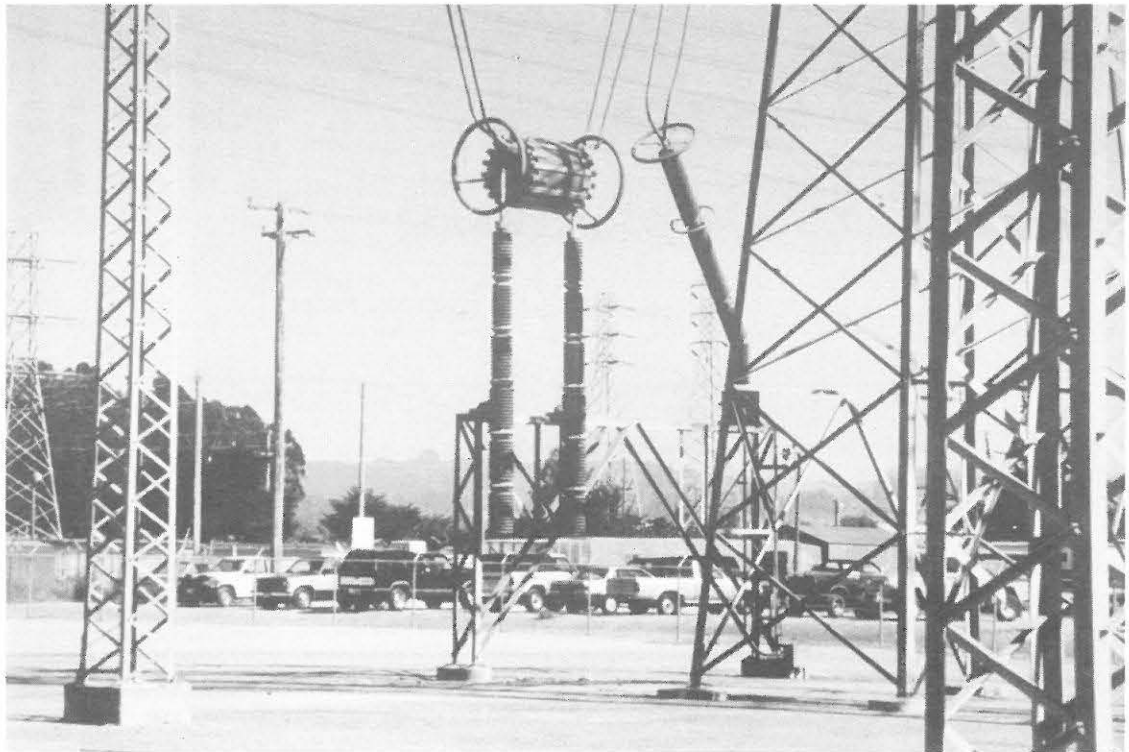
Fig. 5.12 Damaged 500-kV tension transformers at Moss Landing (courtesy of J.W. Lafferty, PG&E)

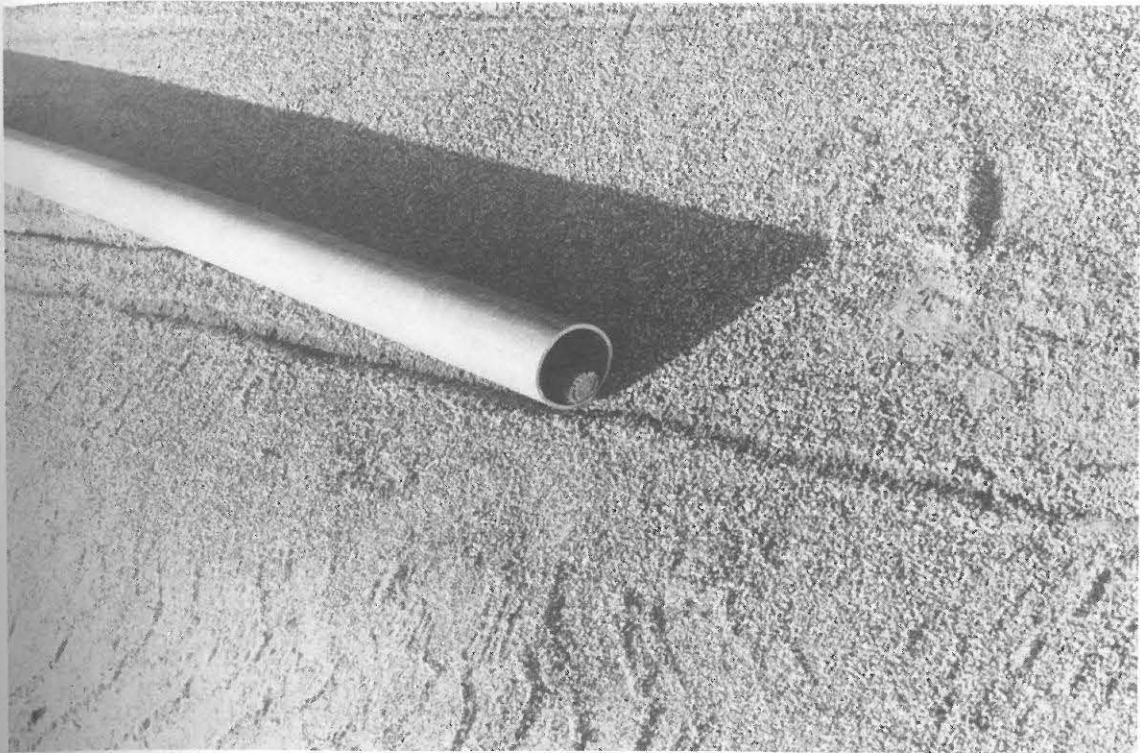
Fig. 5.13 Broken aluminum conductor - Moss Landing Power Plant
