Institute for
Research in
Construction

The 1989 Loma Prieta (San Francisco Area) Earthquake: Site Visit Report

Internal Report No. 594

Date of issue: May 1990

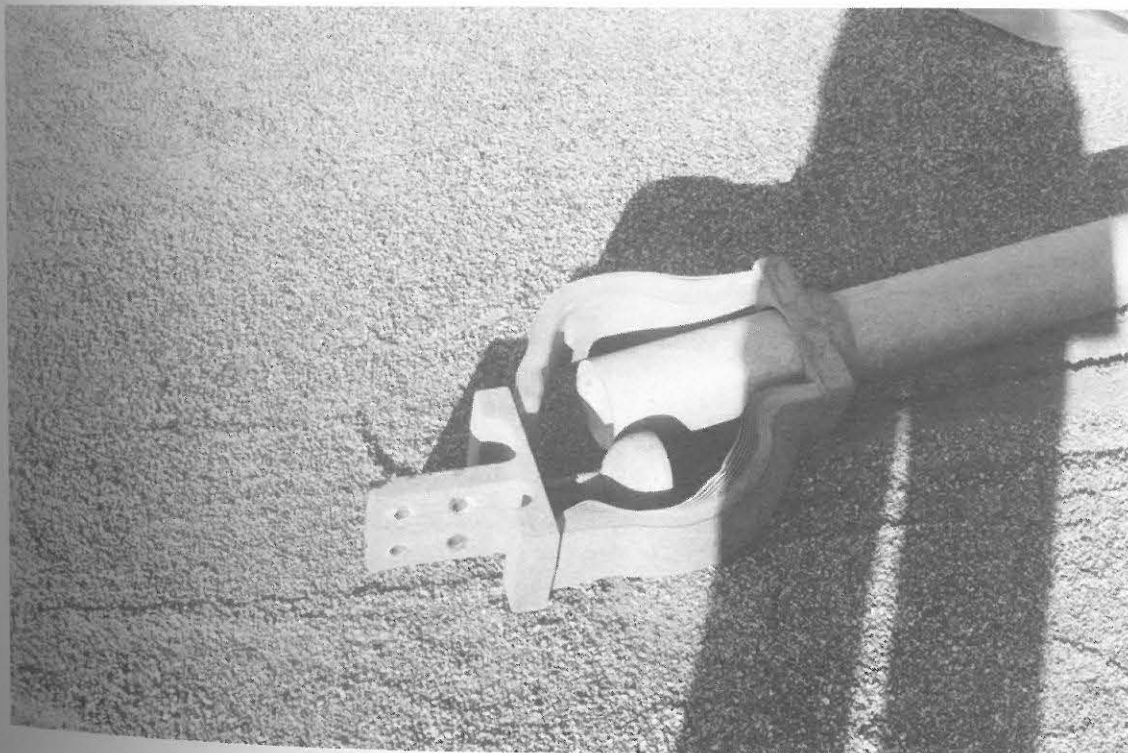
Fig. 5.14 Another broken aluminum conductor - Moss Landing Power Plant

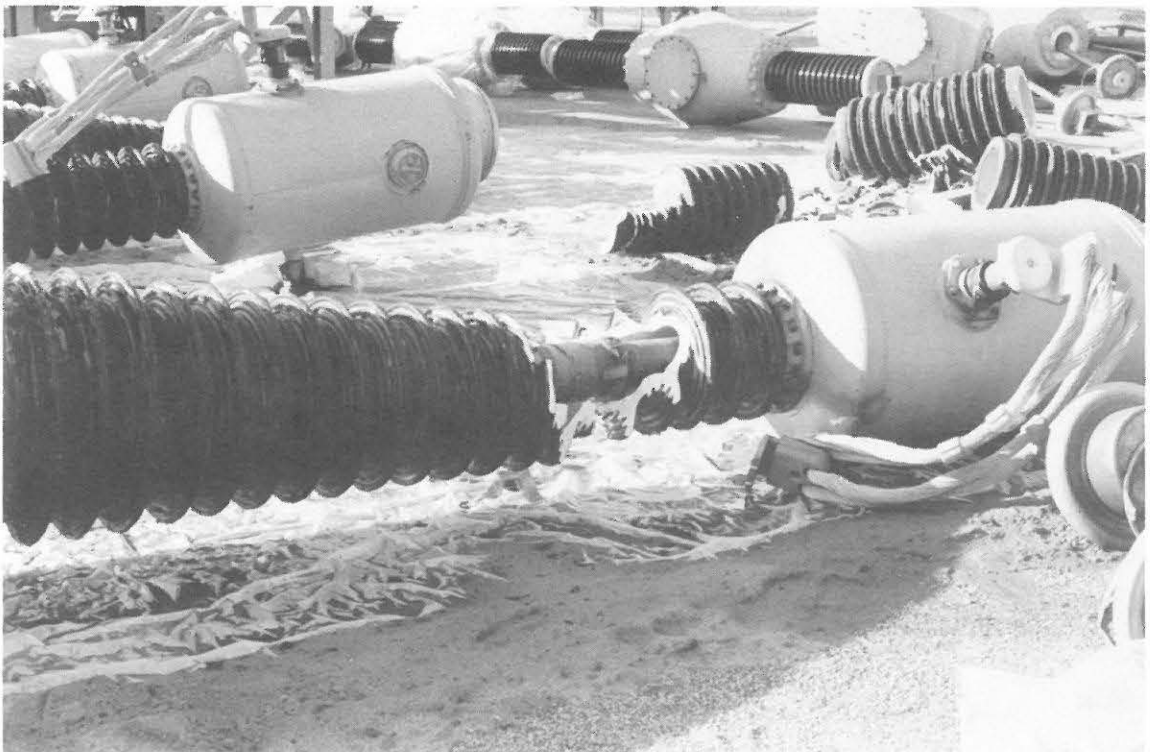
Fig. 5.16 Close-up of broken current transformers in the substation yard

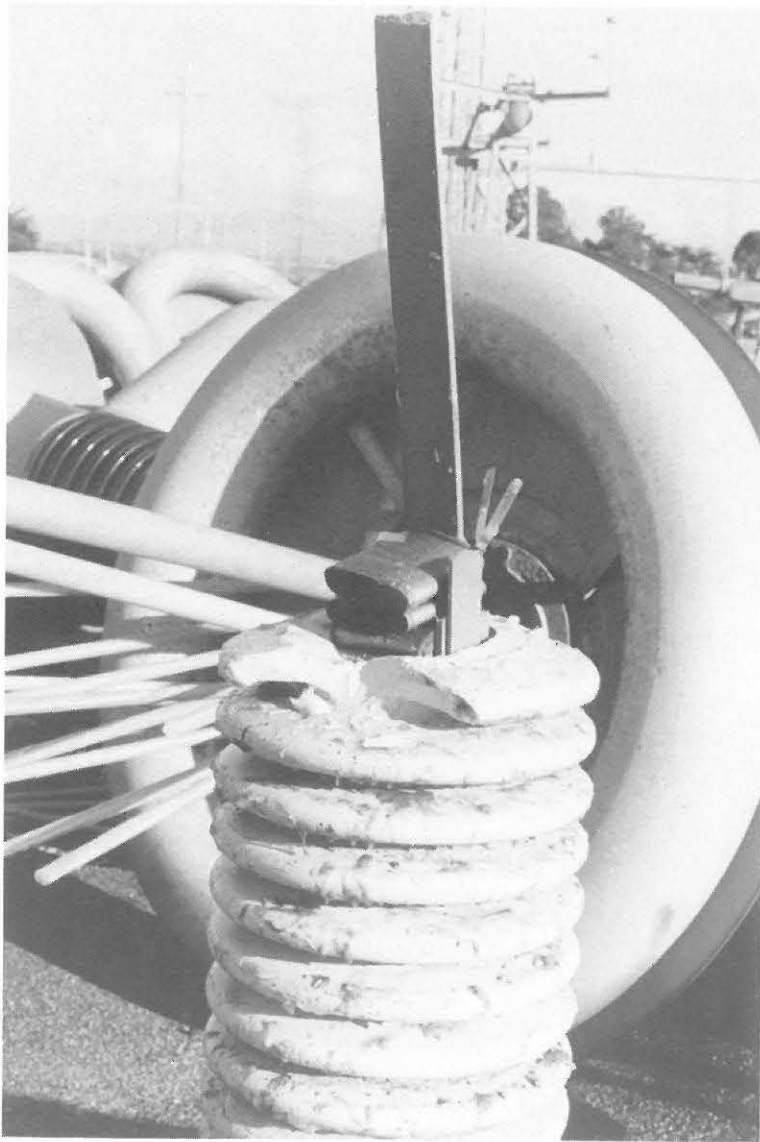
Fig. 5.17 Remains of a destroyed 500-kV tension transformer

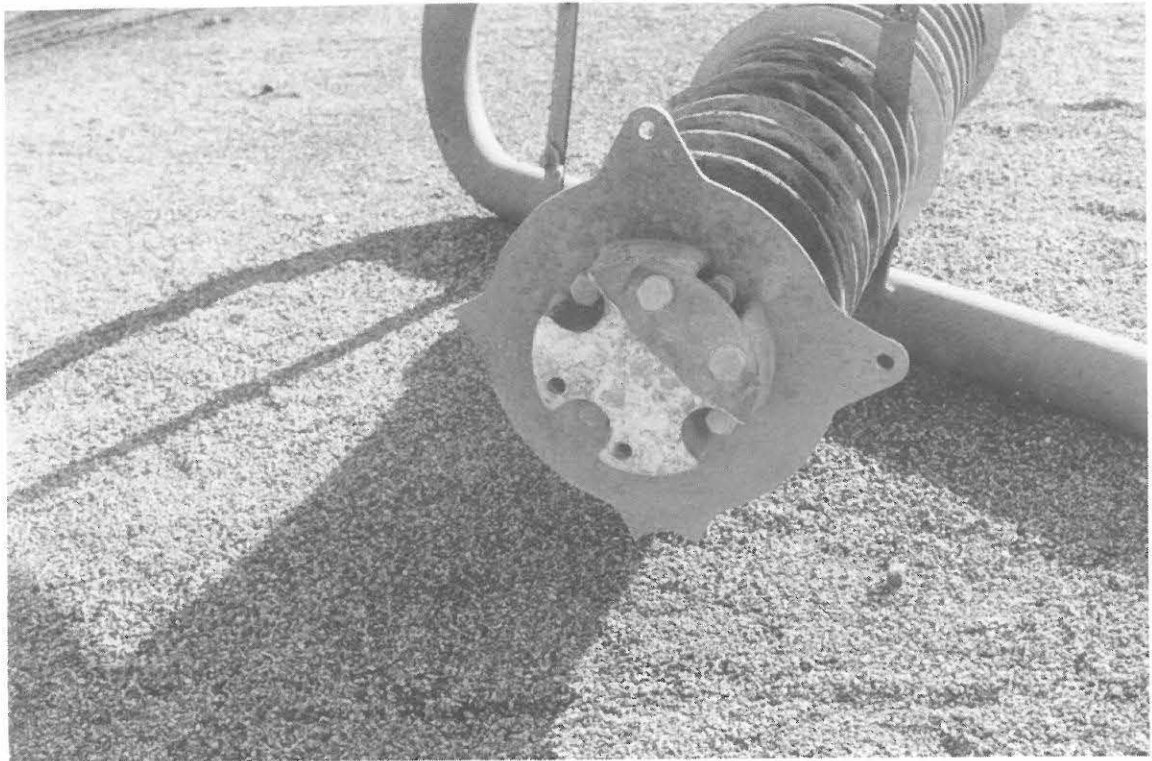
Fig. 5.18 Remains of a destroyed 500-kV disconnector. Failure of a flanged cap

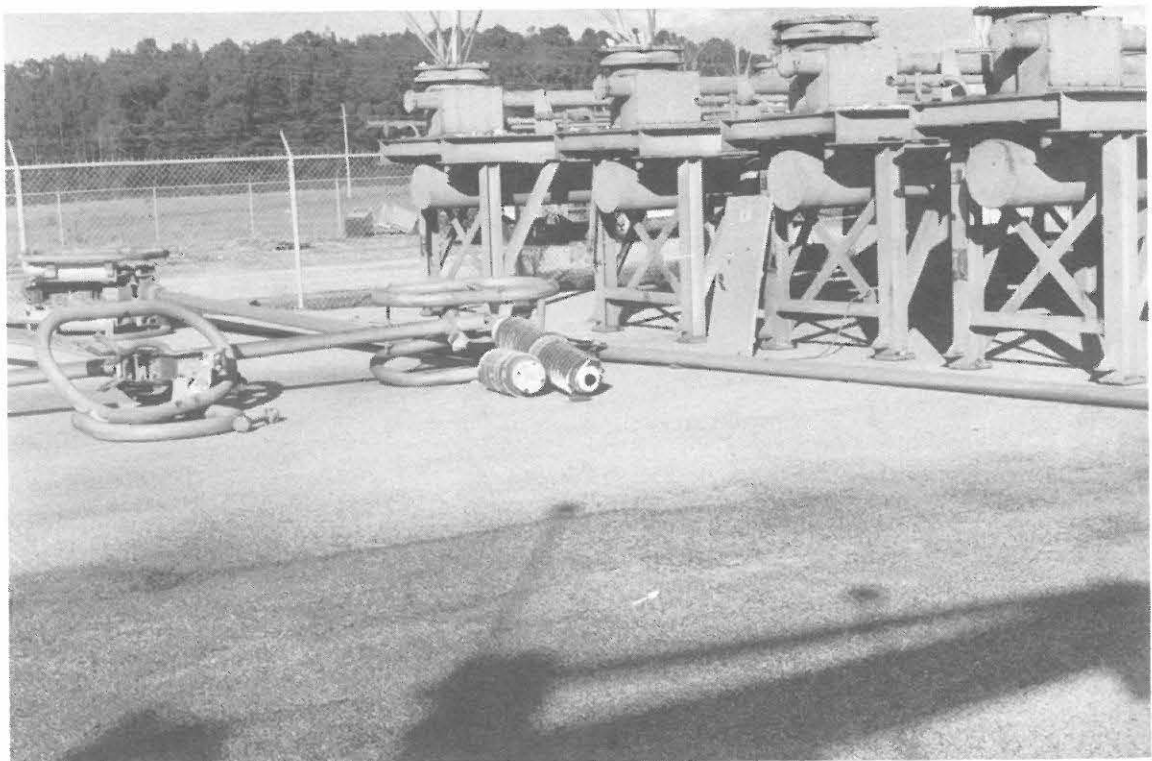
Fig. 5.19 Remains of 500-kV SF6 circuit breakers and disconnectors (one week after the earthquake)

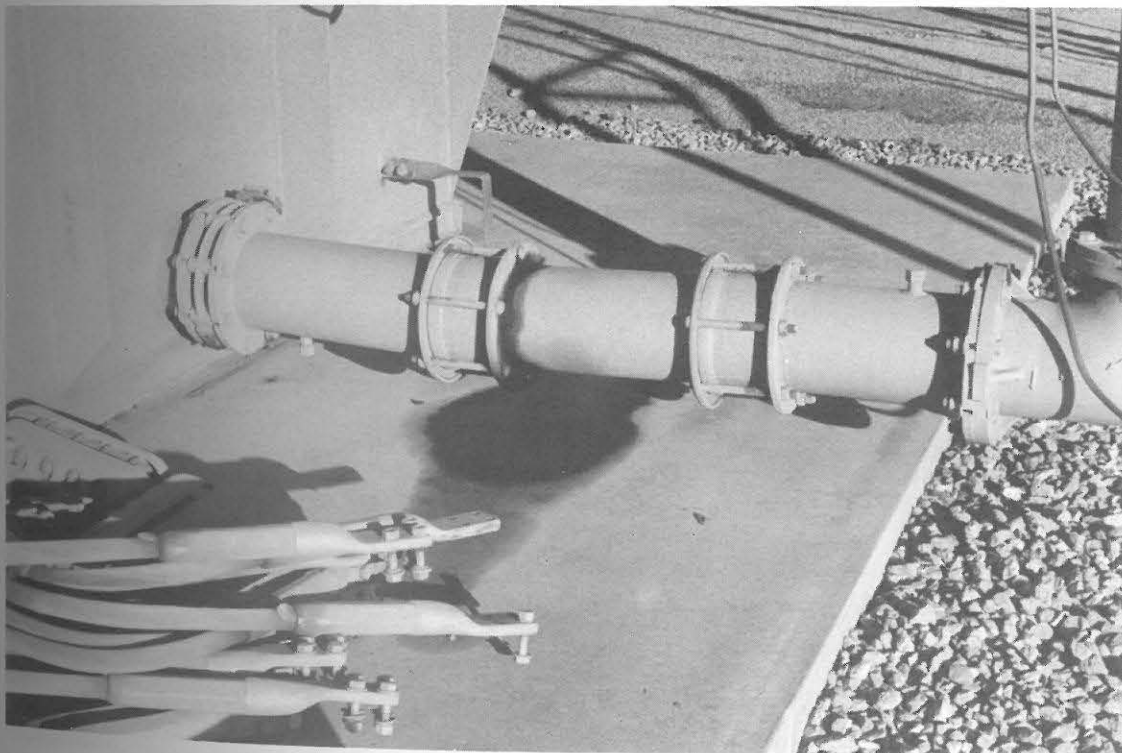
Fig. 5.21 Oil leak at the base of a 500-115-kV power transformer

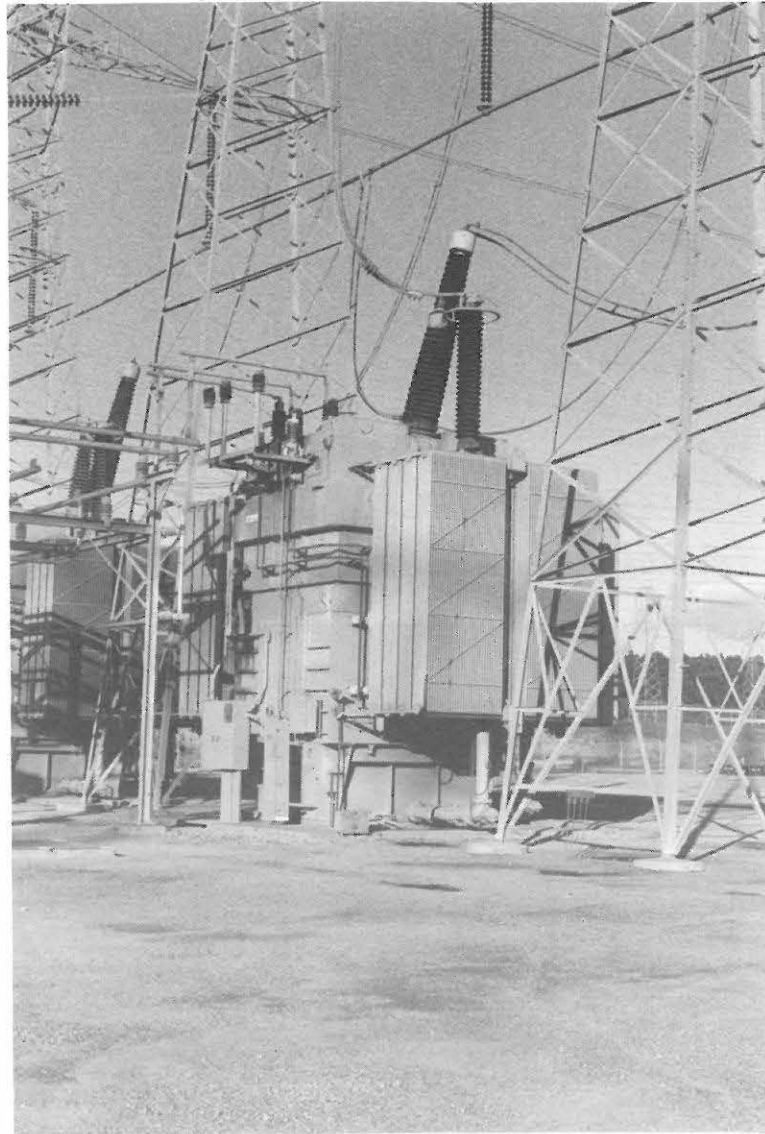
Fig. 5.22 Edison power transformer which leaked during the earthquake

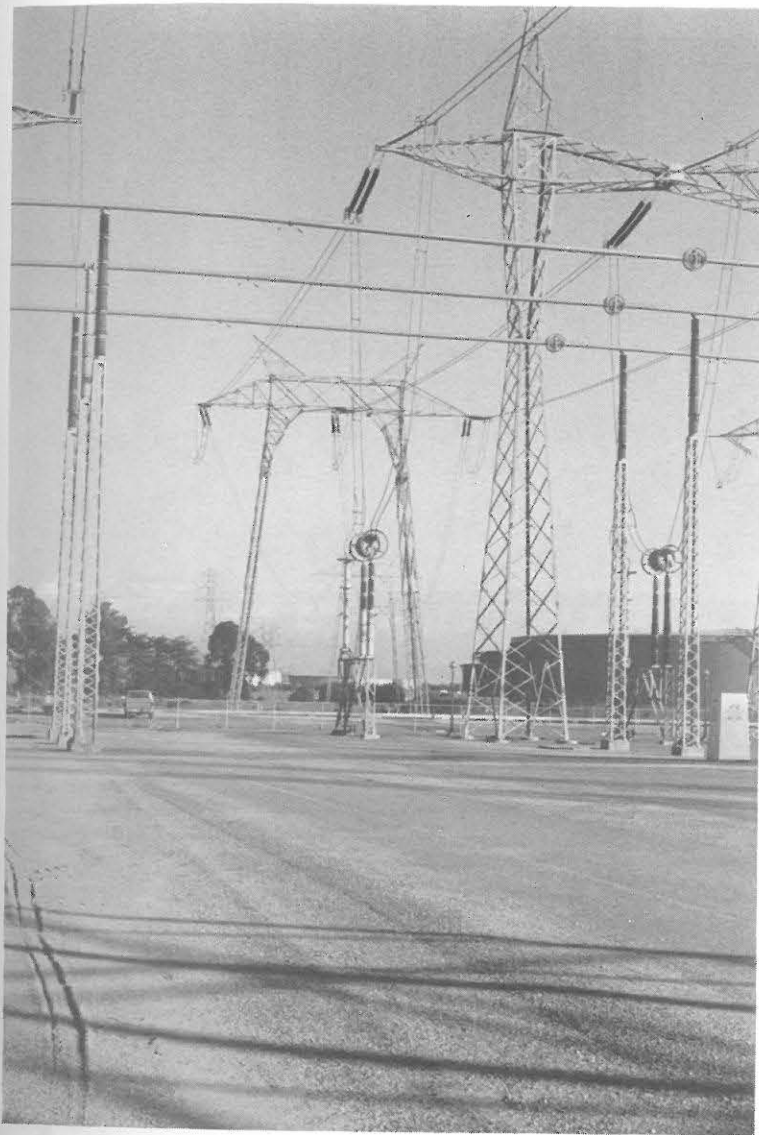
Fig. 5.26 Rigid busbar broken during the earthquake (photograph taken a day after repair)

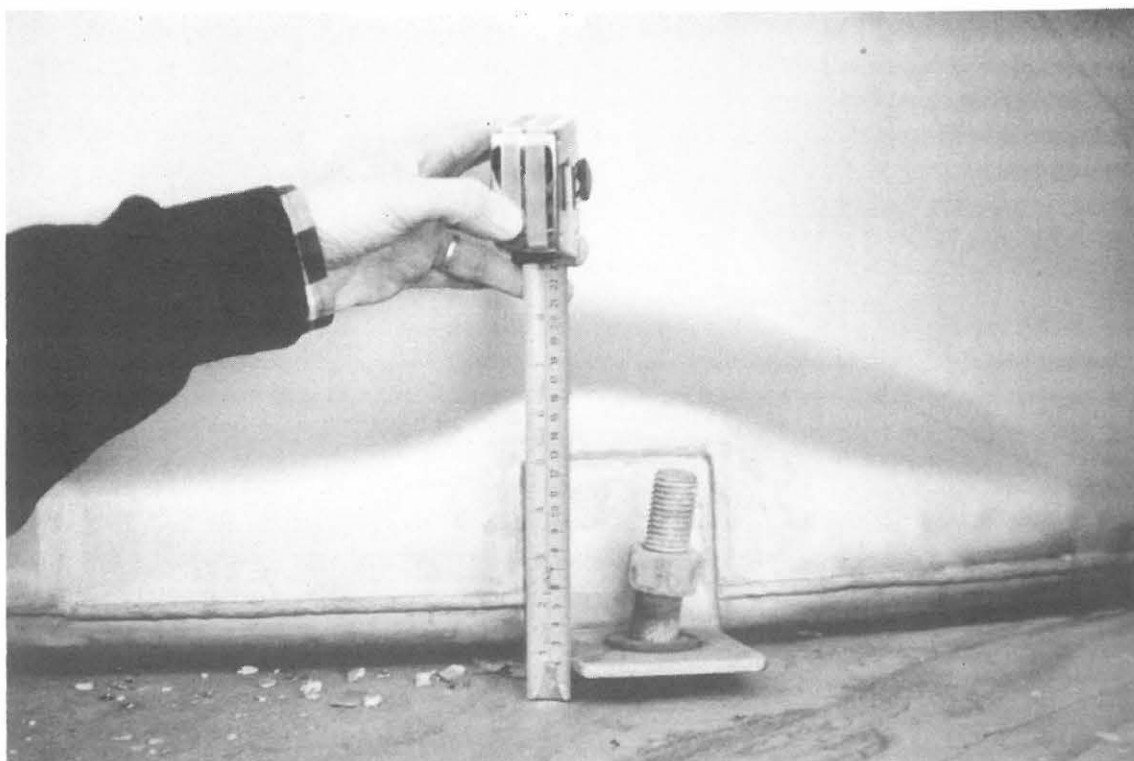
Fig. 6.4 Pulling out of the anchored bolt

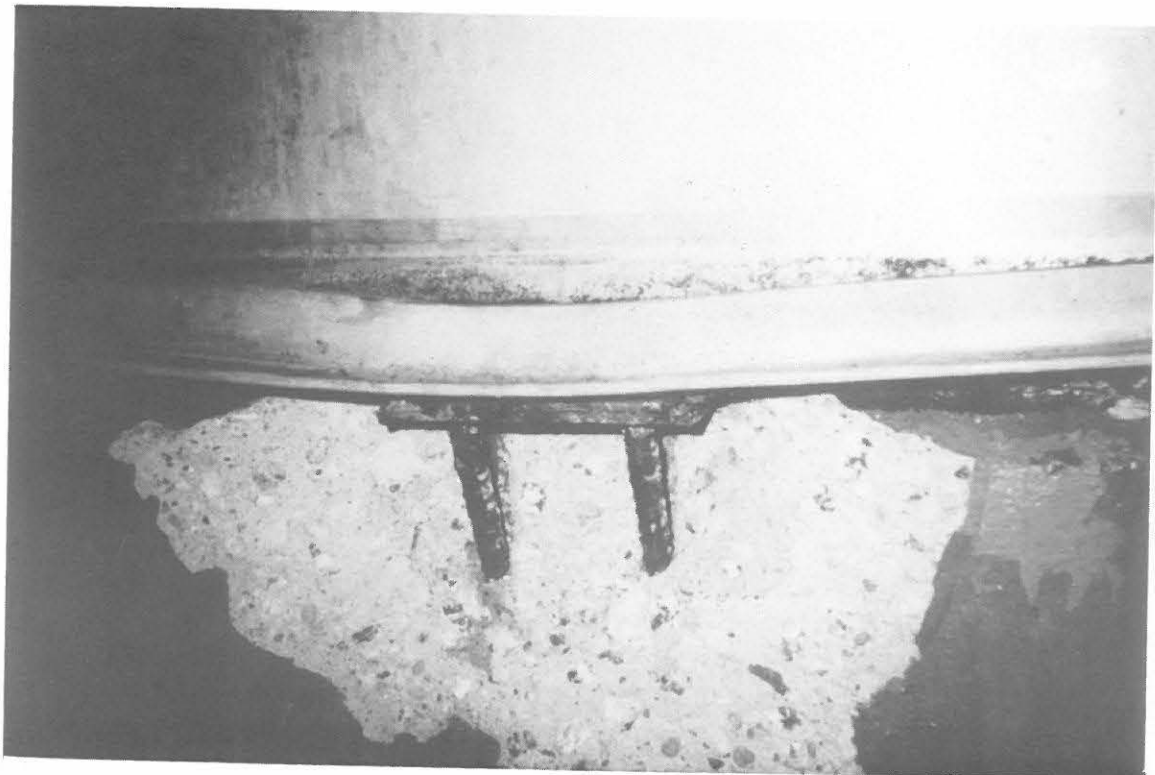
Fig. 6.8 Failure of anchor bars and rupturing of the tank

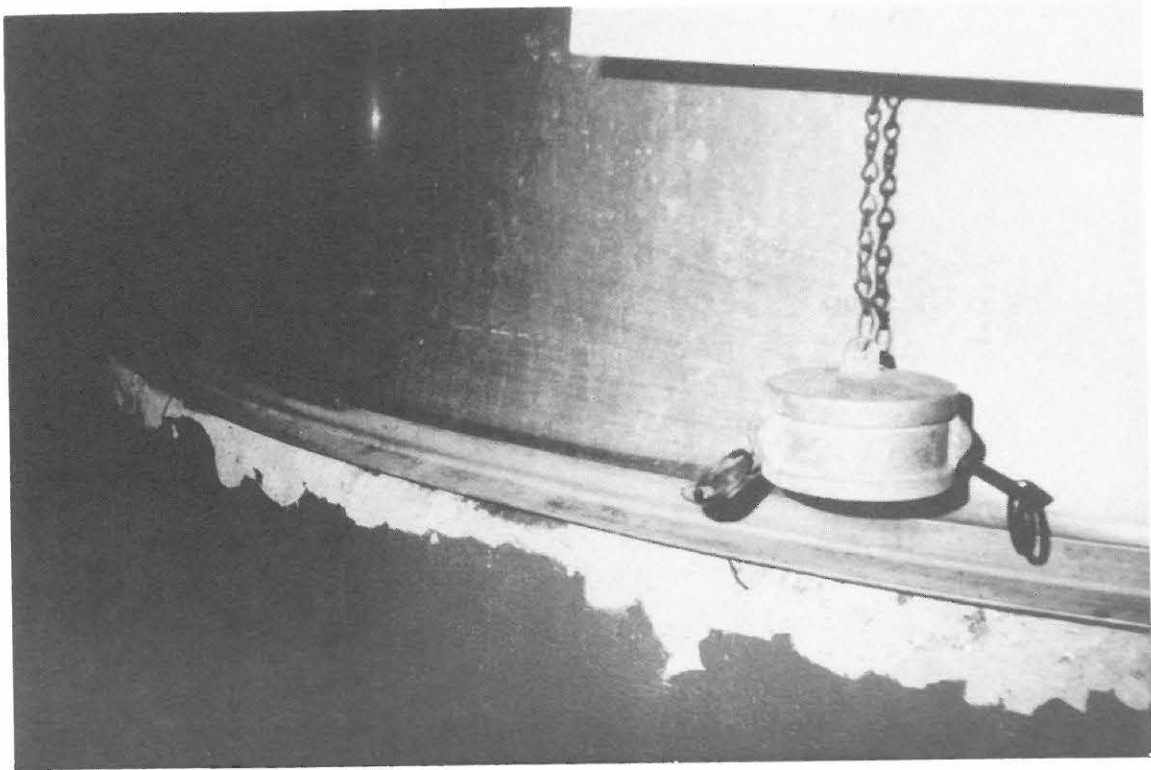
Fig. 6.9 Spalling of the concrete foundation pad due to rocking of tank

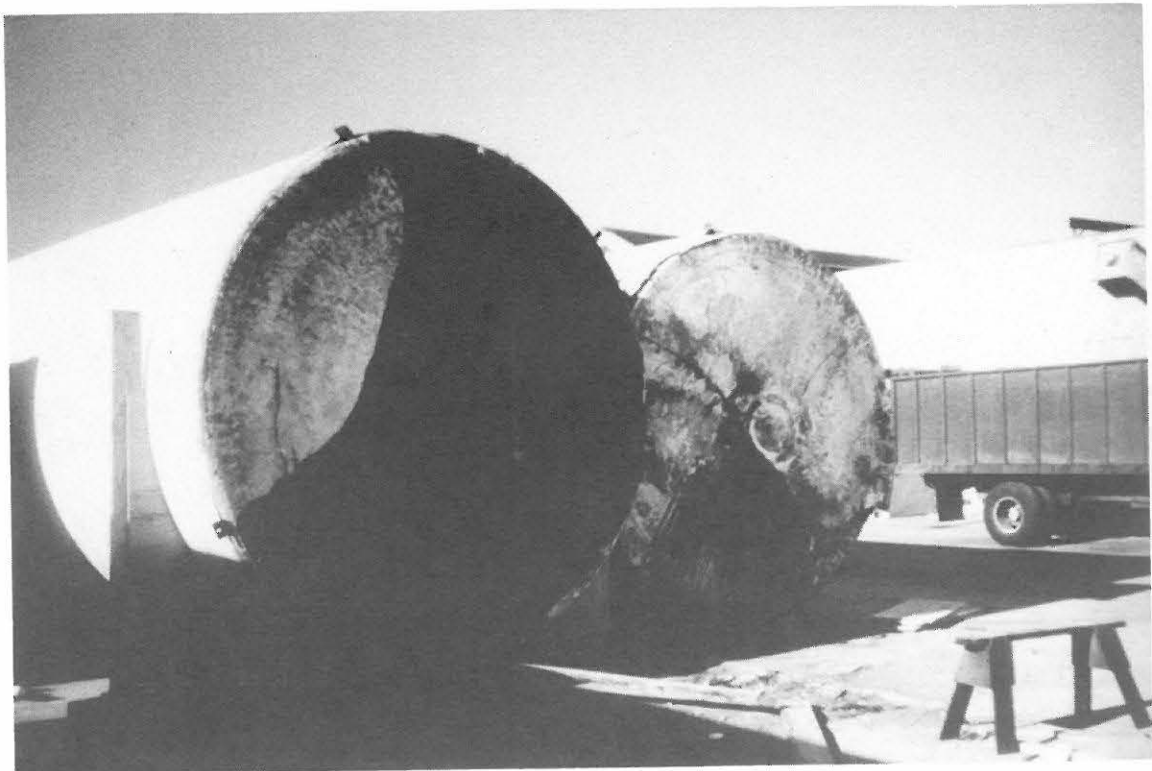
Fig. 6.10 Damaged fibreglass-reinforced plastic tanks

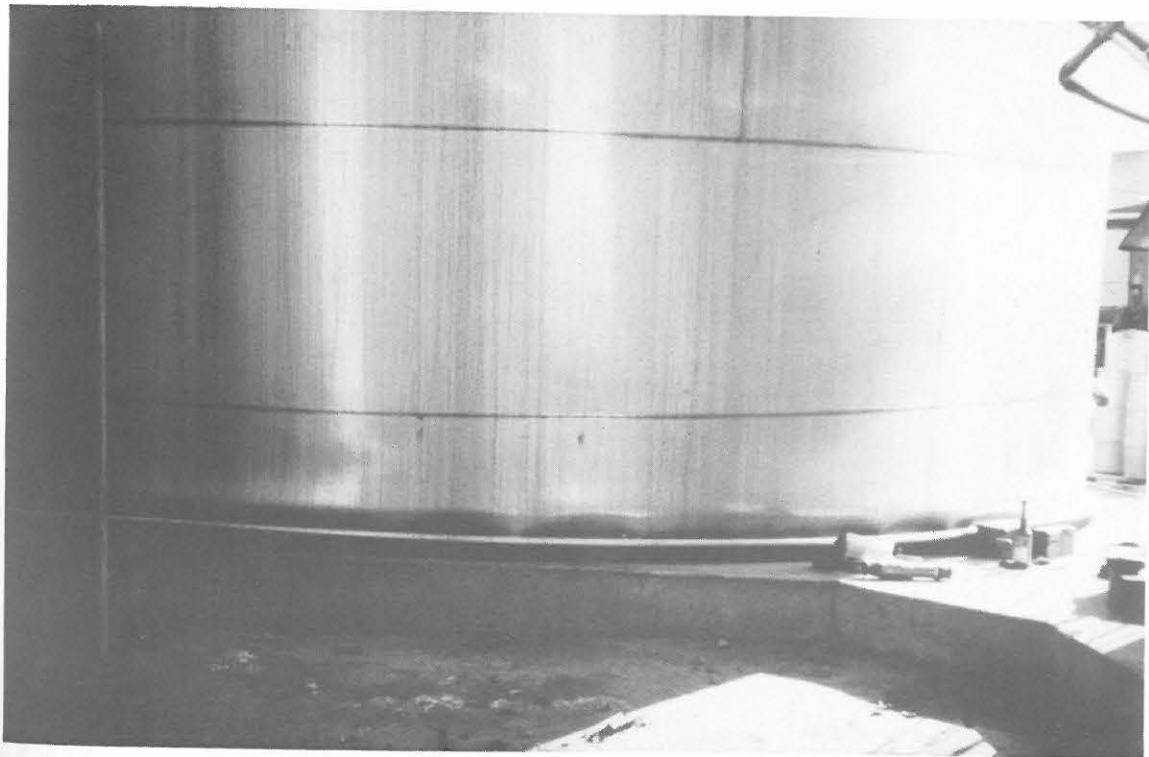
Fig. 6.12 "Elephant-foot" buckling of tank

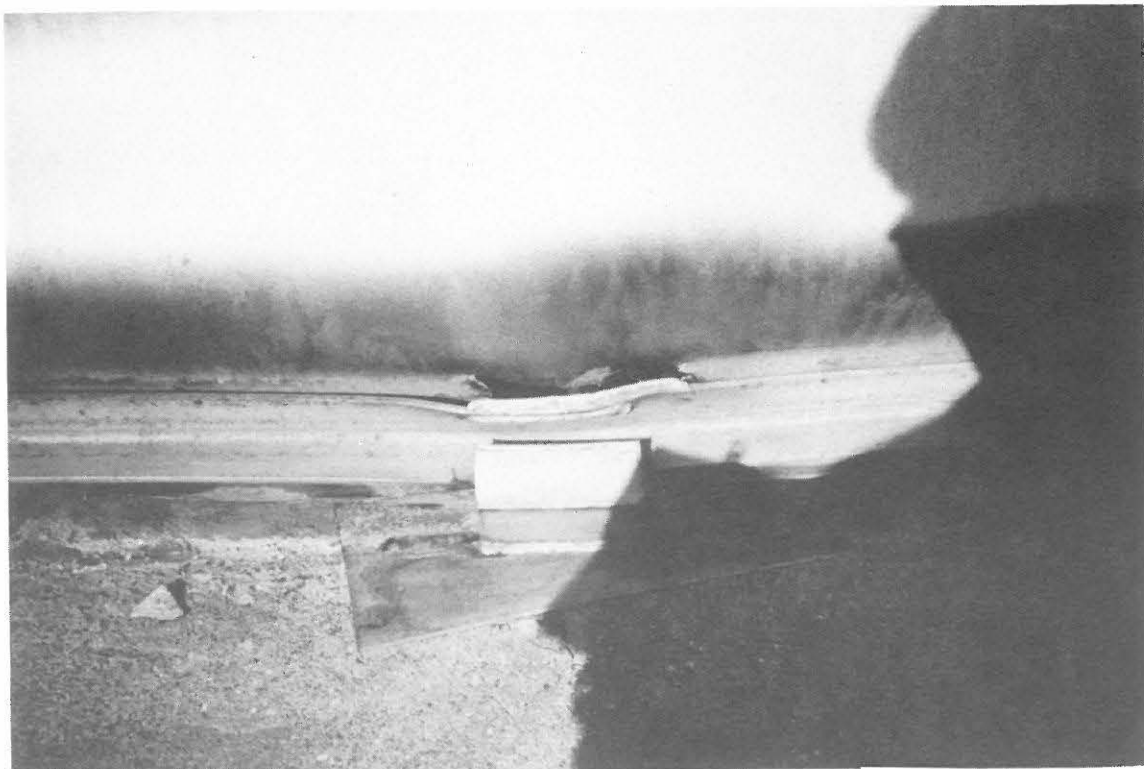
Fig. 6.14 Failure of welded angle plate
