FLIGHT COMMENT

MAY · JUNE · 1957

ISSUED BY
DIRECTORATE OF FLIGHT SAFETY
R.C.A.F. HEADQUARTERS • OTTAWA, ONT.

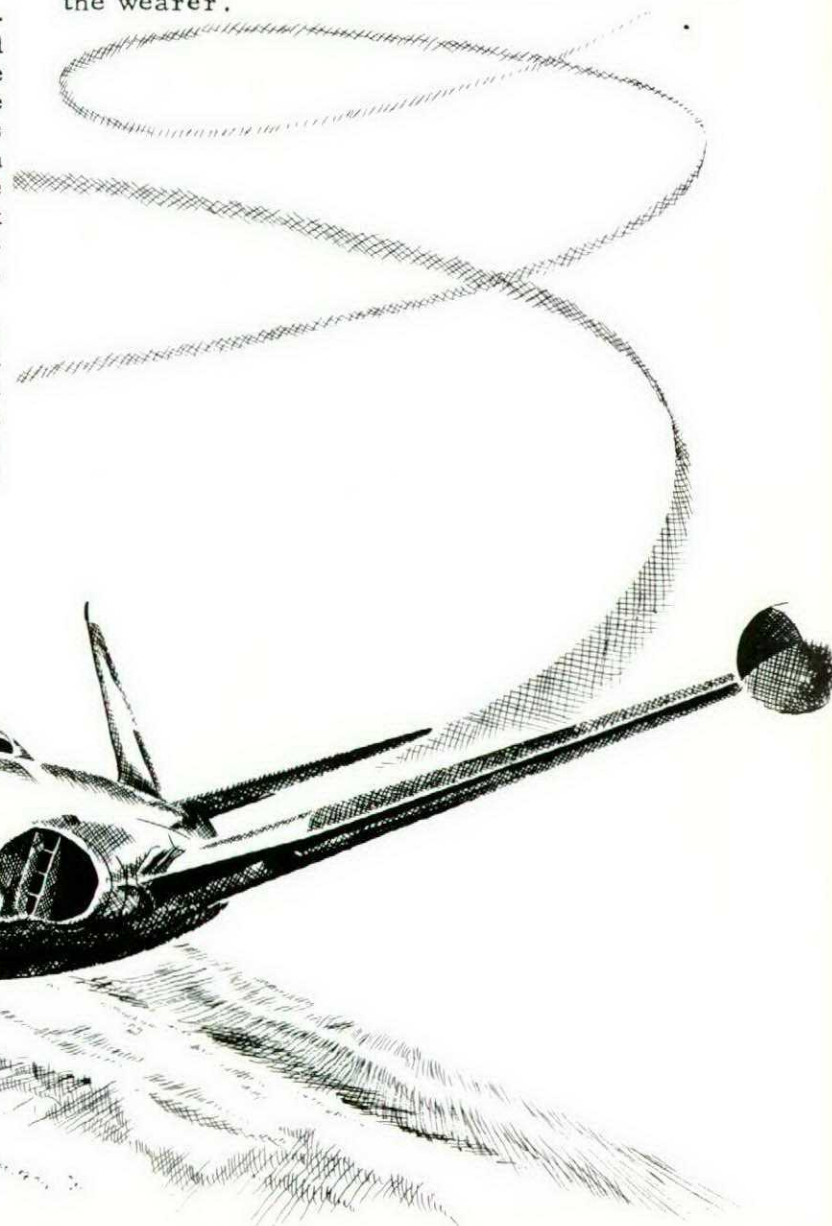
A complete inspection of the aircraft's oxygen system revealed no defects. Hypoxia resulted because of an unservicable oxygen mask: the suspension straps had worn smooth and moved so easily through the holding buckle that they permitted the mask to slip off the

pilot's face during normal head movements. The pilot should have had the worn straps replaced. The safety equipment section can and should check your oxygen mask regularly; however, as with all safety equipment, the final responsibility for its condition remains with the wearer.

The pilot lost altitude during the ensuing spiral dives and spins.

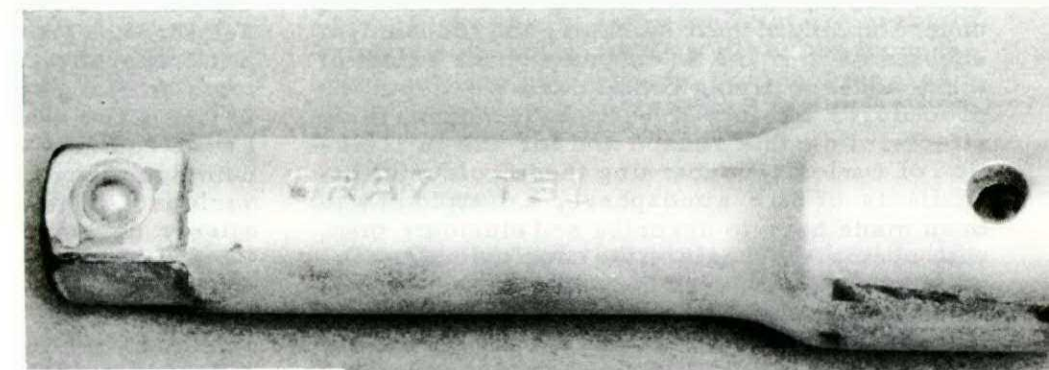
The investigating specialist's comments on the incident were as follows: Upon returning to base the pilot reported this restriction in flying control movement and the aircraft was quarantined. An inspection of flying control runs revealed the cause of elevator control interruption in flight: a three-inch-long socket wrench extension was found lying within the navigator's right-hand console, positioned laterally at the foot of former number eight. The extension was so located that any nose-down change in the Canuck's attitude permitted

The FSO commented that the situation was serious enough to have caused a fatal accident if the socket extension had assumed a position where fore-and-aft pressure on the control column would produce no elevator movement whatever. During flight, fortunately, this situation was only temporary and the controls could be freed by a slight jiggling of the control column and a change in the aircraft's attitude.

Carelessness on the part of one technician was the cause of this near-accident. However, because the situation is not new, it is felt that more emphasis should be placed on the warning that foreign objects in aircraft are dangerous—and definitely intolerable. Technicians must not leave wrenches, pliers and other tools in aircraft. They must be convinced somehow that what they think is a mere trifling detail is actually a threat to a man's life and a potential aircraft writeoff. The tradesman who loses a wrench in an aircraft and says to himself, "I'll look for it after coffee break," is a menace.

Photo of the three-inch-long socket wrench extension found lying within the navigator's right-hand console.

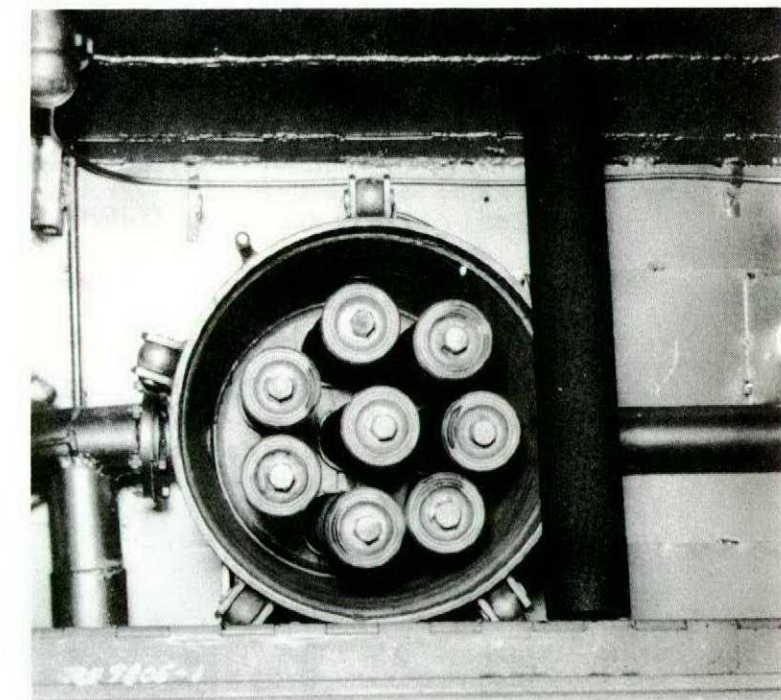
Clean filter in a fuel tender.

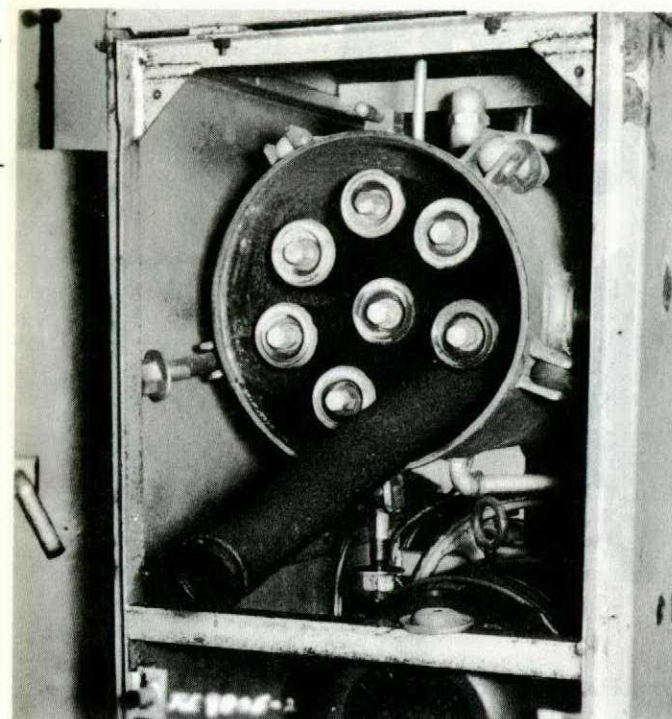
Dirty filter in a fuel storage tank.

If proper fuel handling methods had been followed, this accident would not have occurred. The best way to keep fuel clean is to prevent contamination from getting into it in the first place. There is little hope of providing pure fuel to aircraft if proper inspection methods are not followed. Filters will retain their serviceability only when they are inspected and replaced as required. In other words, the filters will do their job only as long as maintenance personnel are doing theirs.

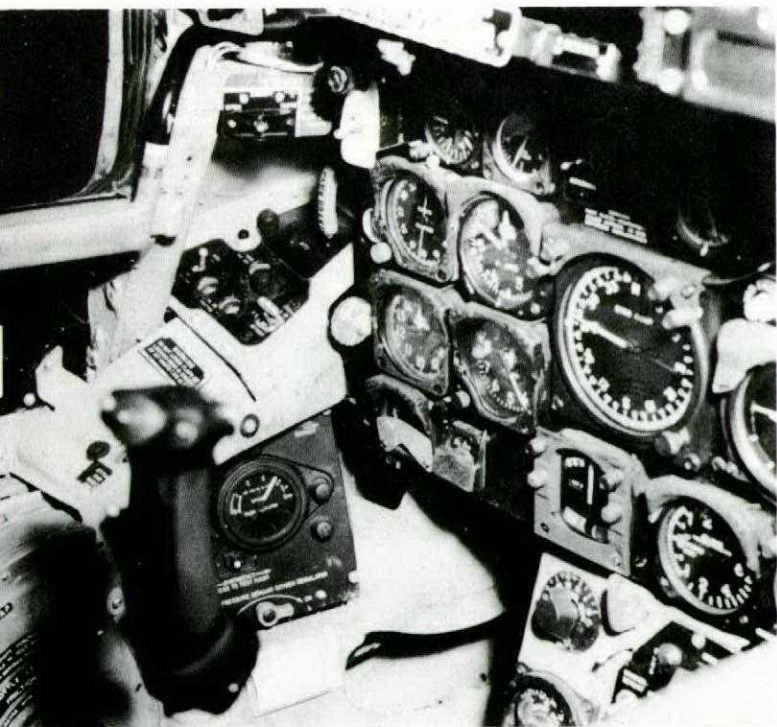
In his statement to the Board of Inquiry, the pilot admitted that he was in the habit of selecting "flaps up" as the nosewheel was being lowered to the runway on the landing run—using the wet, slippery runway technique no matter what the runway condition. This was contrary

The selector was found to be in the "up" position.
