FLIGHT COMMENT

ROYAL CANADIAN AIR FORCE

MAY • JUNE • 1958

ISSUED BY
DIRECTORATE OF FLIGHT SAFETY
 R.C.A.F. HEADQUARTERS • OTTAWA, ONT.

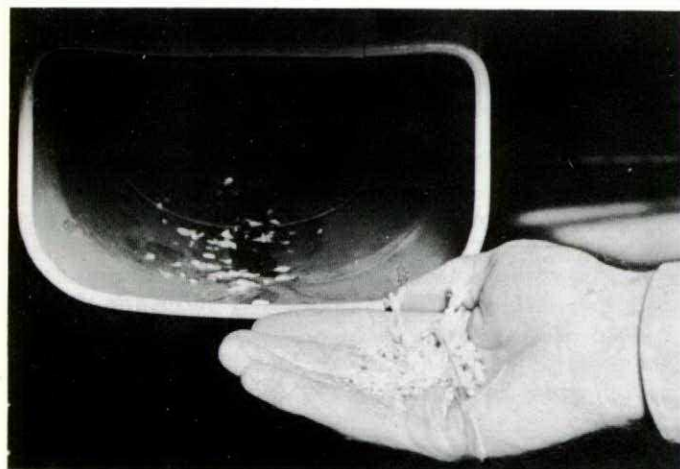
You're right. That's wheat—and that's a Harvard intake.

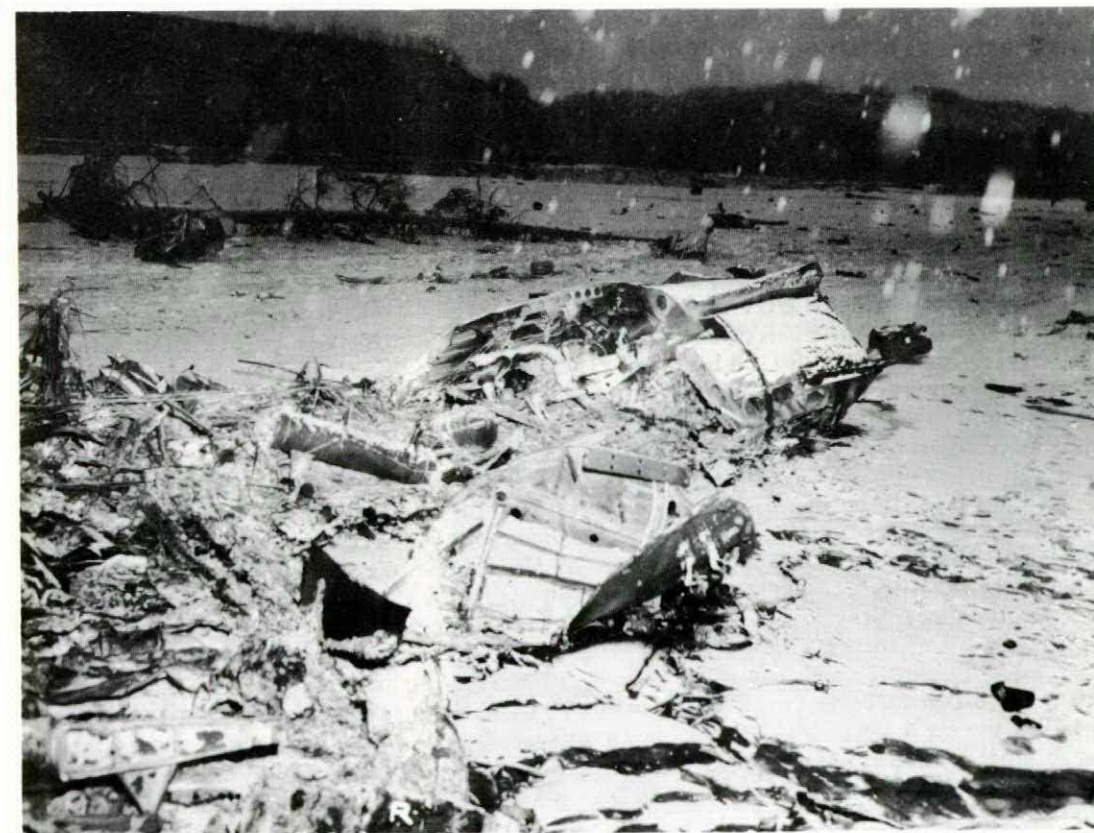
Too low again. Mother Earth didn't budge a foot.

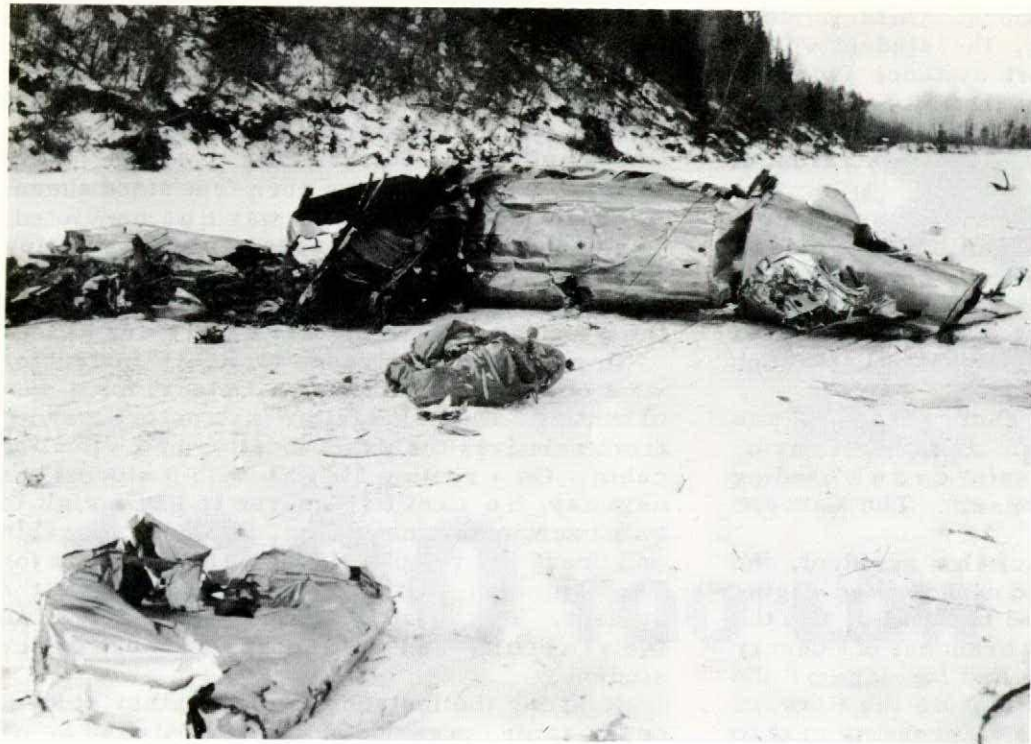
This was a Mitchell that flew a shade too low.

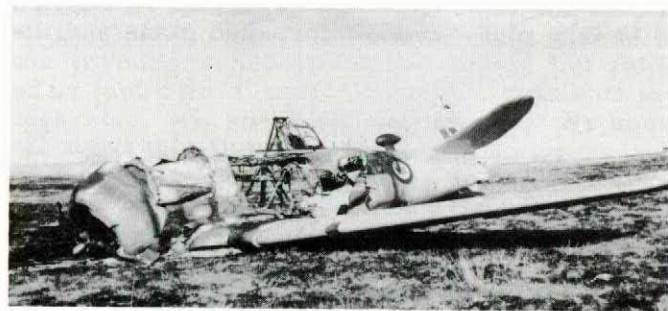
The end of an authorized low flying crosscountry exercise.

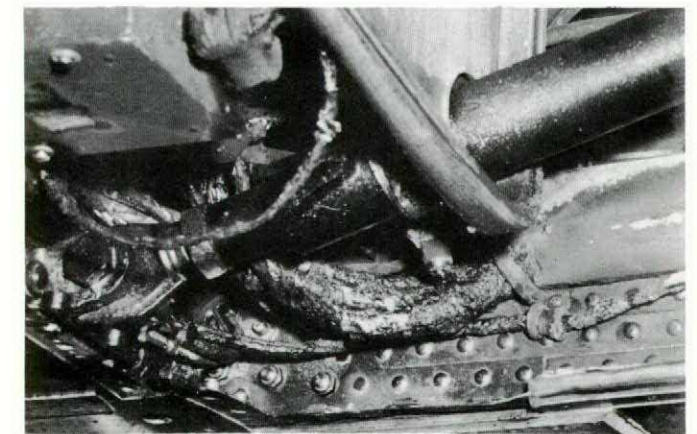
A later investigation revealed that a fire and explosion had occurred in the rear of the port engine cowling. The fire had centered in the vicinity of the rear engine mount bracket, but heat and flames were drawn forward along the wing root and into the space behind the leading edge of the wing. Extensive damage was done to the wiring associated with the E4 junction box, and to piping, tubing and wires (including the alloy pitot and static lines) routed to the wing leading edge.

It was concluded that, during the relight attempts, fuel had leaked through the expansion joint between the exhaust cone and the tailpipe, and flowed forward in the tunnel under the fire cone assembly to settle in the aft cowling in the region of the junction box. When the pilot took relight action, flame was propagated forward via the same route and ignited a substantial fire in the cowling area. This excess fuel had pooled during the undetermined interval between the time the engine flamed out and the time the

Extensive damage was done to the junction box wiring.

Unless the HP cock is closed immediately after flameout, the resulting accumulation of excess fuel constitutes a grave fire hazard. If the flameout is not detected at once, steps must be taken to allow the engine to drain and dry out before relights are attempted.

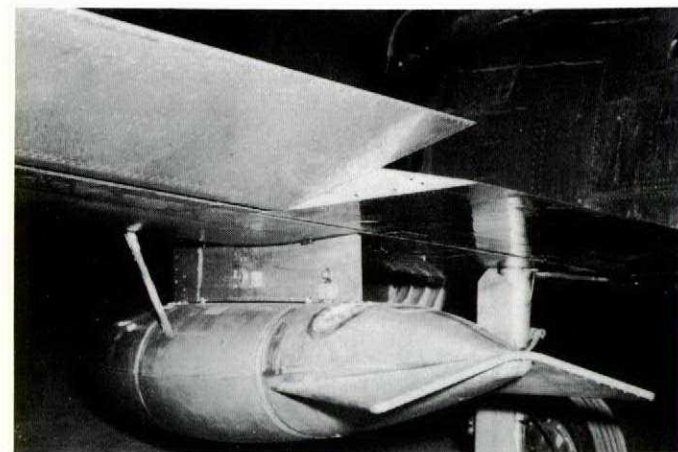
The port aileron actuator piston rod had fractured... jamming the aileron in the "up" position.

aileron actuator piston rod had fractured, the rod end assembly dropping in such a way that it jammed the aileron in the up position.

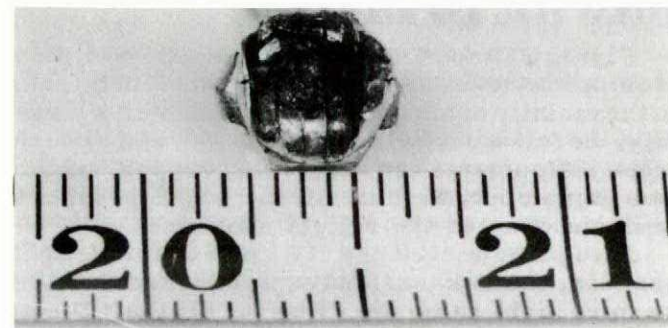
Investigation showed that a 10/32" fibre insert lock nut (AN365) was lodged between the starboard chain and the sprocket on the end of the torque tube. All bolts of this size used in the area were inspected, but none were missing. How the nut got there could not be discovered.

A fibre insert lock nut had lodged between the starboard chain and the sprocket on the end of the torque tube.
