COMMENT

ROYAL CANADIAN AIR FORCE

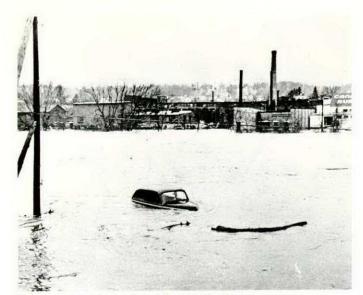
Damage caused by hurricane Hazel in the Toronto area.

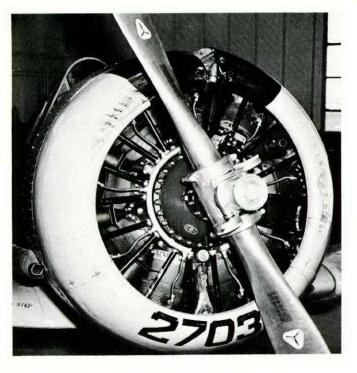
Four dzuz fasteners were not properly secured.

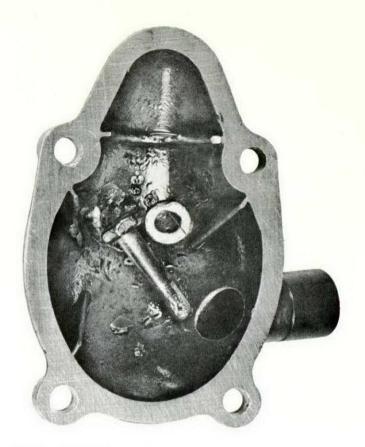
Foreign objects discovered inside a rocker box cover.

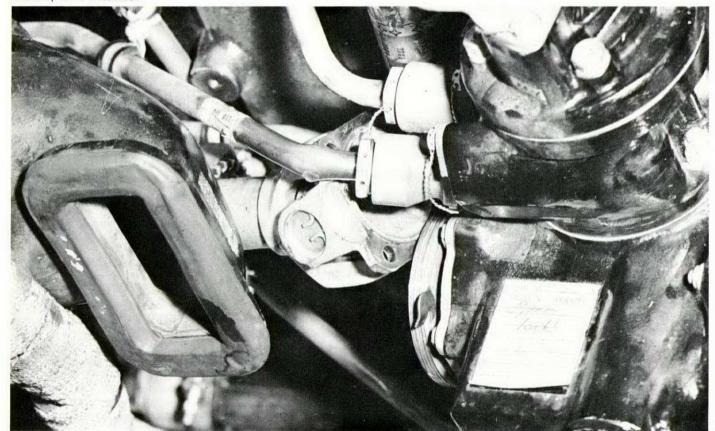
Two trades worked on this accessory drive disconnect.

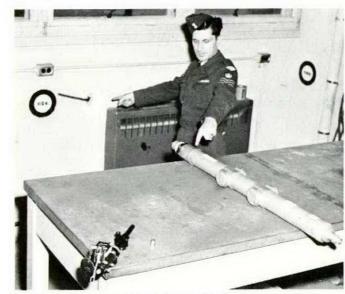
During a periodic inspection on a CF100 the drogue guns were removed and taken to the armament repair shop for servicing. The Cpl put the guns on the workbench and explained to the M&WTech the procedure for carrying out an inspection on the drogue gun. The Cpl then went to the tool crib. In his absence the M&WTech secured a drogue gun in the holding bracket on the bench and proceeded with the inspection. With the barrel, piston and cartridge still installed the safety pin and sear were removed. The gun fired. The piston struck an ejection gun that was on the bench and ricocheted against a concrete wall.

Cause: Instructions laid down in EOs 55-50-2B and 55-50-2C were not followed.

Note dent in drogue gun and damaged wall.

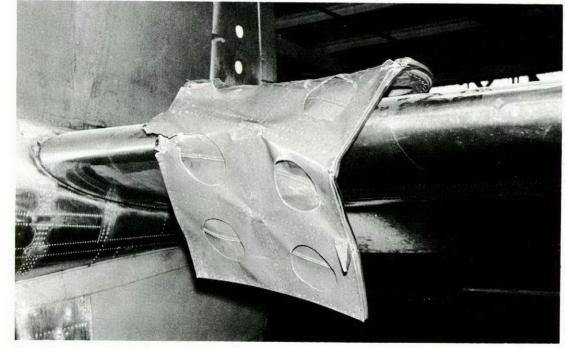
An RCAF C119 was engaged in a paratroop' dropping exercise. When readying the aircraft' for the drop the starboard paratroop door latch' was found jammed in the closed position. The captain sent the flight engineer aft to determine the cause of the jamming and to assist in opening the door.

A paratroop door that was removed during flight.
