FLIGHT COMMENT

ROYAL CANADIAN AIR FORCE

EDITORIAL

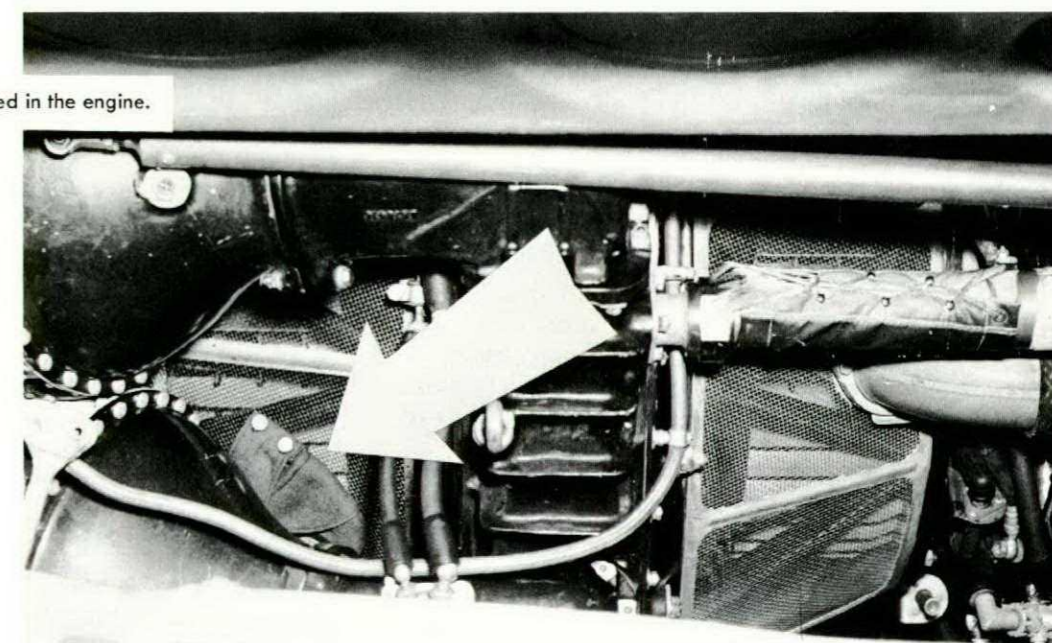
Just in case you always blame groundcrew for foreign objects in aircraft, the accompanying picture shows an aircrew officer's cap wedged firmly between the aft screen and the burner of a T-33. It was found by an airman who did a thorough check through the starboard trunnion access panel. Fortunately, or unfortunately, the owner's initials were inscribed in the cap. The aircraft had flown 21:35 hours between the time the cap was reported lost and the time it was found.

The pilot thought he had left his cap in a flight planning centre somewhere. When questioned, he stated that he never places anything in the intake nor does he suspect that his cap fell from his pocket when he checked the upper plenum chamber. How it became lodged in the engine must remain a mystery.

An aircrew officer's cap was lodged in the engine.

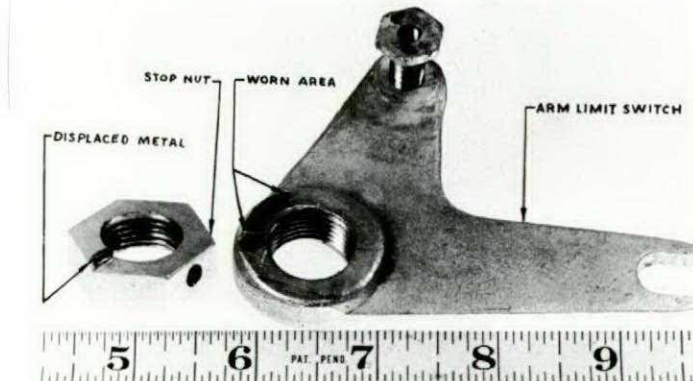
Cause of the trouble was traced to an incorrect adjustment of the bolt flap limit switch on the up selection which allowed the arm flap limit switch to contact the stop nut and limit switch simultaneously. The error in the adjustment slowly increased due to wear on both the stop nut and the threaded portion of the flap arm limit switch. Finally a point was reached where the shaft flap gear sheared across the taper pin hole at the universal.

Because it required a long time for this maintenance error to grow into a serious incident, it is not possible to identify the miscreant. However, time has revealed his error and demanded a few grey hairs and a lot of extra work as payment.

Continued stress caused the shaft to shear. Wear caused by improper adjustment.

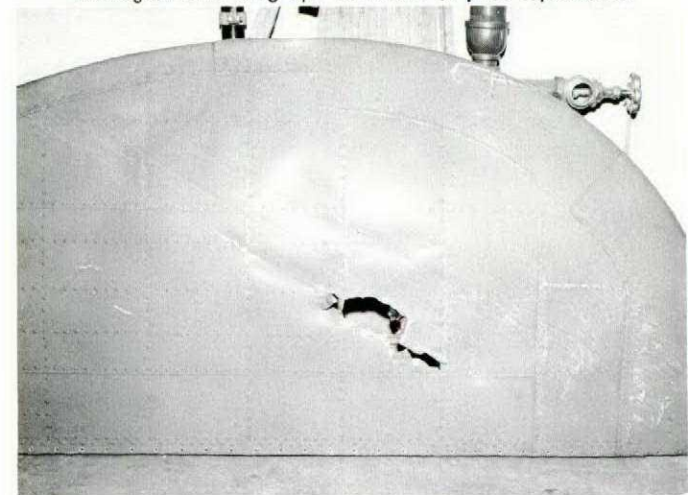
The EOs are quite specific about who should direct the towing of aircraft and where each member of the towing team should be positioned. "Coming into the hangar" is not one of the positions. The NCO in charge of the line servicing crew was also at fault; when he did not choose to direct the towing personally he should have detailed one of the men to take charge. He did not do this and, as a result, we have four men trying to tow aircraft instead of a towing team doing it properly.

Damaged C119 wing tip—the result of poor supervision.

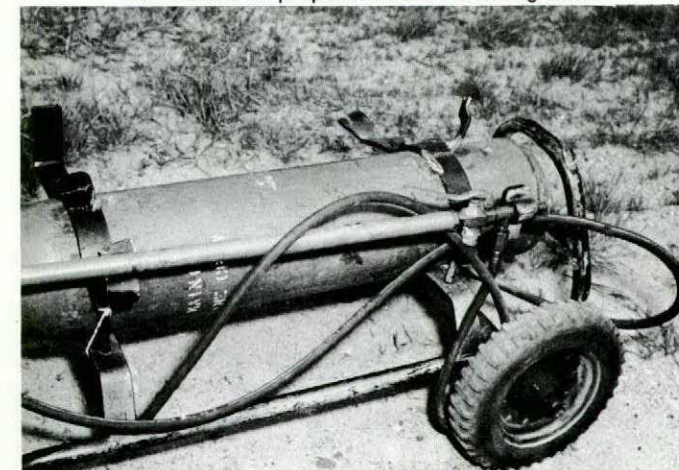
On this night, to cutdown turn around time, a number of aircraft were being serviced and armed in a confined, unlighted area. The ground equipment was pooled to one side of the taxi strip. After the "monster" was fired up the extinguisher was dropped in the grass six feet from the tarmac on the side opposite the pooled equipment. The pilot made a 180° turn and when he started to taxi the propeller tips of the

The "monster's" propeller struck the extinguisher.

outboard engine struck the extinguisher. Fortunately the engine was not damaged so a prop change was all that was required. Cause was assessed as poor marshalling - "Ground". (To quote from the editorial in the July-August issue of Flight Comment: "...and to ensure safe handling of new equipment, a greater emphasis must be placed on supervision." This is a case where old habits and new aircraft are not compatible. Supervisors please take note.—ED)

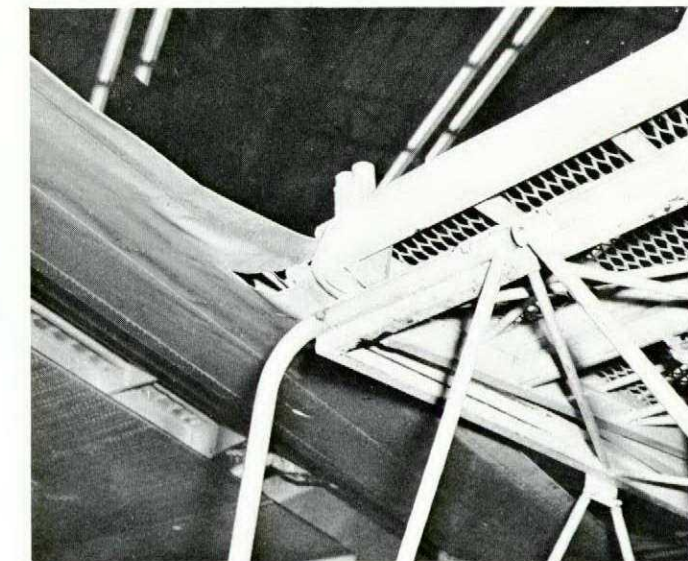
An Argus had been hangared for defrosting, general cleaning, and to have a minor electrical defect corrected. When AC power was switched on at the flight engineer's panel by the electrical technician the flaps lowered onto a maintenance stand. The flaps had been in the full up position when AC power was applied. The cockpit was checked immediately after the accident and the flap selection lever was in the full down position.

The instruction for provision of ground power as detailed in EOs, though adequately covering the procedure for turning on power at the engineer's panel, does not adequately detail the

The flap lowered onto the stand.

checking of selector levers in the cockpit to ensure that they agree with the actual position of the components.

The unit has taken UCR action. It has also issued a Flight and Section Order to ensure that all panels and consoles are checked to ensure that controls are in the required position relative to the component which they operate; and to place the Argus out of bounds to personnel not specifically authorized to work on it.
