# FLIGHT COMMENT

# A FORCED LANDING IS INVESTIGATED

by S/L G. L. Sheahan

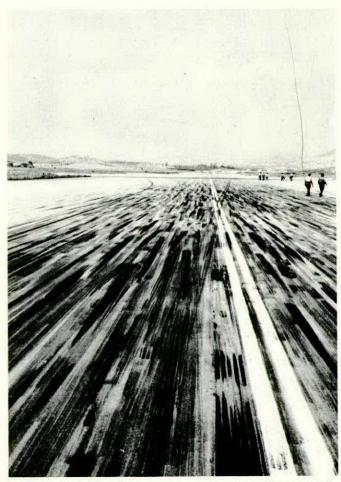
Heavy black marks at the approach end of your runway are proof of premature touchdown.

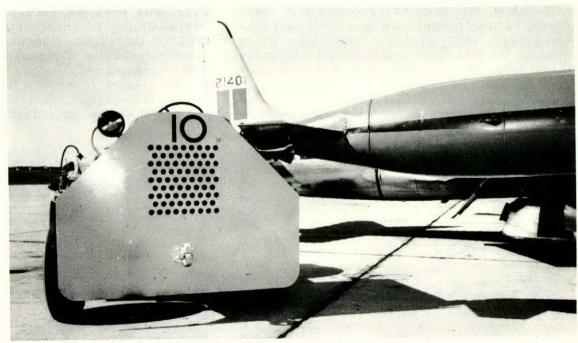
the brake pedal was worn smooth.

cising due caution. And again we have two items—the condition of the airman's boots (his responsibility) and the condition of the D6 (ME's responsibility)—that had nothing to do with the T-33 which, plus a little negligence, contrived an accident.

The brake pedal was worn smooth.

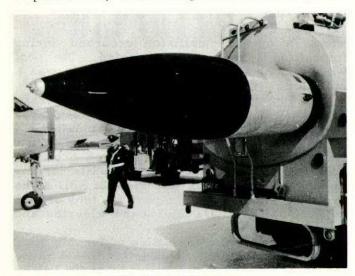
The pilot had been taxiing his aircraft parallel to the back of the fuel bowser. As no marshaller was in sight the aircraft was stopped almost directly behind the bowser. A marshaller finally appeared about 75 yards away and motioned to the pilot to come to him; so the pilot turned to pass between the bowser and another CF100 which was parked 114 feet from the bowser.

In this case the bowser came out second best interms of repair dollars. It goes without saying that this accident may not have happened if the marshaller and the aircraft had been separated by something less than 75 yards.

A secret weapon or a direct hit stbd of centre?

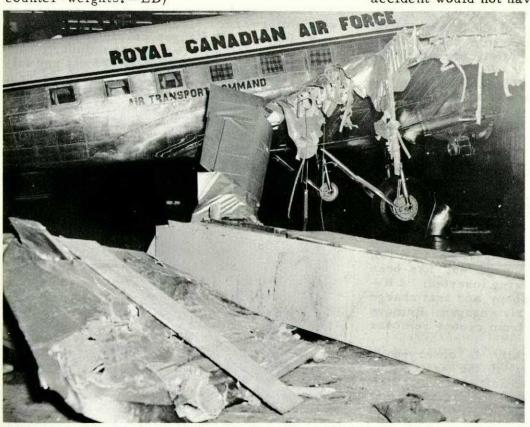
3 feet, the operating cables of one counterweight broke and sent the counter-weight crashing down on the port wing of the Dakota. Three Herman Nelson heaters were also damaged, two of them beyond repair. Total cost, aircraft and heaters, over nine thousand dollars.

The large rectangular object in the right foreground is the concrete filled counter-weight.
