FLIGHT **COMMENT**

ROYAL CANADIAN AIR FORCE

FLIGHT COMMENT

ISSUED BY
DIRECTORATE OF FLIGHT SAFETY
R.C.A.F. HEADQUARTERS • OTTAWA • CANADA

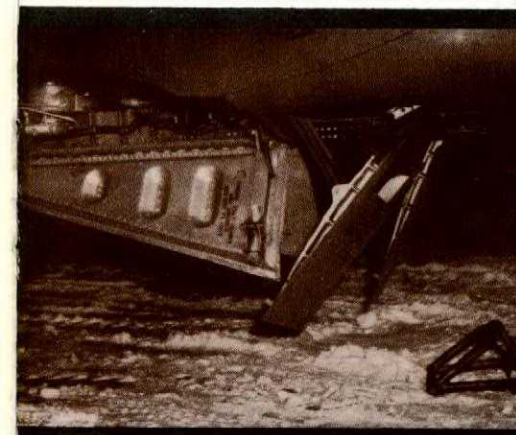
A T-33 was damaged when it was towed over a chock which fell from the mule.

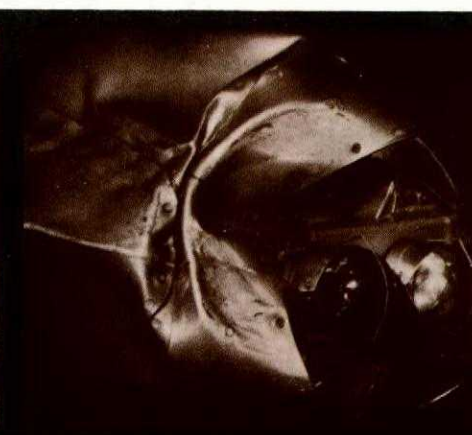
Insufficient brake pressure. Damage to the rear of a CF100 which was struck by another CF100 that broke away from its tow vehicle.

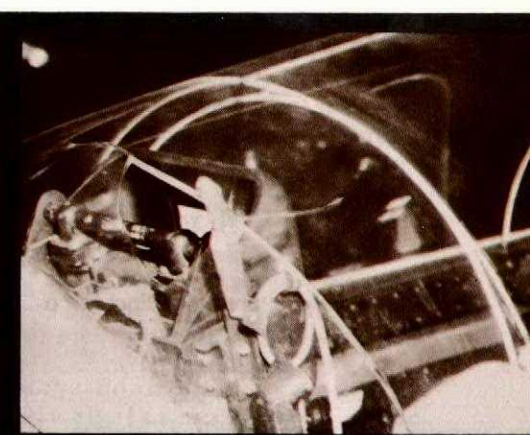
The canopy of a T-33 was closed with the seat arming lever raised.

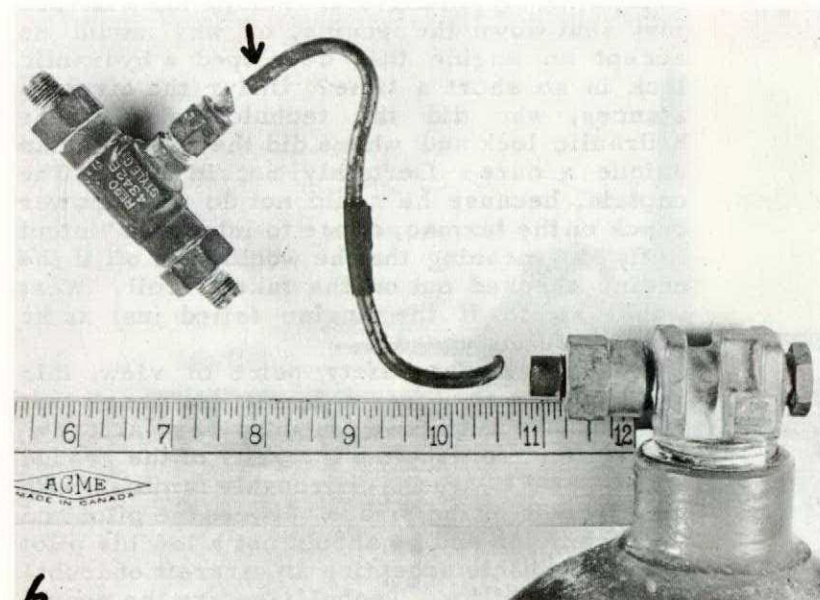
A CF100 was receiving turn-around servicing during a tip tank exercise when the Corporal who was topping up the oxygen system heard a pop, saw a spark fly down from the aircraft and then heard a hissing sound. Before the oxygen cart could be disconnected the Corporal noticed a fire inside the aircraft. The oxygen cart, refuelling tender, and personnel were cleared from the area and the fire fighters were called. Before the fire was extinguished the aircraft was seriously damaged.

A Board of Inquiry was instituted. Here are some of the more interesting items of evidence that it produced: The Corporal did not know where the closest fire alarm box was located. The technician who called the fire hall knew where the box was located but was so excited he drove the mule down to Servicing Section and telephoned the fire hall. The Board did not, however, establish the source of the spark. The oxygen system failure occurred in line 9Q22146 between No. 4 bottle and the non-return valve. (See photographs of failed

The oxygen line that failed.

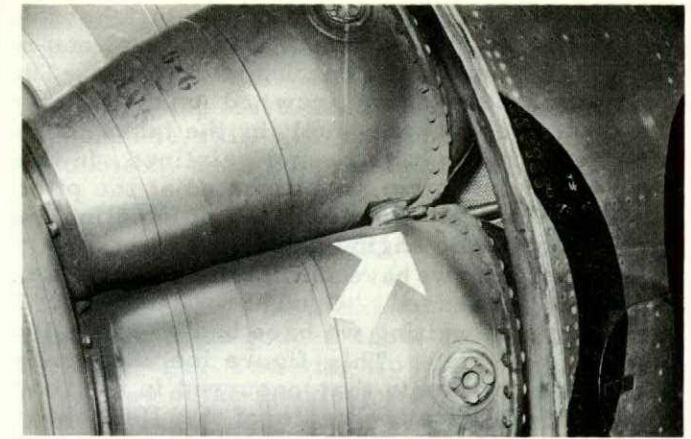
WORN INTERCONNECTOR CLAMP

It is possible to install an interconnector clamp incorrectly.

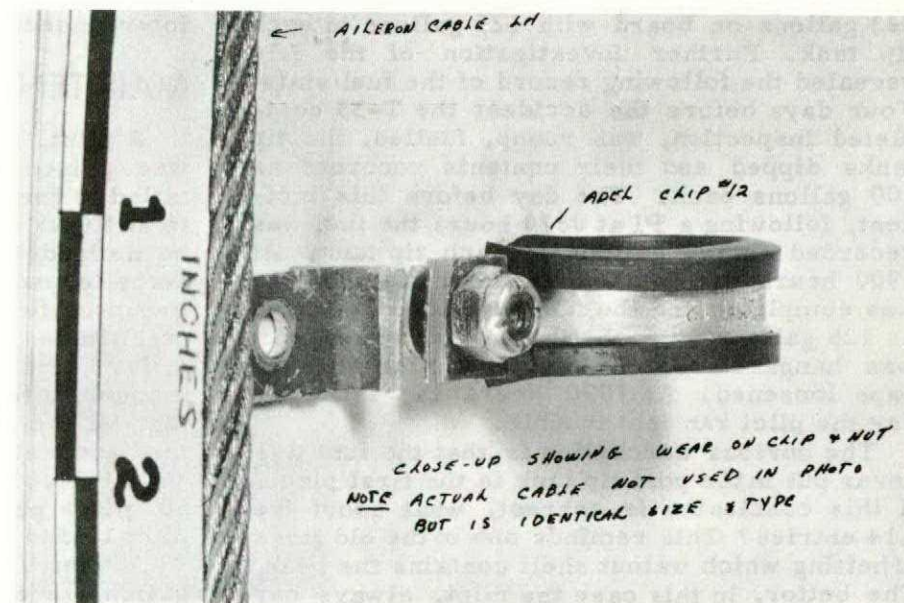
Adel clip severed by control cable.

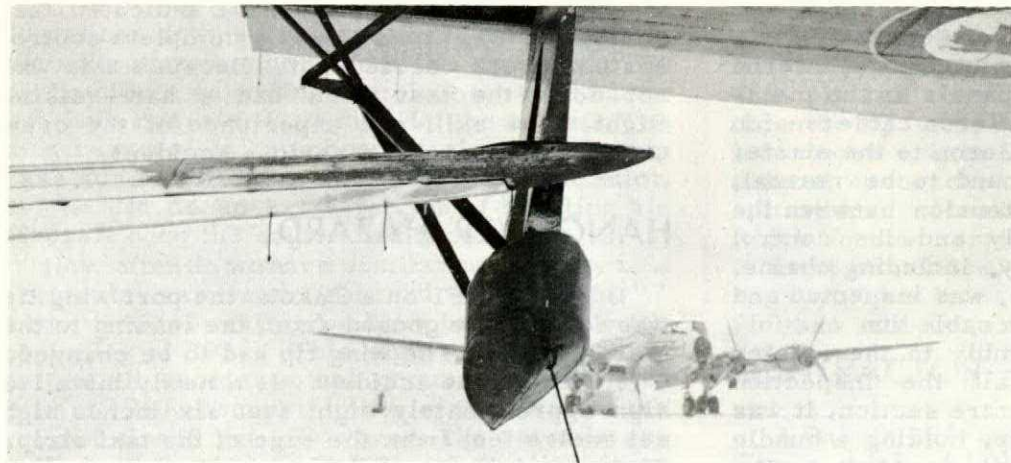
Canso wing tip float in contact with Dakota wing tip.

then "caught". The Canso jumped the starboard chock, swung through 90 degrees, and stopped with its wing tip float against the wing tip of a Dakota. The Dakota's wing tip and wing tip de-icer boot had to be changed. The Canso was undamaged.

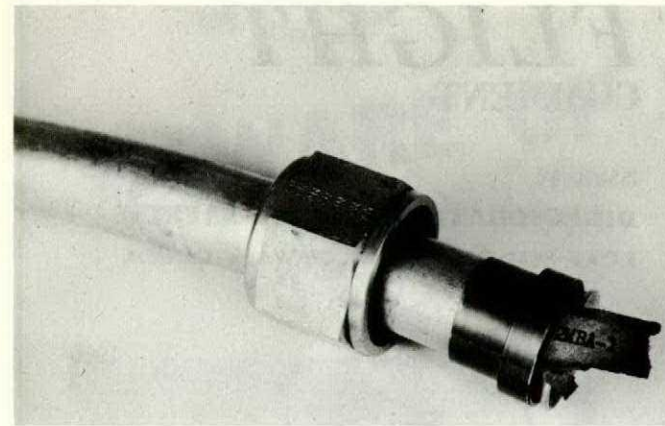
A fuel leak was found in the starboard wheel well where the fuel line from the wobble pump connects to the fuel strainer. When the line was removed the nut was found to be under-torqued, and a paper part number tab, similar to the ones used by contractors, was lodged between the ferrule and the coupling nut (see photo). The paper tab prevented the nut from being properly torqued and, over a period of time, vibration loosened it. As the L14 did

Expedito fuel line with a part identification tab under the ferrule.

not list any removal of this fuel line it was assumed that the part tab was introduced into the fuel line either during CAIR maintenance or during the original installation.

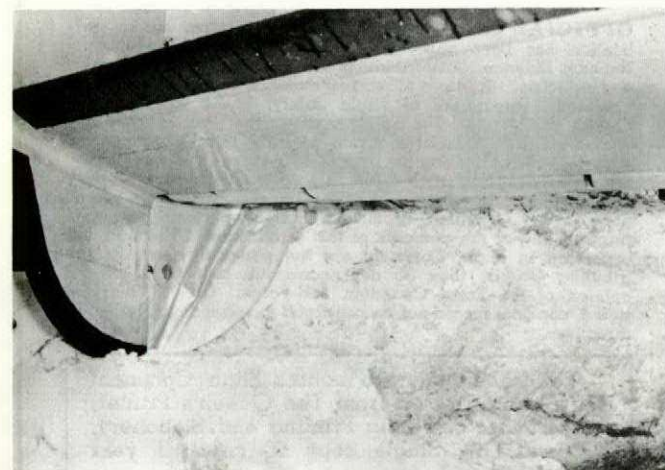
These accidents will occur while the aircraft are being parked tail-to-snowbank by ground personnel. There will be an adequate towing crew. The driver will turn the aircraft as close to the snowbank as possible so that when it is turned into line he will not have to back it into position. The wingman will watch care-

Expedito fin and rudder in contact with snowbank.
