FLIGHT COMMENT

an  
y  
response  
**RCAF**

DIRECTORATE OF FLIGHT SAFETY

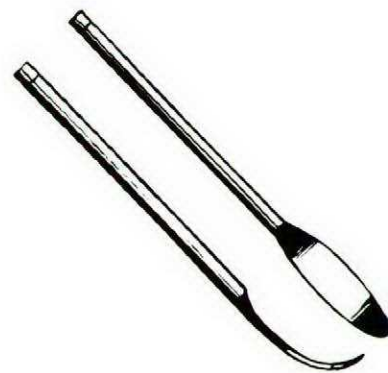
Wood or plastic removal tool will prevent damage to O-ring seat.

Ground work for a good O-ring replacement job starts with the removal of the old existing rings. Sharp or hard instruments should not be used for loosening or prying the old O-rings out of position. Any nicks or scratches incurred in the O-ring seating or groove can contribute to the failure of the new ring. To be safe in this regard, the removal tool, or tools, should be constructed of wood or plastic to preclude damage to the O-ring seat and adjacent area. The tool illustrated, or an orange stick, would be suitable for removing O-rings.

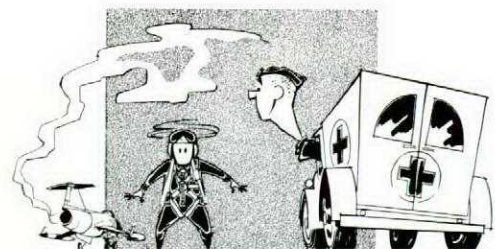
Inspection of the old, damaged O-ring may indicate failure from wear, extrusion, excessive permanent set, excessive temperatures, or "nibbling" (partial rolling) in the groove. Failure from normal wear may be expected, but excessive extrusion may indicate that the O-ring was improperly selected for the groove in which it was placed, or that backup rings were not installed when necessary.

Many factors, plus normal  
wear, cause ring failure.

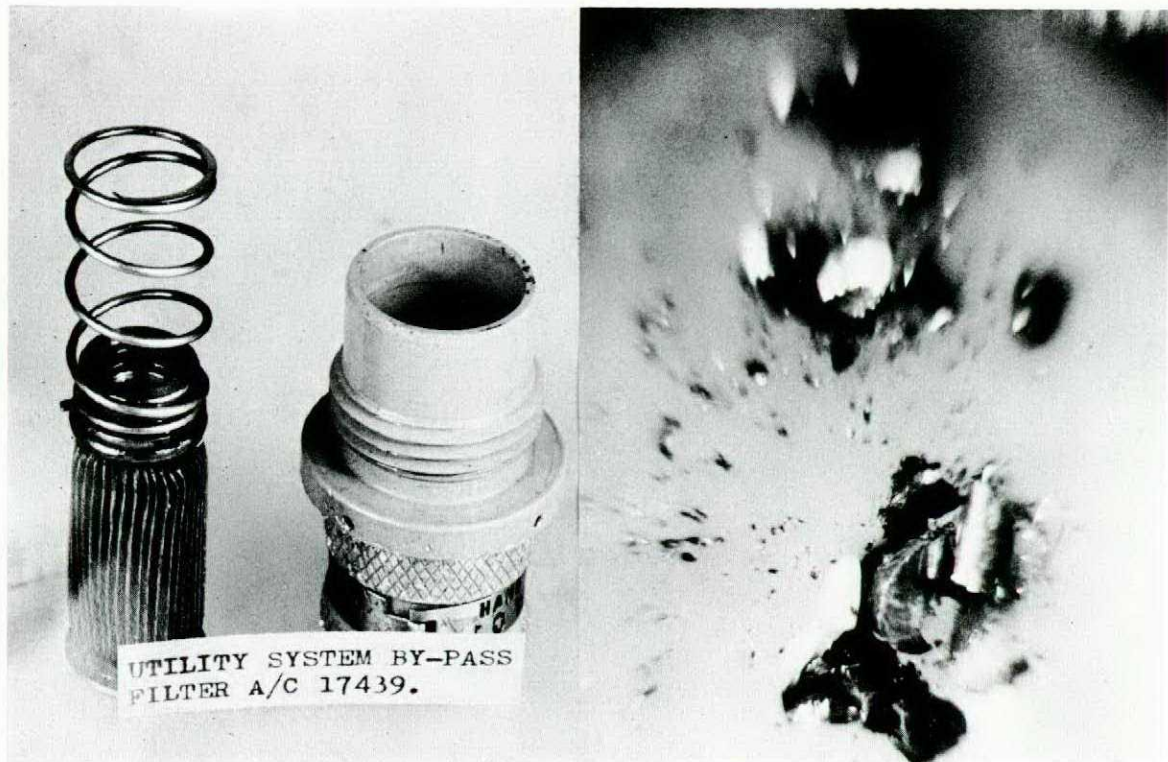
The compensator was removed from the aircraft and pressure checked at 80 PSI. Pressure was maintained for 30 minutes and a loss of 10 PSI was noted. The hydraulic test stand was calibrated and it was found to be leaking about 10 PSI. The compensator was then stripped to check the valve and O ring. They appeared in good condition. There was no evidence of fluid in the spring housing which would be indicative of O ring leakage. Fluid in the compensator by finger test, felt as if contamination was present.

Magnified contamination particles from the steering and shimmy dampening hydraulic system.

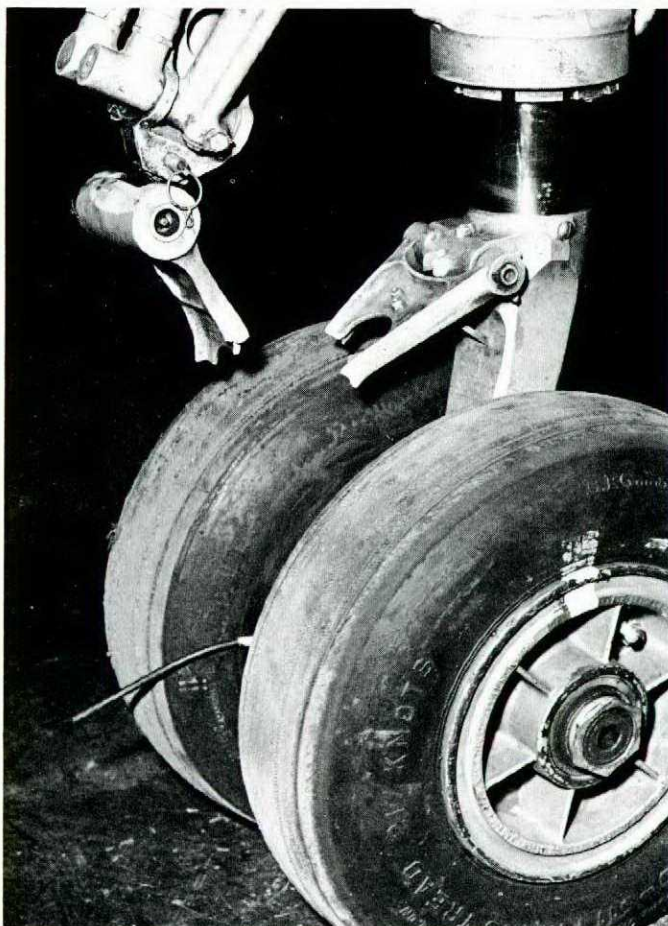
which had overstressed the material in a single occurrence. The character of the fracture excluded any material failure. The other five failed torque arms possessed identical fractures.

Examples of nosewheel steering torque arm failure.

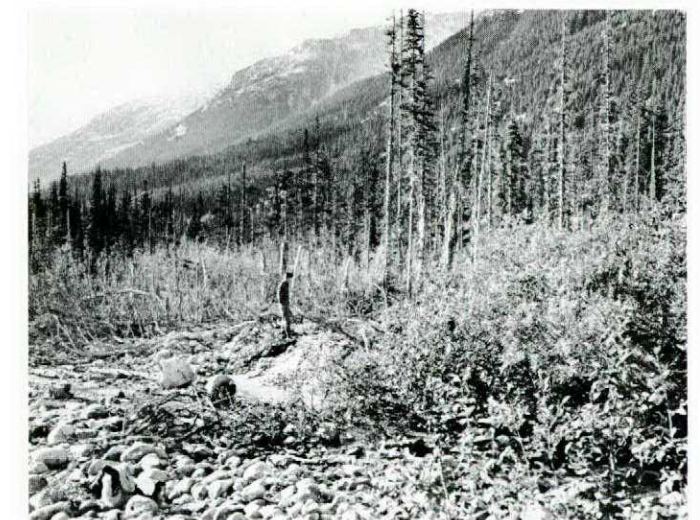
In a recent CF101B accident the crew were forced to eject after experiencing a simultaneous double compressor stall resulting in over temperatures and severe damage to the turbine rotors of both engines. Understanding the problem and thereby avoiding or correcting excessive exhaust gas temperatures (EGT) will prevent serious difficulties in the air (and on the ground).

Main impact area.

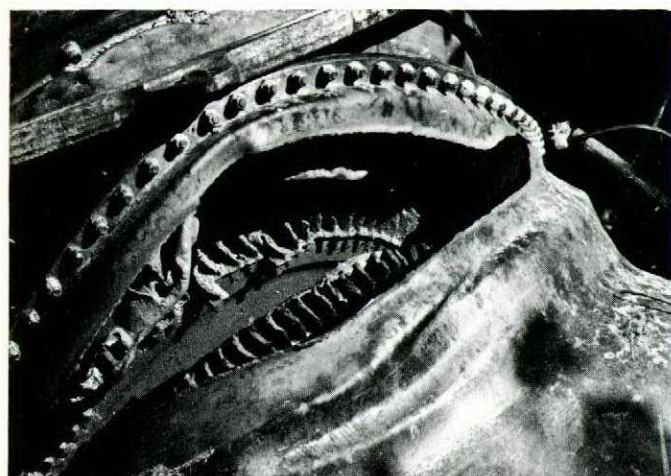
AIB investigators were immediately aware of extreme over temp. Starboard Engine 2nd and 3rd stage turbine wheels illustrate extreme damage from over temp. Port Engine similar emphasizing this happened in a matter of seconds.

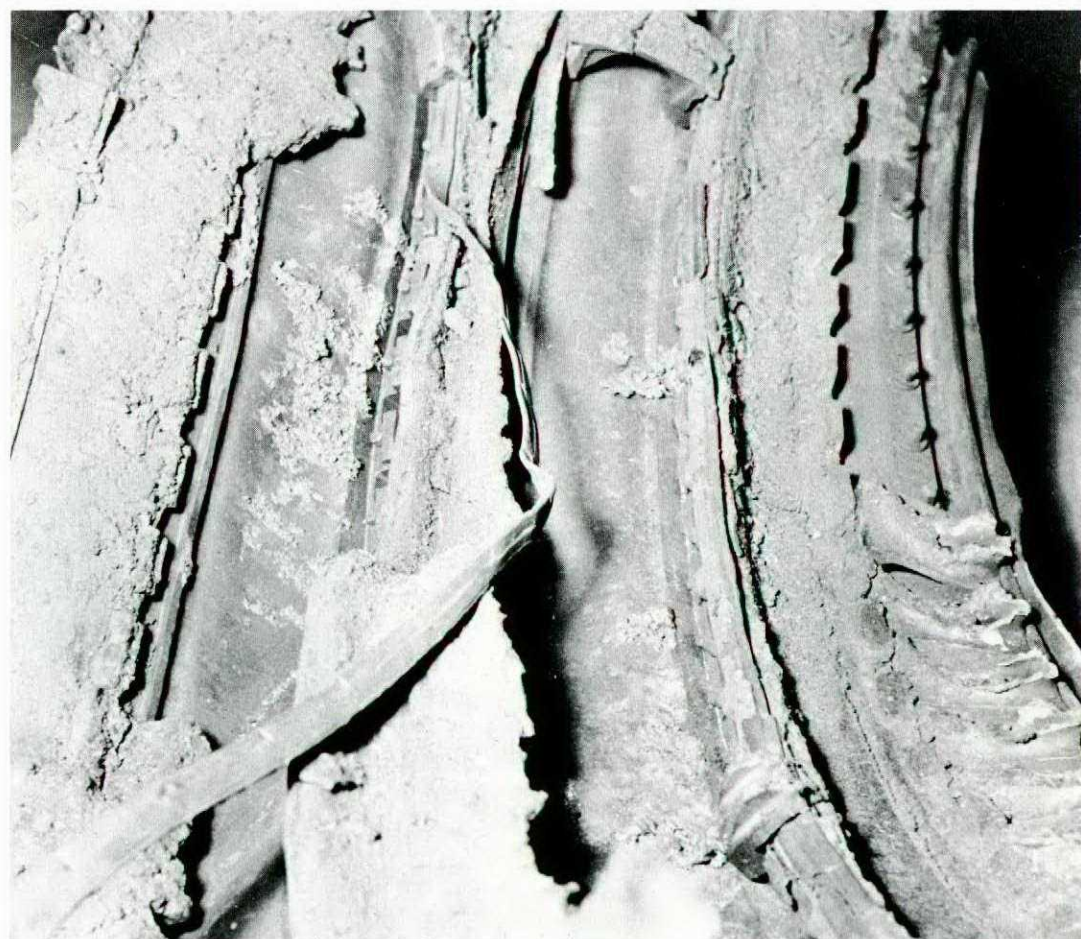
Turbine shroud case showing signs of metal flow from extreme over temp.
